Metalico Aluminum Recovery, Inc.

Re: *Former Roth Bros Smelting Corp. Site
6223 Thompson Road, DeWitt, New York
Consent Order C7-0001-94-10*

REPORT

Former Roth Bros. Smelting Corporation Site Corrective Action Management Unit (CAMU) Evaluation of Asphalt Break in Area Adjacent to CAMU

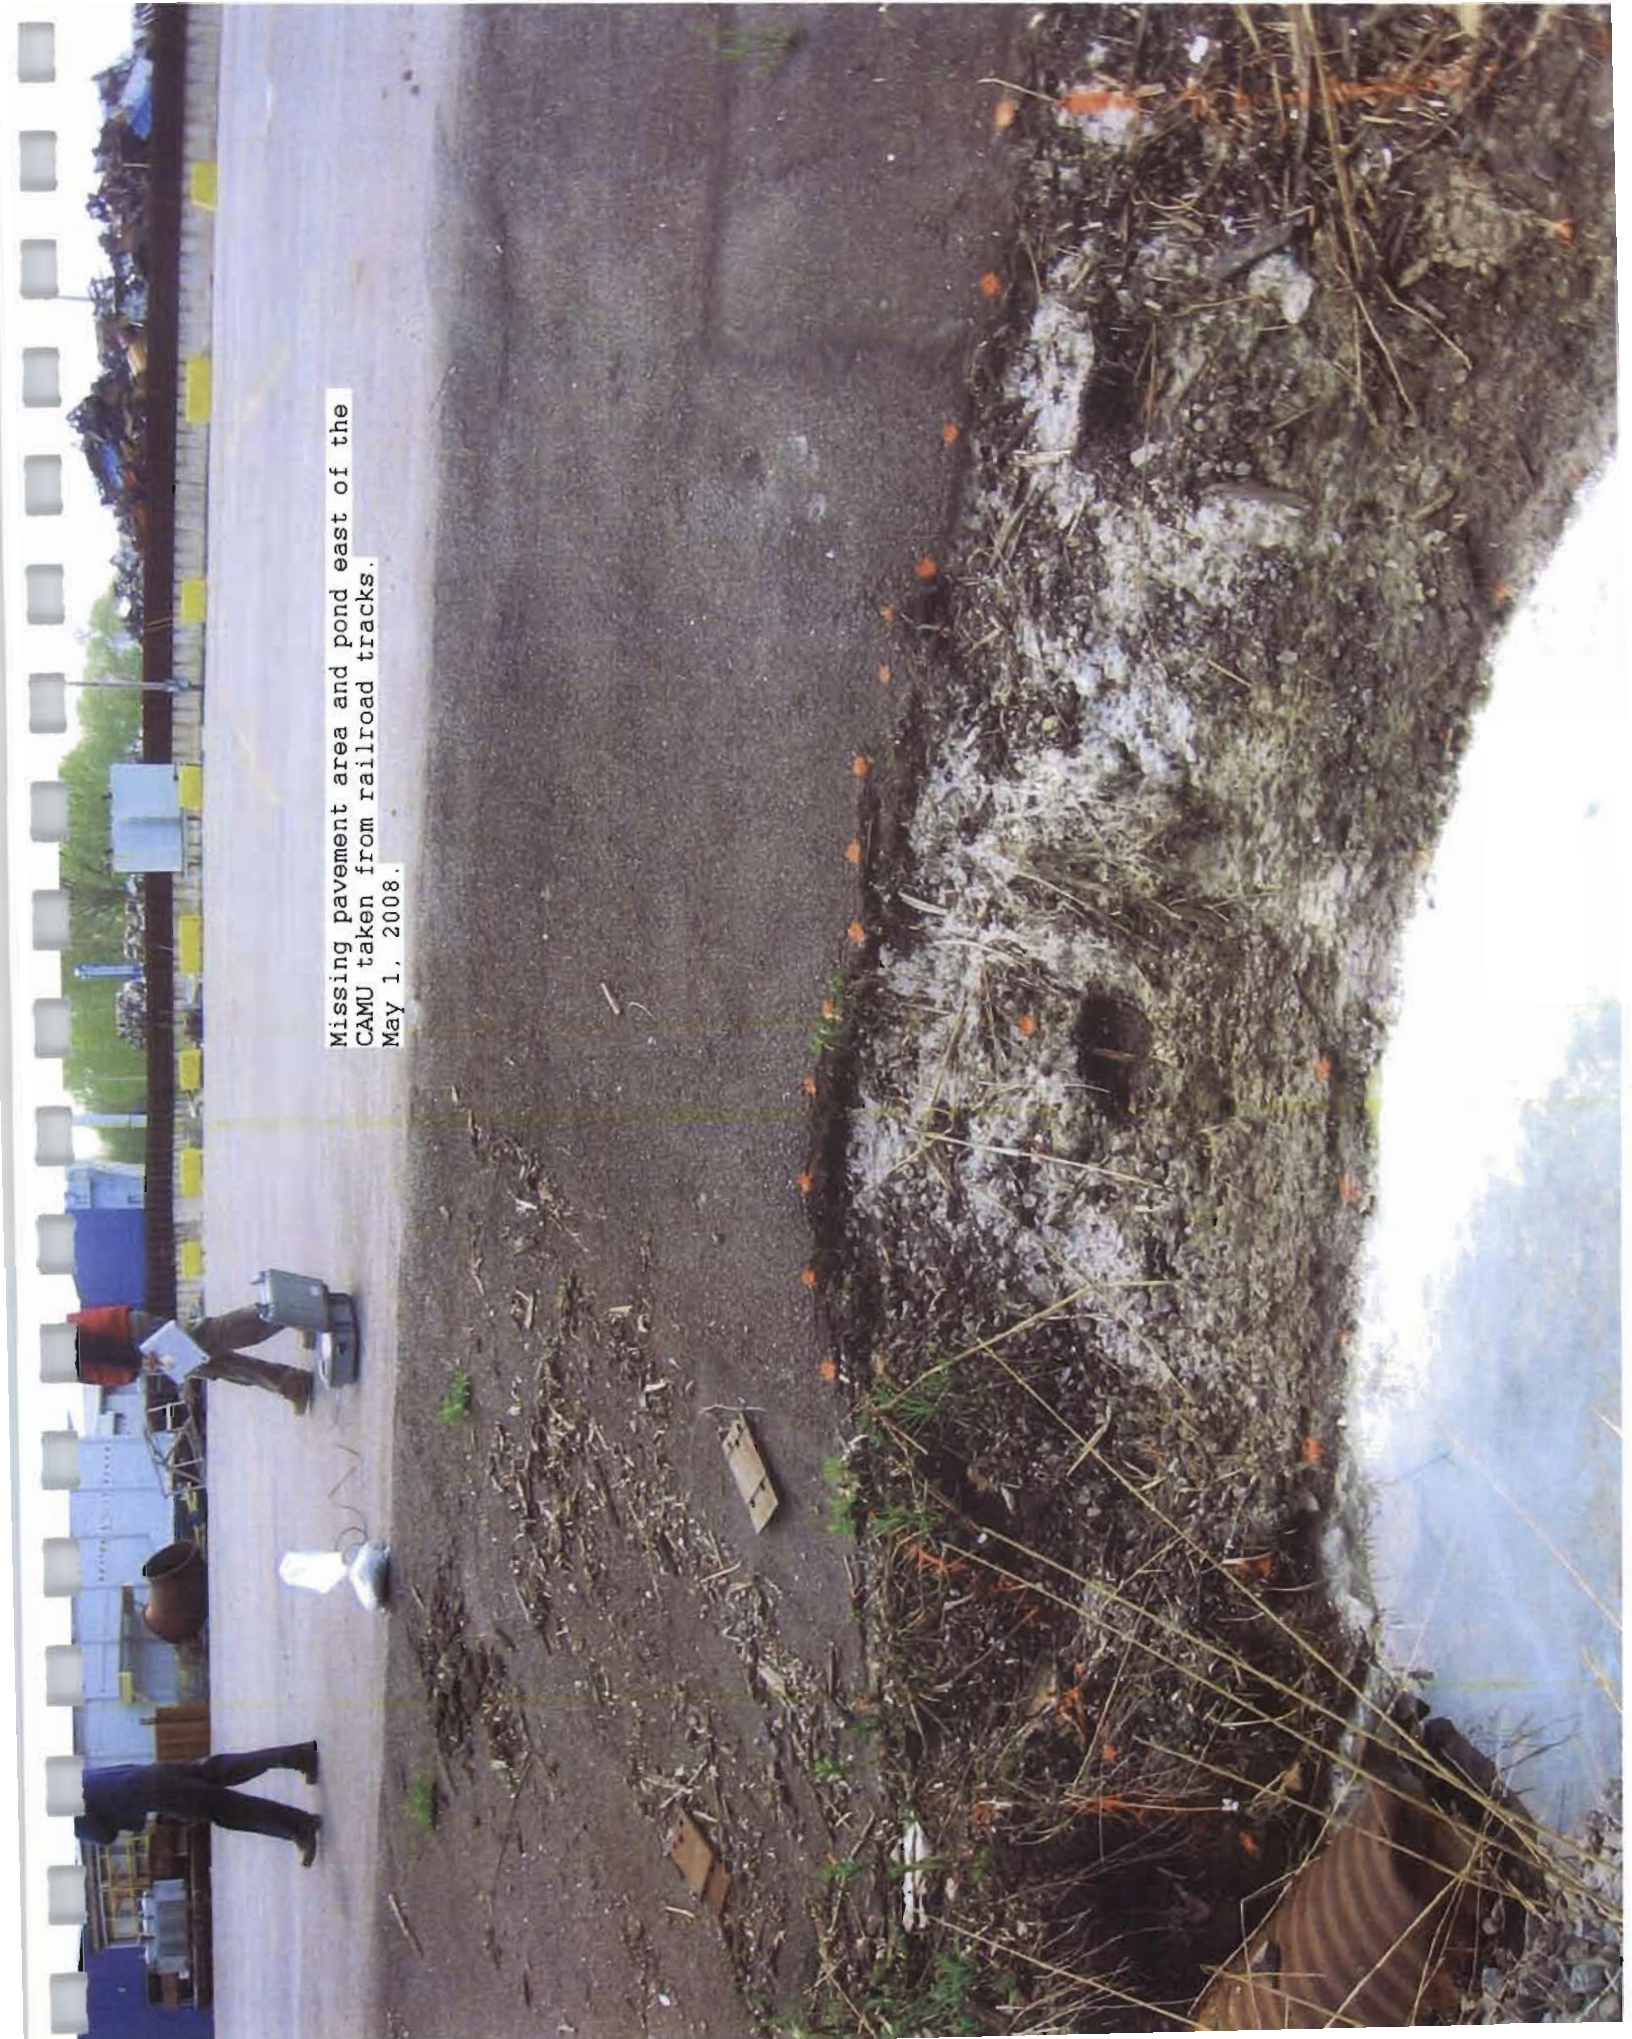
Missing pavement area and pond east of
the CAMU taken from railroad tracks.
May 1, 2008.

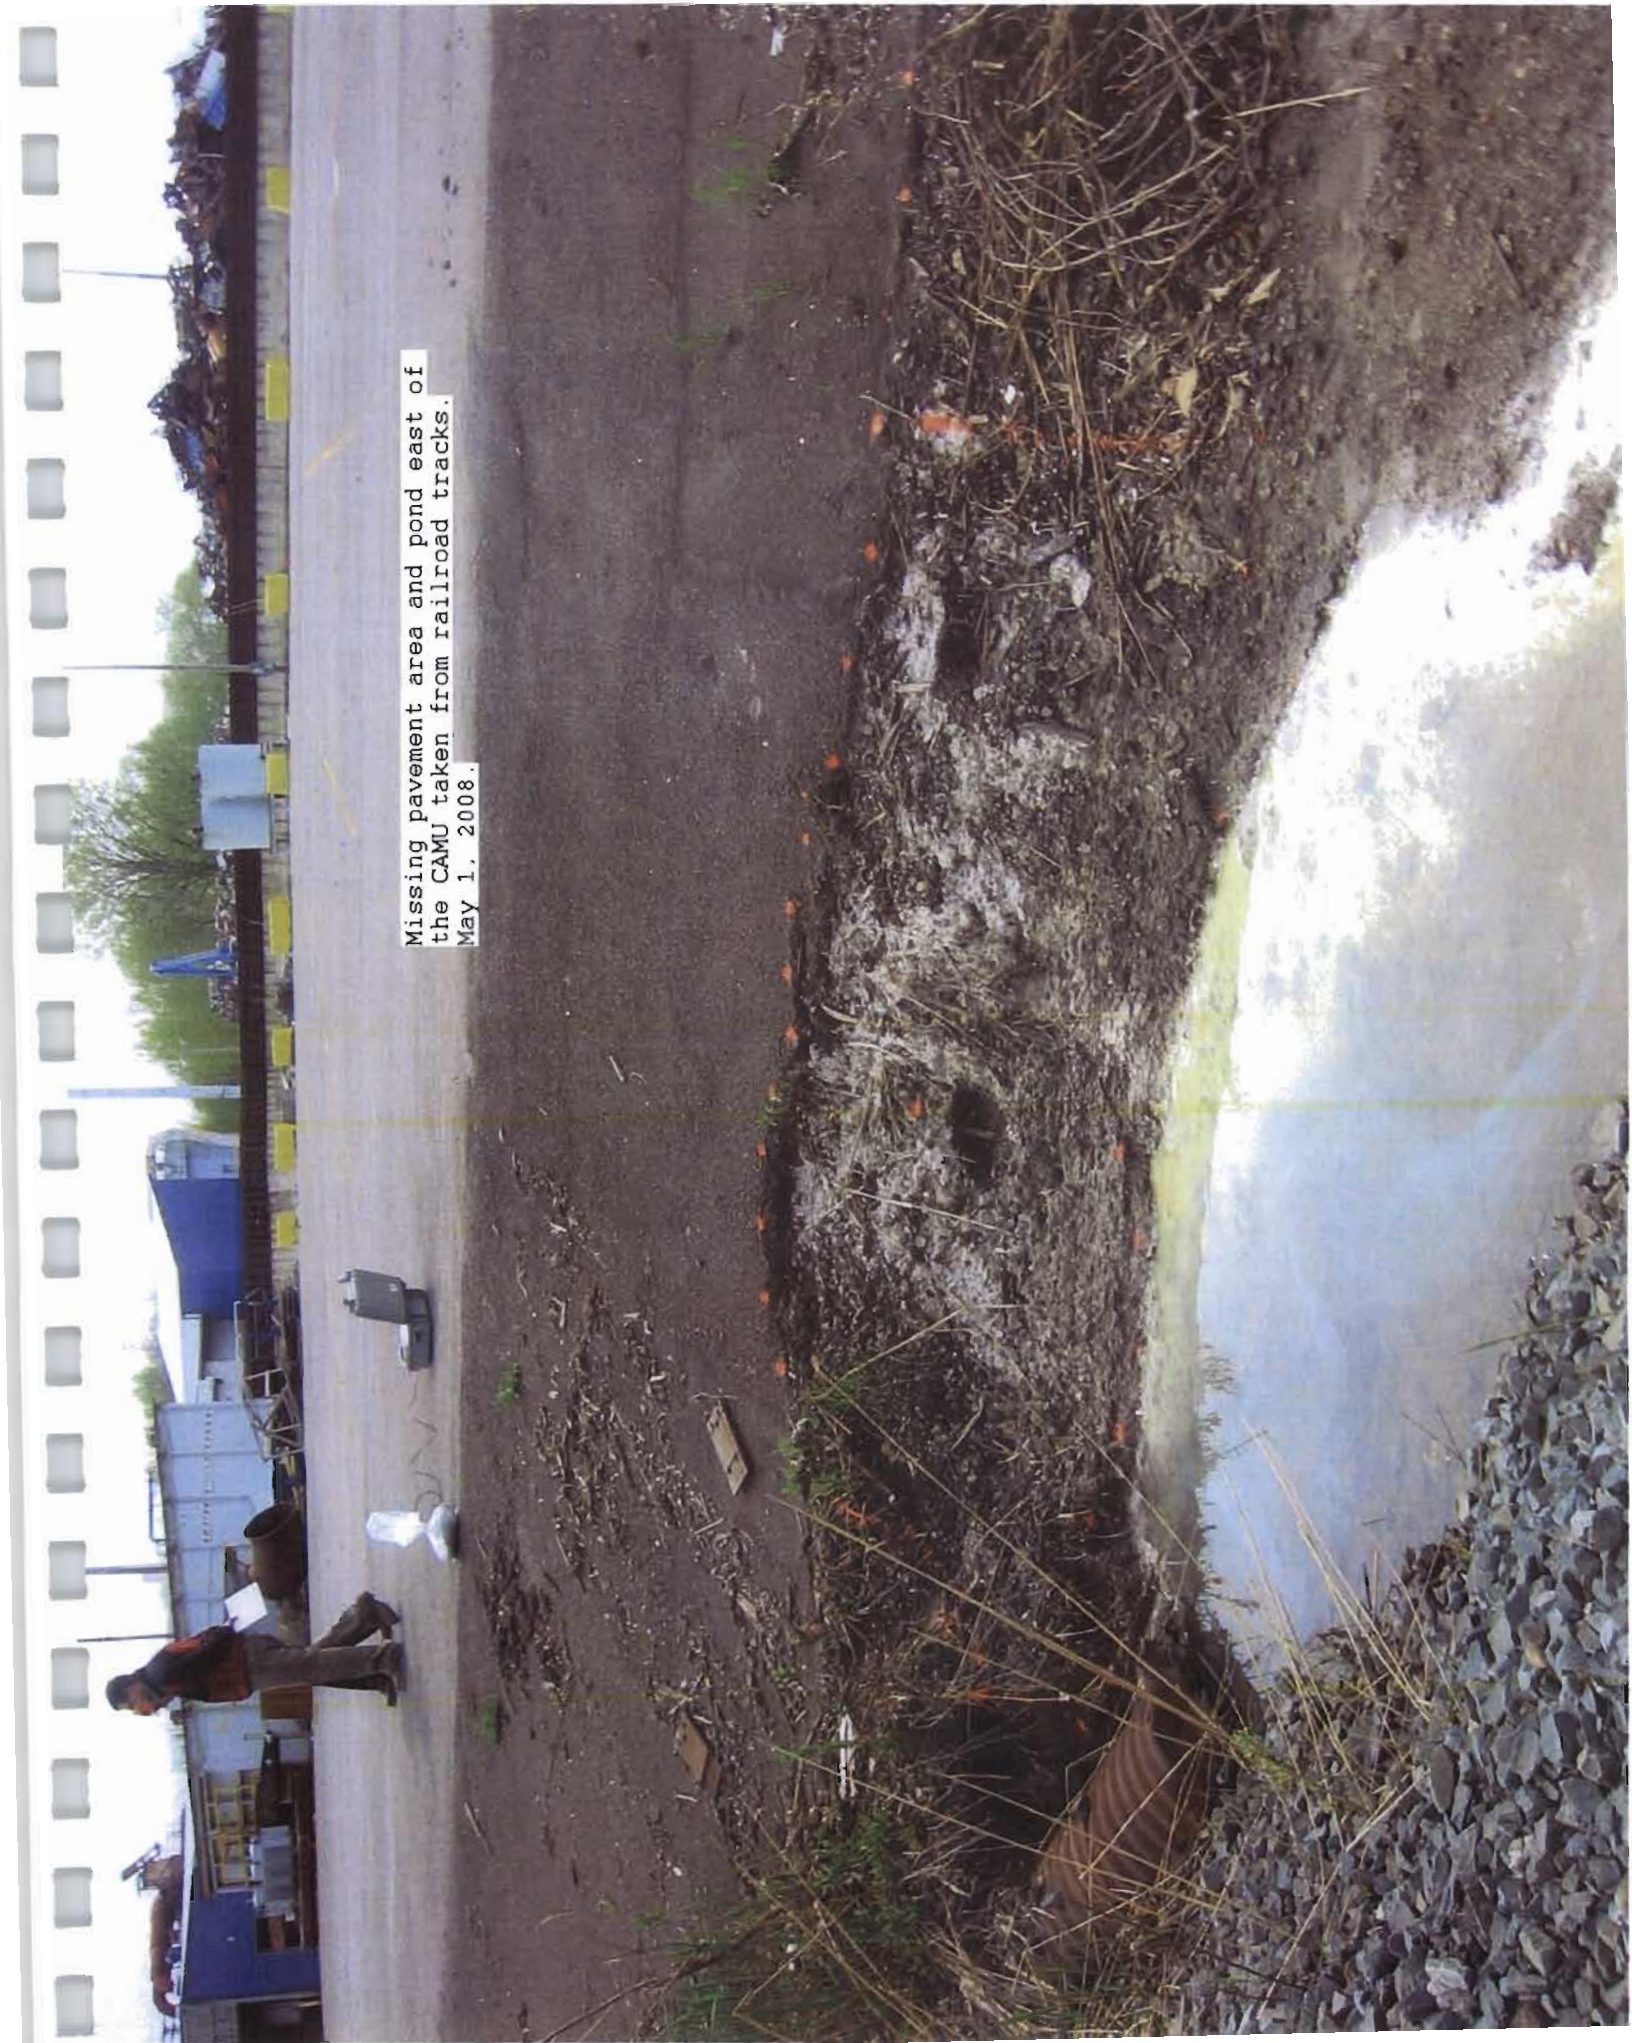
Pond east of the missing pavement area showing 21-in culvert taken from north.
May 1, 2008.

O'Brien & Gere recommends extending the 21-in storm drain pipe approximately 20 ft north and regrading this slope off the eastern edge of the CAMU over the storm pipe to match grades on the railroad side of the swale. Extending the 21-in storm drain will convey water away from the toe of the slope in the critical area while still providing capacity to transmit surface water flow.

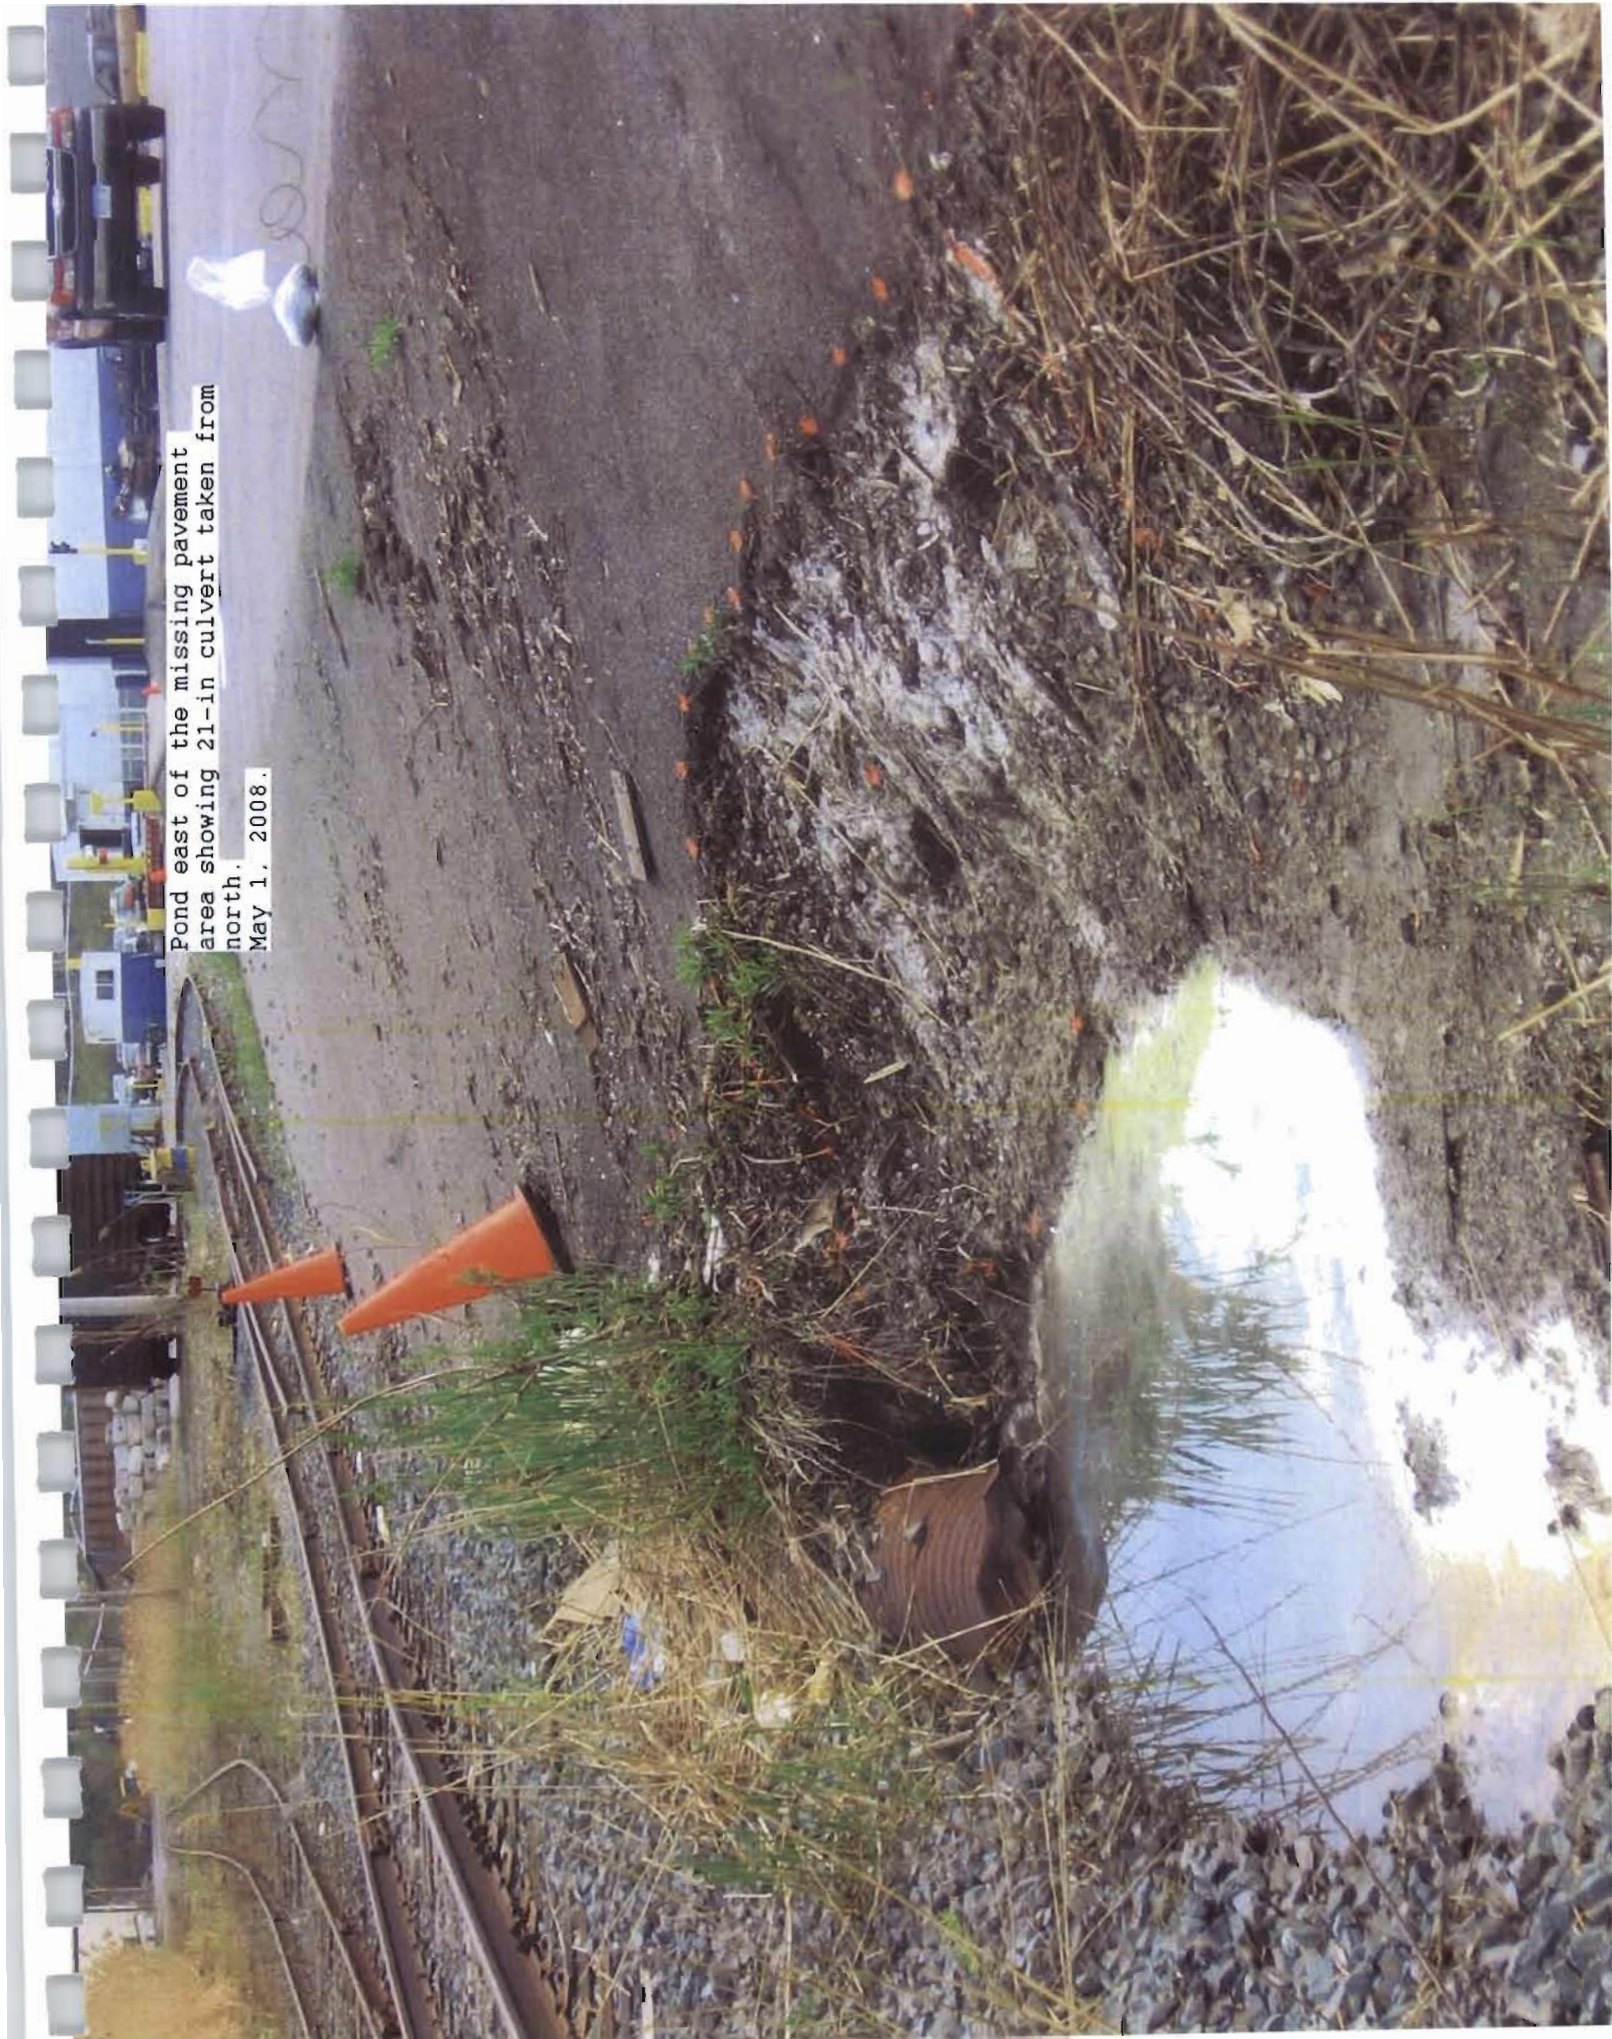
Metalico, Inc.
Slope Stability of CAMU Edge
5/5/08
High Water Condition

The slope stability analyses also showed that the existing slope would have a Factor of Safety less than 1.0 with high water table conditions. Based on these analyses and our visual examination of the area, we believe that the pavement failure is a surficial slope failure. The small section of missing pavement is on the steepest slope adjacent to the CAMU.

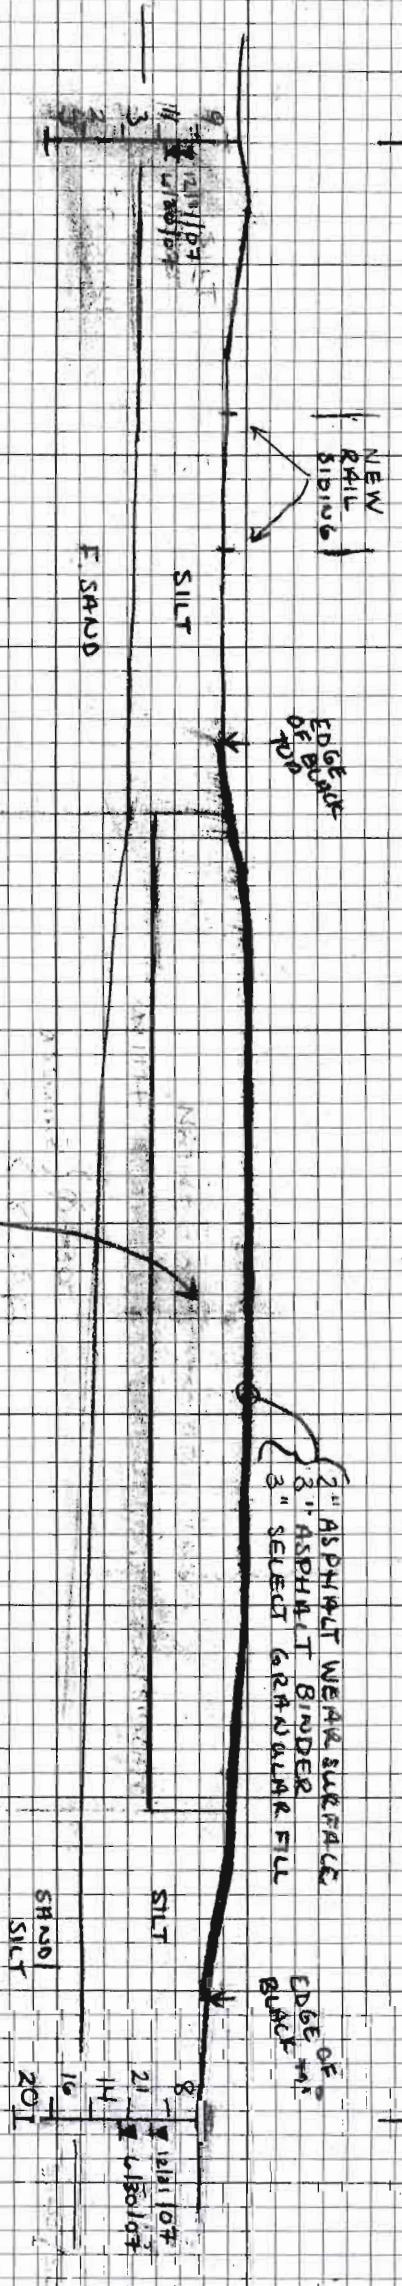
SECTION THRU CANAL EDGE
 METALICO, INC.
 E. SYRACUSE, NY
 54C 3-20-08

NATIVE SOILS STABILIZED WITH 15% PORTLAND CEMENT, 0.2% POLYMER
 ASSUME $\phi = 30^\circ$
 $K = 115 \text{ PCF}$

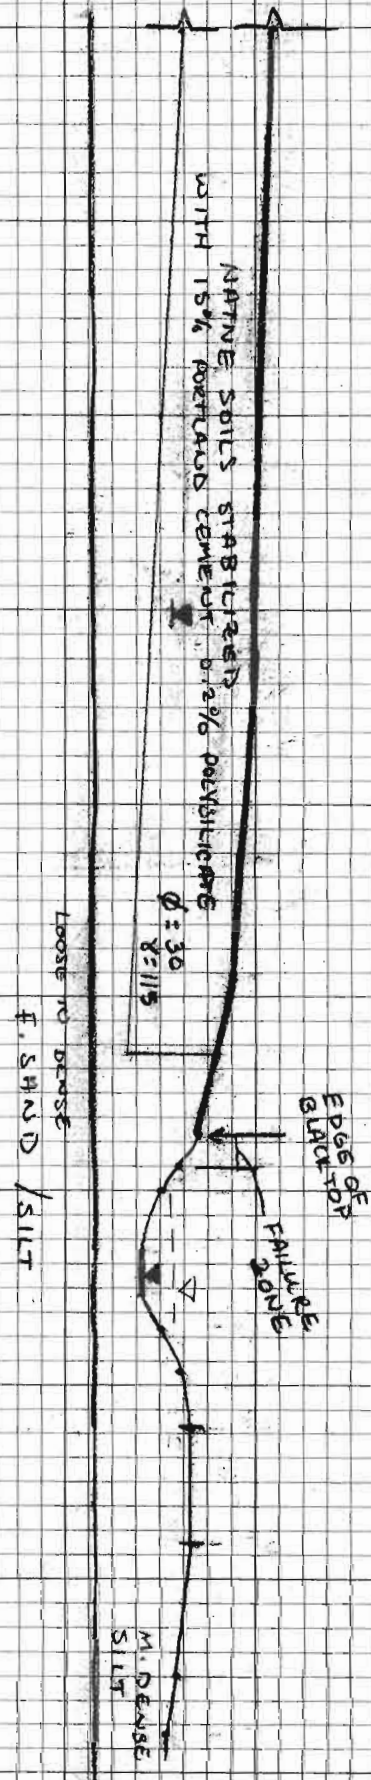
SECTION THROUGH FAILURE ZONE.
METALICO, INC.
E. SYRACUSE, NY
SAC H-2-08

The missing asphalt therefore appears to have been caused by the creation of a slope that was too steep to maintain stability of the asphalt.
