Tioga Casting Fence Removal

Owego

29 April 2009

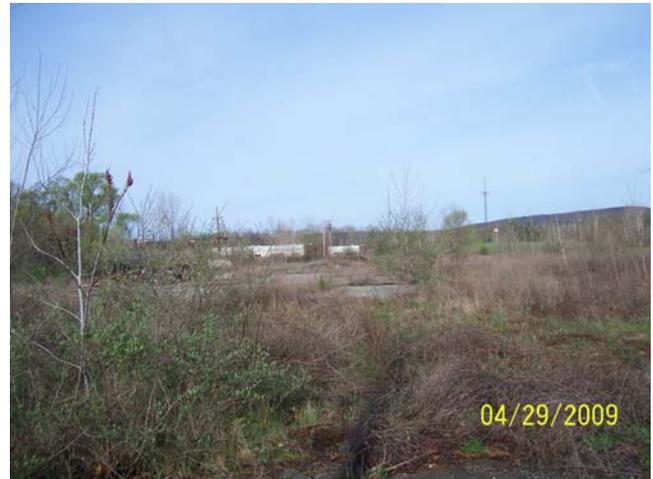
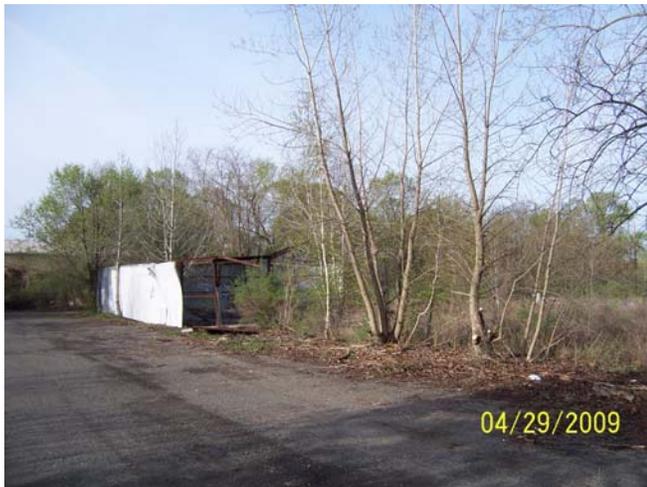
Upon initial site inspection it was noted that the town of Owego removed the fence posts along the east end of the property. The fence fabric and barb wire was removed during a sampling event conducted on April 1, 2009 by DEC work party.

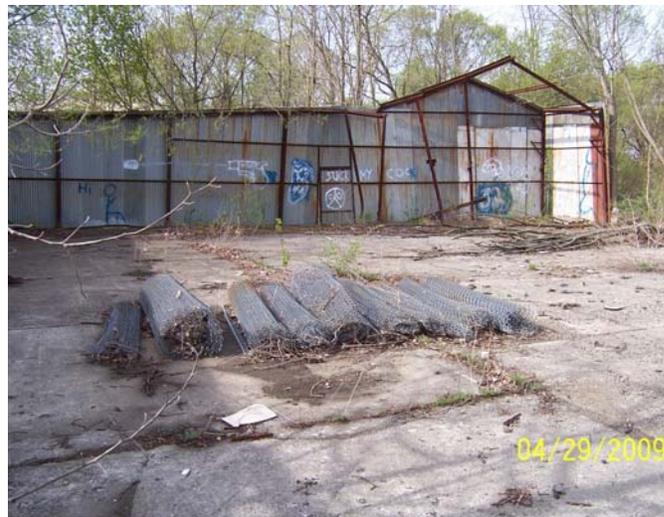
The Corrugated Sheet Metal divider was still in place.

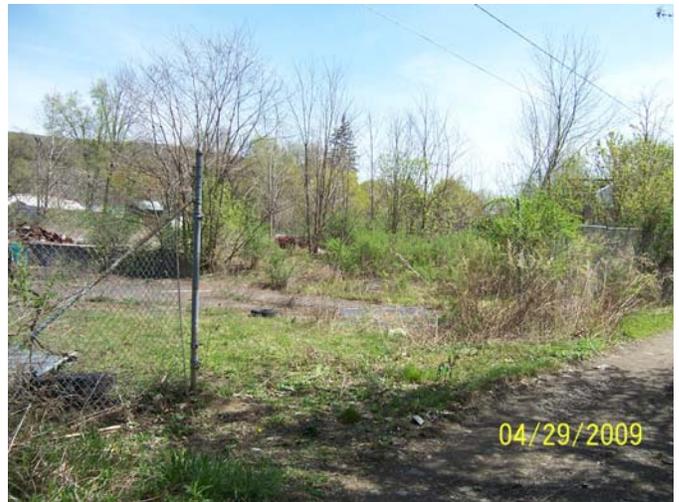
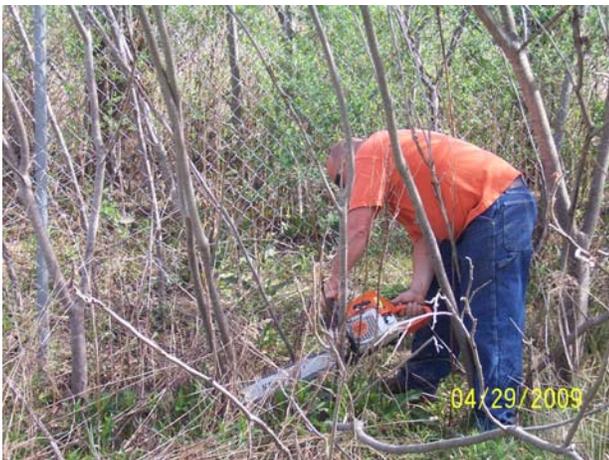
Aztech arrived on site at which time an initial site walk through was conducted. After the site walk through the demolition commenced. The fence fabric was disconnected from the posts. The barb wire was disconnected from the end posts.

The gates were removed.

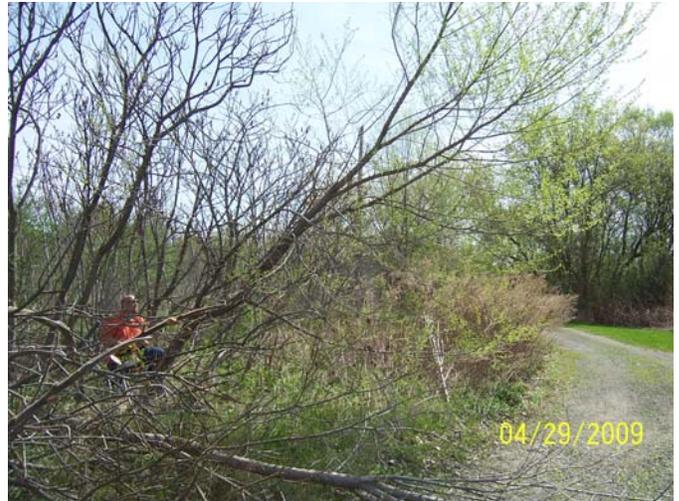
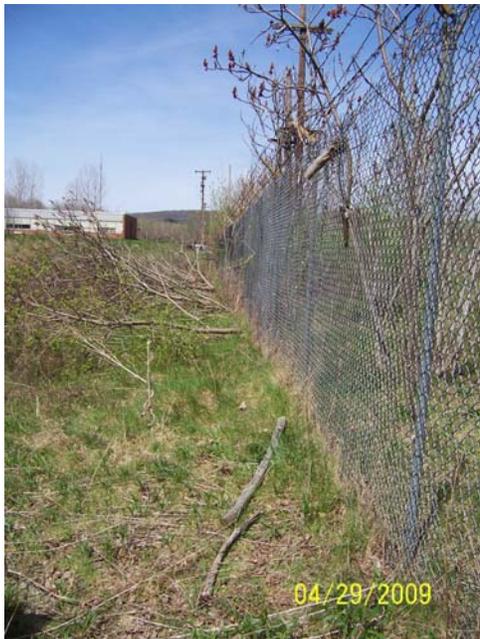
Frank started clearing the brush on the exterior of the fence.

The trees and Brush were dropped onto the dirt road between the site and the former middle school.

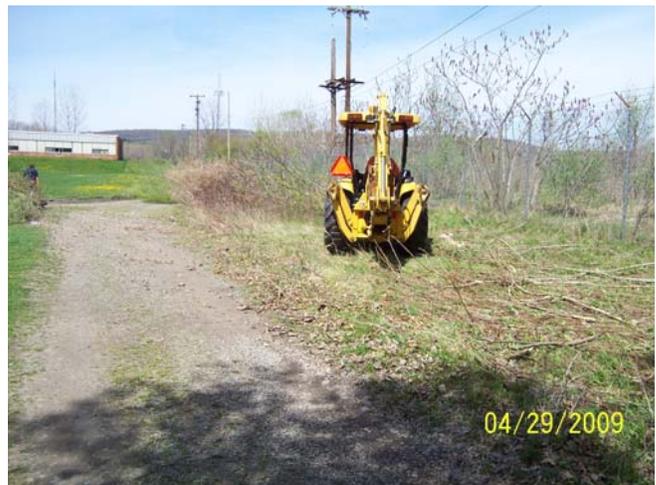
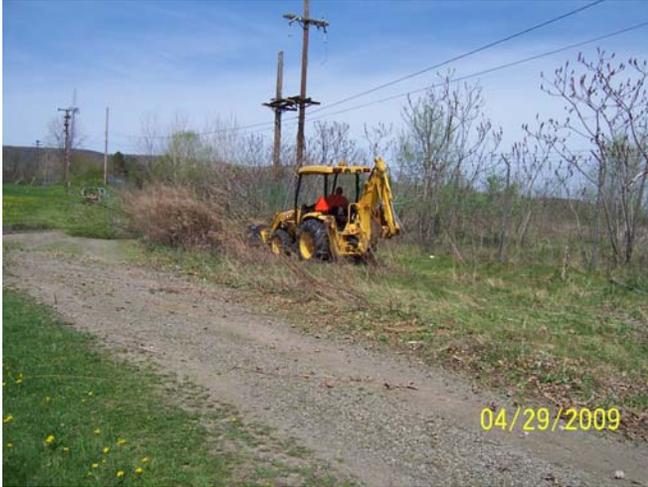
The Back-hoe was delivered at approximately 11:00 am. The machine was immediately placed in service pushing the brush into a pile.

The brush was stacked on the dirt road.

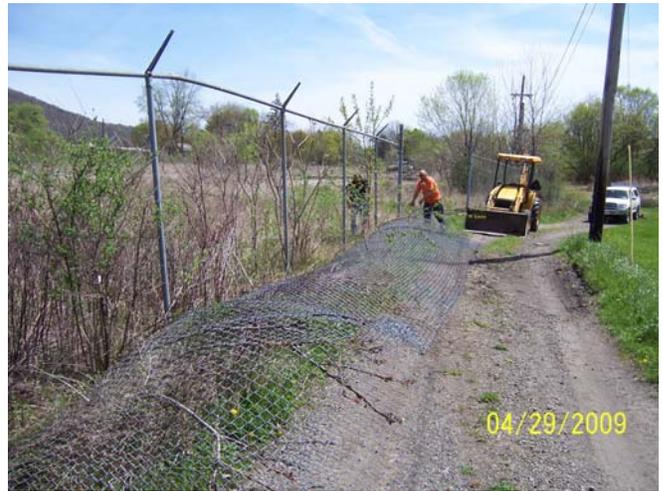
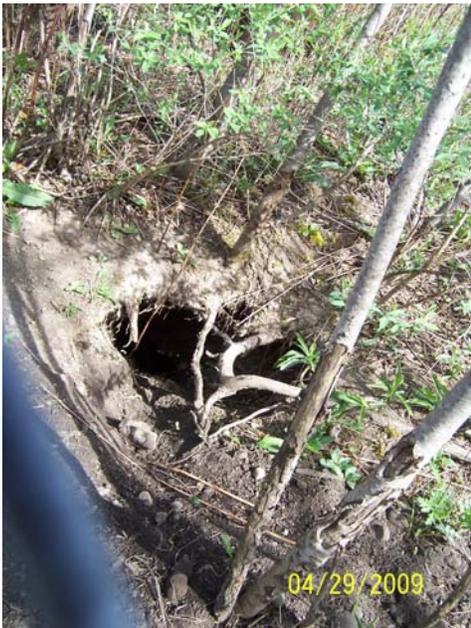
After the brush was piled up, the fence fabric was laid down, rolled up, and moved to the staging area located within the Corrugated Sheet Metal divider.

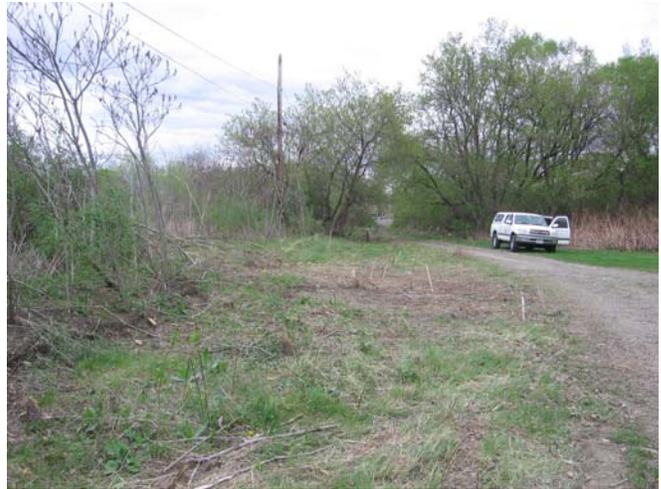
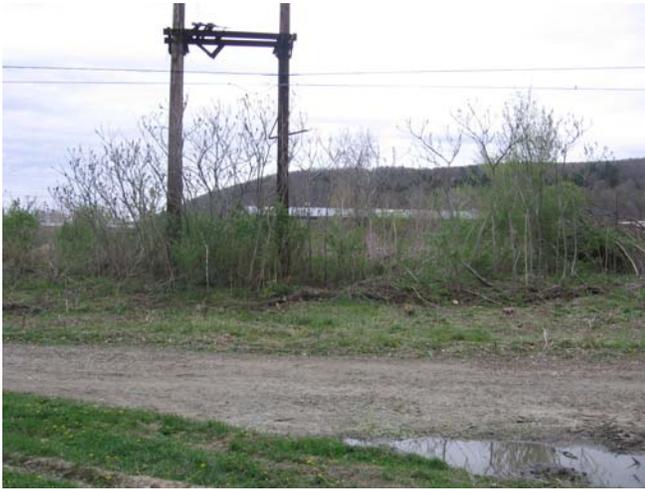
During the removal of the fence an animal (fox or coyote) den was discovered. The den did not look occupied.

Pictures of the fence and posted removed from the south west corner of the fenced area where the perimeter fence met the landfill fence.

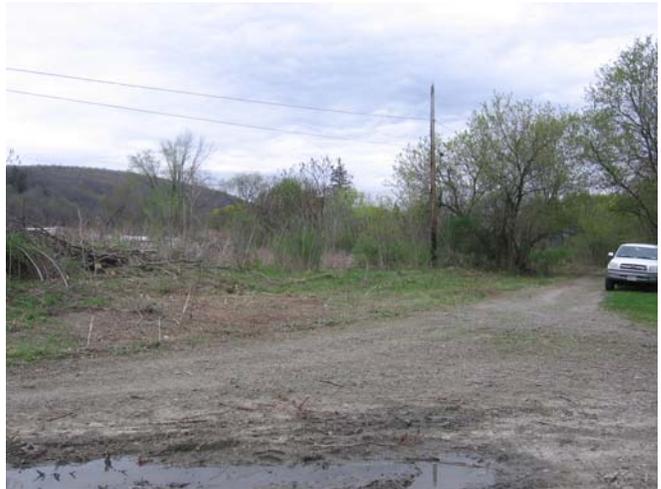
A thicket of trees had grown into the fence. These trees were not removed. The fence fabric was removed as close to the trees as possible.

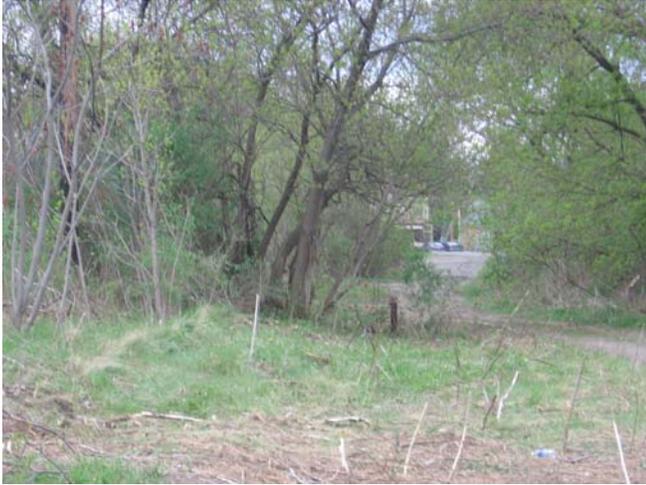
A closer shot of the same thicket.

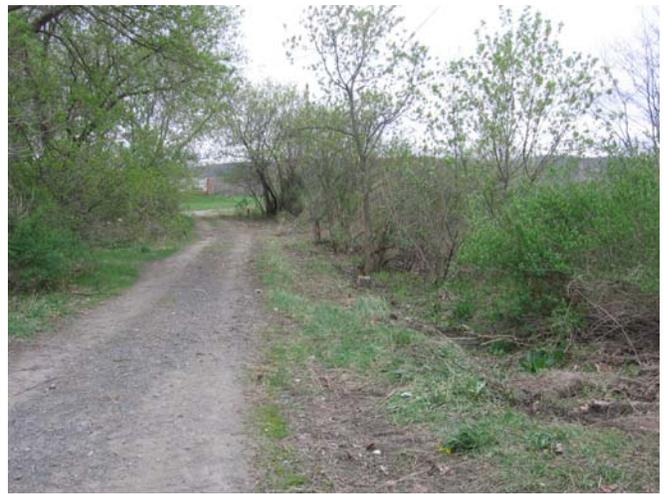
This is a shot of the former fence line standing at the east corner along the south side of the property.

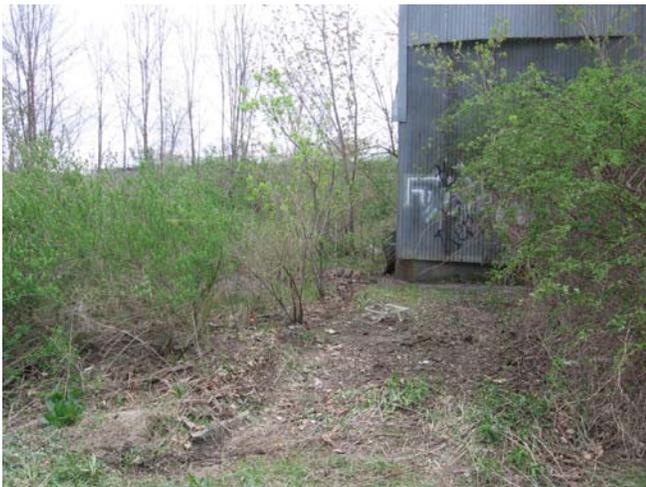
The final photograph is the same east corner looking north to the connection at the corrugated sheet metal divider.
