**New York State Department of
Environmental Conservation**

Site Number 7-54-012

**Tioga Casting Site Quarterly
Report**

Second Quarter 2013

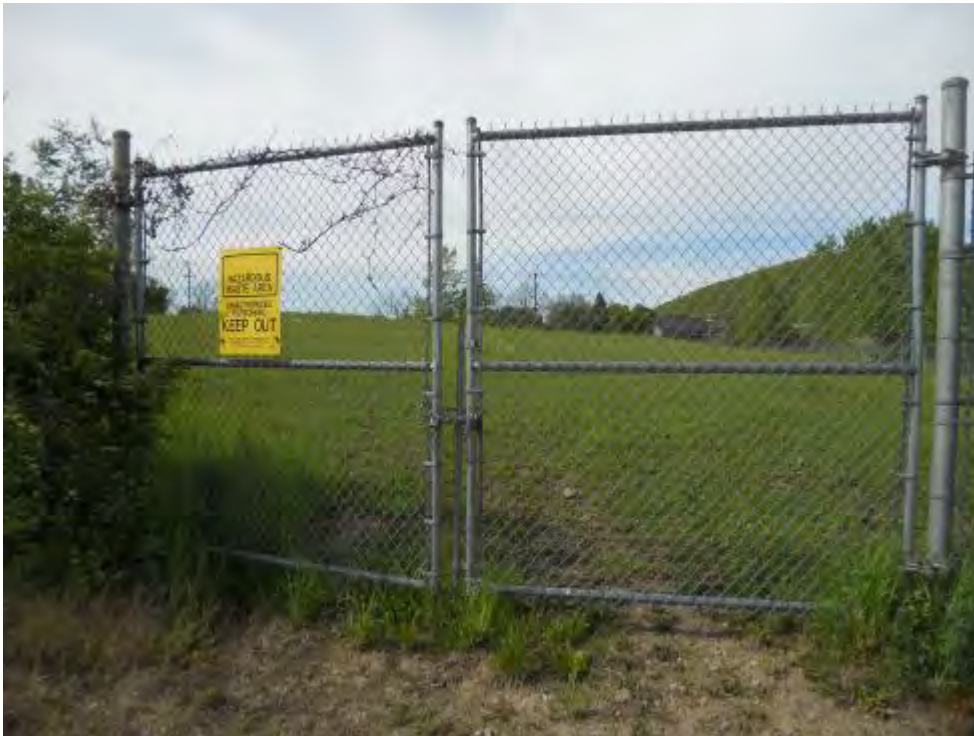
Landfill Access Gate

The landfill perimeter fence, entry gate, and locks were inspected for proper operation and signs of deterioration. As indicated in the O&M Checklist, no problems were observed with the integrity of these components. In addition, the Foundry Street entry gate warning sign was in place and in acceptable condition.
