Subject: 2023 Annual Site Inspection Report RG&E Pavilion Former MGP Site 6903 Ellicott Street Road Town of Pavilion, Genesee County, New York 14525 NYSDEC Site No. 819024

SITE-WIDE INSPECTION FORM

RG&E Pavilion Former MGP Site

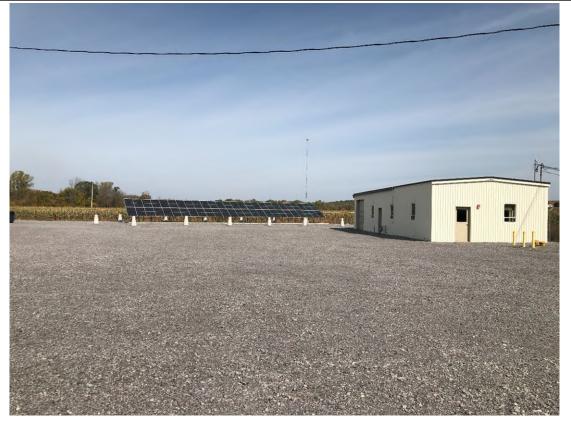
Training Building and Solar Panels on the Northeastern Portion of the Site -Viewing North

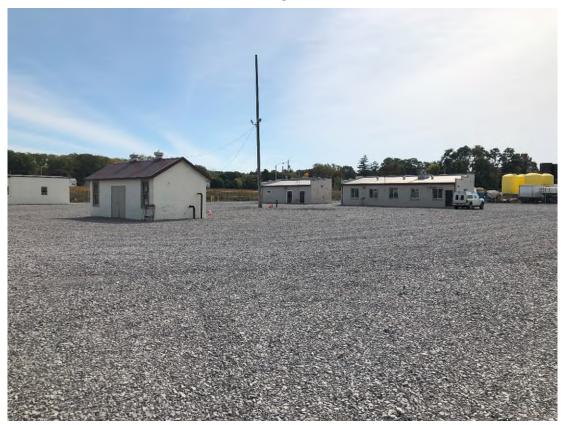
Gas Regulator Building and the Central Portion of the Site - Viewing Southeast

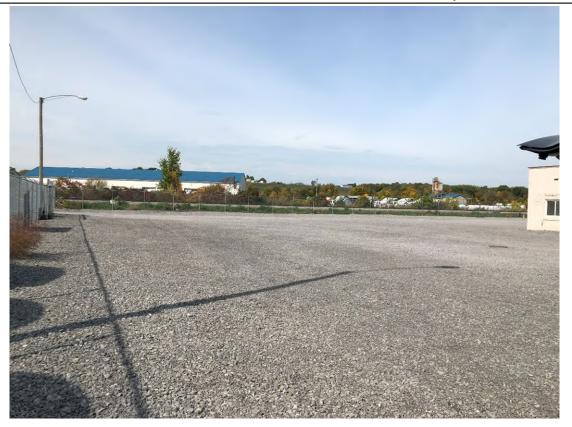
Western Portion of the Site - Viewing North

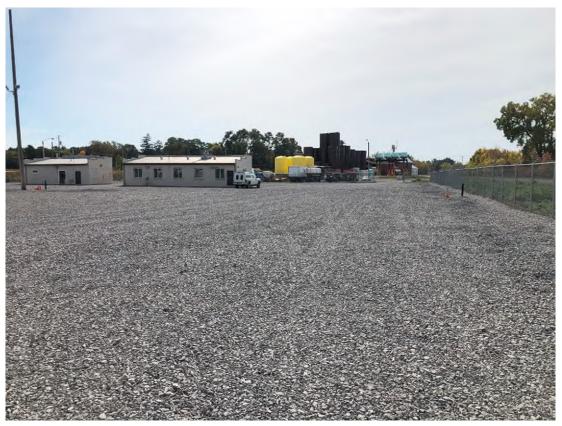
Office Building and Western Portion of the Site - Viewing South

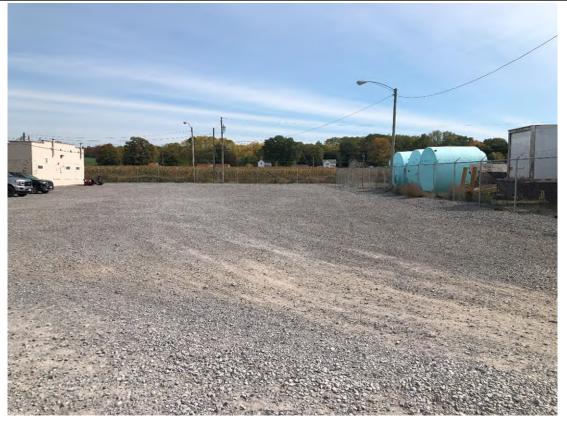
Southern Portion of the Site - Viewing East

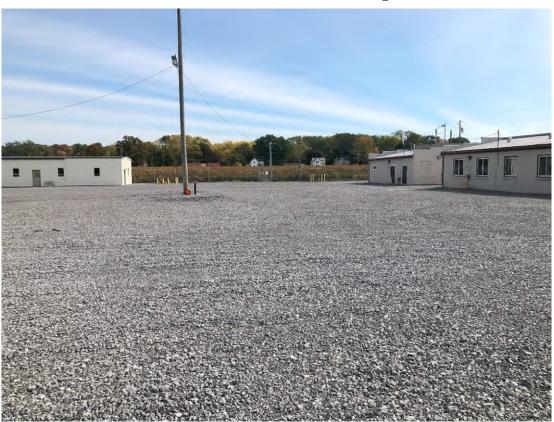
Central Portion of the Site - Viewing East

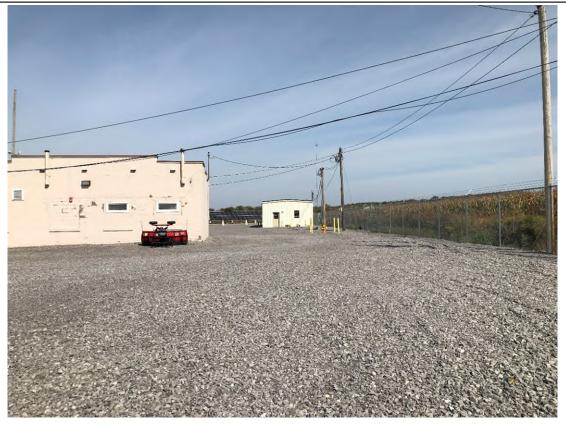
Eastern Portion of the Site – Viewing North

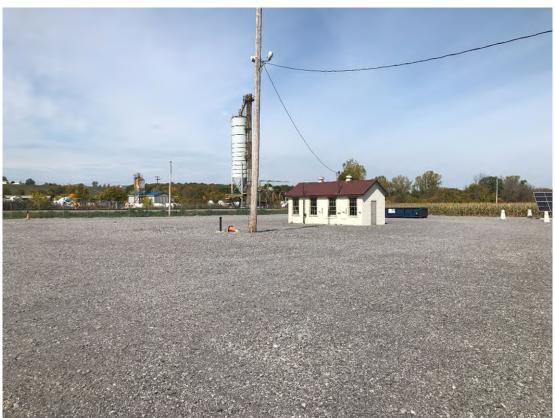
Gas Regulator Building and the Central Portion of the Site - Viewing Northwest
