# **SITE CHARACTERIZATION REPORT**

**BARTHELMES MANUFACTURING COMPANY, INC.  
15 CAIRN STREET  
CITY OF ROCHESTER, NEW YORK  
BCP SITE NO. C828122  
INDEX B8-0607-02-01**

**Leader Professional Services, Inc.  
271 Marsh Road, Suite 2  
Pittsford, NY 14534**

**October 2006**

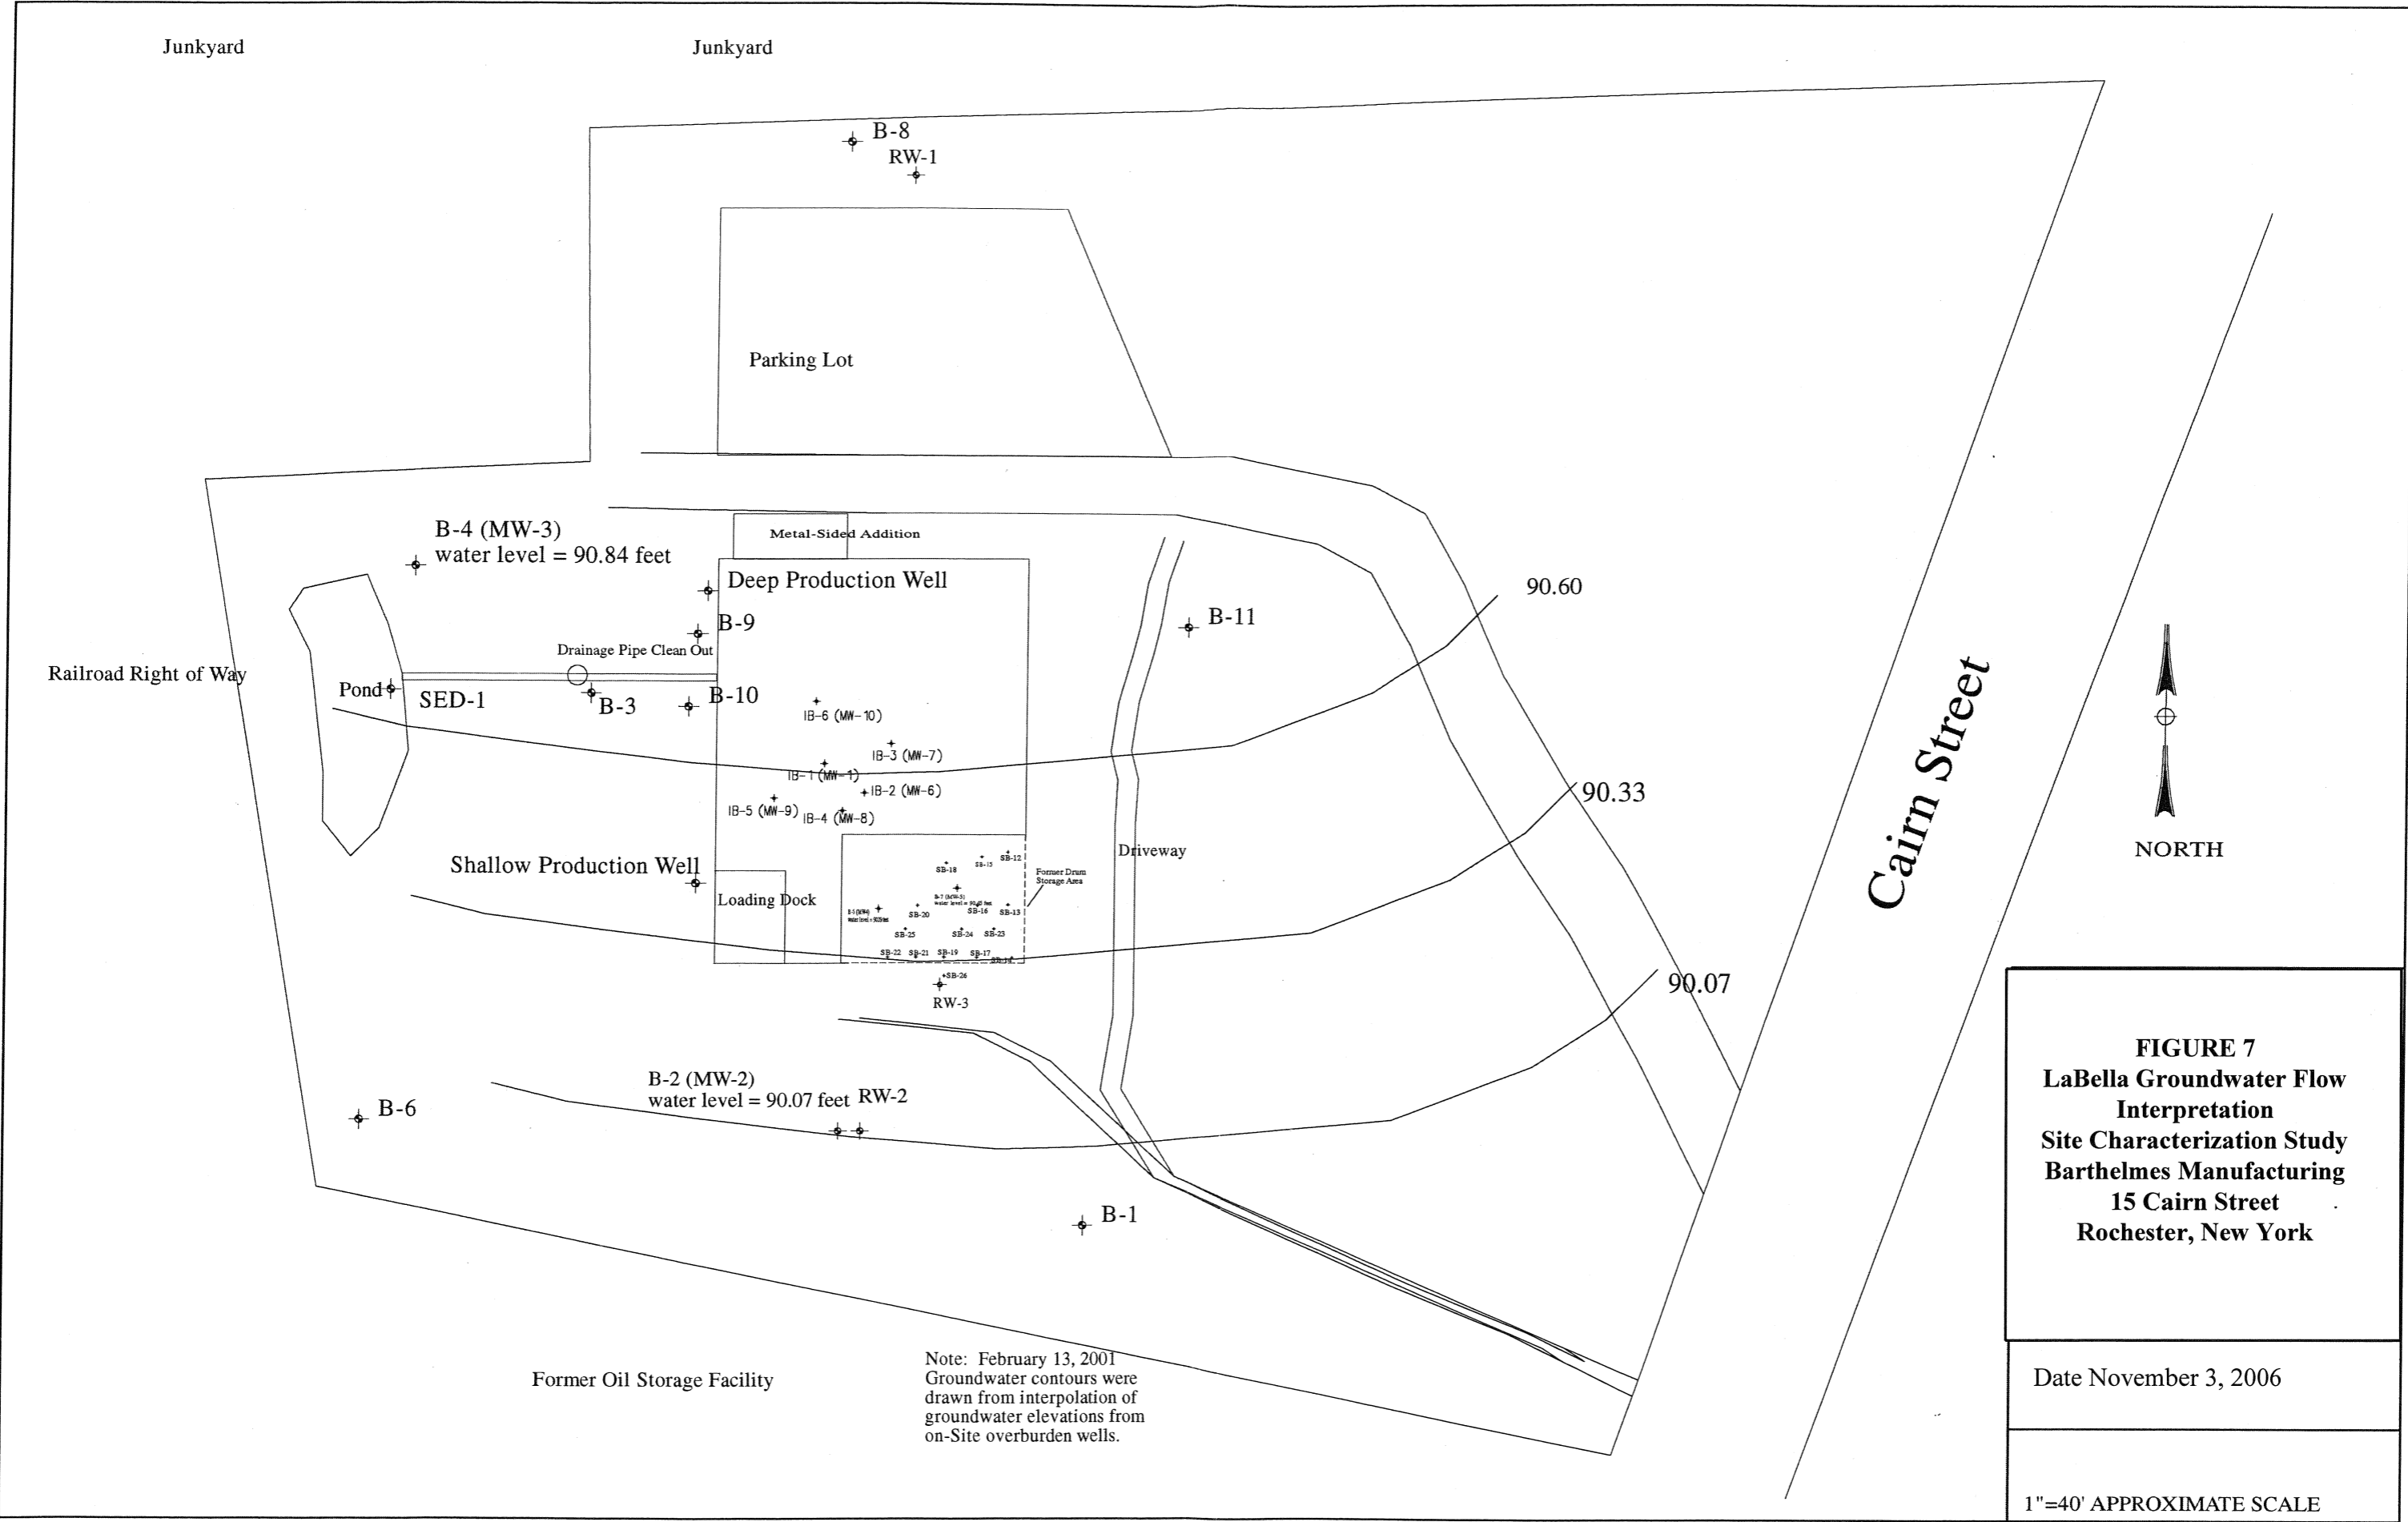
**FIGURE 7**  
**LaBella Groundwater Flow**  
**Interpretation**  
**Site Characterization Study**  
**Barthelmes Manufacturing**  
**15 Cairn Street**  
**Rochester, New York**

The monitoring wells installed by the previous consultant's to determine the groundwater quality and to estimate the direction of groundwater flow are shown on Figure 7. Monitoring wells identified as "MW" were installed into the overburden using direct push sampling tools and were terminated at a point of refusal, which range in depth from 15 to 19.5 feet below the ground surface. Monitoring wells identified as "RW" are overburden-bedrock inter face wells, which range in depth from 30 to 37 feet below the ground surface. The RW monitoring wells found bedrock at a depth ranging from 23 to 26 feet below the ground surface. Interface monitoring wells have screens which begin at a depth ranging from 21 to 27 feet below the ground surface and terminate at a depth ranging from 30 to 37 feet below the ground surface.

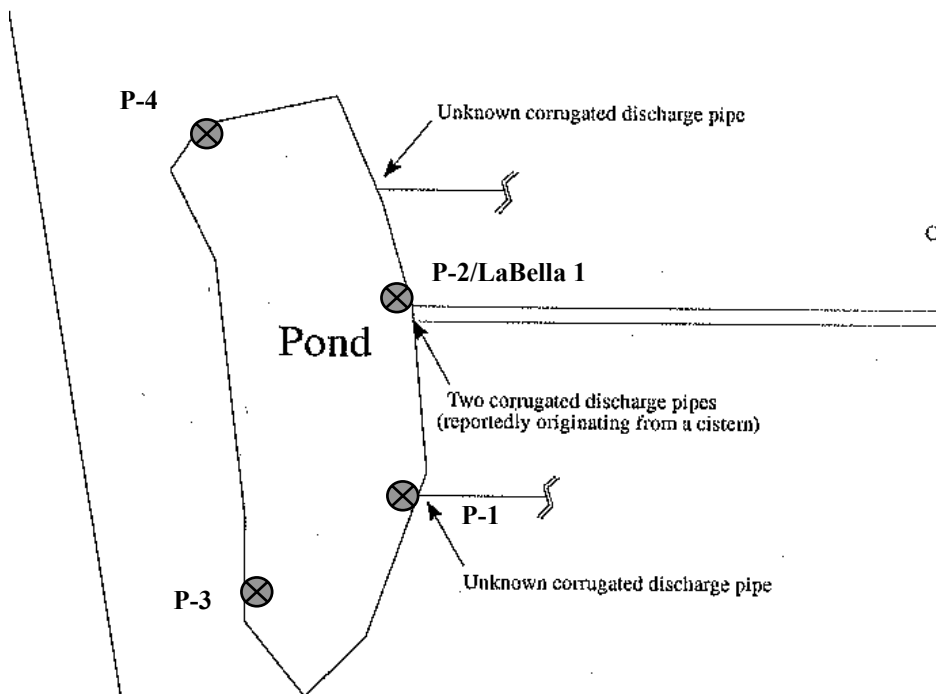
Figure  
**11**

Leader's 2006 samples showed that the following VOCs were found in the sediment: 1,4-Dichlorobenzene, Acetone, Dichlorodifluoromethane, Methylene Chloride, p-Cymene, and Toluene. 1,4-Dichlorobenzene and Dichlorodifluoromethane were found in each sample but at concentrations which were lower than the reporting limits. Methylene Chloride was found in every sample but also in the laboratory blanks and qualified as a laboratory contaminant. Acetone was found in each sample ranging in concentration from 22 ppb (below the reporting limit) in sample P-3 to 80 ppb in sample P-2. p-Cymene was found in 3 of 4 samples ranging in concentration from 5 ppb (below the reporting limit) in sample P-4 to 27 ppb in sample P-1. Toluene was found in each sample ranging in concentration from 5 ppb (below the reporting limit) to 250 ppb in sample P-2.

The only RCRA metals found in the sediment samples include: Barium, Chromium, and Lead. Barium was found in each sample at a concentration ranging from 11.9 ppm in sample P-3 to 61.9 ppm in sample P-2. Chromium was found in each sample, but qualified because spike sample recovery was not within quality control limits. Chromium concentrations ranged from 11.5 ppm in sample P-3 to 247 ppm in sample P-2.

To remove or reduce the concentration of Chromium in the storm water swale area will require excavation of the sediment and disposal of the material as a non-hazardous waste. However, since Chromium in the sediment was found during the Phase II not to be leachable, it is not a hazardous waste. The best solution is to manage the storm water swale area by restricting access. Fencing around the storm water swale is a reasonable solution.

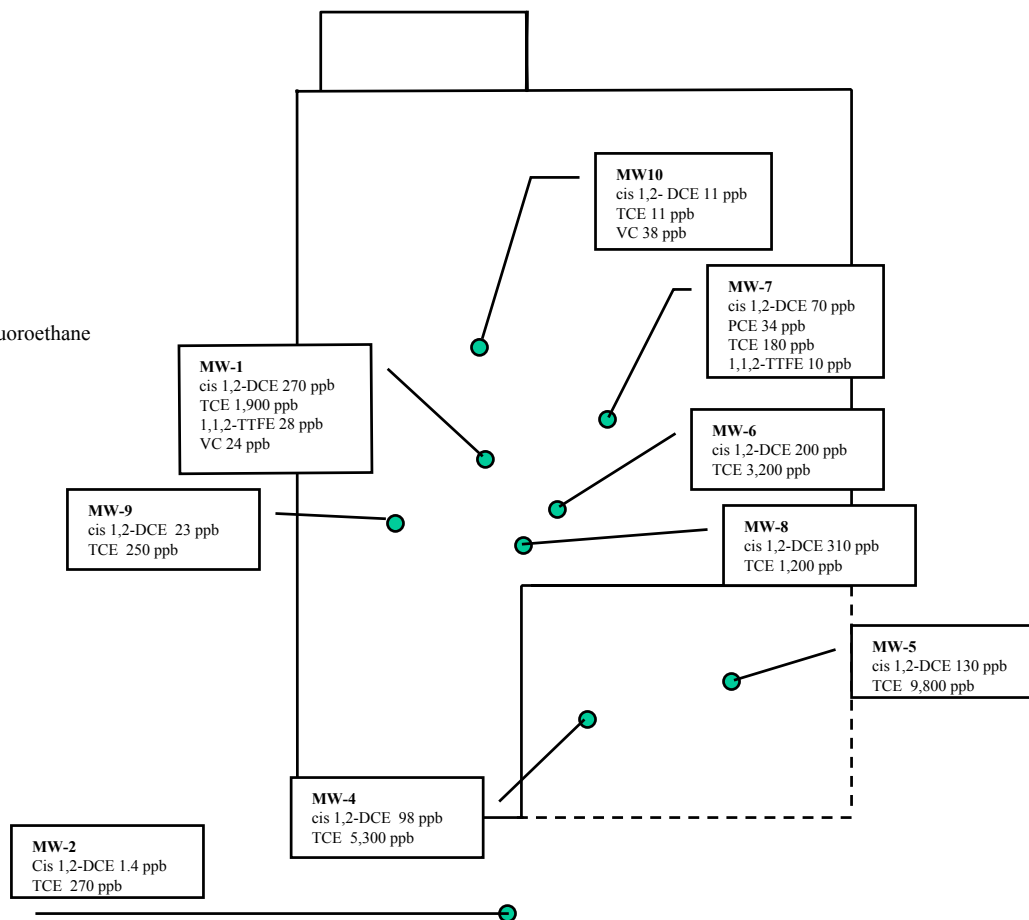
The 2006 data from the site was similar to 2001. Six of the 10 monitoring well results showed a decrease in TCE concentration. In the overburden monitoring wells TCE was found to range in concentration from 11 ppb in monitoring well MW-10 to 9,800 ppb in monitoring well MW-5. Figure 15 and Figure 16 present the groundwater sample results.

Title Overburden Groundwater Chlorinate Compounds Results  
Barthelmes Manufacturing  
Rochester, New York

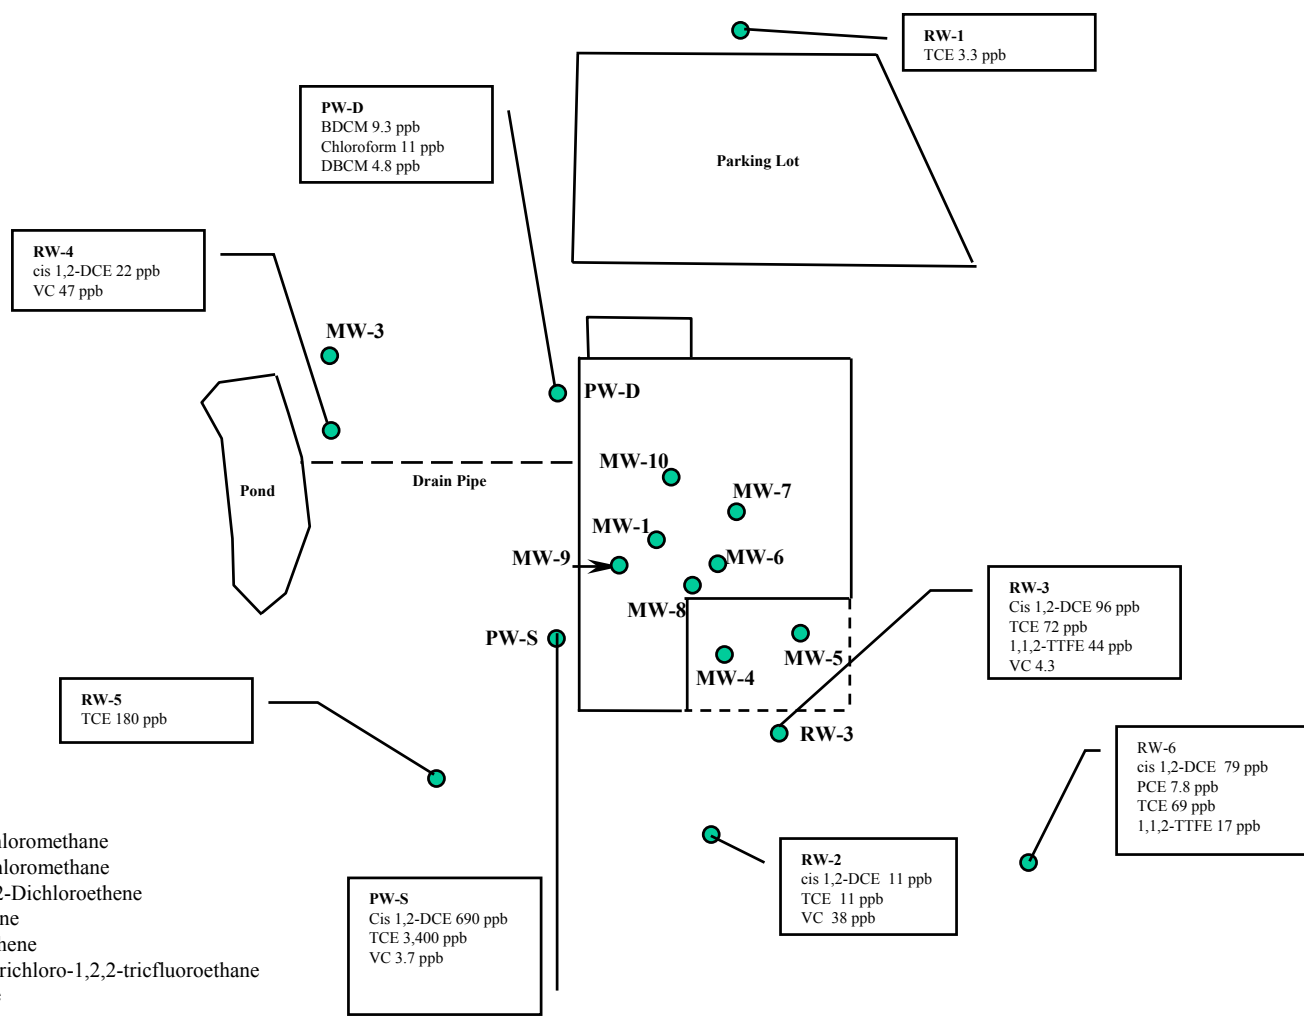
Figure  
**16**

There are two bedrock wells on the property that have been identified as a shallow production well and a deep production well. The shallow production well, PW-S, had a TCE concentration of 3,400 ppb in 2006, which was an increase from the 2001 concentration of 2,110 ppb. Other contaminants of concern found in PW-S include: 1,1-Dichloroethene found only in 2006 at a concentration of 3.9 ppb; cis 1,2-Dichloroethane found in 2001 at a concentration of 325 ppb and in 2006 at a concentration of 690 ppb; Trans 1,2-Dichloroethene which was found only in 2006 at a concentration of 40 ppb; Tetrachloroethene which was found only in 2006 at a concentration of 1.5 ppb; and 1,1,2-Trichloroethane which was found only in 2006 at a concentration of 0.77 ppb. The deeper production well, PW-D, sample did not contain TCE in 2006 and only 3.6 ppb in 2001.

Title   Interface and Bedrock Groundwater Chlorinated Compound Results  
          Barthelmes Manufacturing  
          Rochester, NY

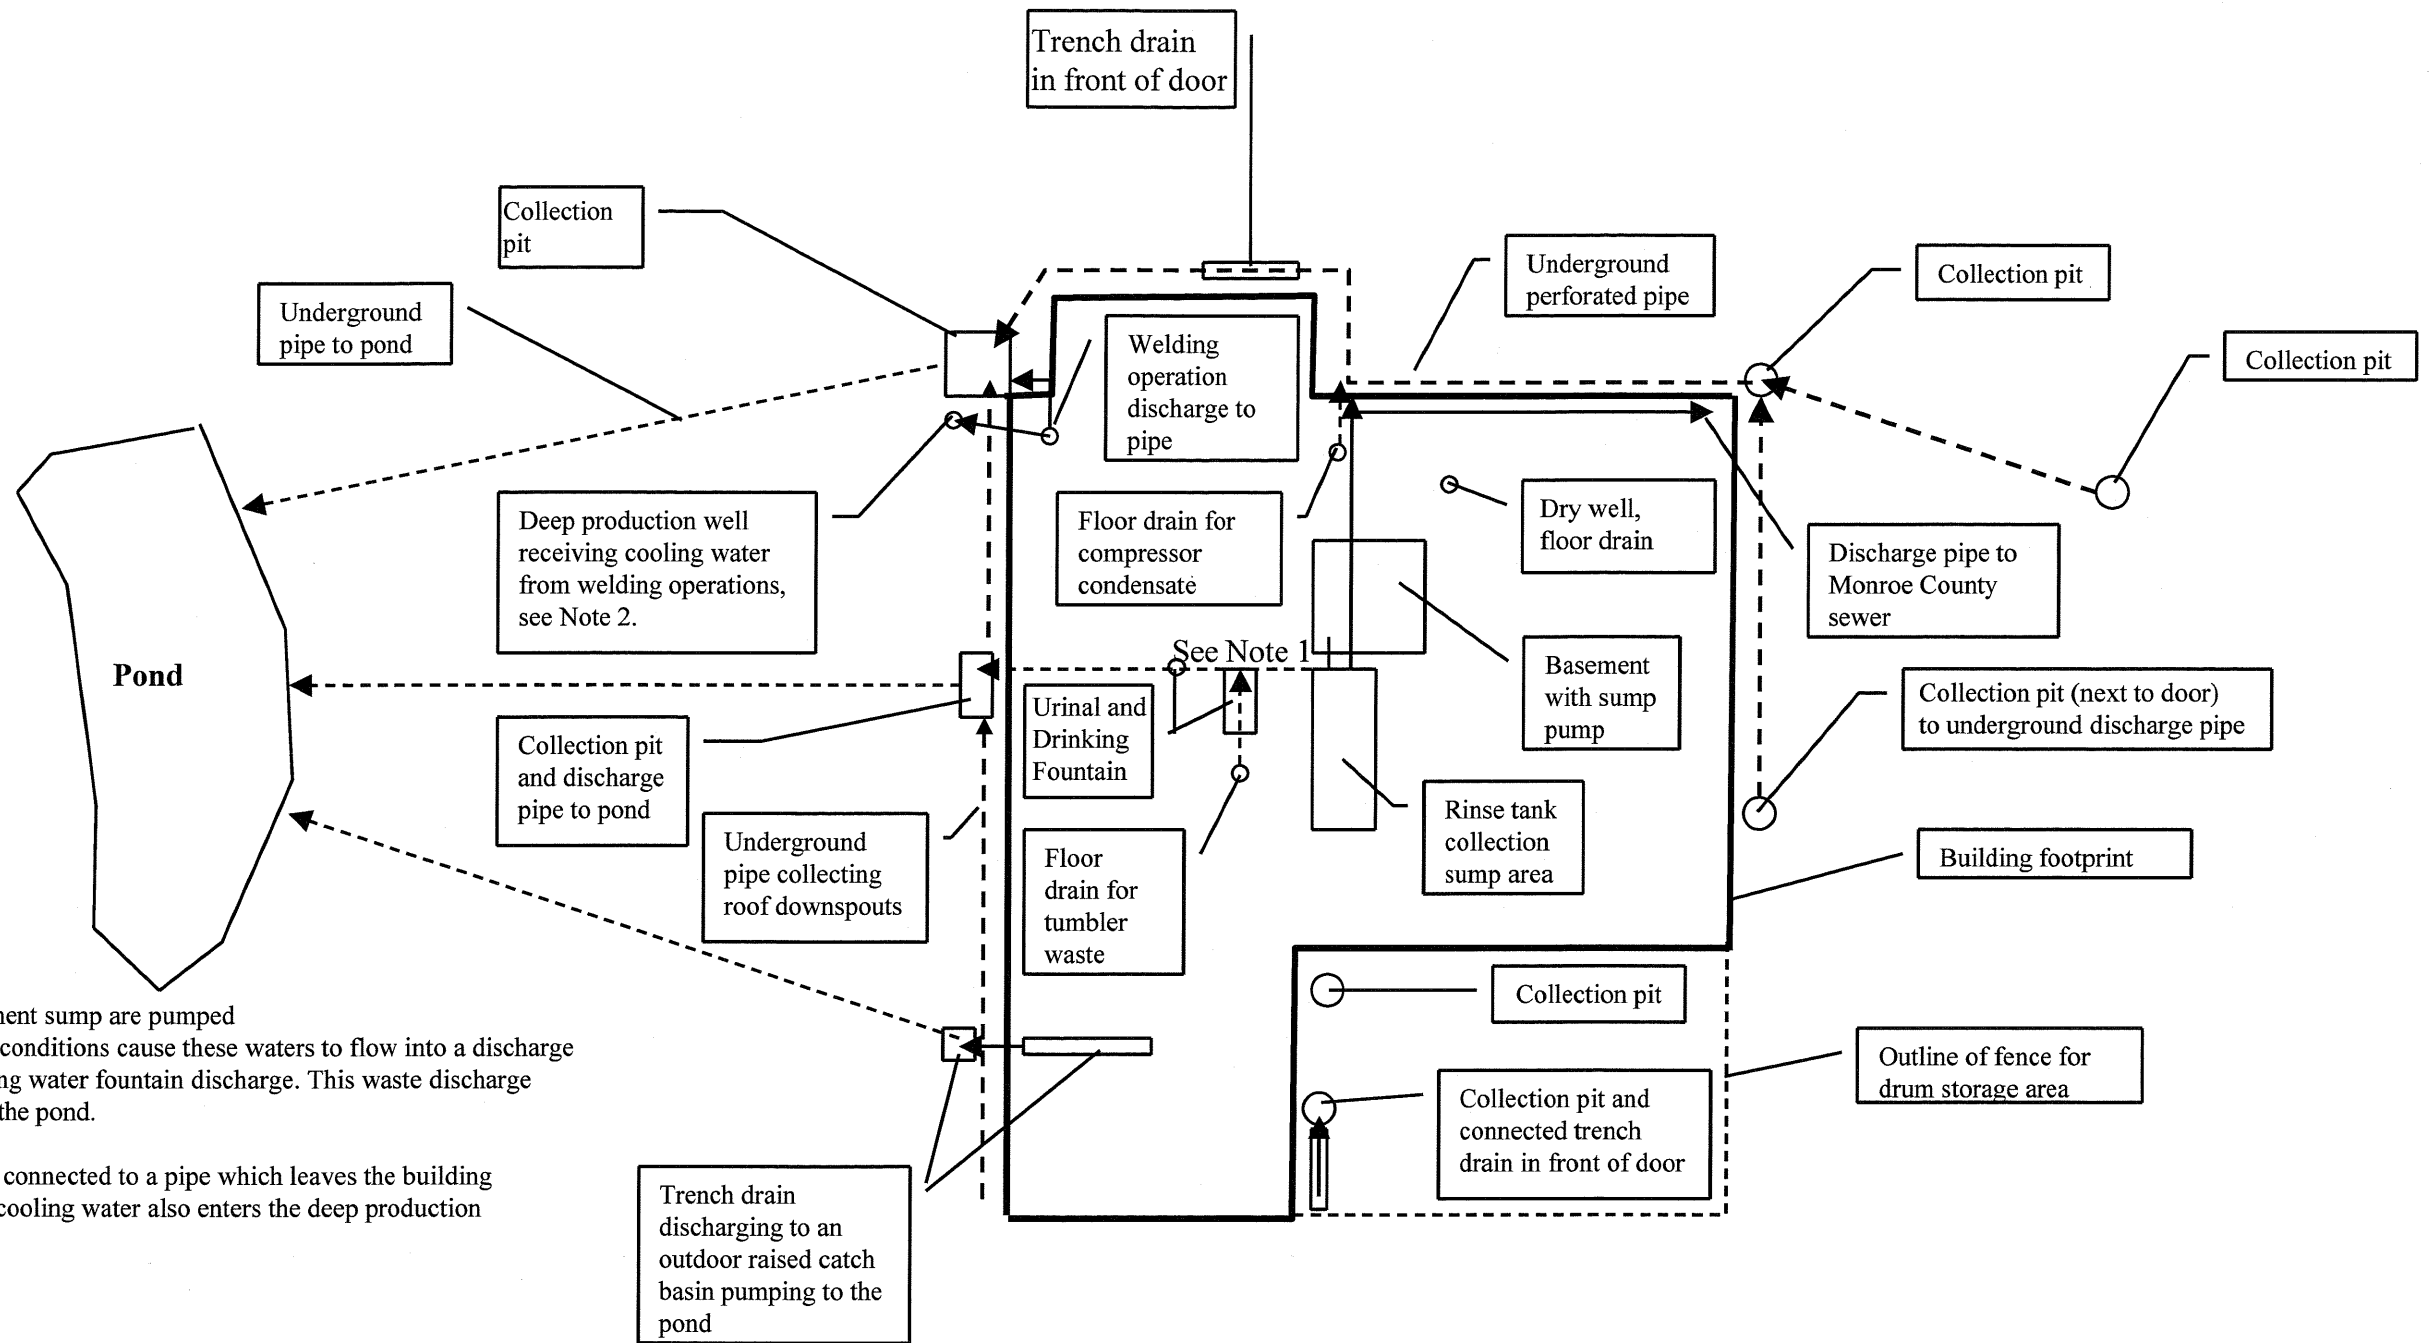
There are three processes within the plant that have a discharge: rinse tanks, tumbler, and welding. The rinse tanks discharge into the Monroe County sewer system. If a tank failure or a pump failure occurred, this wastewater would flow into an overflow pipe and into a collection pit, located on the west side of the plant, which ultimately discharges into the storm water swale. The tumbler discharges to a collection pit, located on the west side of the plant, which ultimately discharges into the storm water swale. The welding operation cooling water discharges to a collection pit located on the northwest corner of the plant. Some of the cooling water is also received into the deep production well also located off the northwest corner of the plant. It is unclear if the connection between the welding cooling water and the deep production well is a piped connection or a leak in the well casing which could receive water from the pit.

1. Effluent from the rinse tanks and basement sump are pumped to the Monroe County's sewer. Overflow conditions cause these waters to flow into a discharge connecting the urinal, tumbler, and drinking water fountain discharge. This waste discharge flows into the collection pit and then into the pond.
