# EMPIRE GEO SERVICES, INC.

**Subject: Floor Drain Closure  
Barthelmes Manufacturing  
15 Cairn Street  
Rochester, New York 14611  
Site No. 828122**

Empire Geo-Services, Inc. (Empire) has prepared this letter report to document the closure of two floor drains at the above-referenced facility. The closures were performed by NYSDEC and Empire personnel on July 31, 2013. Photographs documenting the closure activities are attached.

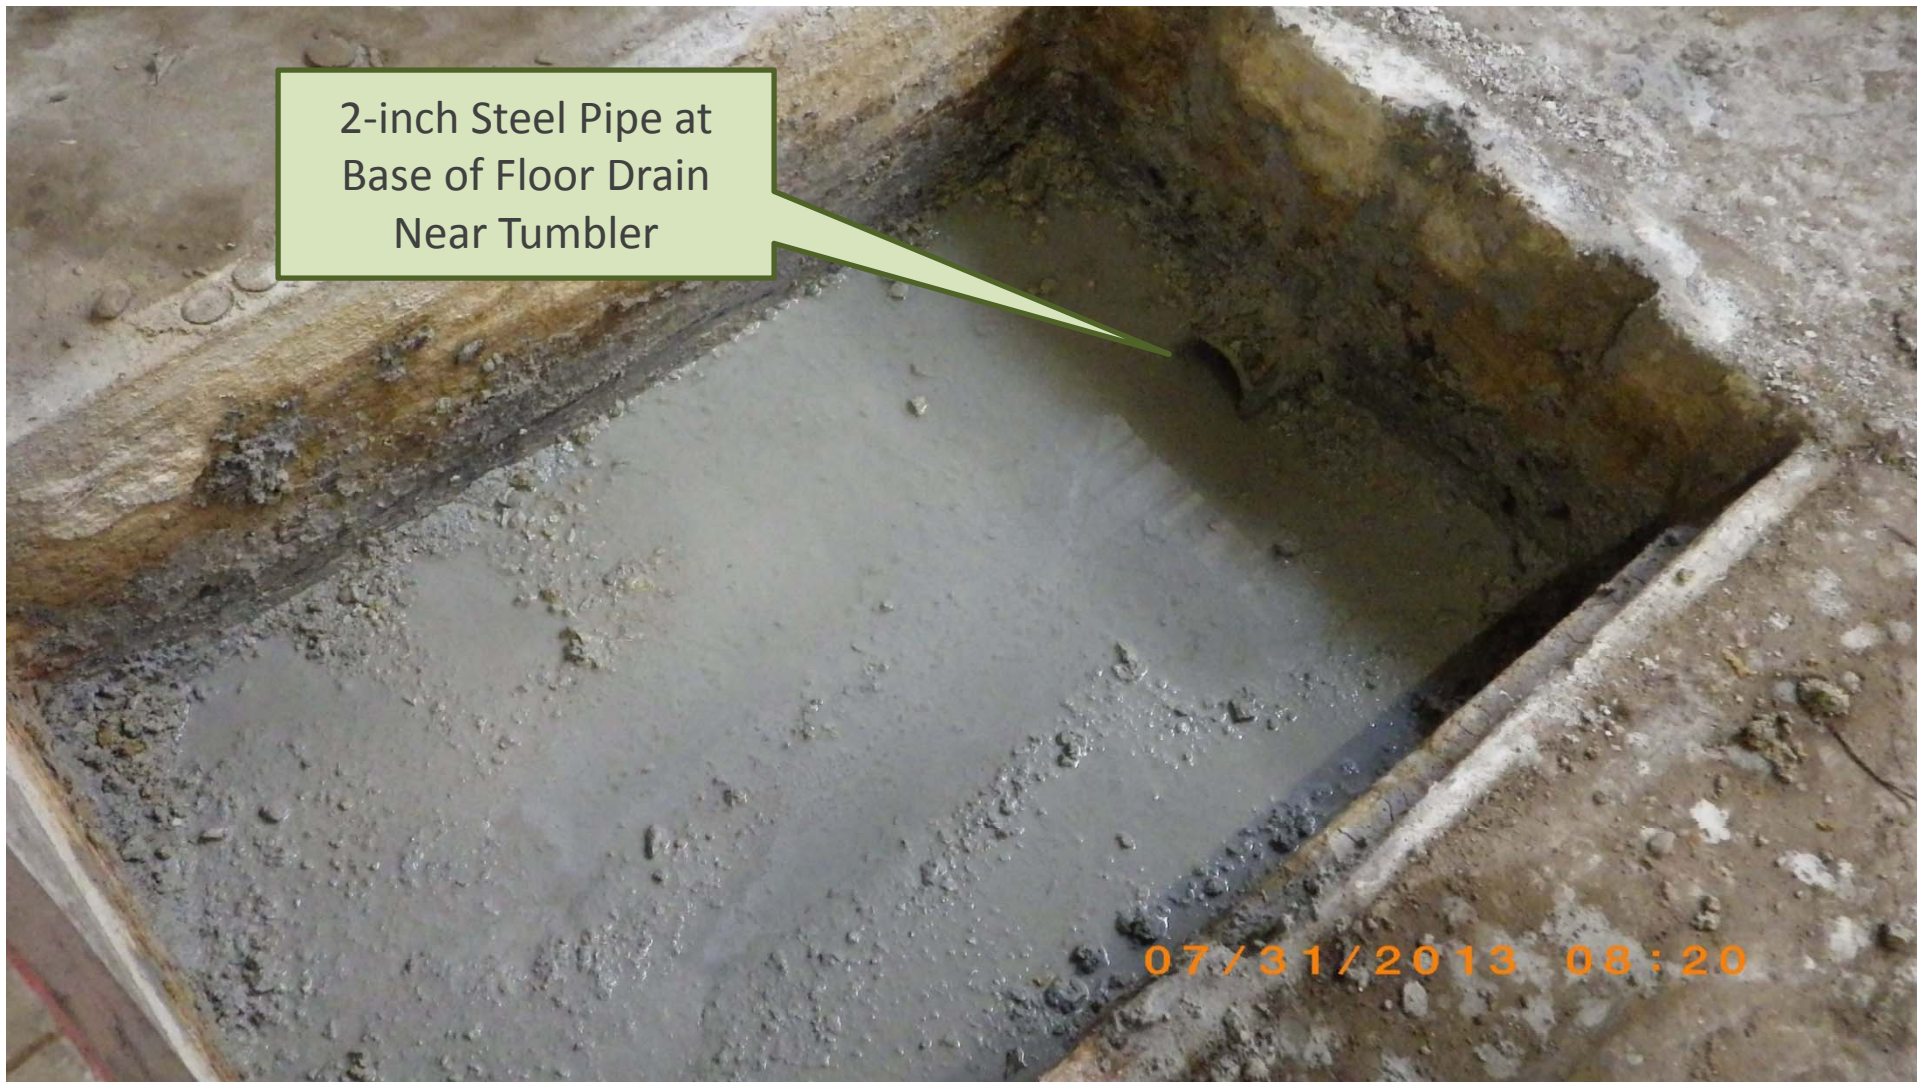
July 31, 2013 – Barthelmes Manufacturing: Closure of floor drains that discharge to the on-site stormwater basin located on east side of property.

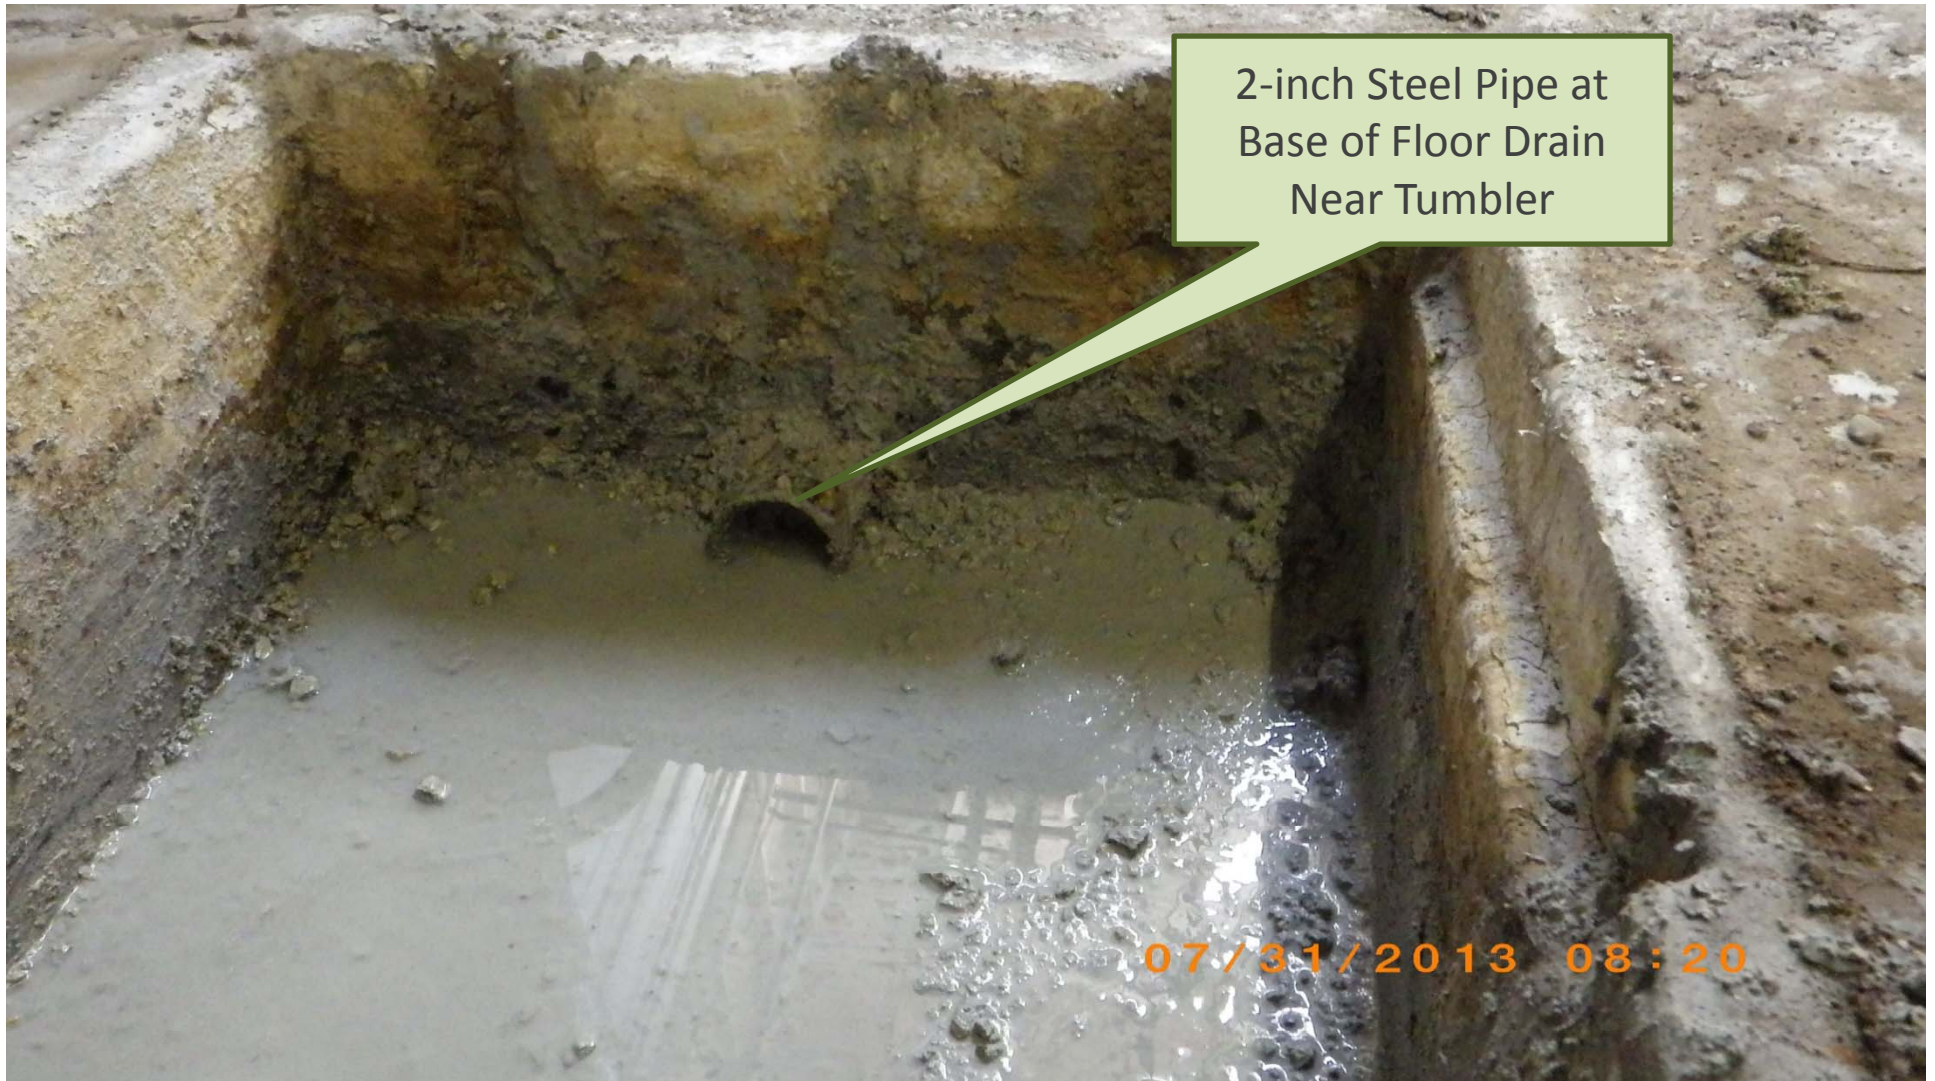
2-inch Steel Pipe at  
Base of Floor Drain  
Near Tumbler

July 31, 2013 – Barthelmes Manufacturing: Closure of floor drains that discharge to the on-site stormwater basin located on east side of property.

The first closure was performed on a rectangular drain located adjacent to the tumbler. Prior to closing the drain, the accumulated sediment was removed. A two-inch-diameter water-proof plug was then installed in the drain pipe. The drain was filled to grade with cement prepared using 4,000 pound per square inch (psi) concrete mix and an appropriate volume of water.

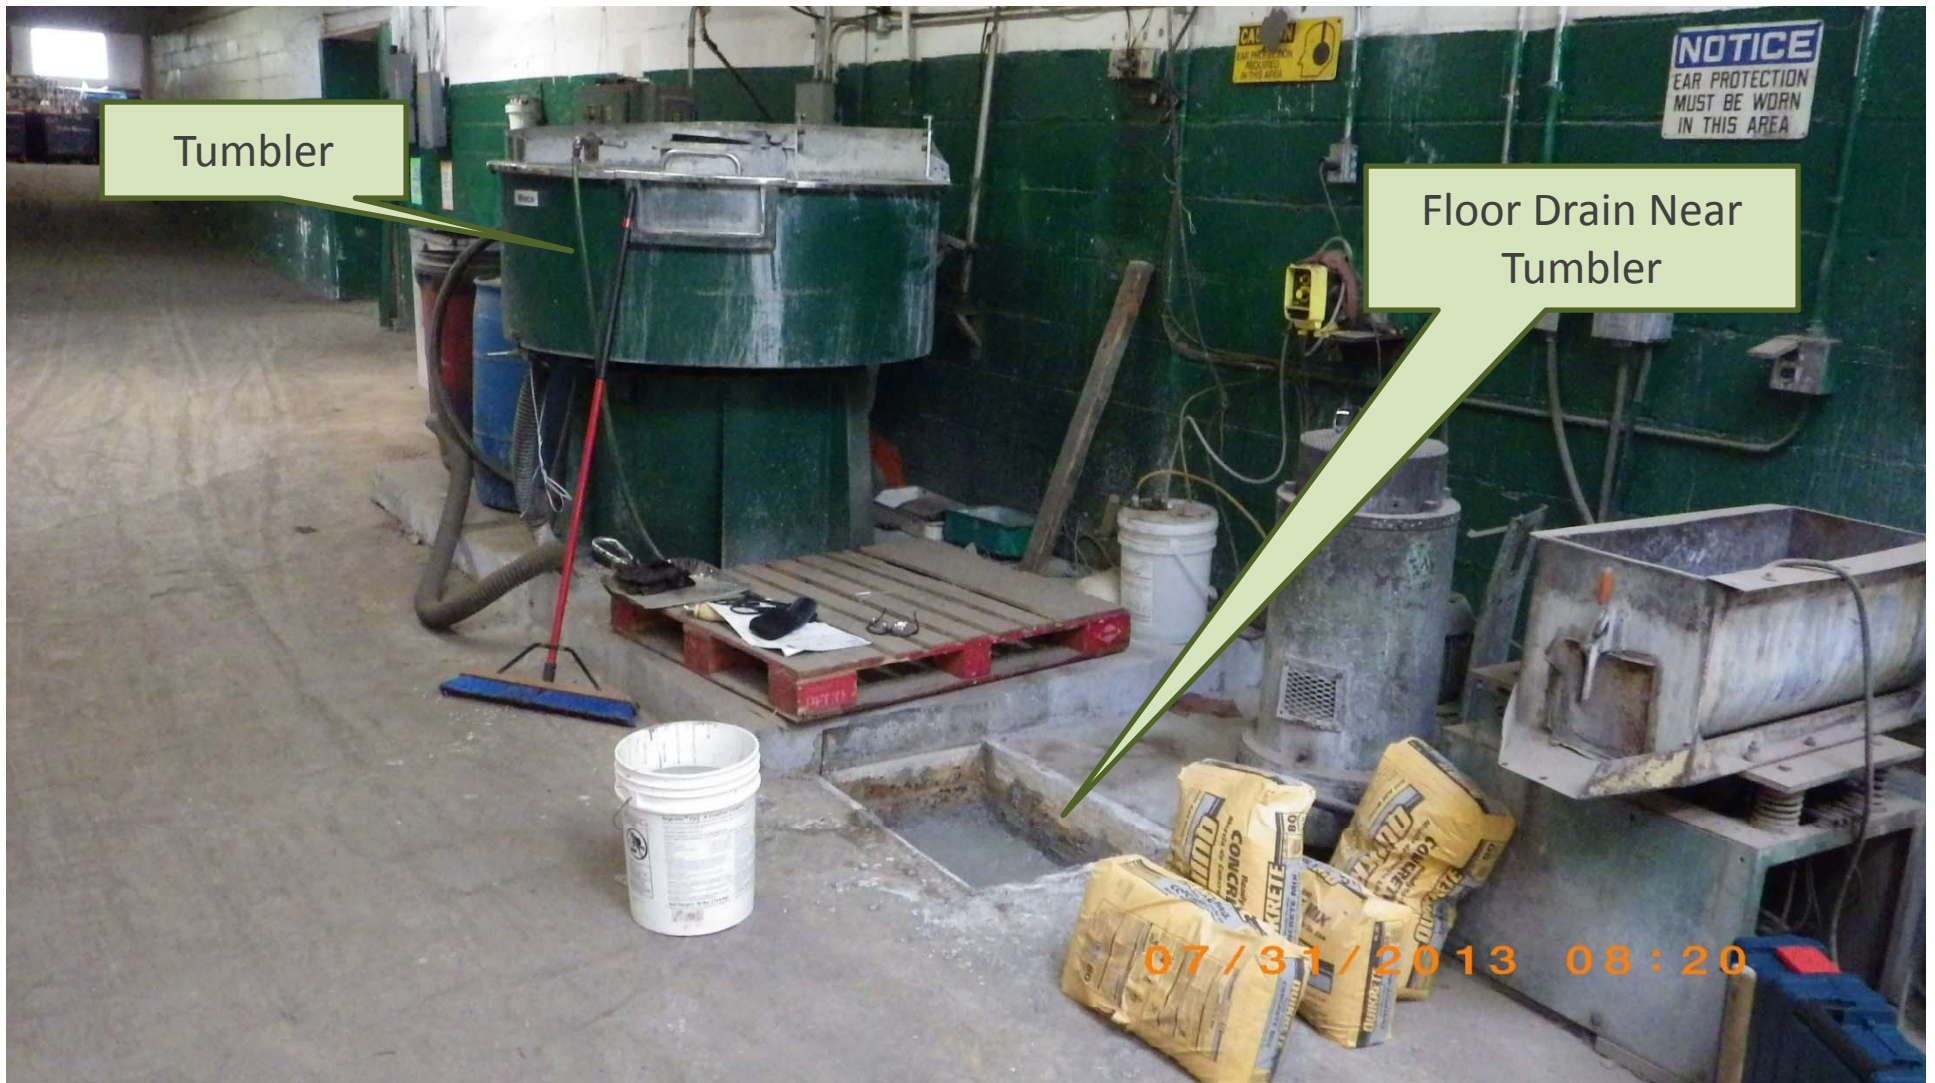
July 31, 2013 – Barthelmes Manufacturing: Closure of floor drains that discharge to the on-site stormwater basin located on west side of property.

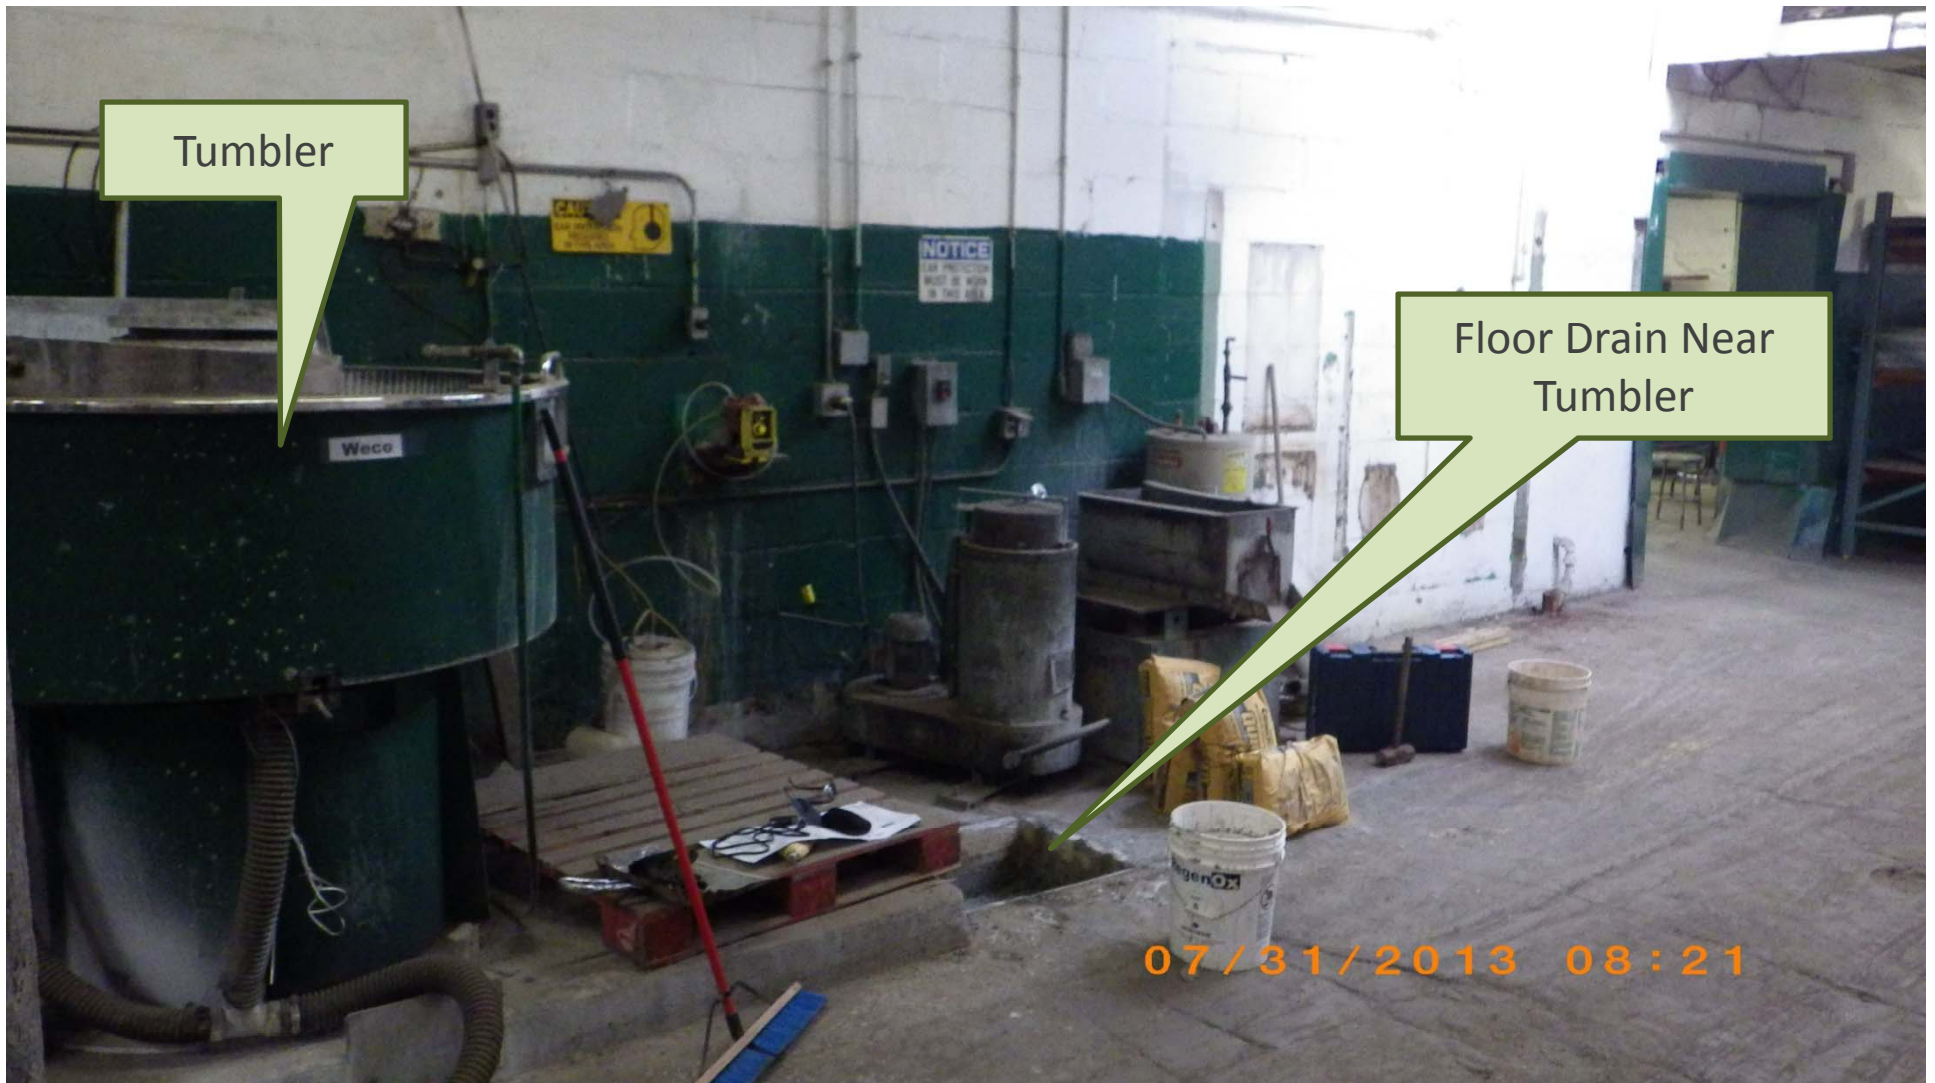
July 31, 2013 – Barthelmes Manufacturing: Closure of floor drains that discharge to the on-site stormwater basin located on west side of property.

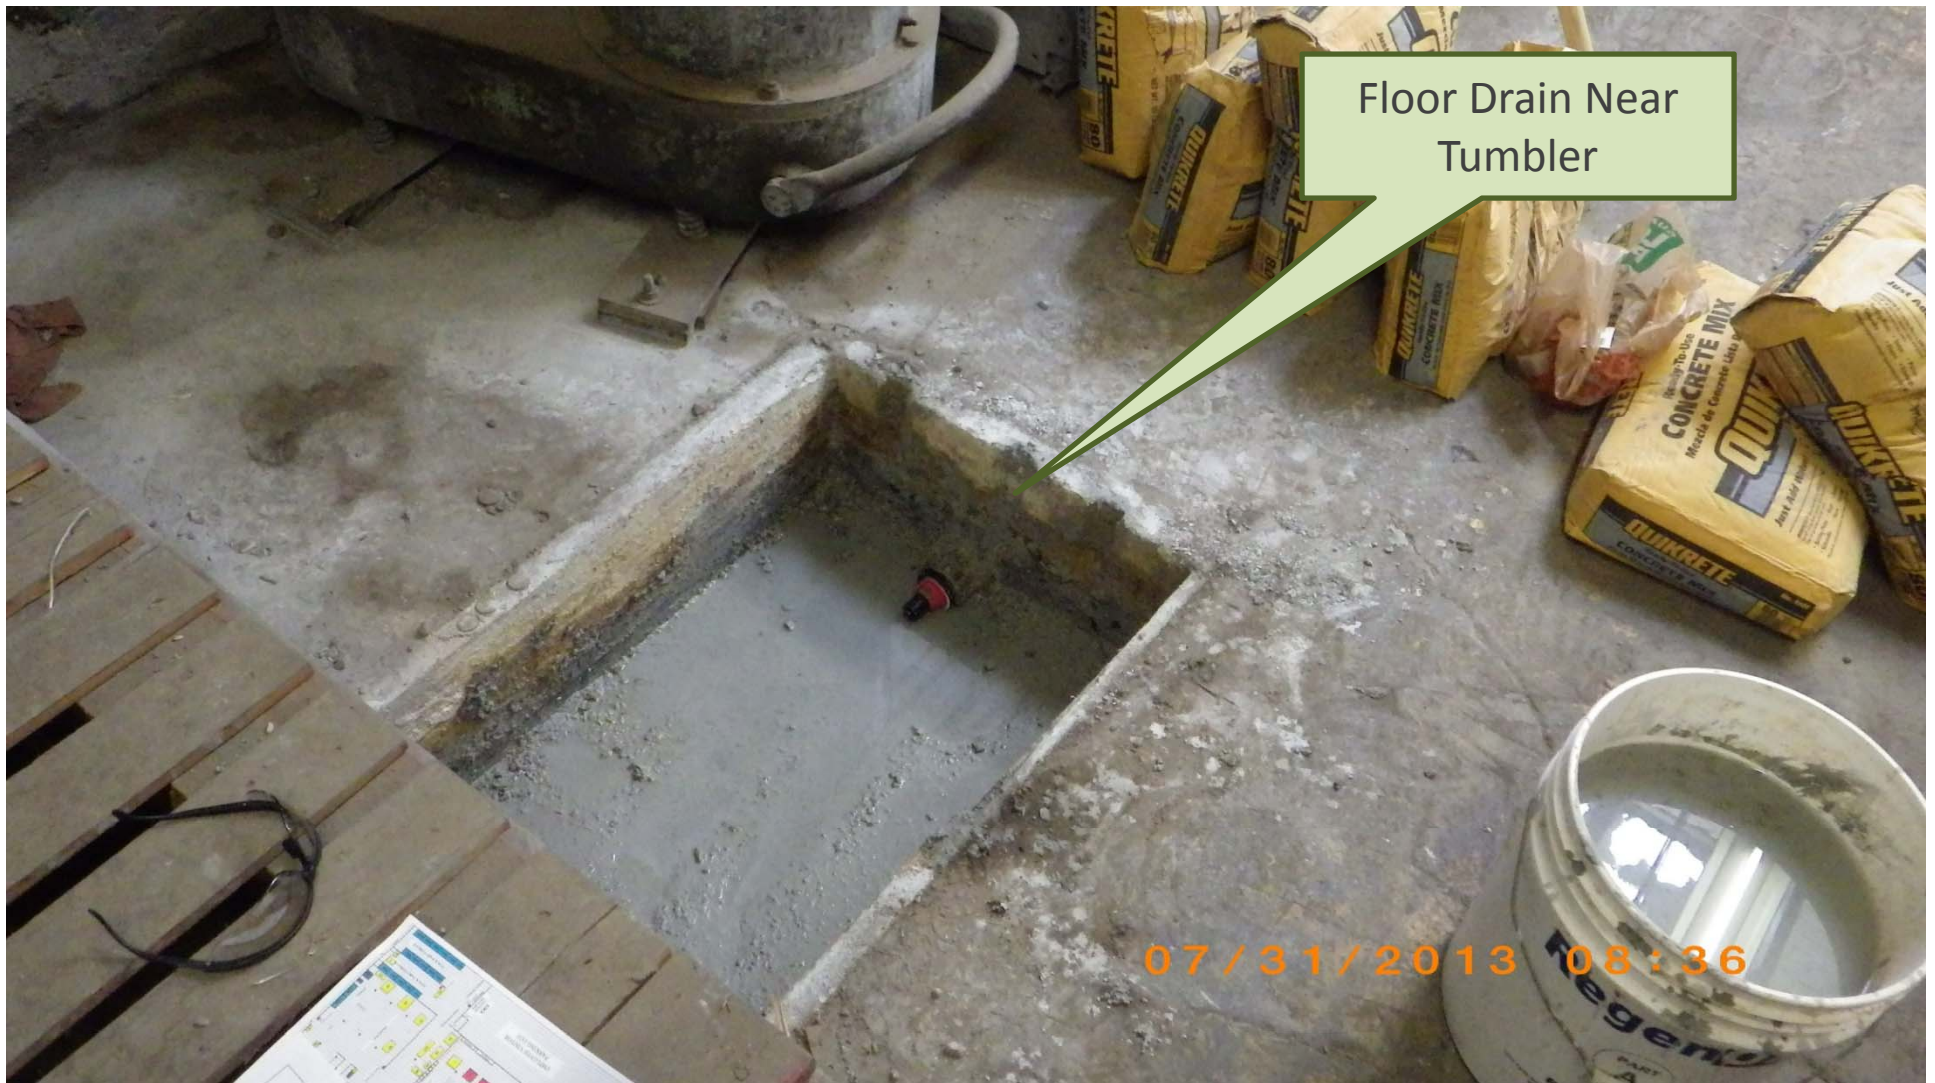
July 31, 2013 – Barthelmes Manufacturing: Closure of floor drains that discharge to the on-site stormwater basin located on west side of property. Plug placed in 2-inch drain pipe prior to cementing in-place.

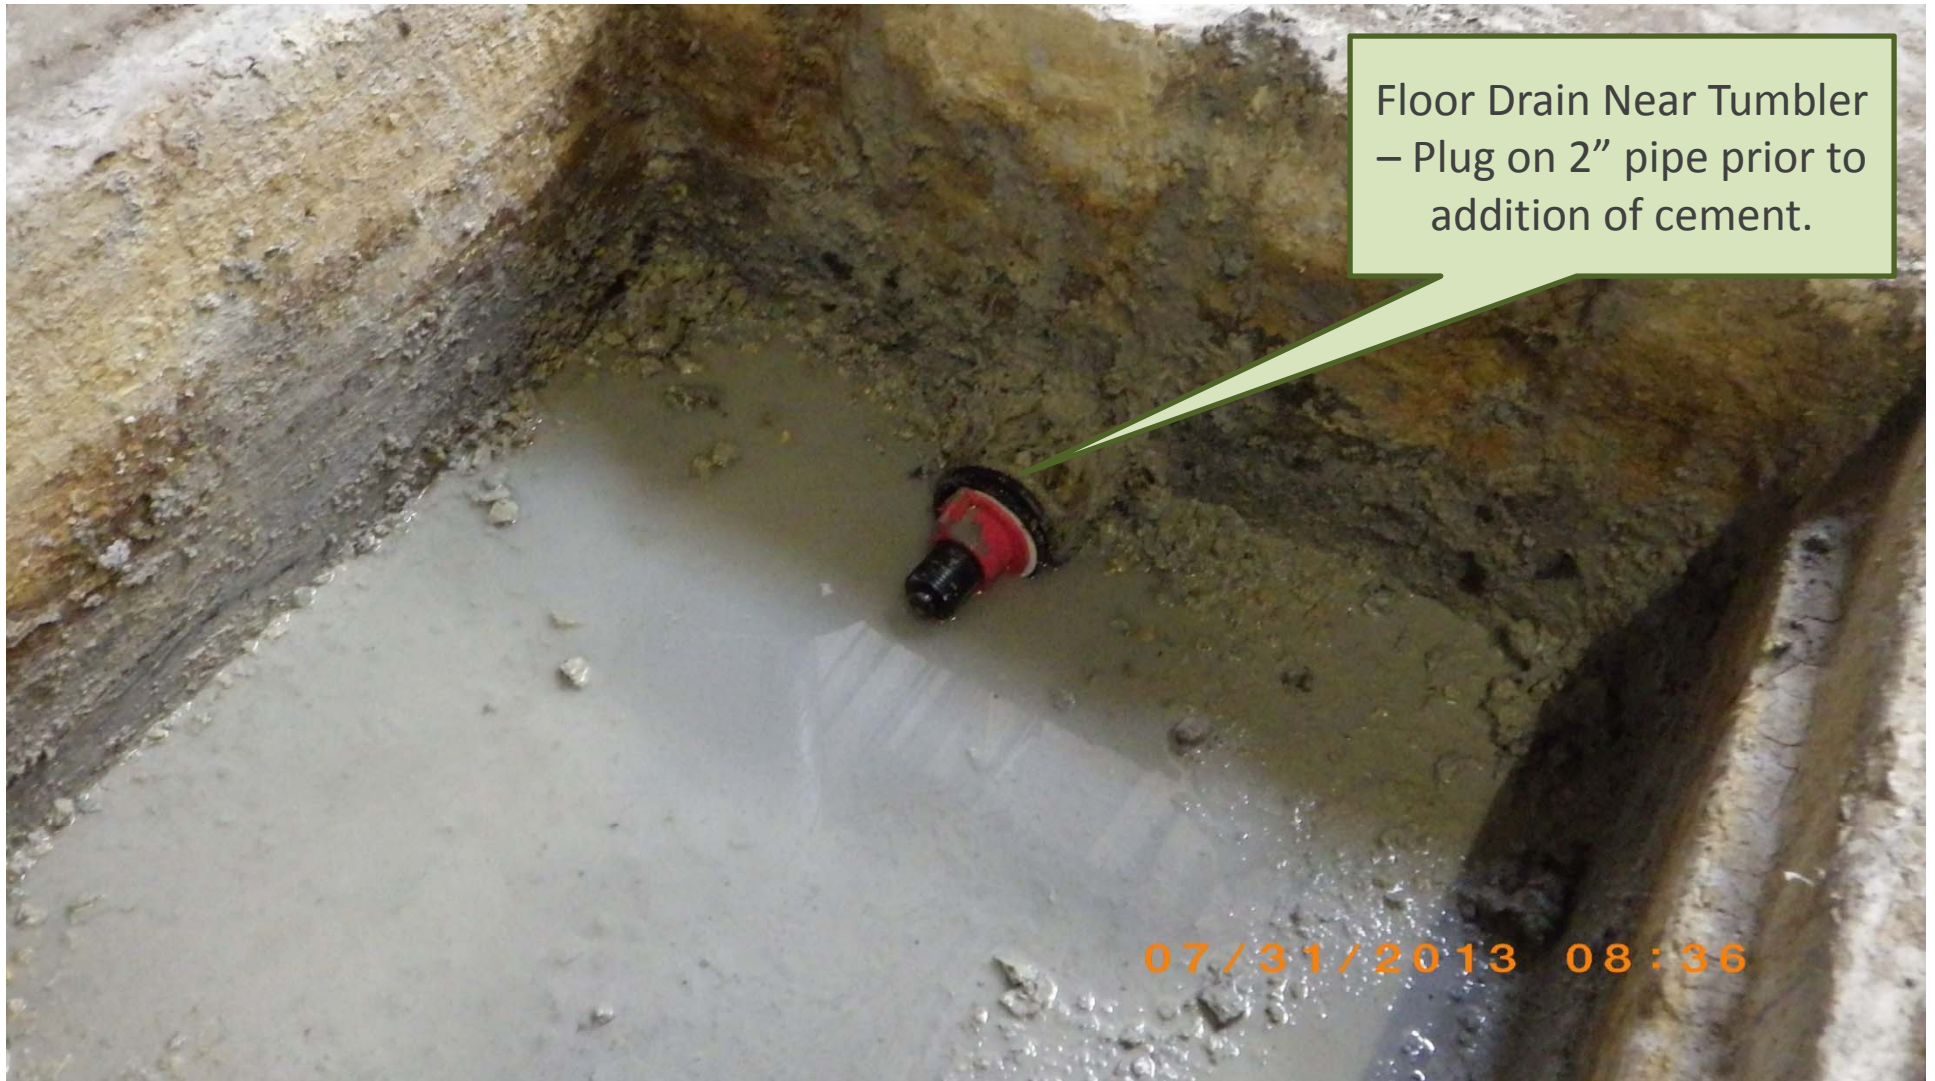
July 31, 2013 – Barthelmes Manufacturing: Closure of floor drains that discharge to the on-site stormwater basin located on west side of property. Plug placed in 2-inch drain pipe prior to cementing in-place.

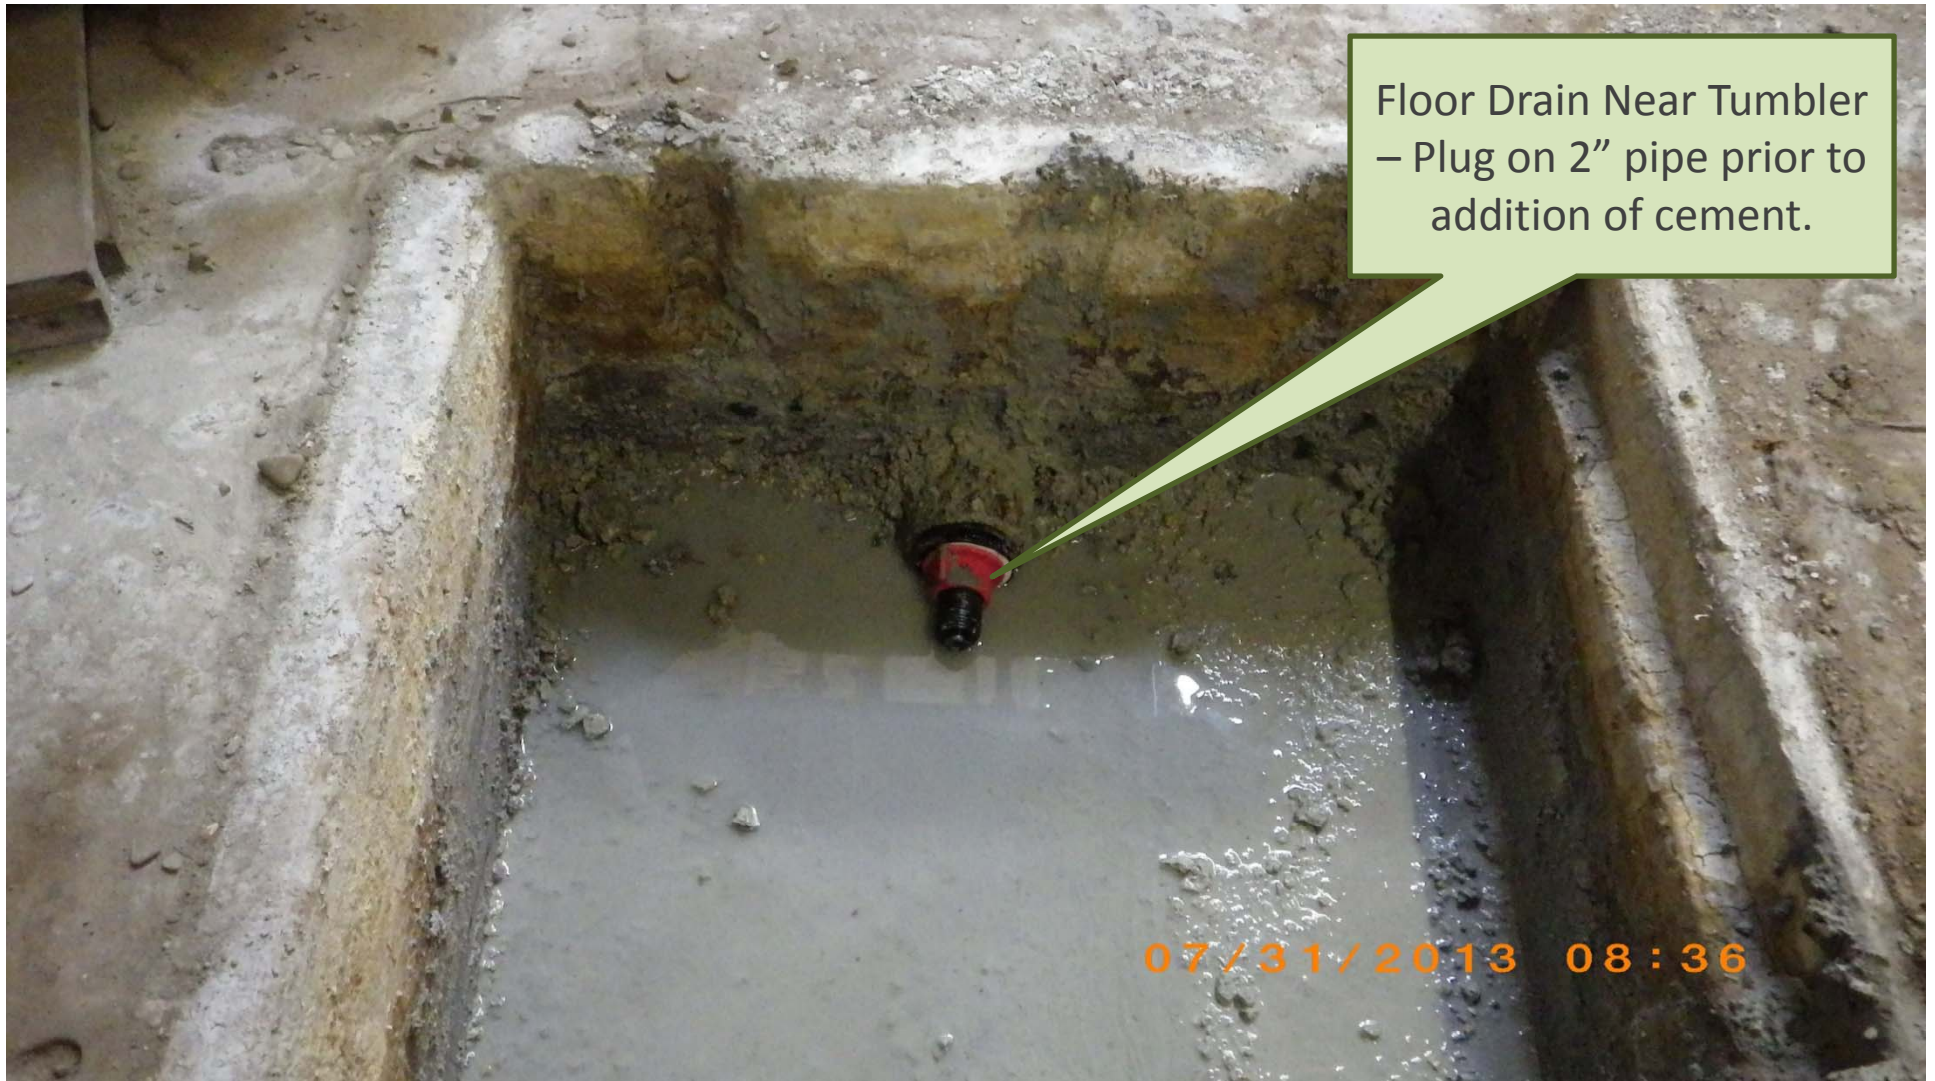
July 31, 2013 – Barthelmes Manufacturing: Closure of floor drains that discharge to the on-site stormwater basin located on west side of property. Plug placed in 2-inch drain pipe prior to cementing in-place.

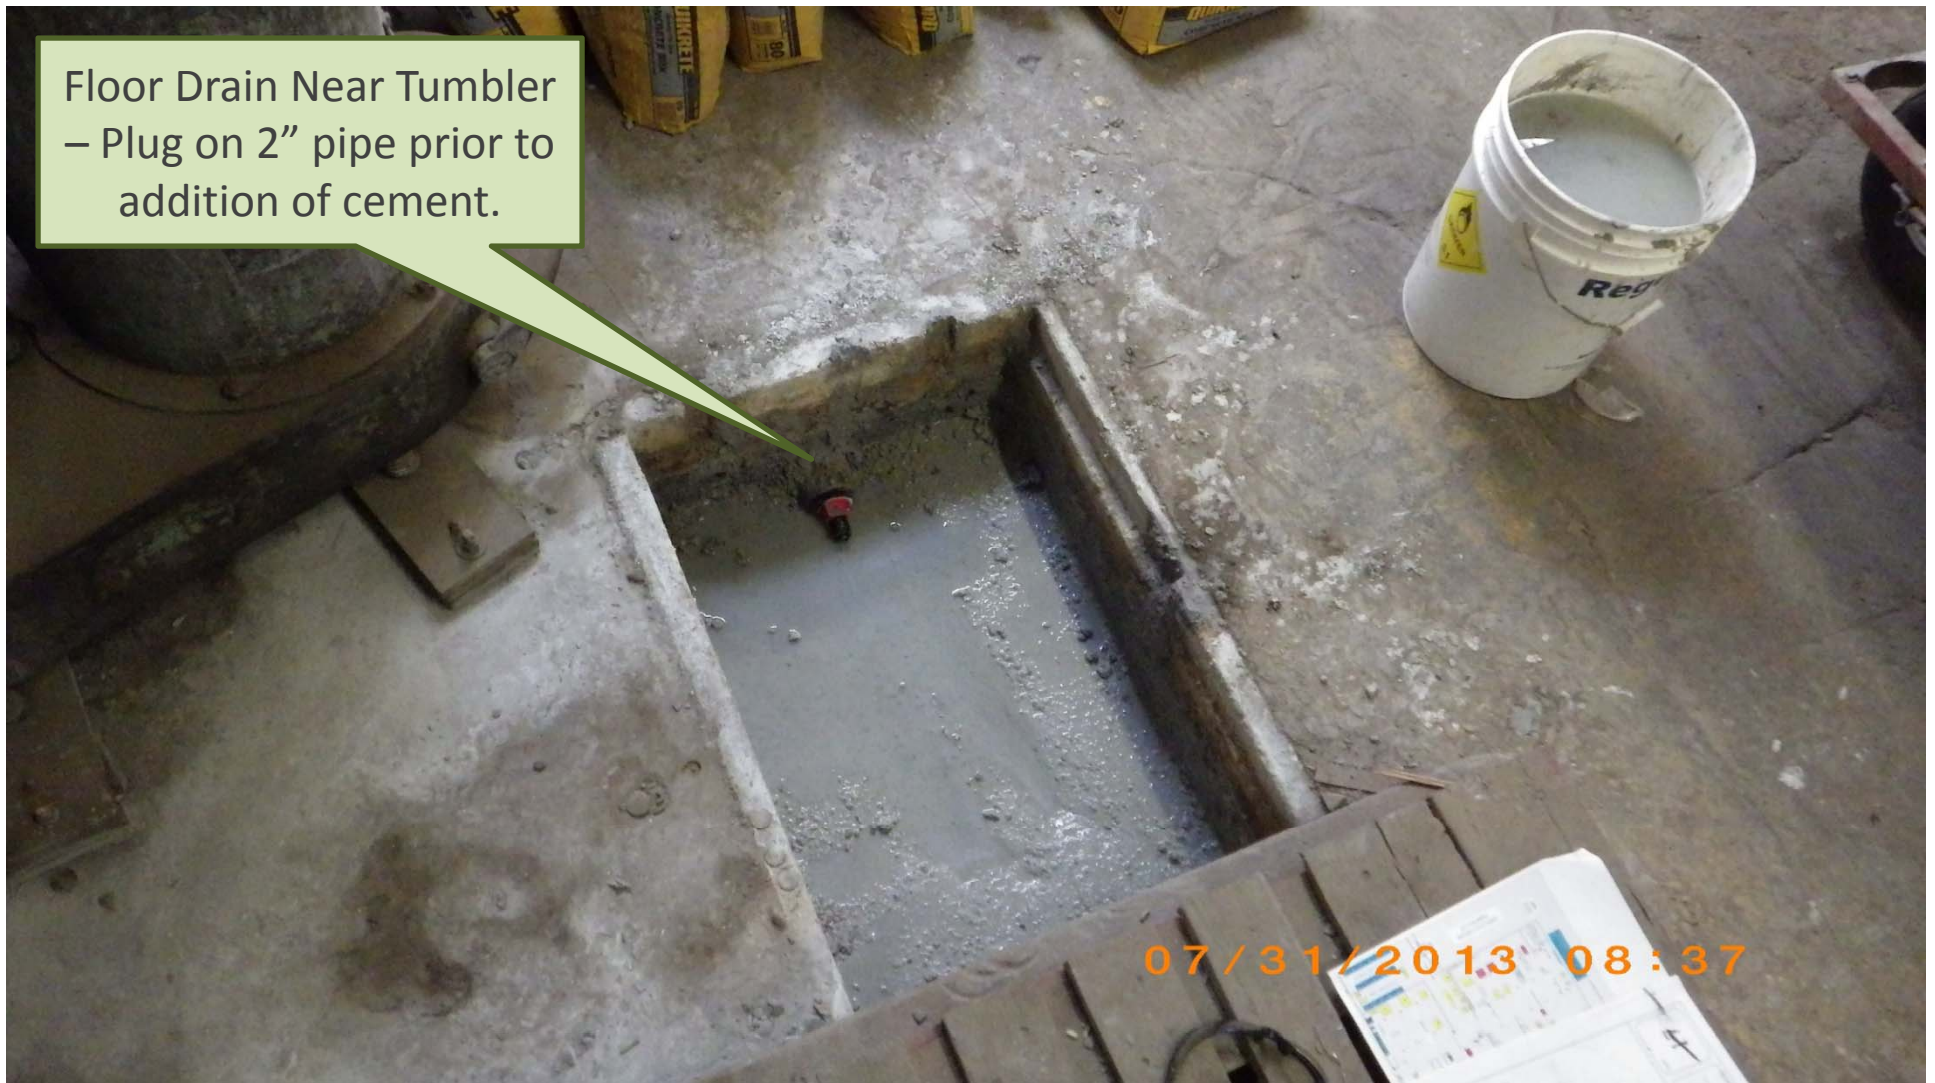
July 31, 2013 – Barthelmes Manufacturing: Closure of floor drains that discharge to the on-site stormwater basin located on west side of property. Plug placed in 2-inch drain pipe prior to cementing in-place.

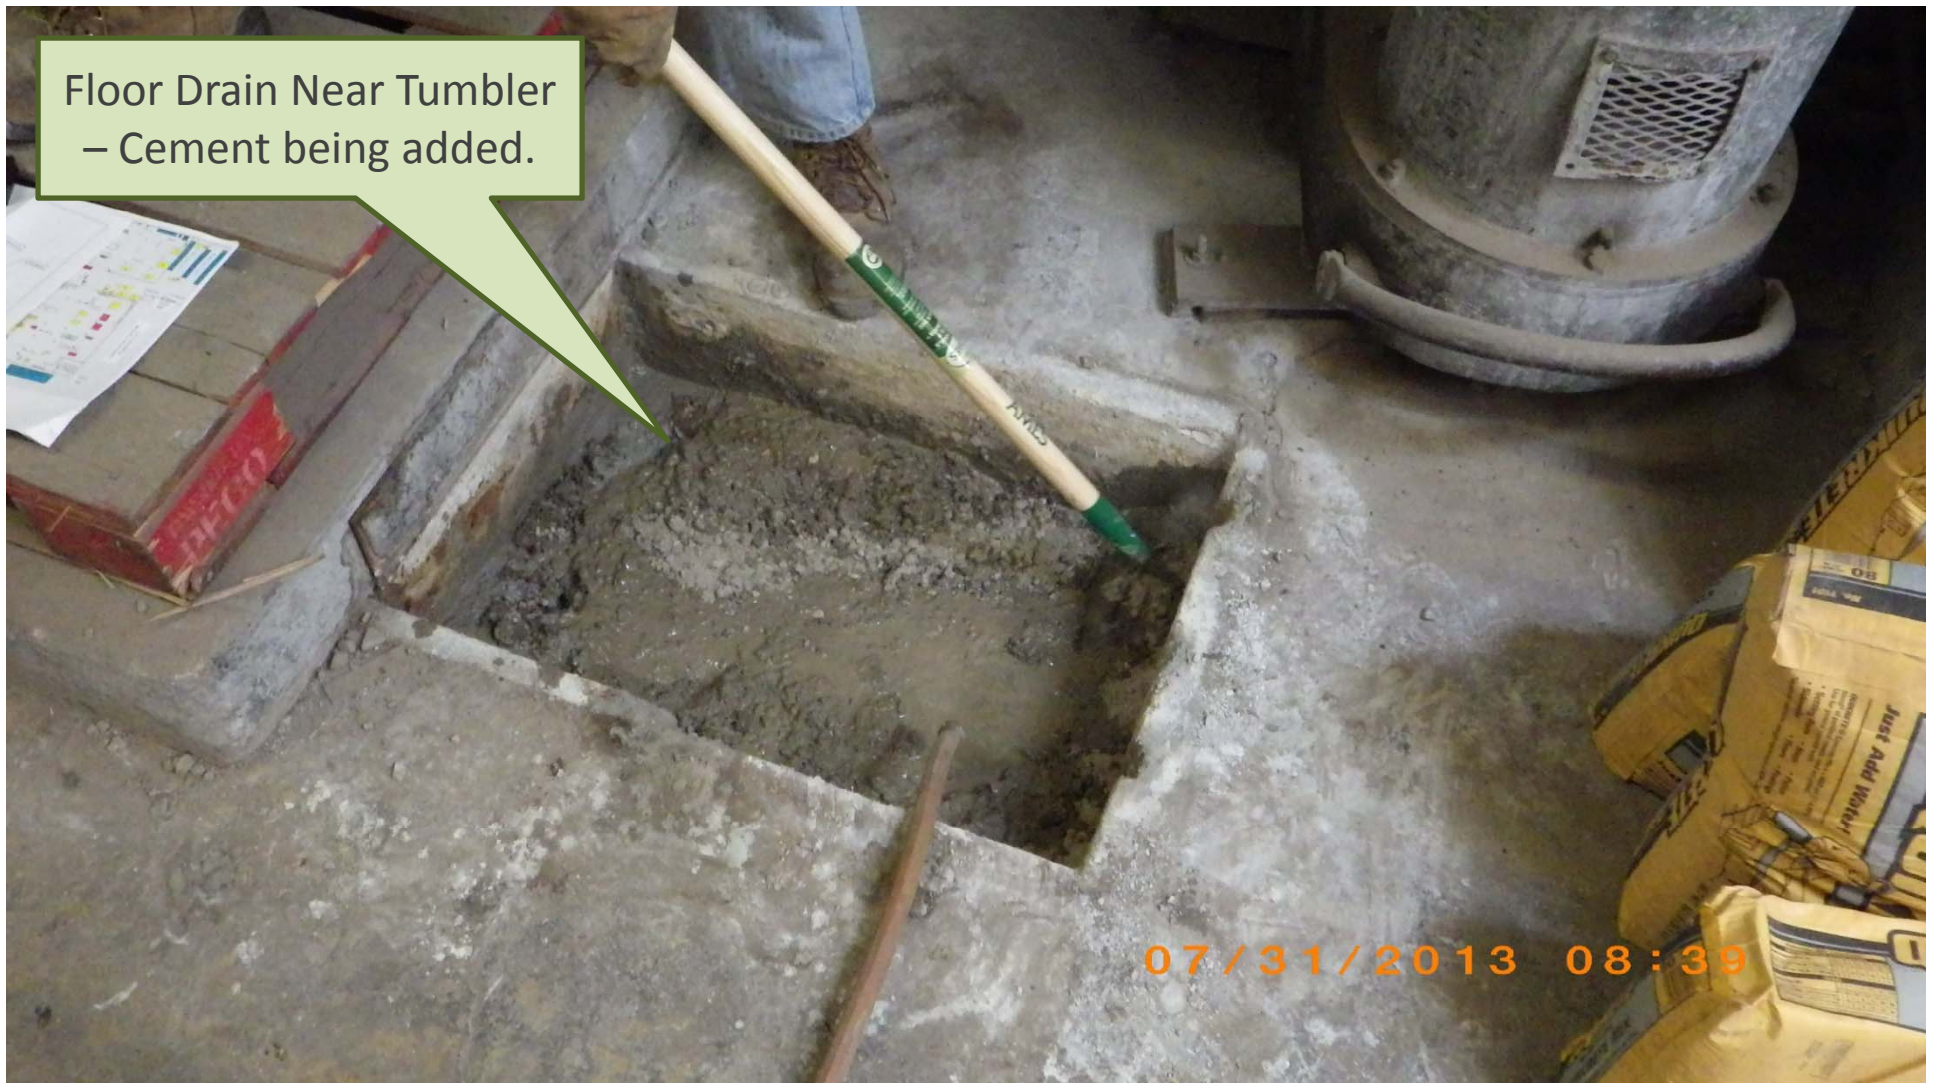
Floor Drain Near Tumbler  
– Cement being added.

July 31, 2013 – Barthelmes Manufacturing: Closure of floor drains that discharge to the on-site stormwater basin located on west side of property. Cement being added to drain.

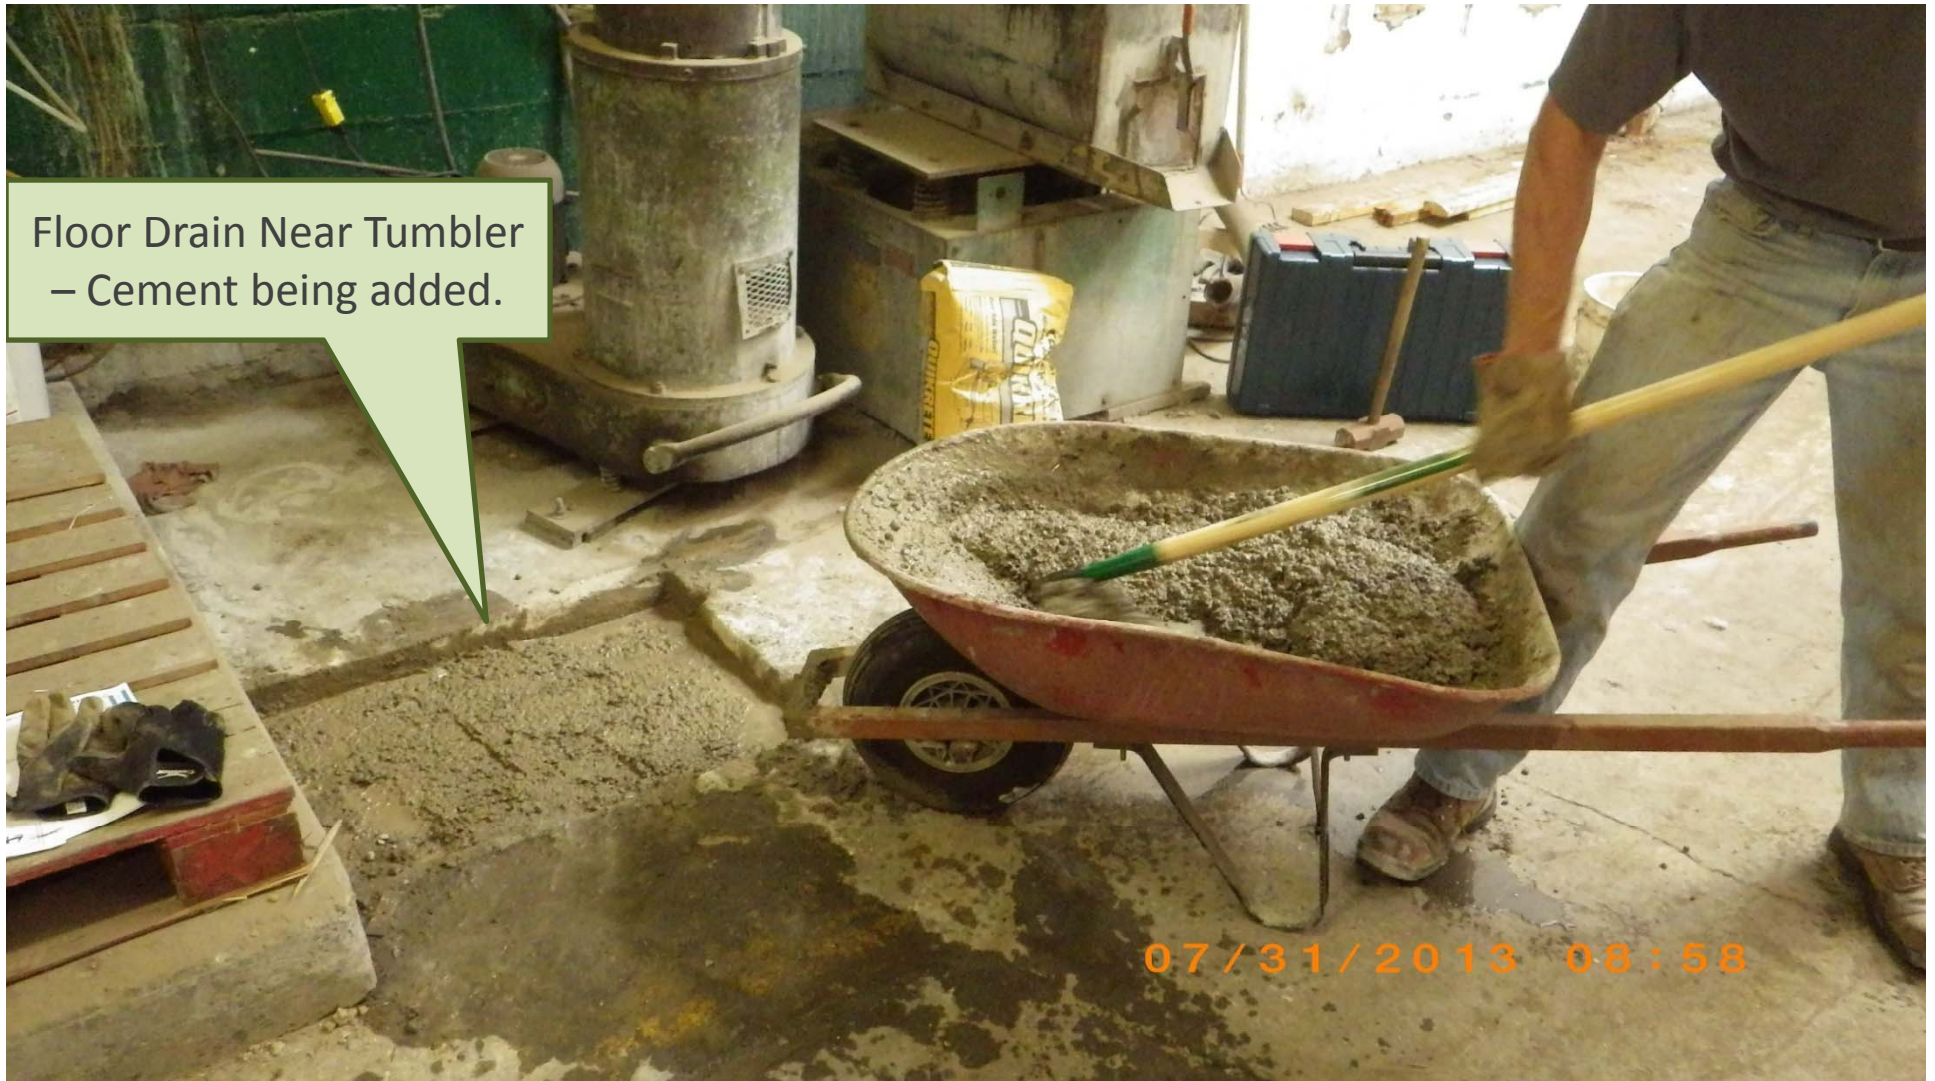
July 31, 2013 – Barthelmes Manufacturing: Closure of floor drains that discharge to the on-site stormwater basin located on west side of property. Cement being added to drain.
