# EMPIRE GEO SERVICES, INC.

**Subject: Floor Drain Closure  
Barthelmes Manufacturing  
15 Cairn Street  
Rochester, New York 14611  
Site No. 828122**

Empire Geo-Services, Inc. (Empire) has prepared this letter report to document the closure of two floor drains at the above-referenced facility. The closures were performed by NYSDEC and Empire personnel on July 31, 2013. Photographs documenting the closure activities are attached.

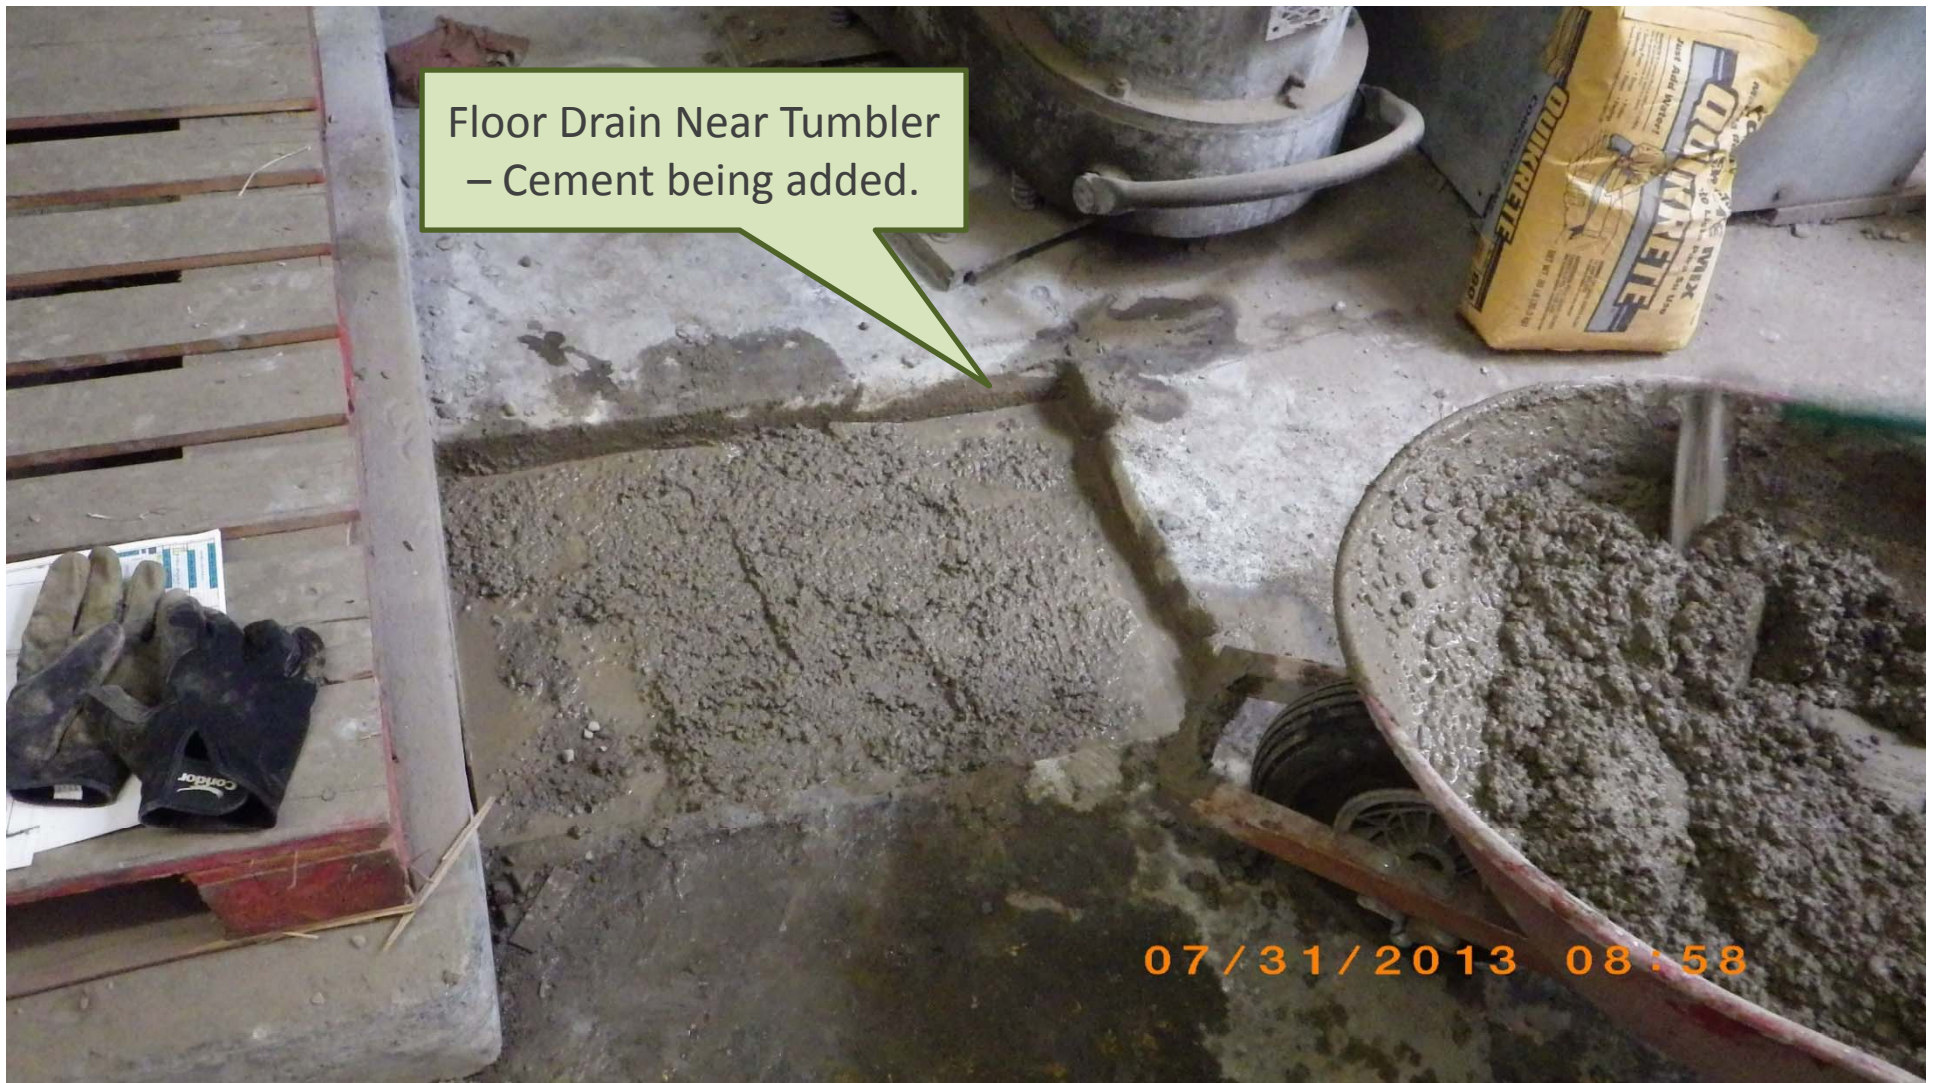
July 31, 2013 – Barthelmes Manufacturing: Closure of floor drains that discharge to the on-site stormwater basin located on west side of property. Cement being added to drain.

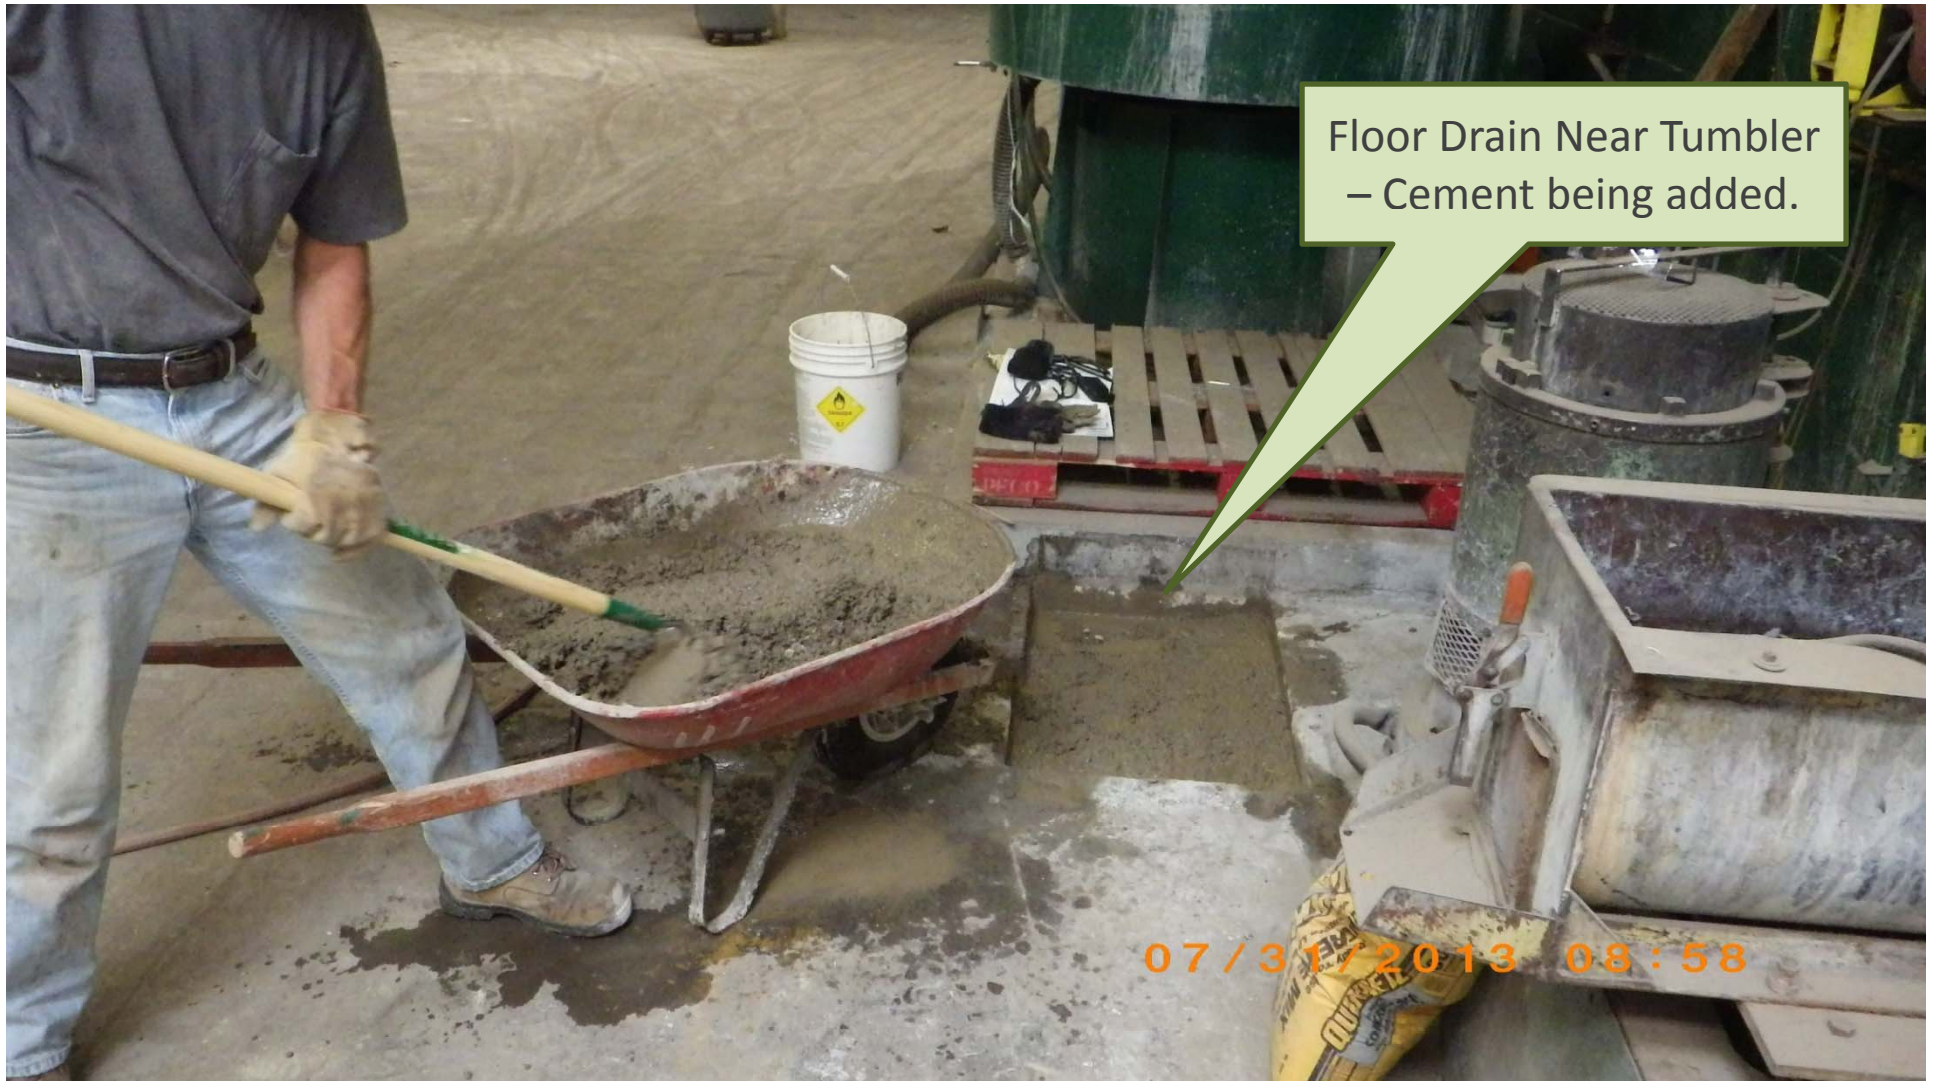
July 31, 2013 – Barthelmes Manufacturing: Closure of floor drains that discharge to the on-site stormwater basin located on west side of property. Cement being added to drain.

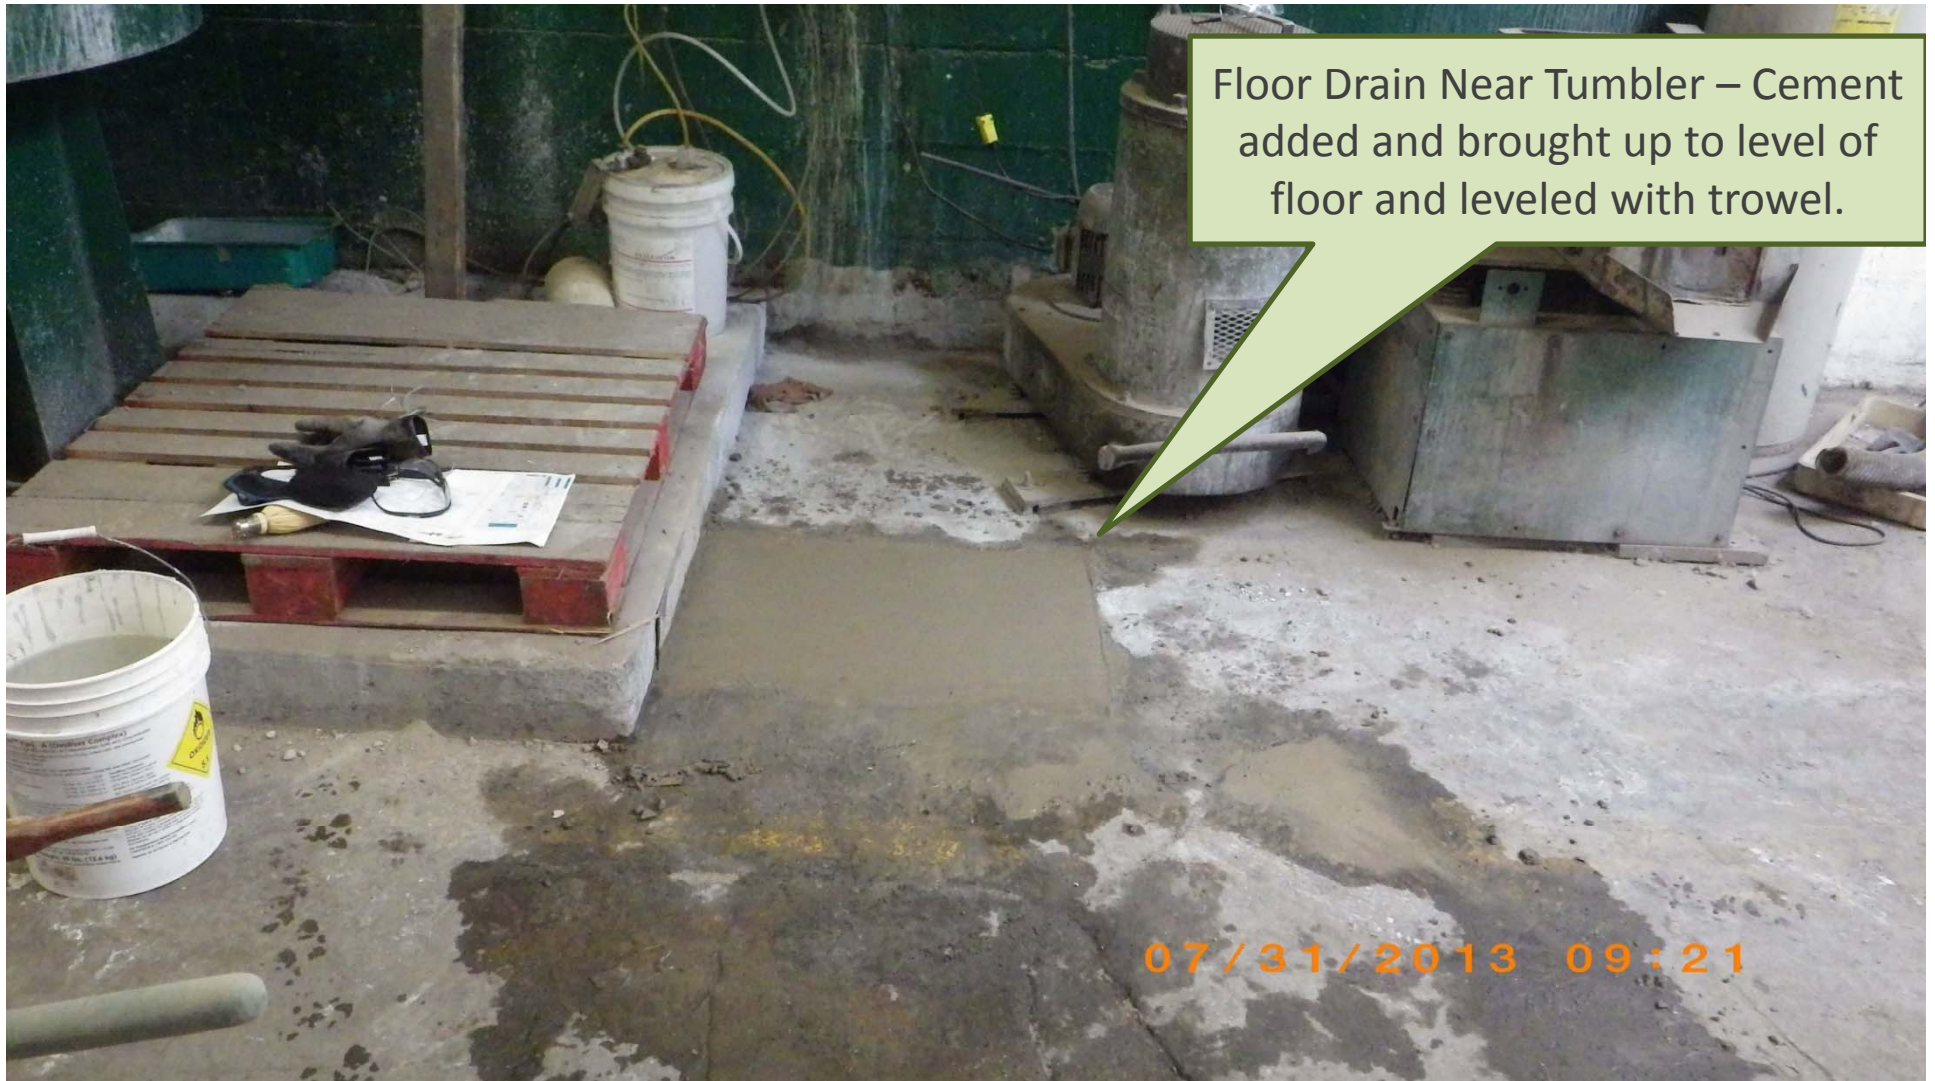
July 31, 2013 – Barthelmes Manufacturing: Closure of floor drains that discharge to the on-site stormwater basin located on west side of property. Cement added to drain and brought to the level of the floor.

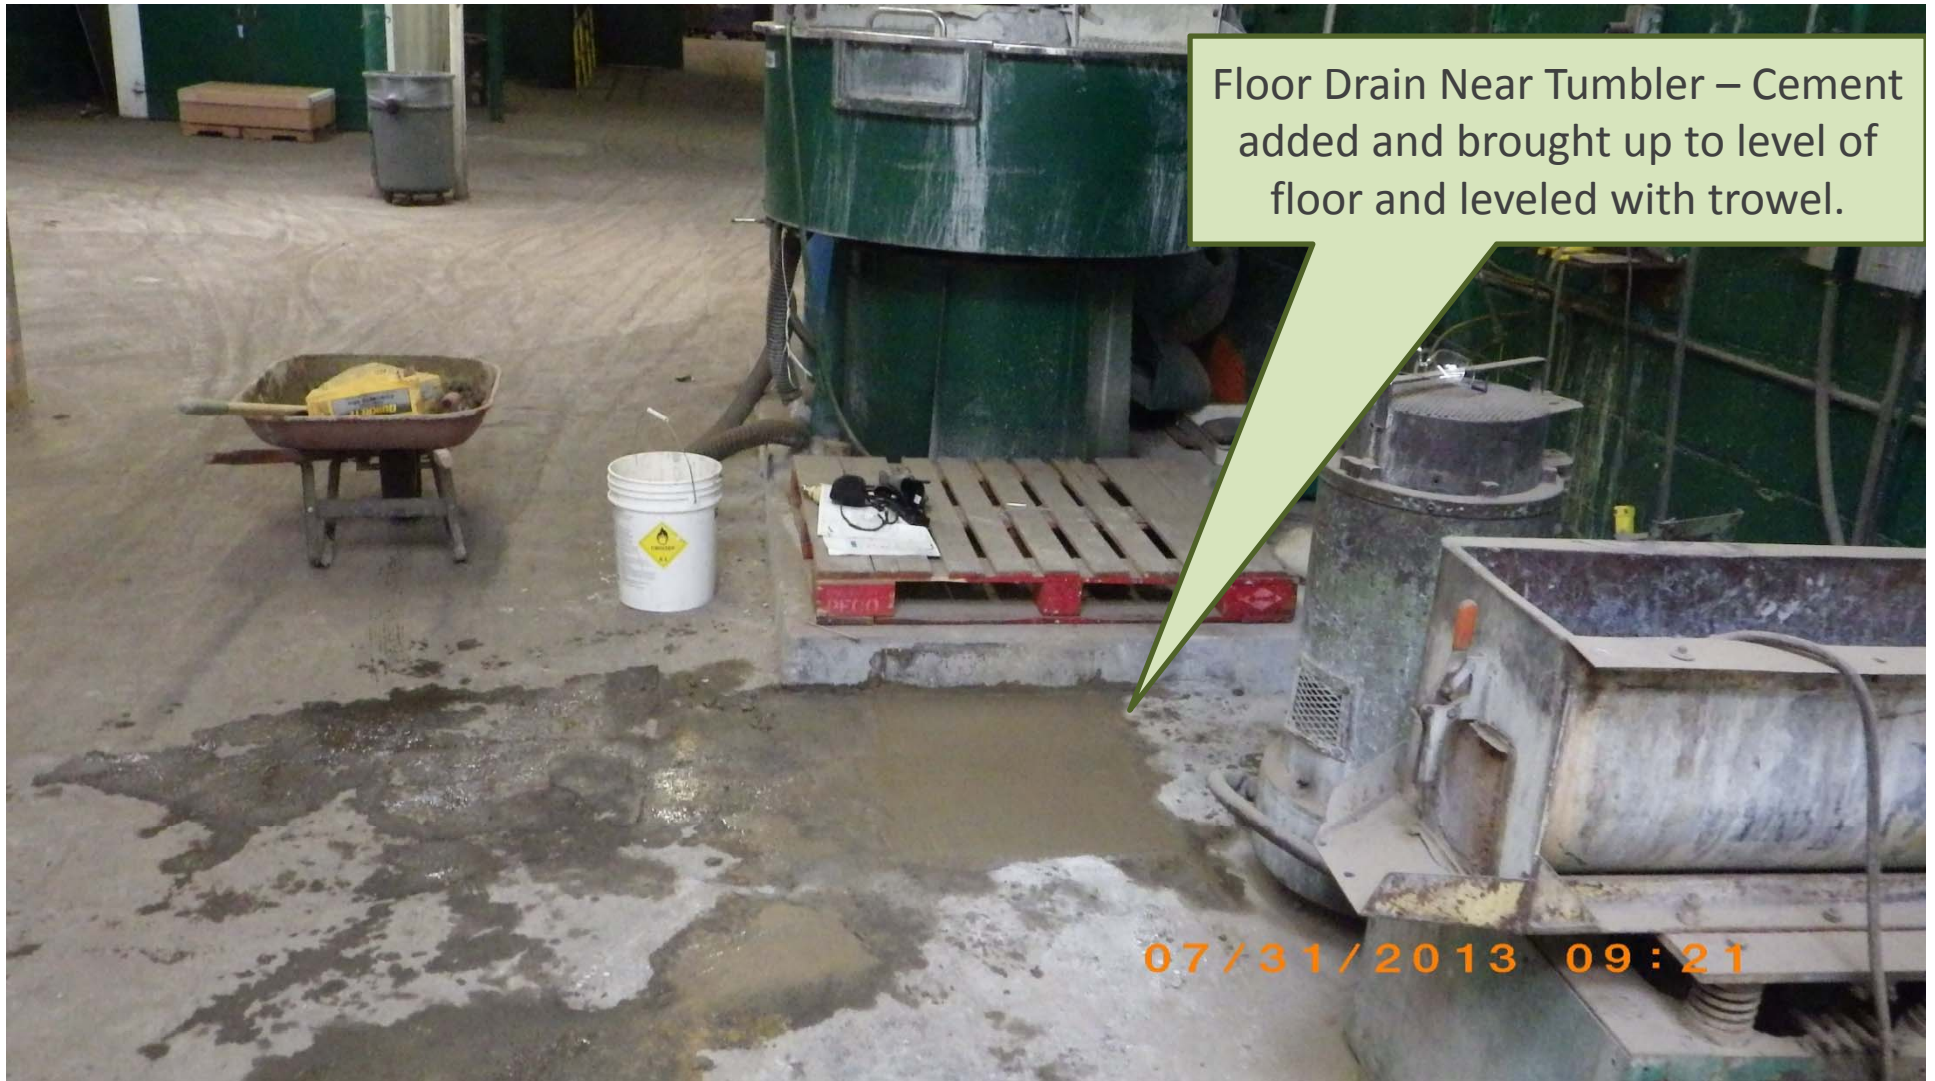
Floor Drain Near Tumbler – Cement added and brought up to level of floor and leveled with trowel.

July 31, 2013 – Barthelmes Manufacturing: Closure of floor drains that discharge to the on-site stormwater basin located on west side of property. Cement added to drain and brought to the level of the floor.

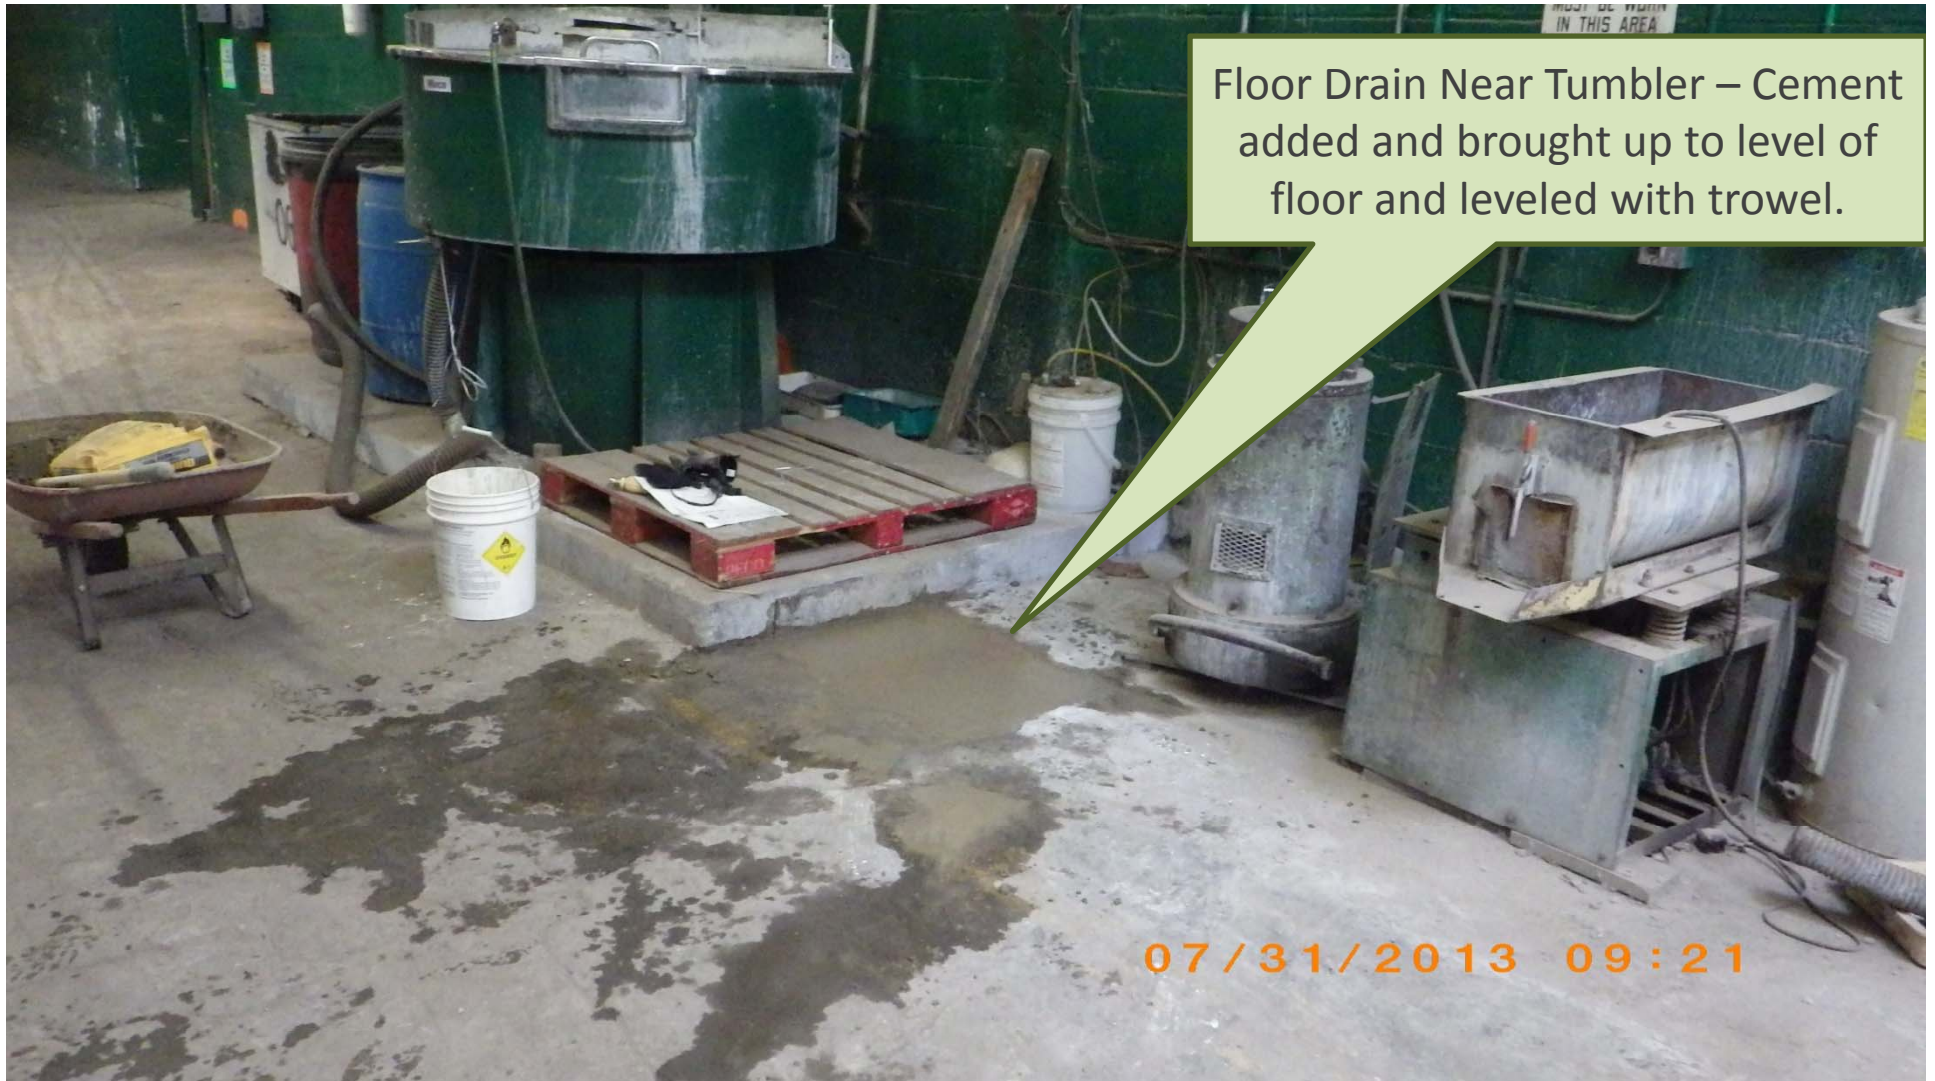
July 31, 2013 – Barthelmes Manufacturing: Closure of floor drains that discharge to the on-site stormwater basin located on west side of property. Cement added to drain and brought to the level of the floor.

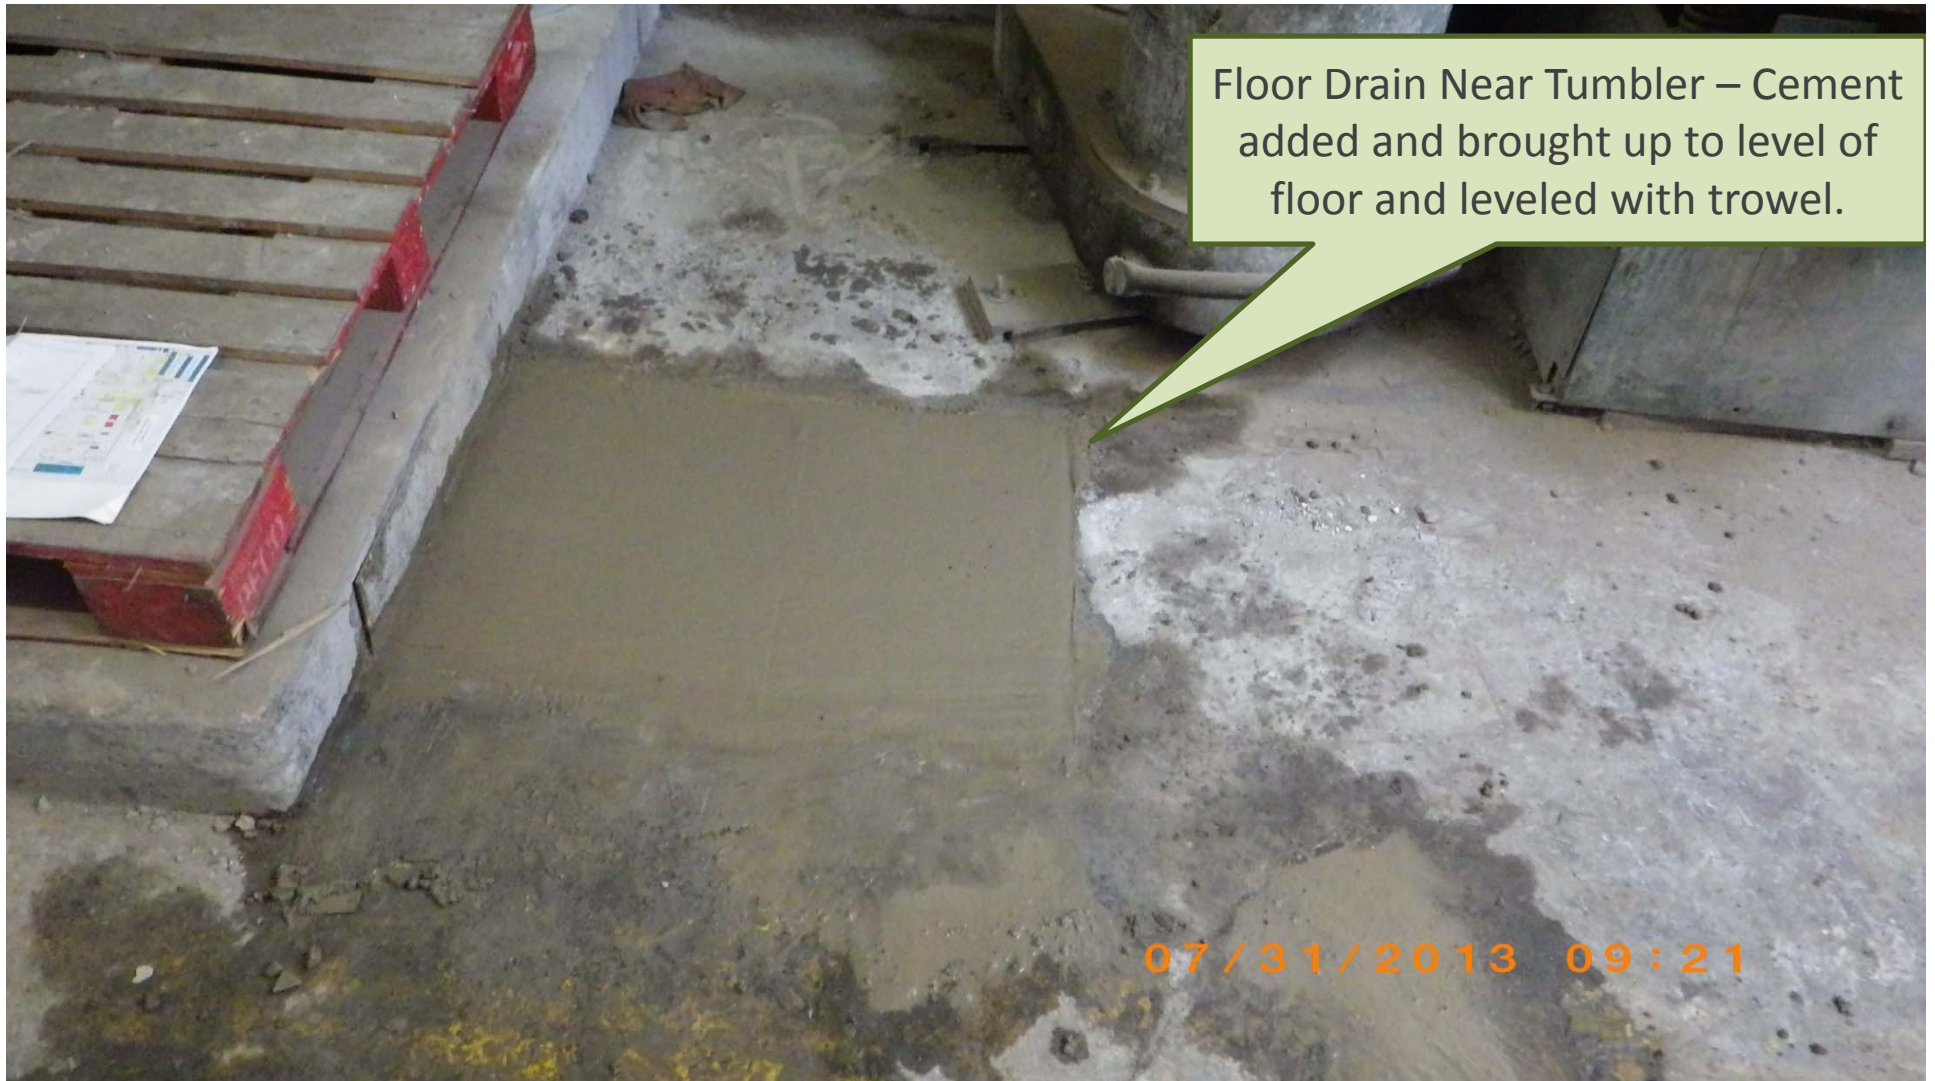
July 31, 2013 – Barthelmes Manufacturing: Closure of floor drains that discharge to the on-site stormwater basin located on west side of property. Cement added to drain and brought to the level of the floor.

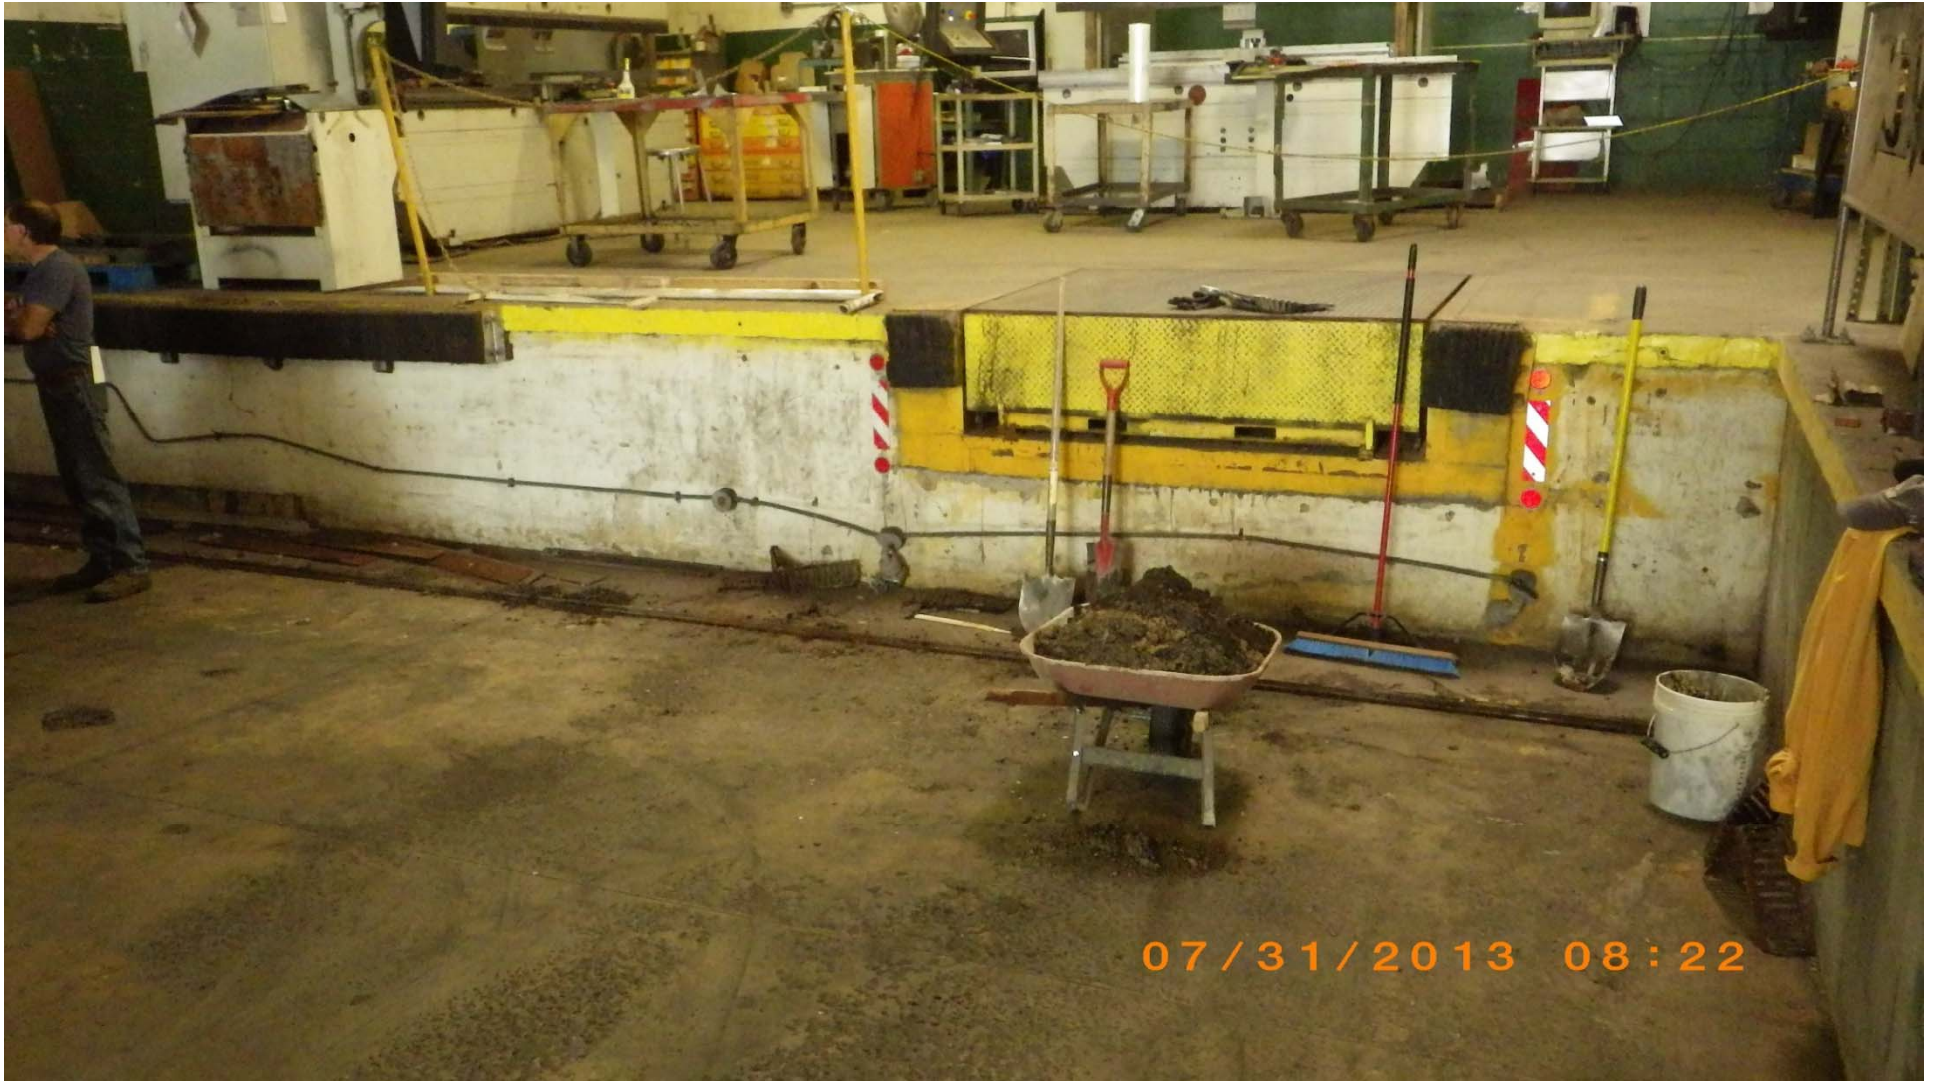
July 31, 2013 – Barthelmes Manufacturing: Closure of floor drains that discharge to the on-site stormwater basin located on west side of property. Image shows location of Trench Drain in loading dock area.

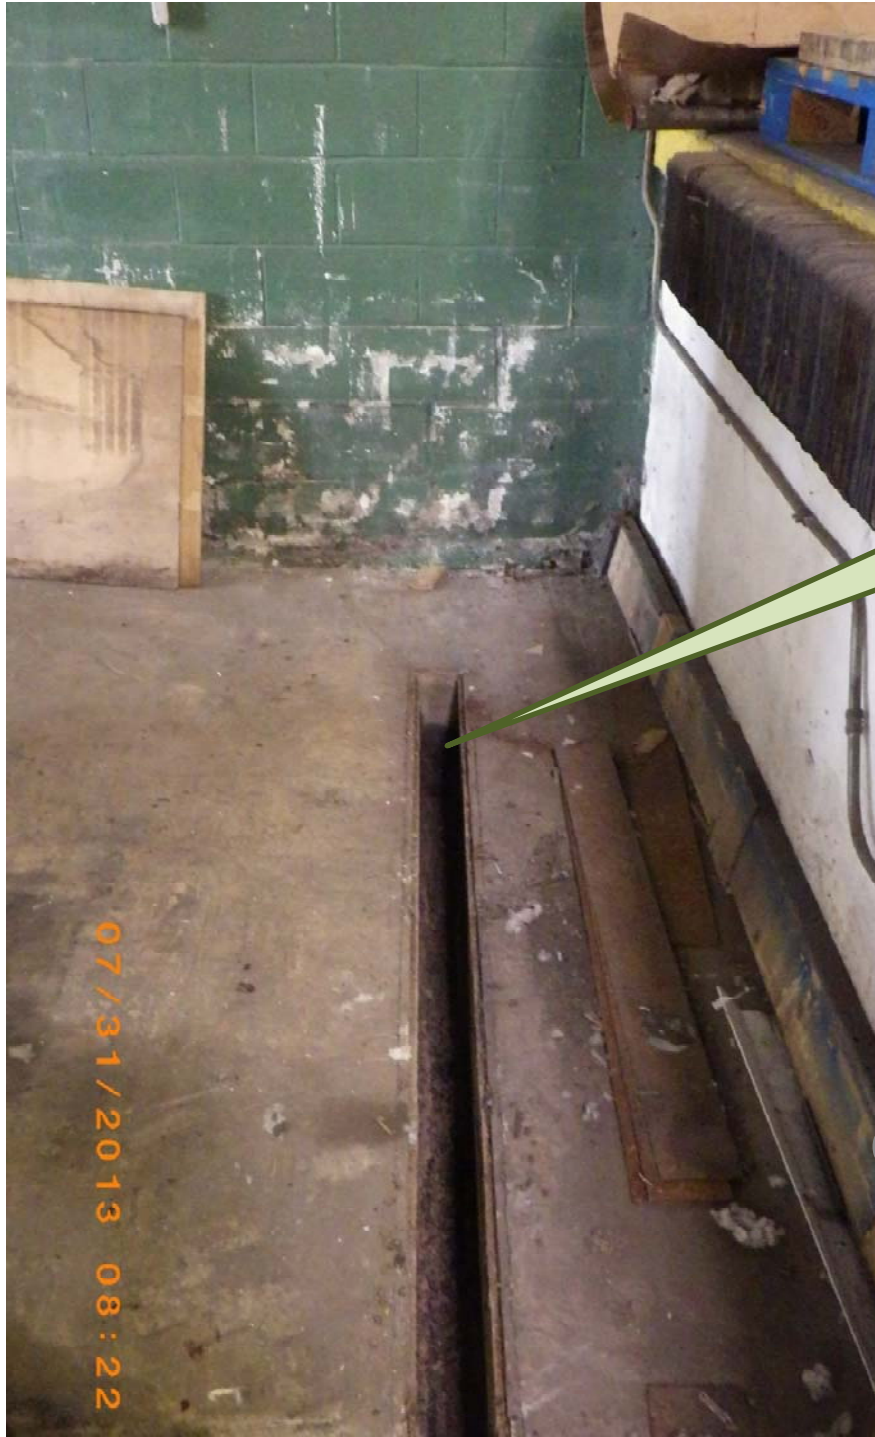
Trench Drain in Loading Dock – Location of 2-Inch Drain Pipe

July 31, 2013 – Barthelmes Manufacturing: Closure of floor drains that discharge to the on-site stormwater basin located on west side of property. Image shows location of Trench Drain in loading dock area.

The second closure was performed on a trench drain in the loading dock area. Prior to closing the drain, the accumulated sediment was removed. A two-inch-diameter water-proof plug was then installed in the drain pipe. The trench was filled with cement to just below grade above and immediately adjacent to the drain pipe. The remainder of the trench was filled with cement to a depth of approximately 2- to 3-inches.

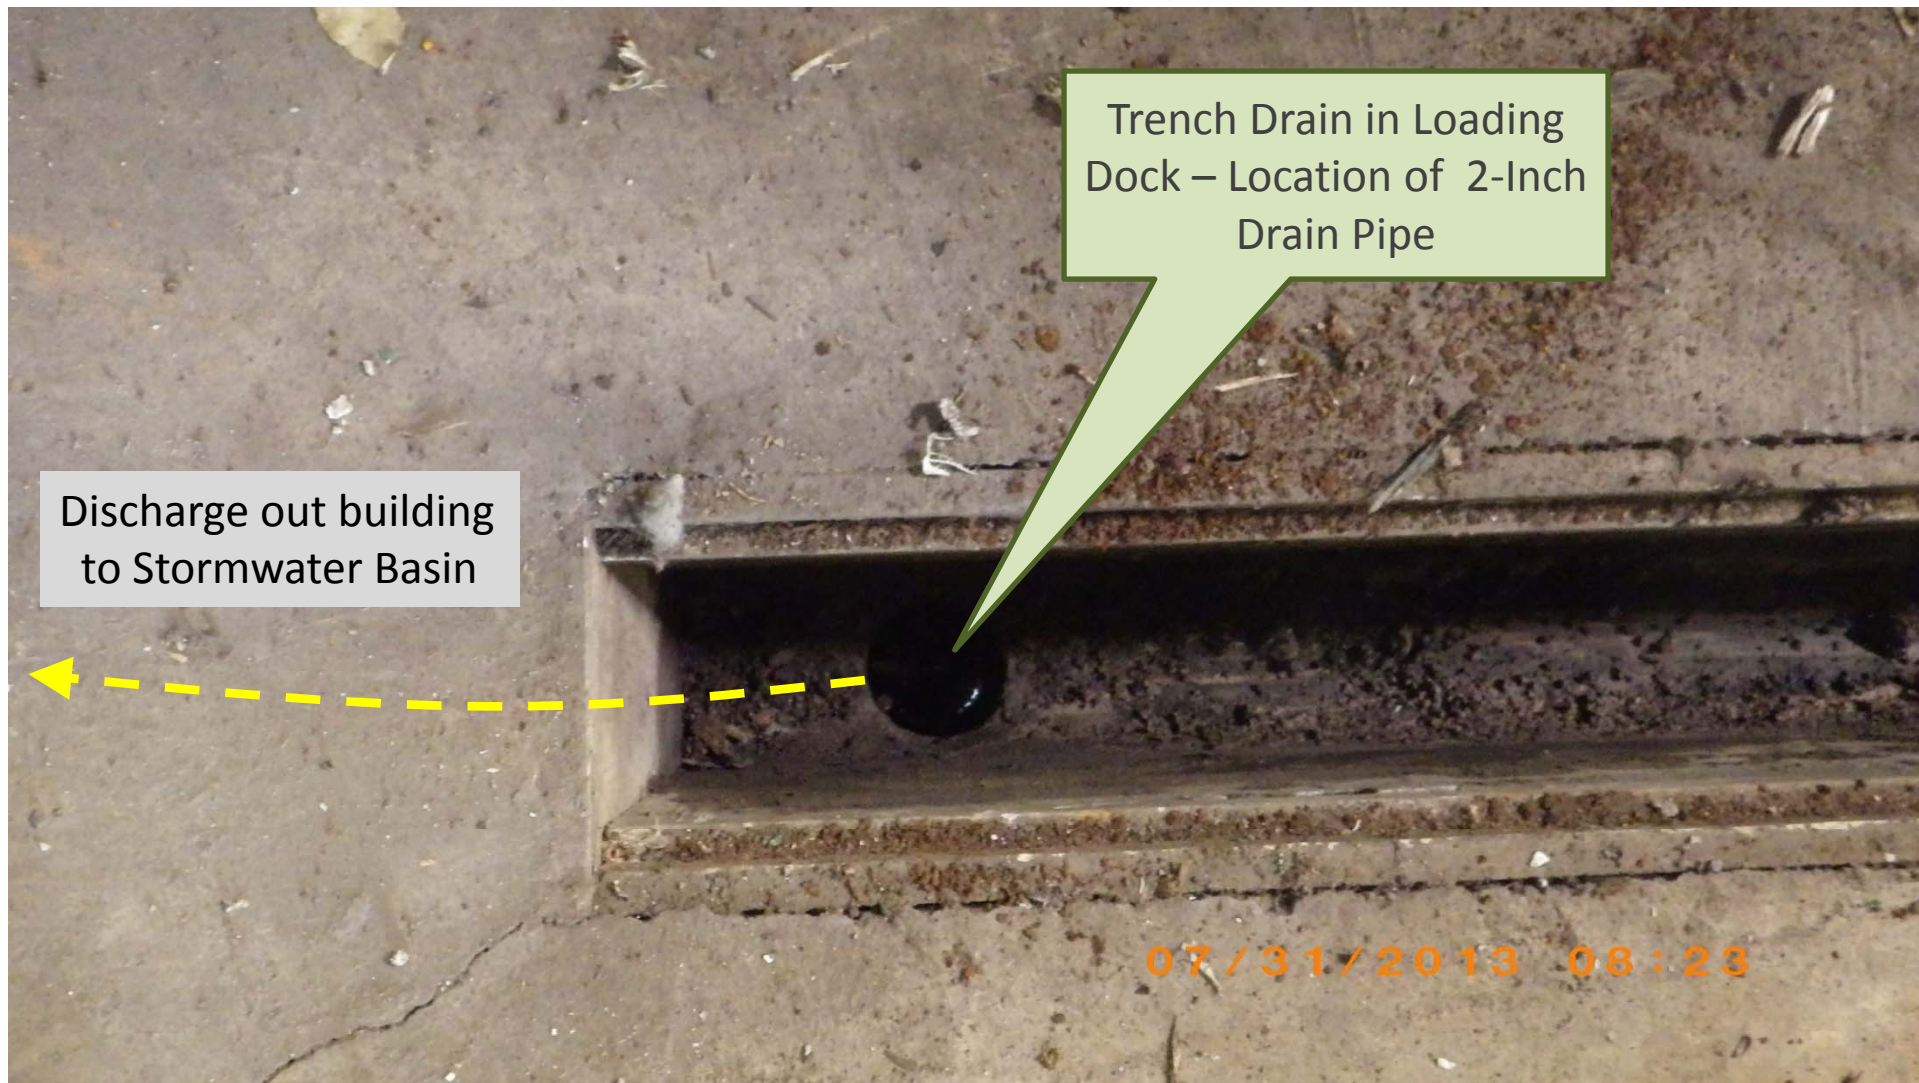
July 31, 2013 – Barthelmes Manufacturing: Closure of floor drains that discharge to the on-site stormwater basin located on west side of property. Image shows location of Trench Drain in loading dock area.

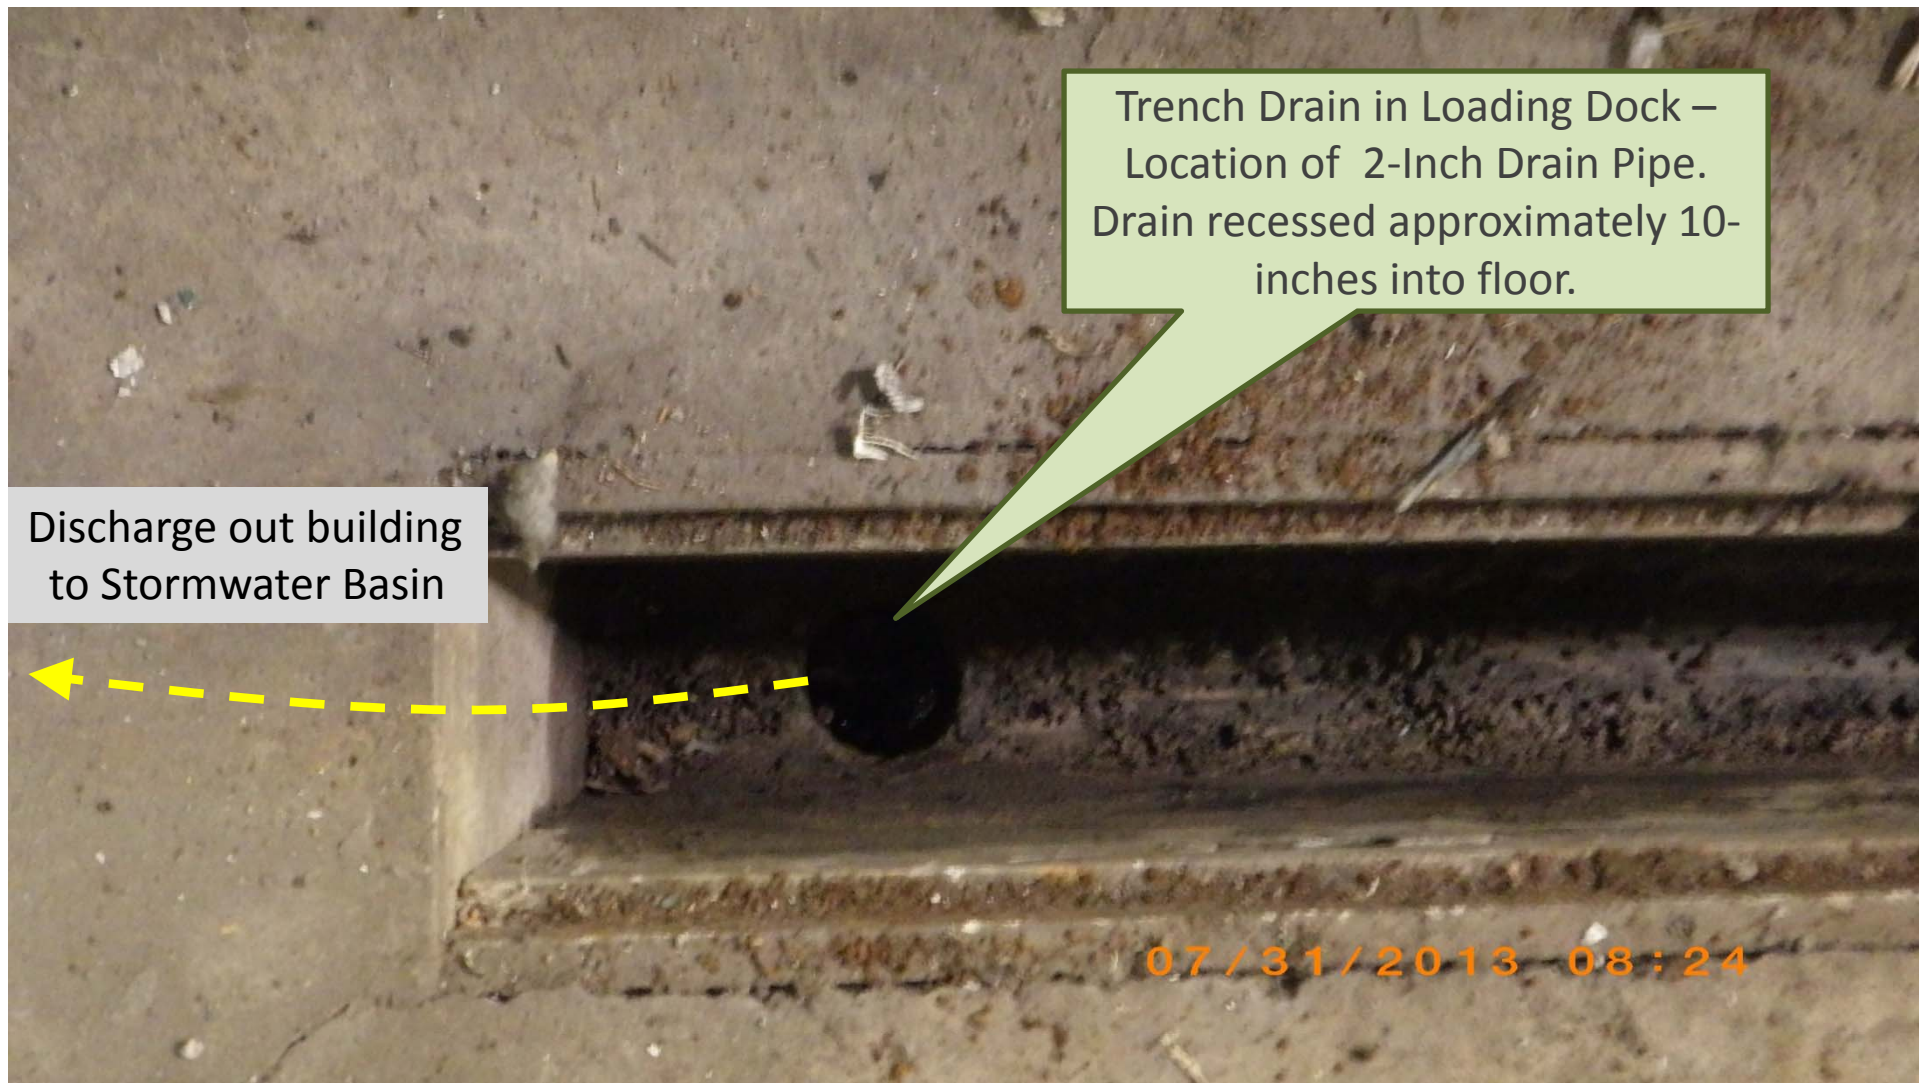
July 31, 2013 – Barthelmes Manufacturing: Closure of floor drains that discharge to the on-site stormwater basin located on west side of property. Image shows location of Trench Drain in loading dock area.

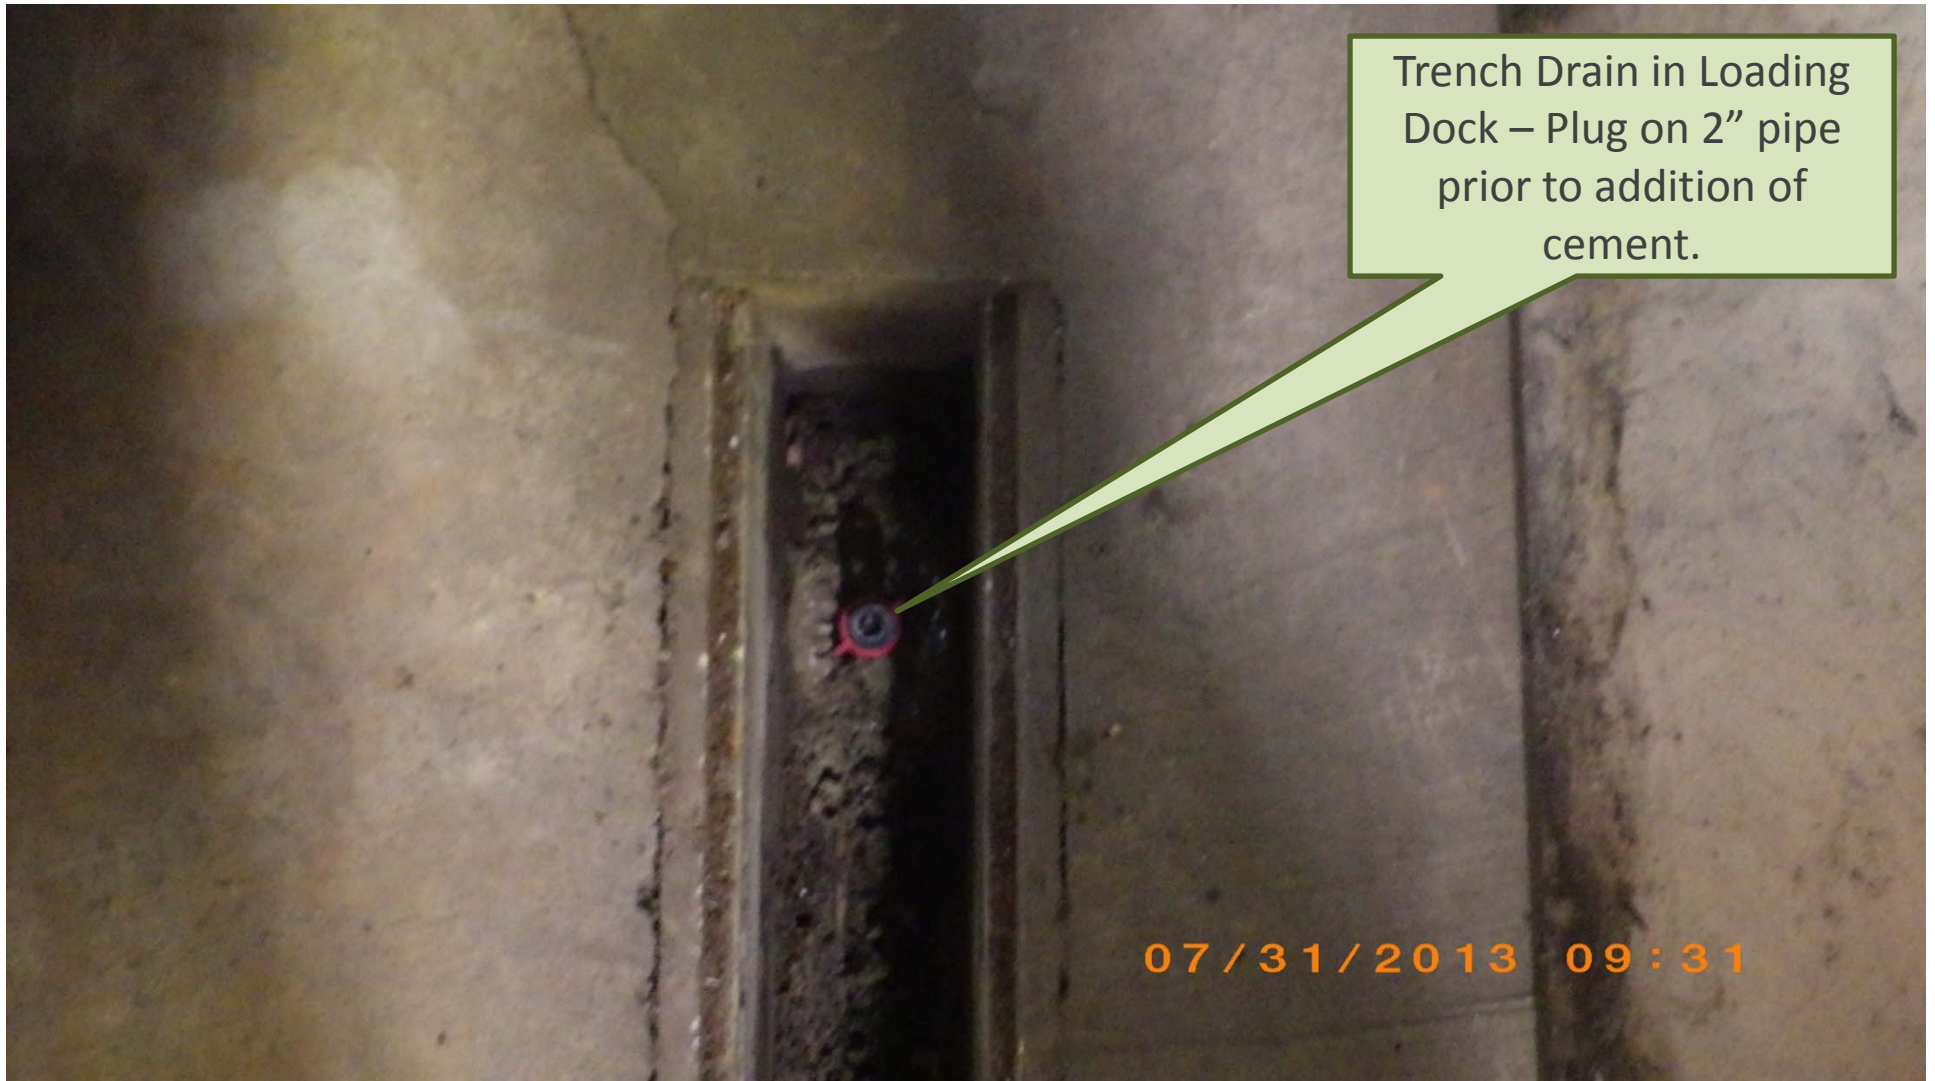
July 31, 2013 – Barthelmes Manufacturing: Closure of floor drains that discharge to the on-site stormwater basin located on west side of property. Image shows plug placed on 2” pipe prior to closure of Trench Drain in-place.
