# EMPIRE GEO SERVICES, INC.

**Subject: Floor Drain Closure  
Barthelmes Manufacturing  
15 Cairn Street  
Rochester, New York 14611  
Site No. 828122**

Empire Geo-Services, Inc. (Empire) has prepared this letter report to document the closure of two floor drains at the above-referenced facility. The closures were performed by NYSDEC and Empire personnel on July 31, 2013. Photographs documenting the closure activities are attached.

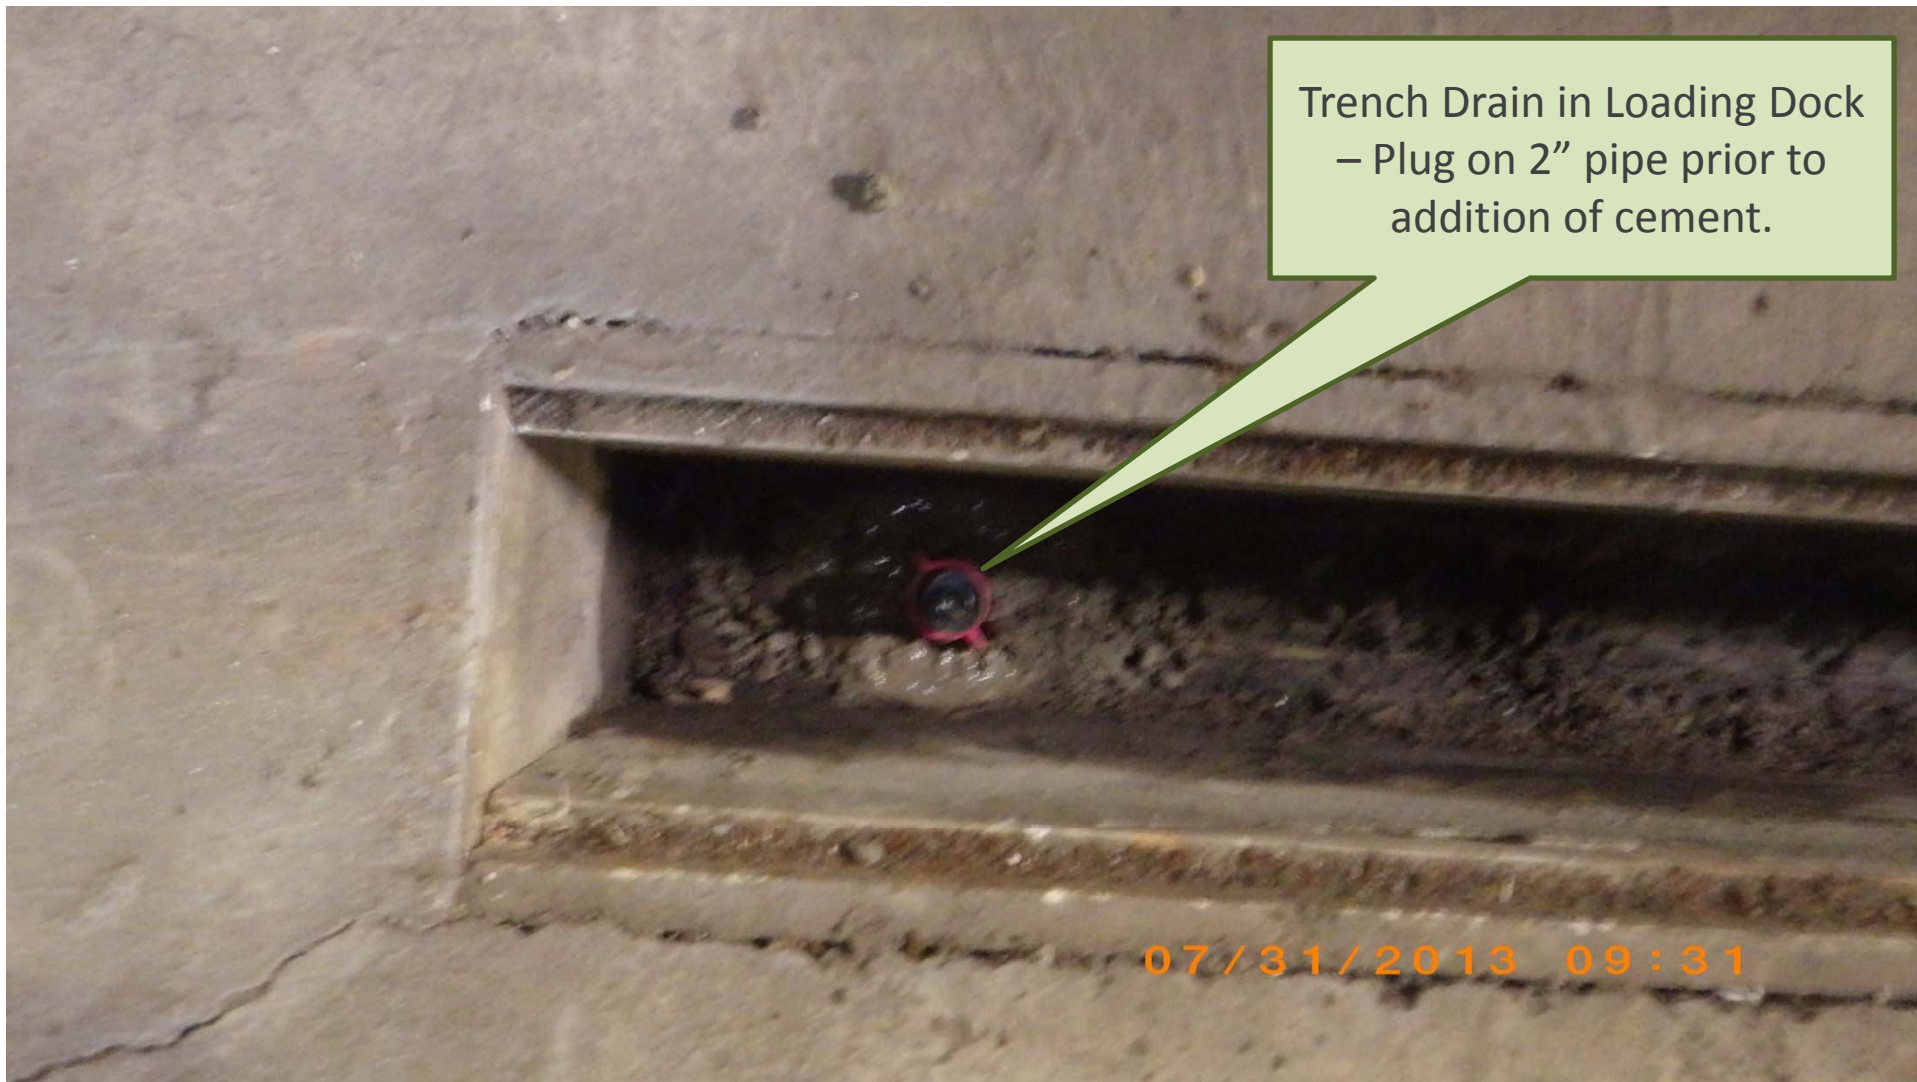
July 31, 2013 – Barthelmes Manufacturing: Closure of floor drains that discharge to the on-site stormwater basin located on west side of property. Image shows plug placed on 2" pipe prior to closure of Trench Drain in-place.

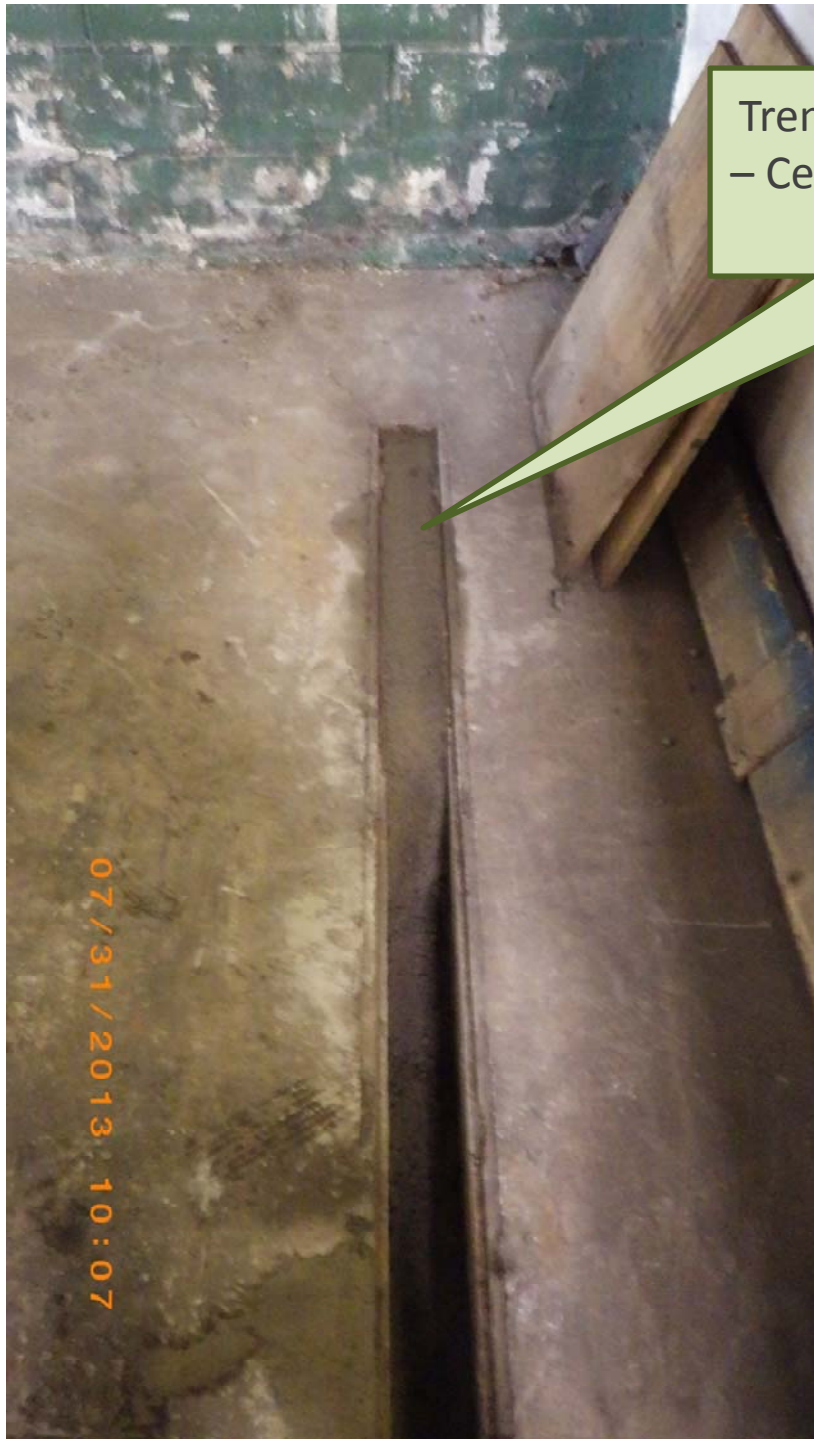
Trench Drain in Loading Dock  
– Cement added over drain to  
level floor.

July 31, 2013 – Barthelmes  
Manufacturing: Closure of  
floor drains that discharge to  
the on-site stormwater basin  
located on west side of  
property. Image shows  
cement added to Trench Drain  
as part of closure in-place.

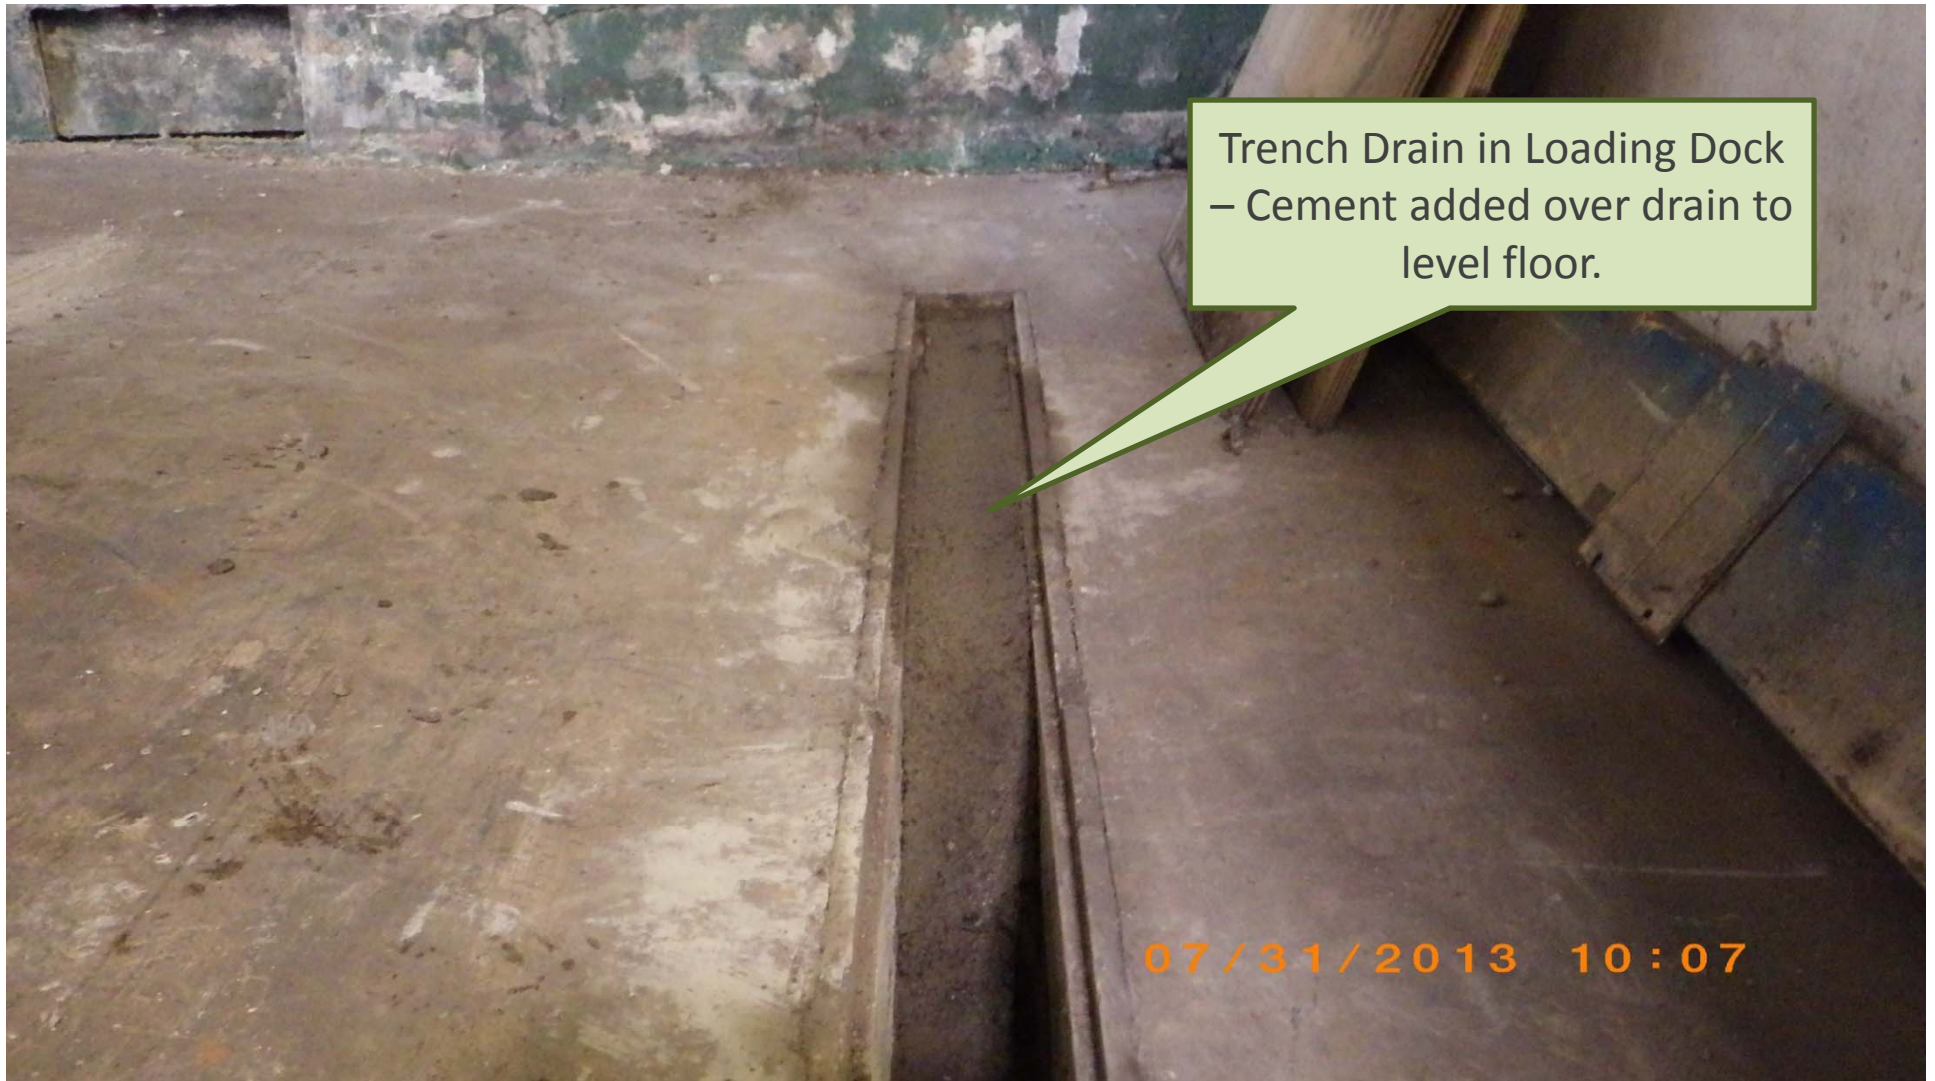
July 31, 2013 – Barthelmes Manufacturing: Closure of floor drains that discharge to the on-site stormwater basin located on west side of property. Image shows cement added to Trench Drain as part of closure in-place.

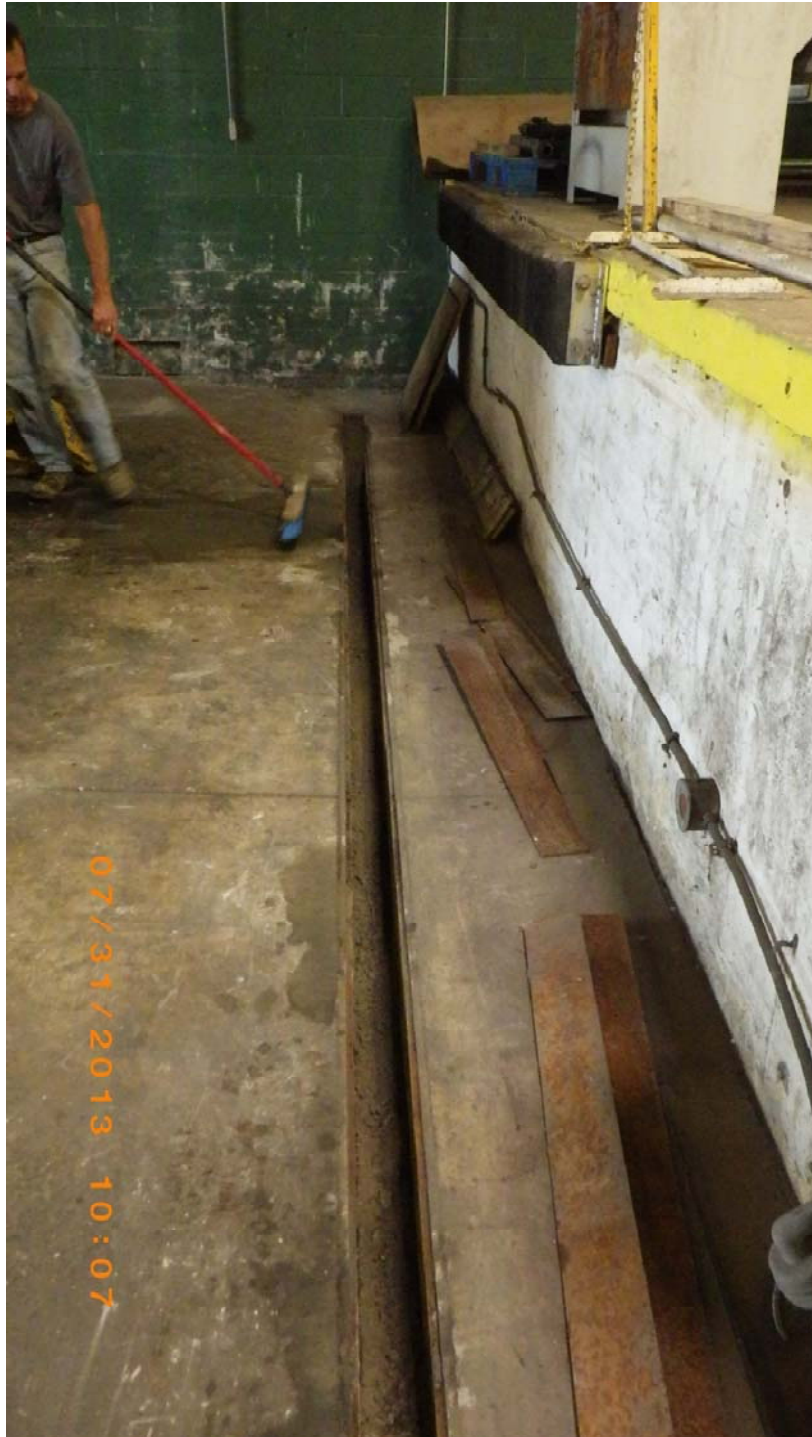
July 31, 2013 – Barthelmes Manufacturing: Closure of floor drains that discharge to the on-site stormwater basin located on west side of property. Image shows cement added to Trench Drain as part of closure in-place.
