TECHNICAL PROJECT REPORT

ENVIRONMENTAL TECHNICAL SERVICES DIVISION

DATE 2/22/83	TITLE 1982 Kodak Park Groundwater Sampling Survey	
-----------------	--	--

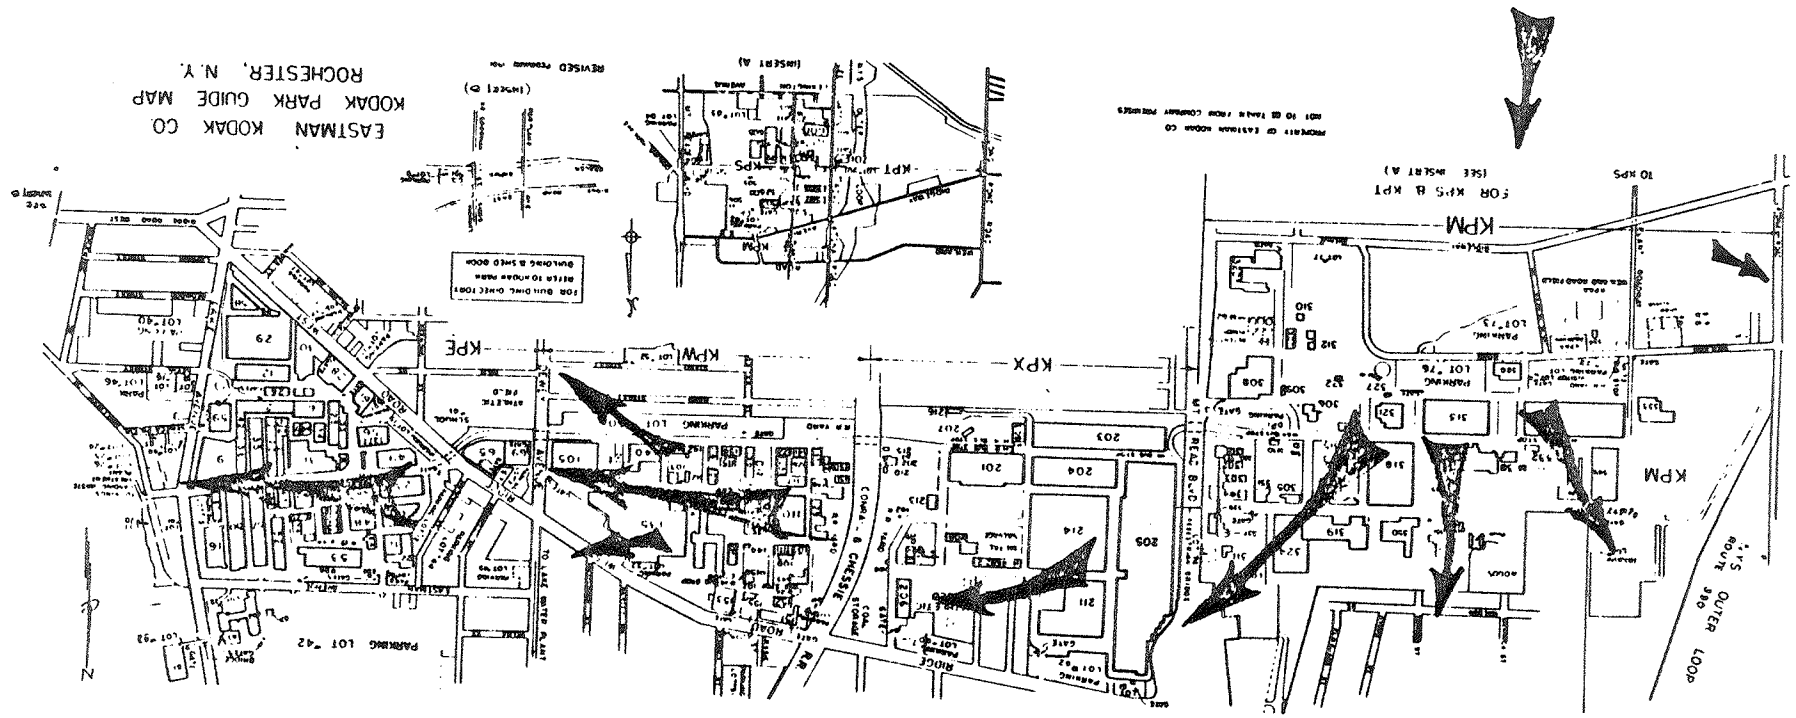
FIGURE 2

Figure 2 presents a general description of the groundwater flow in the KP area. Overall there appears to be little difference between the general flow pattern of the deep and shallow aquifers. Flow in KPM is generally to the north towards the area's boundaries with the groundwater flowing towards NYS Route 390 and the Ridge Road area. Flow in KPX has not been well defined at this time, although preliminary evaluation suggests the overall flow is easterly. Flow in KPW is mainly to the southeast with some flow to the north. It is theorized that the main 48" industrial sewer which runs along the south edge of KPW serves as a discharge point for groundwater and limits flow across the southern boundary of KPW. Flow in KPE has not yet been defined in detail; however, it is expected that the general flow direction is easterly towards the Genesee River. A hydrogeologic study of KP is currently being conducted by Haley and Aldrich Geologic Consultants which will better quantify the groundwater flow pattern in the KP area.

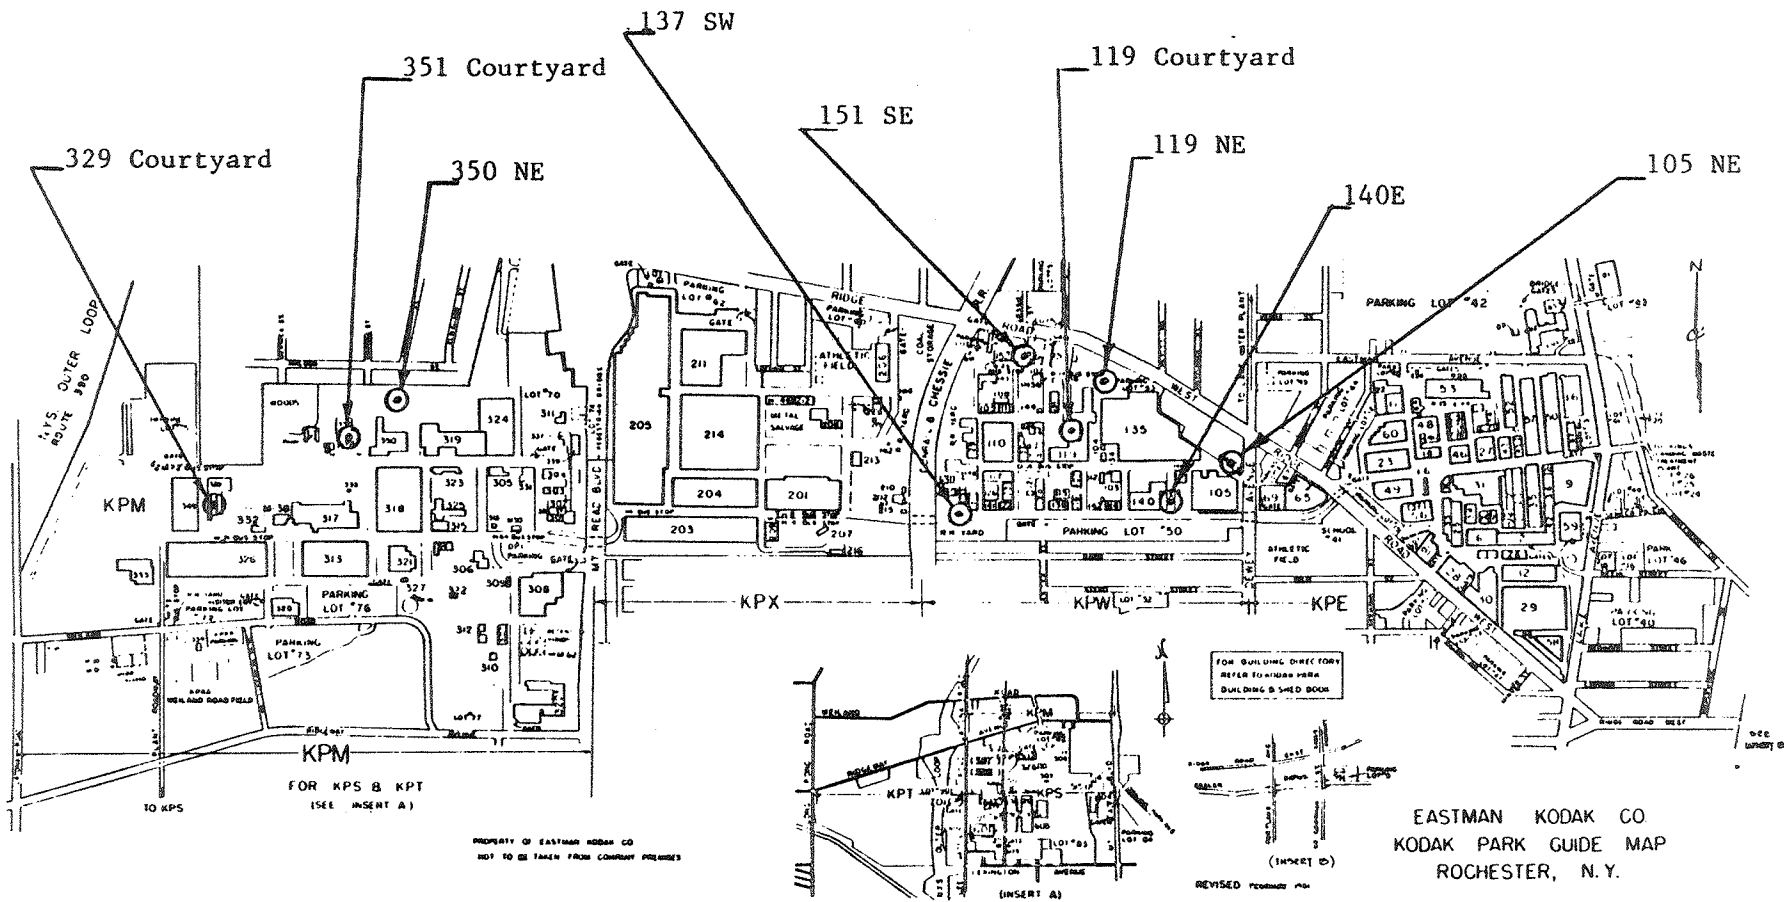
FIGURE 3

Nine organic compounds were detected and quantified by GC/MS in the shallow and deep aquifers southeast of Building 137. Both aquifers also exhibited a TOD of greater than 50 ppm. Suspected sources of these organics are the drum handling area near Building 210, leakage from rail cars handled in the marshalling yards, or former drum storage and handling operations in this area.

Vinylidene chloride (VDC) was detected by GC/MS in the deep aquifer east of Building 140 and northeast of Building 119 at an average concentration of greater than 200 ppb as well as detectable quantities of p-dioxane (>500 ppb). The source of the VDC was a damaged reactor feed line in the Building 119 courtyard which was repaired approximately two years ago. A study is currently underway to determine the extent of VDC dispersion and the most appropriate remedial cleanup action. The p-dioxane is expected to have originated from leaking sewers in the Building 119 area.

Greater than 10 ppm of both p-dioxane and ethylene glycol were detected in the shallow aquifer in the Building 351 courtyard during 1982. Samples taken northeast of Building 350 in the soil water table had a TOD concentration of 300-600 ppm. The cause of this oxygen demand has yet to be attributed to any particular compound.

Detectable quantities of methylene chloride (>500 ppm) have been measured in the groundwater under Building 329 despite continued clean-up efforts. Monitoring wells to the north end east contain no detectable quantities of the compound. The methylene chloride originated from a break in a waste solvent line in 1980. The groundwater in the area is currently being pumped to the industrial sewer to maintain a cone of depression to control migration and eventually clean-up the area.

A summary of groundwater quality data for KPW and KPM is available upon request from ETS. A map locating the areas described above is presented in Figure 3.

Of the seven areas listed, the Building 351 area, Building 151 area and the Building 105 area have not been previously identified. Each of these areas will be evaluated in separate investigations. It is recommended these be conducted in 1983.
