Periodic Review Report

*Urbana Landfill Site
Urbana, New York
NYSDEC Site No. 8-51-007*

July 2021

0001-001-300

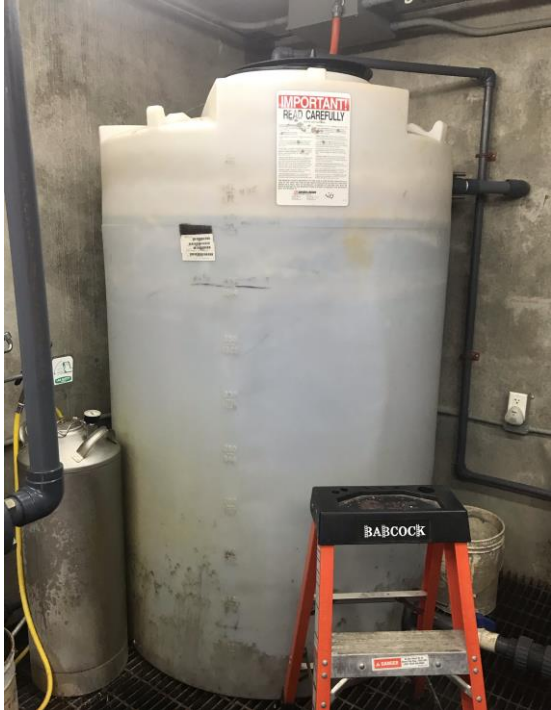
Client Name: Mercury Aircraft, Inc		Site Location: Town of Urbana Landfill- Urbana, New York	Project No.: 0001-001-300
Photo No. 1	Date 06/07/21

Direction Photo Taken: North			
Description: Site Conditions- groundwater treatment system

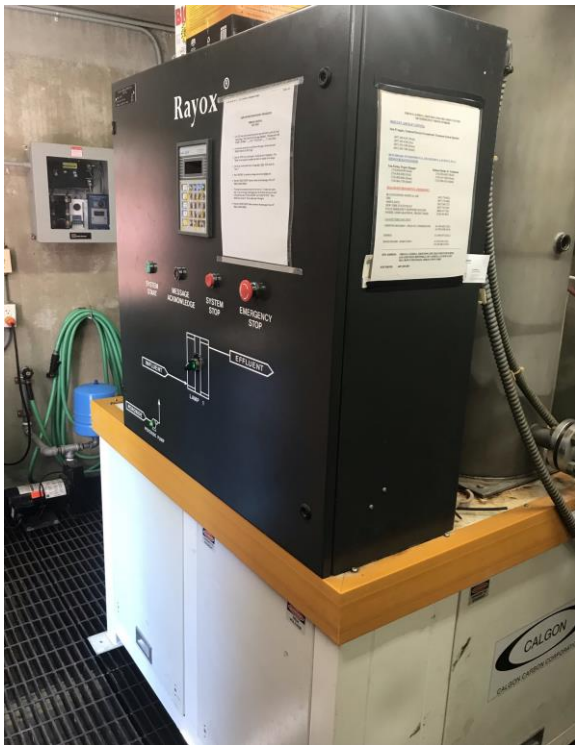
Photo No. 2	Date 06/07/21

Direction Photo Taken: South		
Description: Site Conditions- groundwater treatment system

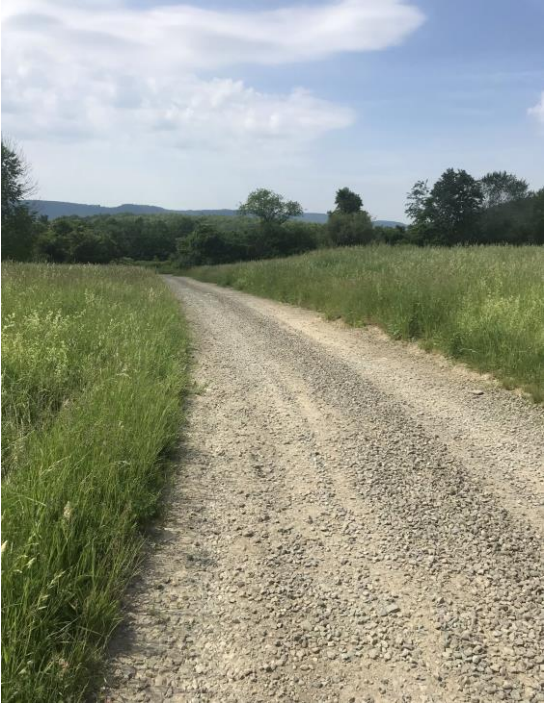
Client Name: Mercury Aircraft, Inc		Site Location: Town of Urbana Landfill- Urbana, New York	Project No.: 0001-001-300
Photo No. 13	Date 06/07/21

Direction Photo Taken: South			
Description: Site Conditions- Landfill access road
