REMEDIATION SUMMARY REPORT

VAN DER HORST PLANT NO. 2 SITE
CITY OF OLEAN, CATTARAUGUS COUNTY
CONTRACT NO. D003337
SITE NO. 9-05-022

REMEDIATION SUMMARY REPORT
VAN DER HORST PLANT #2
SOIL CONSOLIDATION AND CAPPING PROJECT

NYSDEC Site No. 9-05-022
Contract No. - D-0003337
Olean, New York

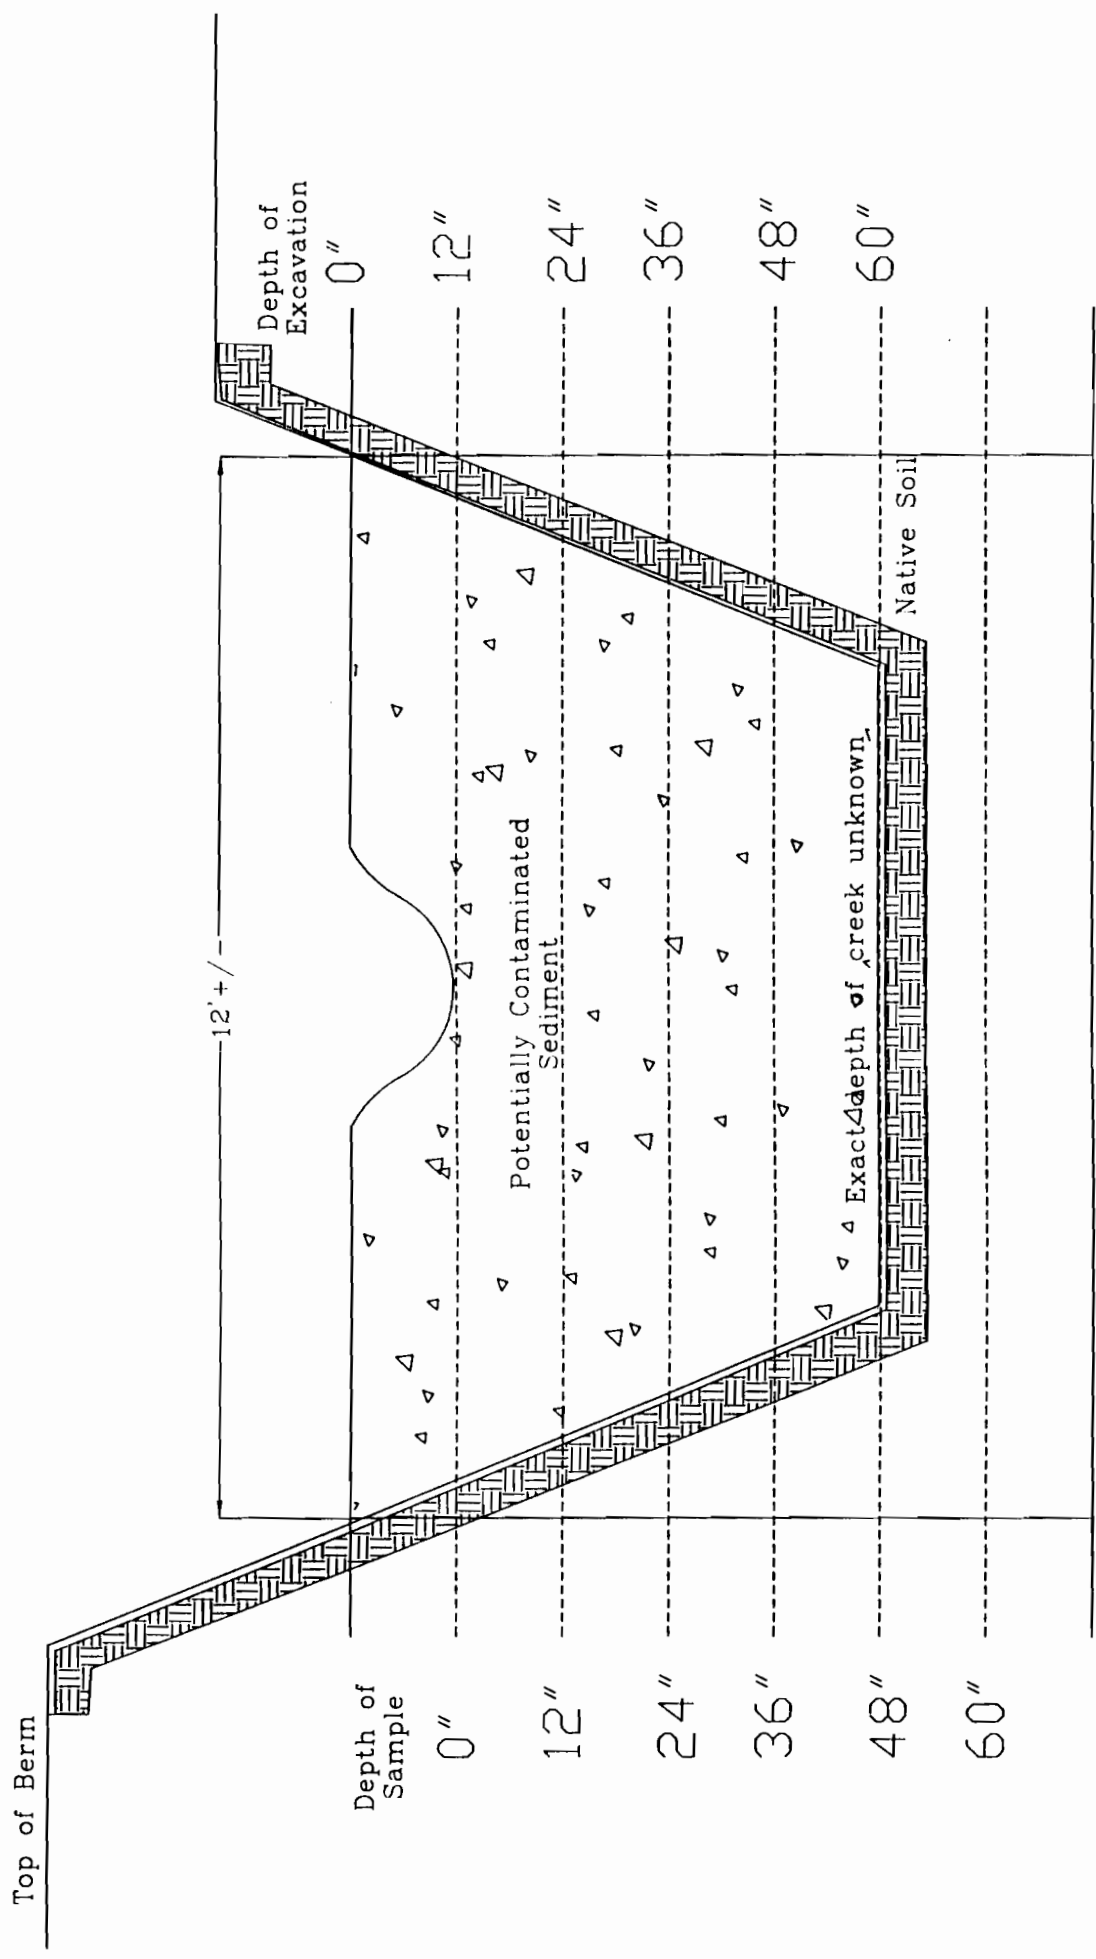
Figure 2

Depth of excavation shall be based on the results of verification samples for chromium.

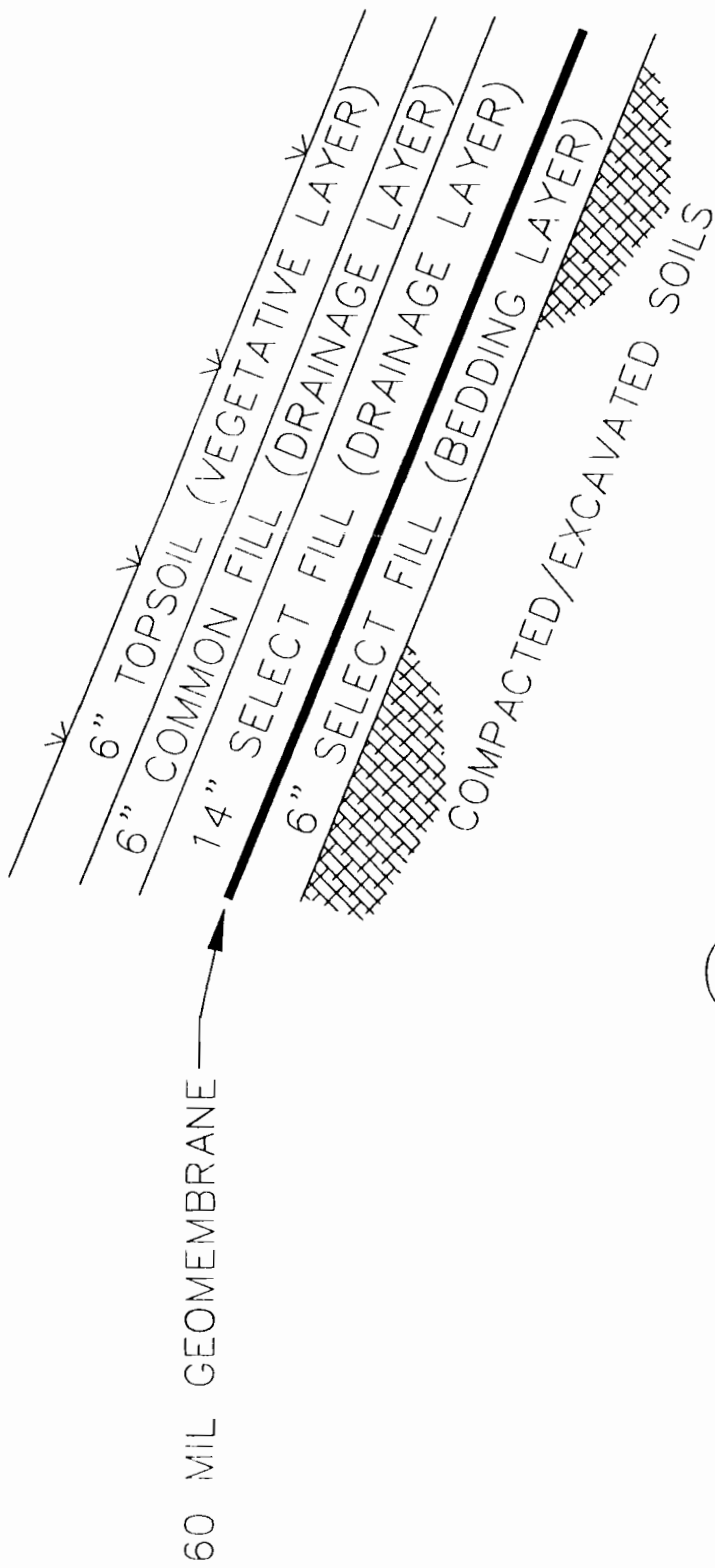
| Figure 3 | |

geomembrane installer Chenango, Inc. on May 23, 1996. A design change was made by Field Order No. 11 that modified the structure of the cap to replace the common fill sub-base layer with a select fill sub-base, (Figure 3). To maintain the same quantities as noted in the contract documents, the 20 inch drainage layer of select fill now consists of a 14 inches of select fill and a 6 inch common fill layer followed by the 6 inches of vegetated topsoil.

10. Seed and fertilize the area around the basin that was disturbed due to additional work requested by the Department.
11. Change the sequence of fill materials used to construct the cap. Replace the 6" common fill subbase with a 6" select fill subbase. Replace the 20" select fill protection layer with 14" of select fill on the geomembrane and 6" of common fill after the select fill. This does not increase quantities or work effort required.
