## **2022 PERIODIC REVIEW REPORT SPECIAL METALS CORPORATION DUNKIRK, NEW YORK NYSDEC Site Number 907031**

March 10, 2022

Re: 2022 Periodic Review Report (NYSDEC Site No. 907031)  
Special Metals Corporation  
100 Willowbrook Avenue  
Dunkirk, New York

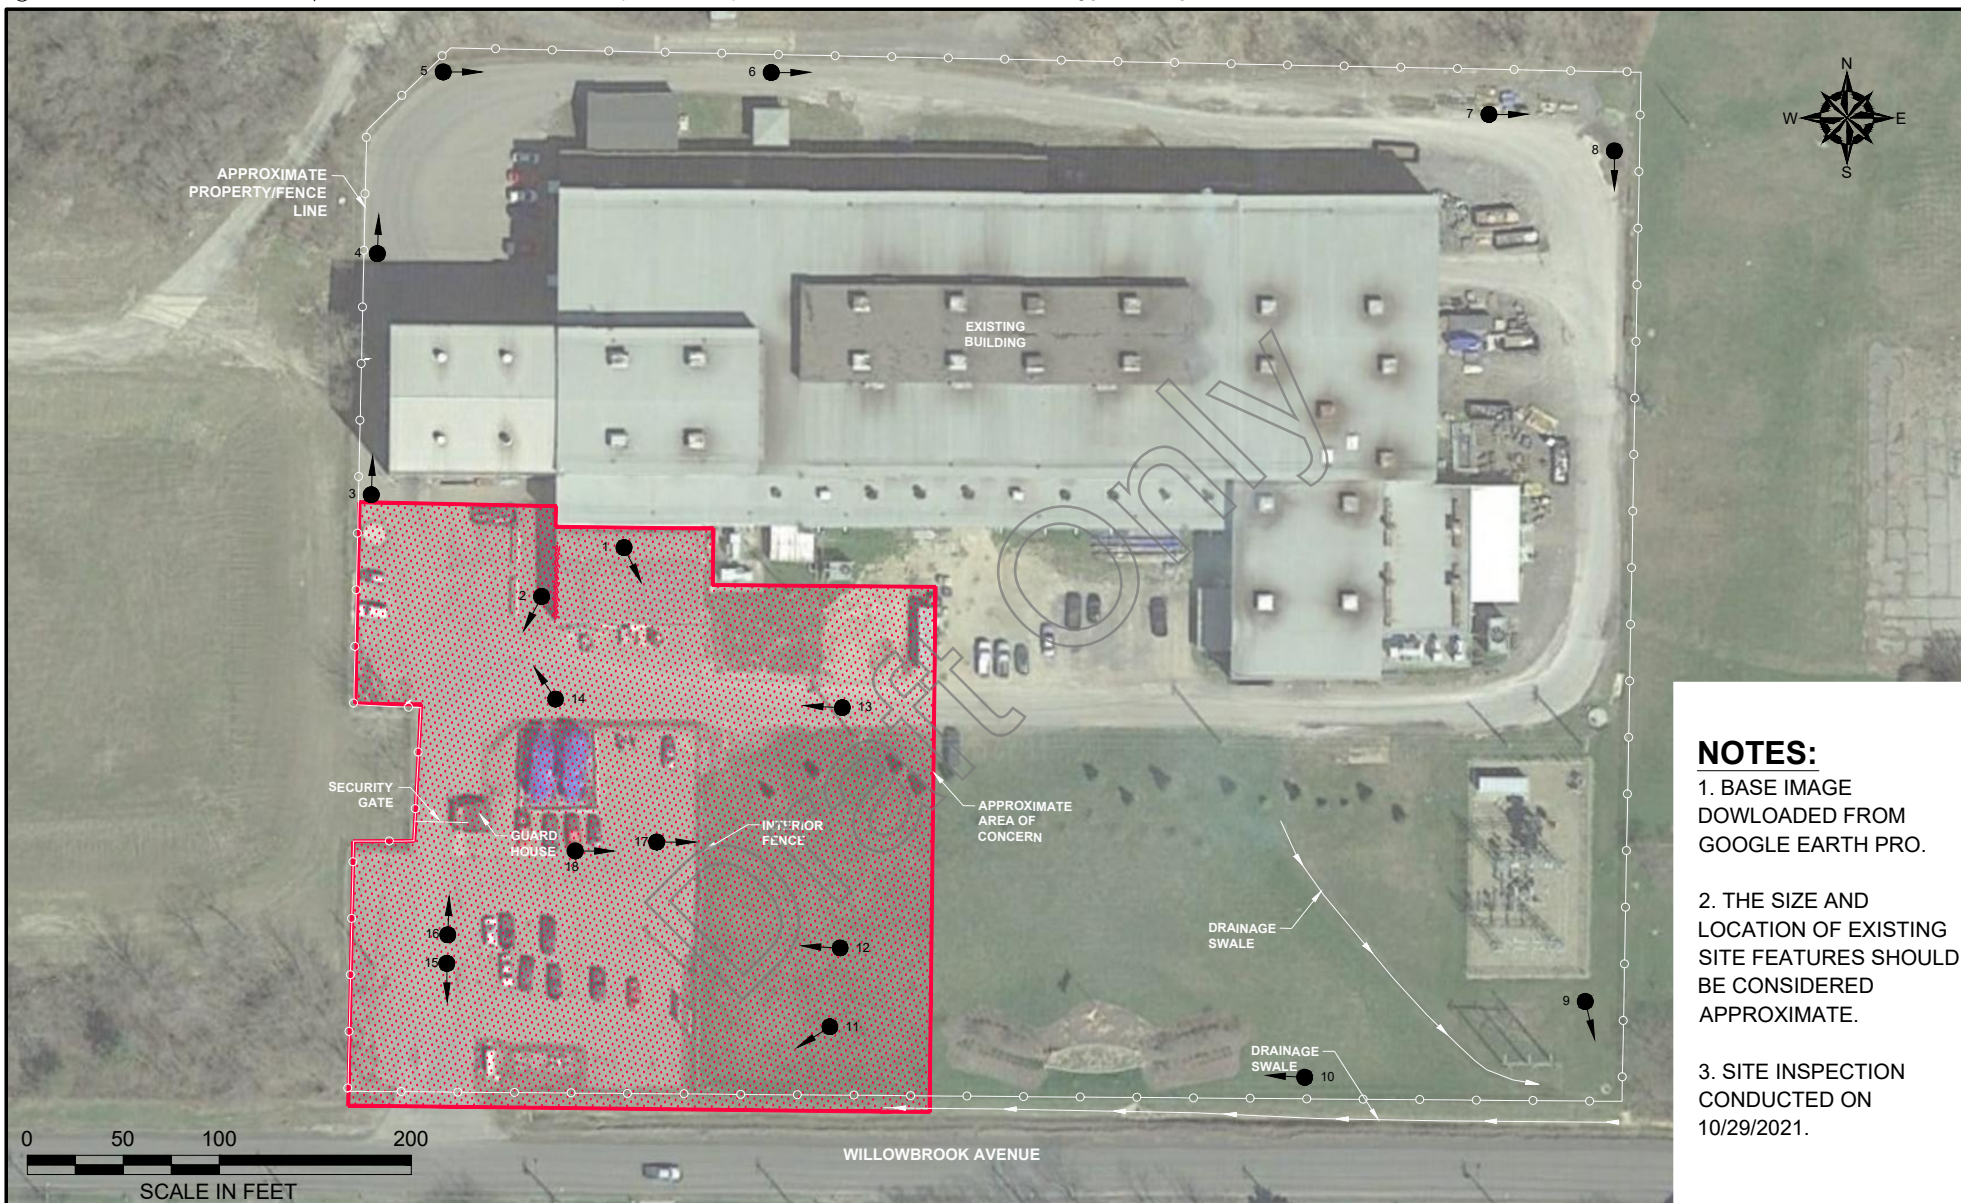
**OCTOBER 29, 2021**  
**SITE INSPECTION PHOTO LOCATIONS**

<p>Two small areas of asphalt in need of repair located along east side of the site entrance road, between the entrance gate and the security building: See Photo # 15 and # 16</p> <p>Some cracks in pavement in parking lot. No subbase exposed yet. Preventative sealing recommended. See Photo 18</p> <p>A closed/chained gate located along the east side of the parking lot has a significant gap that needs to be narrowed to prevent unauthorized access by trespassors: see Photo # 17</p>		
<b>INTRUSIVE ACTIVITIES PLANNED FOR AREA OF CONCERN</b>	<b>DATE</b>	<b>LOCATION</b>
None		
<b>ADDITIONAL NOTES &amp; COMMENTS</b>		
Besides the areas noted above, pavement is in good condition.		
Besides gap in gate mentioned above, security fence is complete and in good condition.		
Healthy grass on soil cover system.		
See photo log.

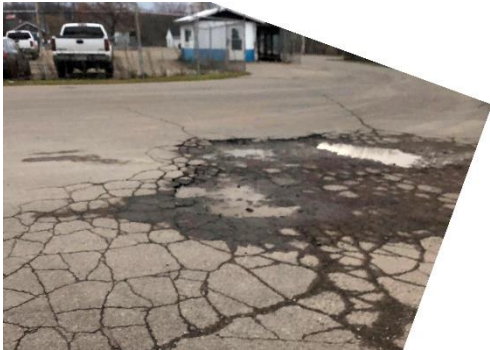
<b>Client Name:</b> Special Metals Corp.		<b>Site Location:</b> SMC Facility, Dunkirk, NY	<b>Project No.</b> 21.0056196.51
<b>Photo No.</b> 1	<b>Date:</b> 11-22-19

<p>One small area of asphalt located approximately 75-feet NNE of the guard house in need of repair.</p> <p style="text-align: center;">See Figure.</p>		
<b>INTRUSIVE ACTIVITIES PLANNED FOR AREA OF CONCERN</b>		
	<b>DATE</b>	<b>LOCATION</b>
None		
<b>ADDITIONAL NOTES &amp; COMMENTS</b>		
<p>Security fence is complete and in good condition.</p> <p>Healthy grass on soil cover system.</p> <p>See photo log.</p>

<b>Direction Photo Taken:</b>  South			
<b>Description:</b>  Damaged pavement between the repair shop and guard house.

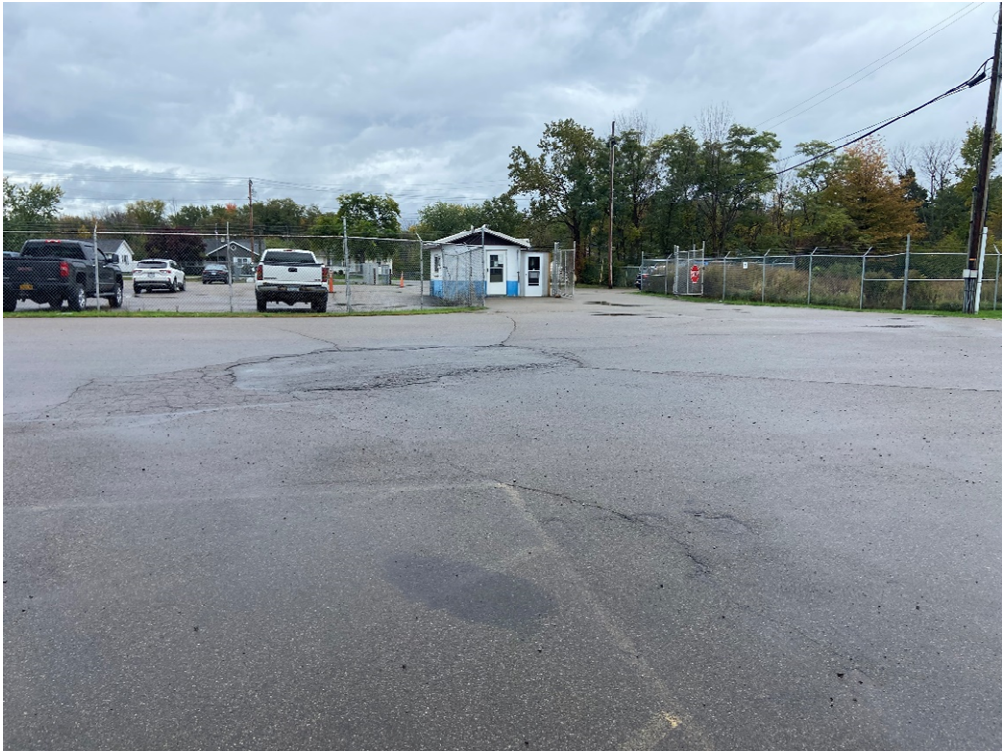
<b>Photo No.</b> 2	<b>Date:</b> 10-29-2021

<b>Direction Photo Taken:</b>  South		
<b>Description:</b>  Repaired pavement (foreground) and security building (background)

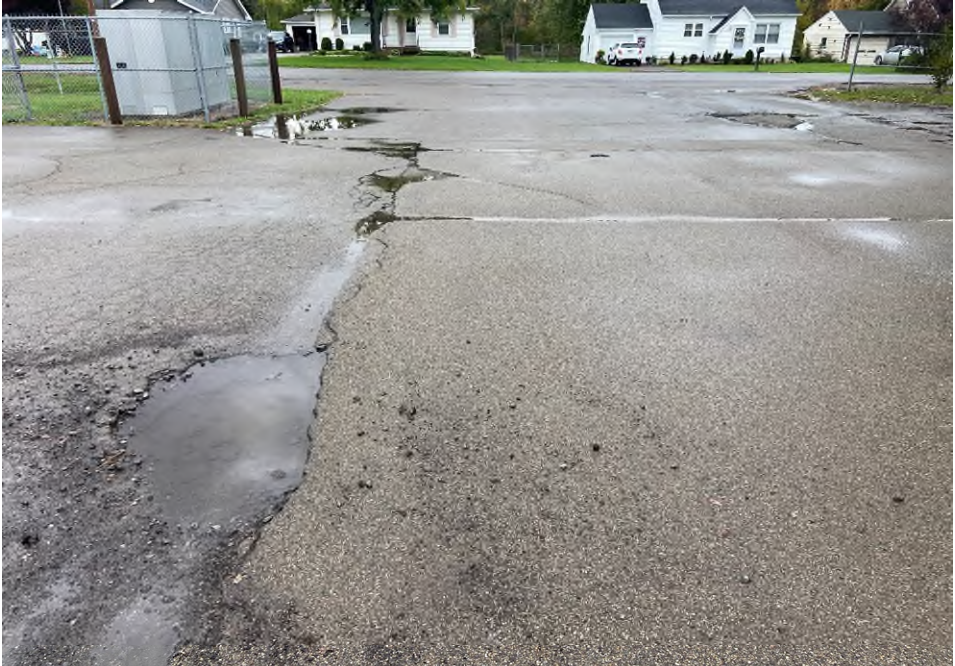
<b>Client Name:</b> Special Metals Corp.		<b>Site Location:</b> SMC Facility, Dunkirk, NY	<b>Project No.</b> 21.0056190.51
<b>Photo No.</b> 15	<b>Date:</b> 10-29-2021

<b>Direction Photo Taken:</b>  South			
<b>Description:</b>  One of two small areas of pavement in need of repair at the site entrance. Subbase stone exposed.
