ENGINEERING INVESTIGATIONS AT INACTIVE HAZARDOUS WASTE SITES

PRELIMINARY SITE ASSESSMENT

Bisonite Paint Company Site No. 915010

March 1993

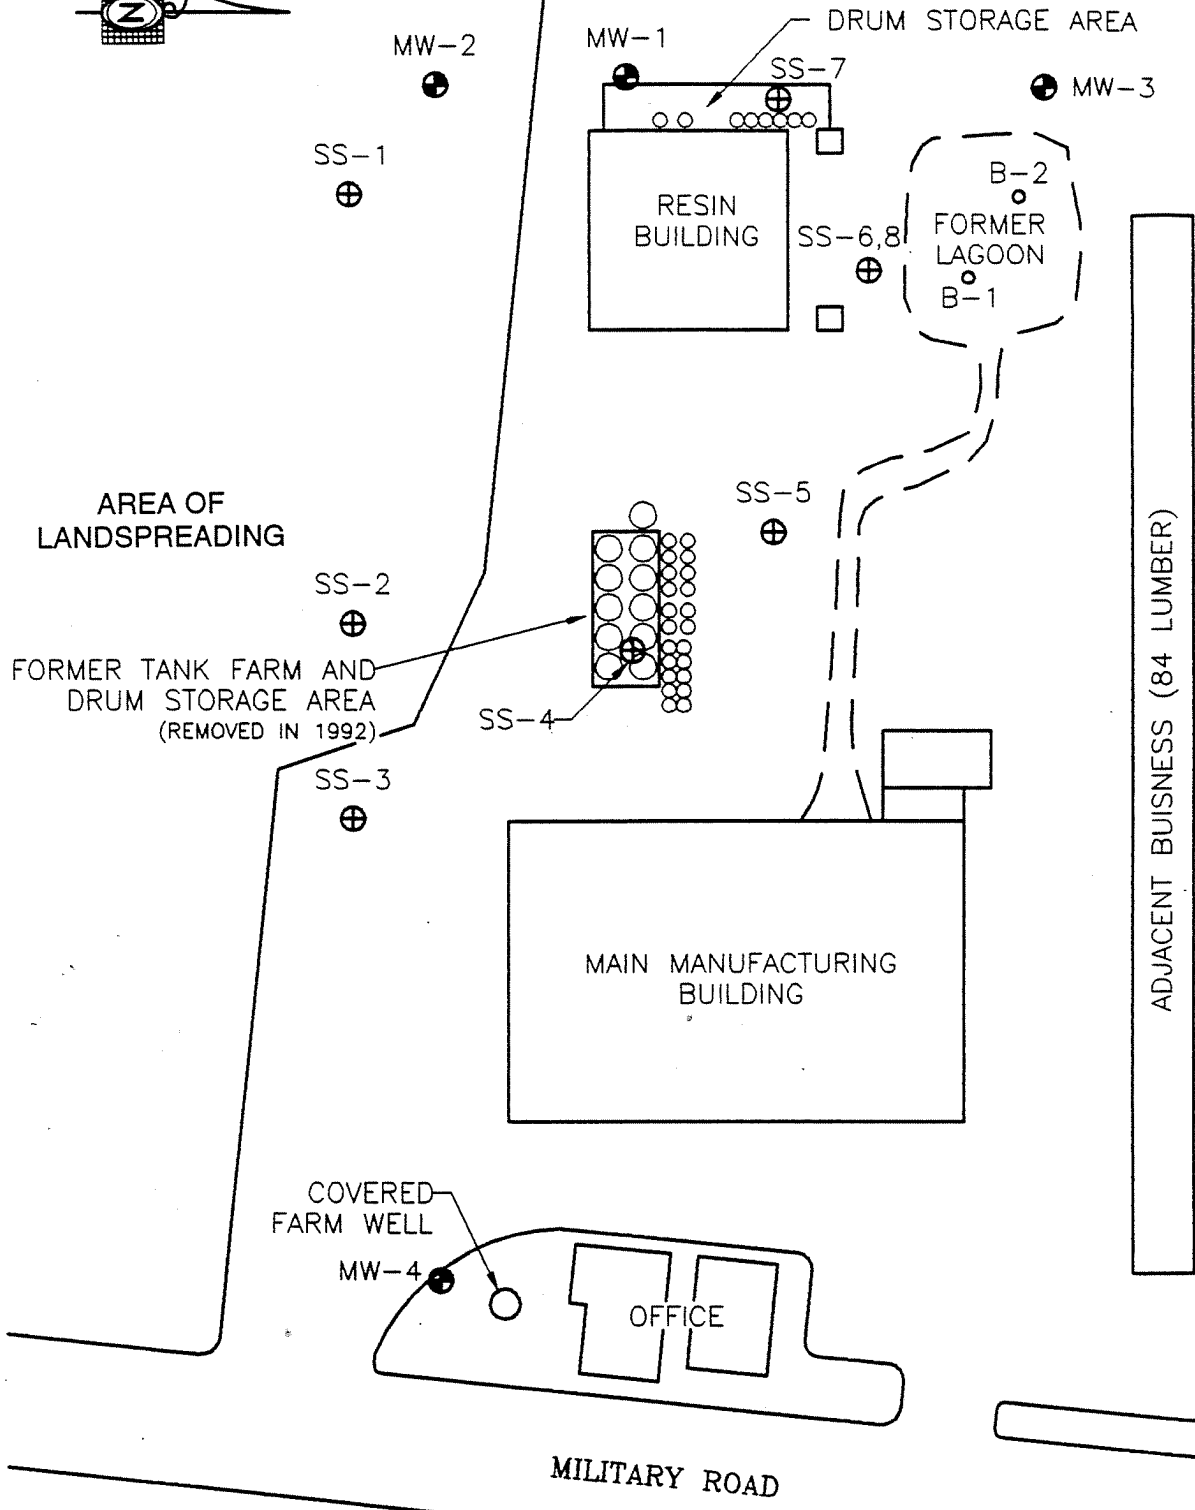
SOIL SAMPLE AND MONITORING WELL
 LOCATION DIAGRAM

Two of the surface soil samples showed elevated levels of volatile organics that exceed Recommended Soil Cleanup Objectives (RSCOS) established by NYSDEC in their Technical and Administrative Guidance Memorandum (TAGM) of November 16, 1992 (HWR-92- 4046). Surface soil sample BIS-SS-4, which was located beneath what was the former solvent tank farm and drum storage area, contained 400,000 parts per billion (ppb) ethylbenzene and 3,200,000 ppb of xylene. Sample BIS-SS-5 contained toluene (4,500 ppb) at three times the RSCO (1,500 ppb) for this compound. Benzo (a) pyrene (RSCO = 61 ppb) was identified in four samples at estimated concentrations ranging from 64 ppb to 1,200 ppb. Sample BIS-SS-1 also contained dibenzo (a,h) anthracene above the RSCO (14 ppb) at an estimated concentration of 70 ppb. Sampling location BIS-SS-7 contained three additional semi-volatile compounds: Benzo (a) anthracene (1,300 ppb, estimated); chrysene (1,500 ppb, estimated), and; benzo (k) fluoranthene (1,100 ppb, estimated), above their RSCOs of 990 ppb, 400 ppb and 1,100 ppb, respectively. PCB concentrations exceeded RSCOs at three surface sampling locations. Aroclor-1248 was detected at 1,900 ppb in BIS-SS-3 and Aroclor-1254 was detected at 2,500 ppb and 1,600 ppb in BIS-SS-6 and BIS-SS-7, respectively. The RSCO for PCBs in surface soil is 1,000 ppb. Seven different metal constituents were detected in surface soils at concentrations exceeding the background range for eastern U.S. soils. These metals are typical components used in the manufacture of paint and include arsenic, barium, cadmium, chromium, lead, mercury and zinc.

One subsurface sample from the area of the former lagoon indicated the presence of "resinlike" material which contained several VOCs at levels exceeding RSCOs. VOCs found included toluene (19,000,000 ppb), ethylbenzene (200,000 ppb) and xylene (1,000,000 ppb). Each of these solvents were used at the site in the manufacture of paint. Semi volatile and pesticide/PCB compounds were not detected in subsurface soils above their respective RSCOs. Six inorganic constituents (barium, cadmium, chromium, lead, mercury and zinc) exceed the background concentrations for eastern U.S. soils.

DUNN further recommends that a Remedial Investigation/Feasibility Study (RI/FS) be performed to define the extent of residual contamination in surface soils and the former lagoon area and further define the potential threat to groundwater. Additionally, the RI/FS should evaluate appropriate methods for site remediation.

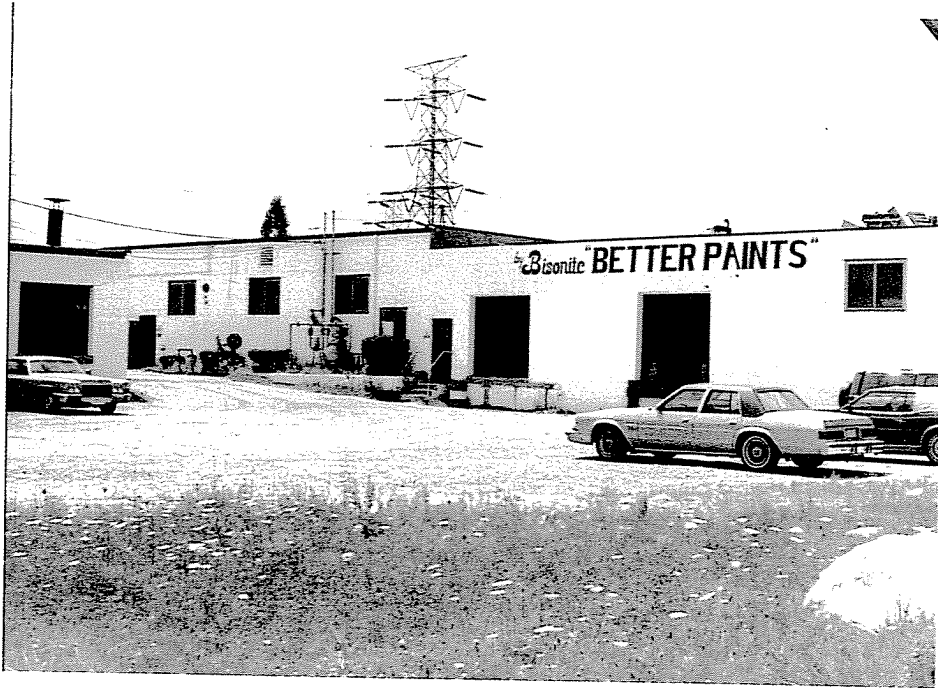
Photo No. 1

- 1) The Bisonite Paint Company plant. Direction: Southwest
- 2) On the western side of the filled in lagoon area. Direction: East
- 3) Southern side of the filled in lagoon area. Direction: Northeast
- 4) The southern side of the lagoon and a drum storage area in the background. Direction: East
- 5) Northern side of the old varnish plant with a drum storage area. Direction: West
- 6) Area of landspread waste solvents (Southern side of the plant). Direction: West
- 7) Drum storage area on the loading dock. Direction: Northeast
- 8) Old varnish plant, no longer in use. Several drums are located in and around the building. Direction: Northwest
- 9) Storage area for old processing tanks. Direction: South
