ENGINEERING INVESTIGATIONS AT INACTIVE HAZARDOUS WASTE SITES

PHASE I INVESTIGATION

Ernst Steel Site No. 915022
Cheektowaga Erie County

DATE: March 1986

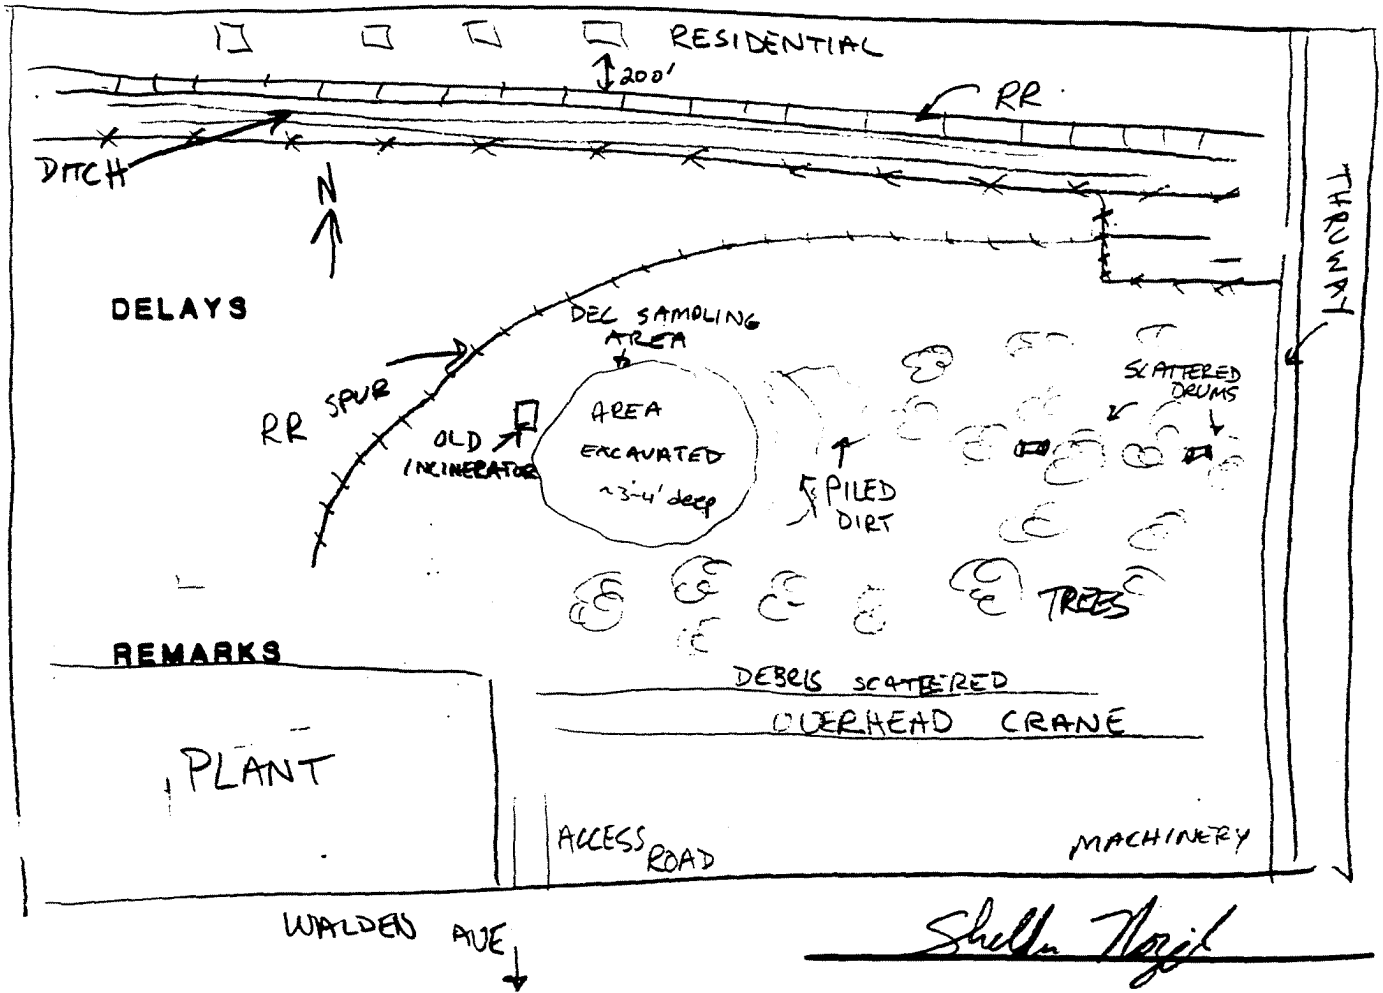
ACTIVITIES Andre and I on site 10:00 a.m. Frank Ernst not there so we proceed to site anyway. Property is leased by U.S. Steel Supply. Area of concern is in northeast portion of property. Most of area is covered by trees. Some empty rusted drums scattered around area. Area near incinerator has been recently excavated ~ 3-4 feet of dirt etc pushed back towards trees. Slag, concrete "Red lead" piled around. Area excavated is currently ponded but frozen. See diagram below:

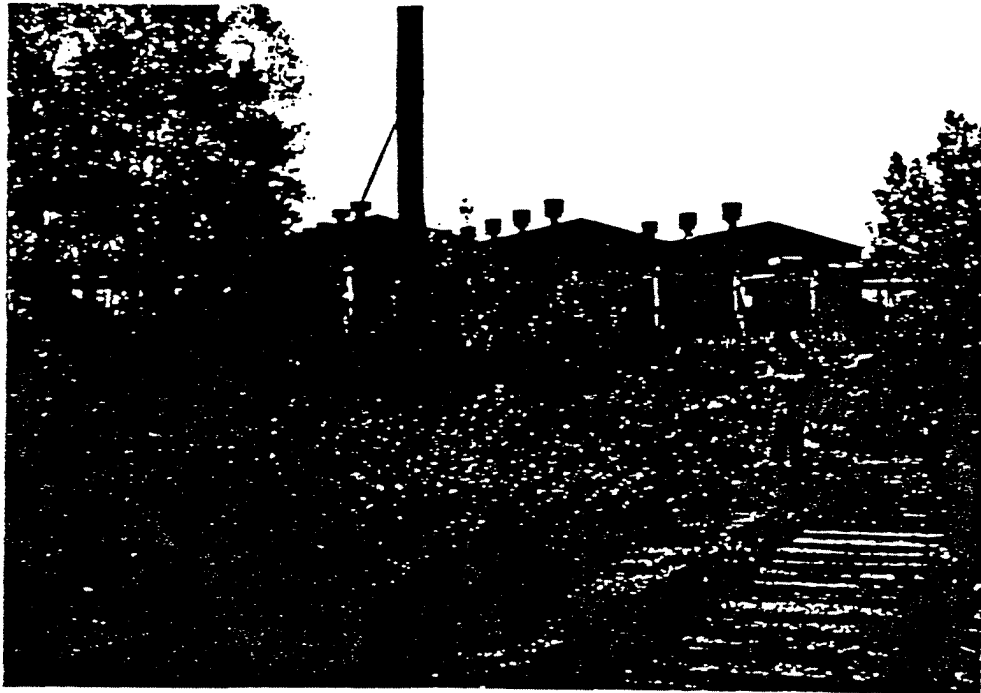
2. Incinerator used for paper scrap.
