From: john.black@inventumeng.com <john.black@inventumeng.com>
Sent: Wednesday, May 11, 2022 9:05 AM
To: Mcpherson, Benjamin J (DEC) <benjamin.mcpherson@dec.ny.gov>; Martin, Angela L (HEALTH) <Angela.Martin@health.ny.gov>
Cc: 'jyensan' <jyensan@oscinc.com>; Rich Galloway <Rich.Galloway@Honeywell.com>; 'Dan Flanigan' <dflanigan@oscinc.com>; bmikolin@gesonline.com; Peter Zaffram <peter.zaffram@InventumEng.com>; Glaza, Edward <Edward.Glaza@parsons.com>; Tom.Abrams@parsons.com
Subject: Site 108 Tar Pipe Leak Memo.pdf

To: Benjamin McPherson, Angela Martin
From: John Black
CC: John Yensan, Rich Galloway
Re: Pumphouse Pipe Leak
3800 River Road
Town of Tonawanda, New York.

In the late afternoon of May 5, 2022 a tar leak was observed during routine inspection in the former pump house on 3800 River Road (a/k/a Site 108, Listed as #915055). The pump house was a former Tonawanda Coke Corporation structure used to pump tar to and from three tanks that had been previously removed from the property. On May 6, 2022, Inventum Engineering, PC (Inventum) and Ontario Specialty Contracting (OSC) mobilized to conduct a small scale cleanup operation. Inventum, along with OSC established an action plan t

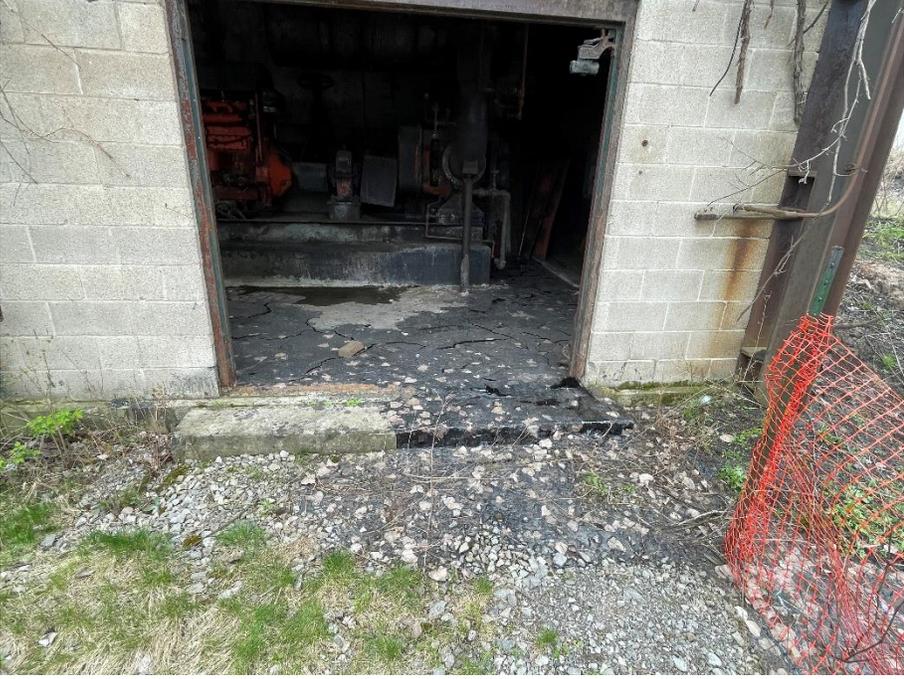
<p>Client Name: RITC</p>	<p>Location of Cleanup: Site 108 Pump house</p>	<p>Project: Tonawanda</p>
<p>Photo No. 1 Direction Photo Taken: South</p>

<p>Description: Former pumphouse on site 108. Tar was observed inside and outside the doorway of the structure. Note the tar in the building and the base of the step.</p>		
<p>Client Name: RITC</p>	<p>Location of Cleanup: Site 108 Pump house</p>	<p>Project: Tonawanda</p>
<p>Photo No. 2 Direction Photo Taken: Southwest</p>

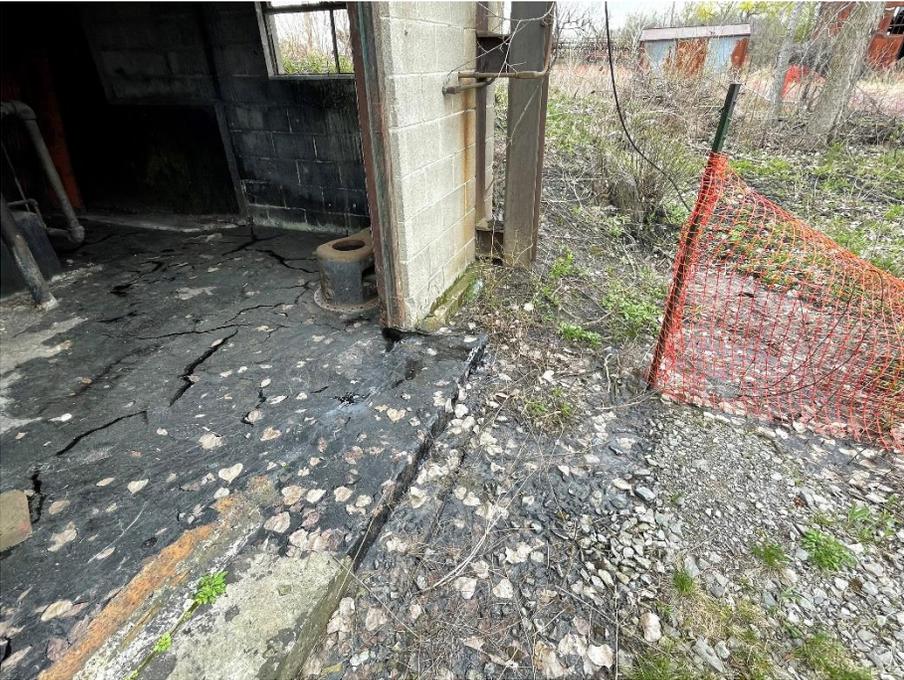
During initial inspection of the pump house prior to any cleanup efforts, a tar seep was observed coming from the north side of the structure. Tar could be seen on the concrete floor of the structure and outside the doorway. The materials on the surface suggested that the tar had flowed a short distance (less than 4 feet) in a northwest direction. Inside the pump house, the tar covered the floor approximately 17 feet wide, by 13 feet long and 0.25 inches deep. Outside the northwest corner of the structure, the tar had apparently migrated from open doorway to a low spot approximately 4 feet wide by 6 feet long and 0.25 inches deep. On further inspection, an ongoing tar leak was observed coming from a small drip leg section of piping on the south side of the pump house. The structure has several areas of staining inside the building. A one-inch diameter pipe located along the south wall, behind a large piece of pump equipment was identified as the source of the tar. The pipe contains a gate valve about 6 inches from the end of the pipe. The gate valve was not fully closed. The valve was tightened and secured. The pipe was observed over several days and the seep has stopped. The pipe will be inspected daily to ensure the valve is secure and no further leakage occurs.

<p>Description: Tar on floor and outside pumphouse on Site 108.</p>

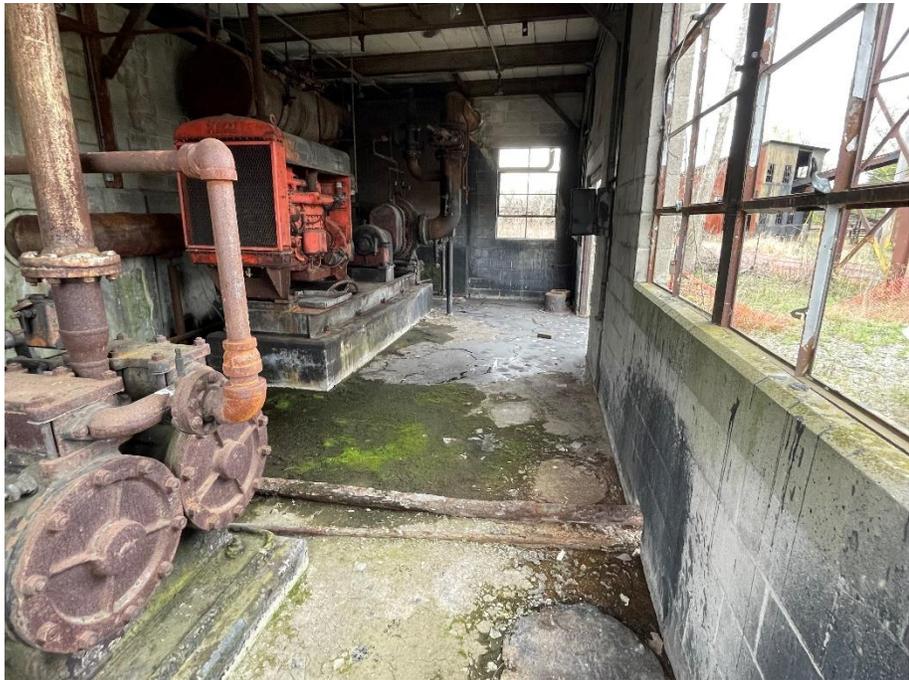
<p>Client Name: RITC</p>	<p>Location of Cleanup: Site 108 Pump house</p>	<p>Project: Tonawanda</p>
<p>Photo No. 3 Direction Photo Taken: West</p>

<p>Description: Inside pumphouse looking west. Note, tar is limited to the west side of the Pumphouse.</p>		
<p>Client Name: RITC</p>	<p>Location of Cleanup: Site 108 Pump house</p>	<p>Project: Tonawanda</p>
<p>Photo No. 4 Direction Photo Taken: East</p>

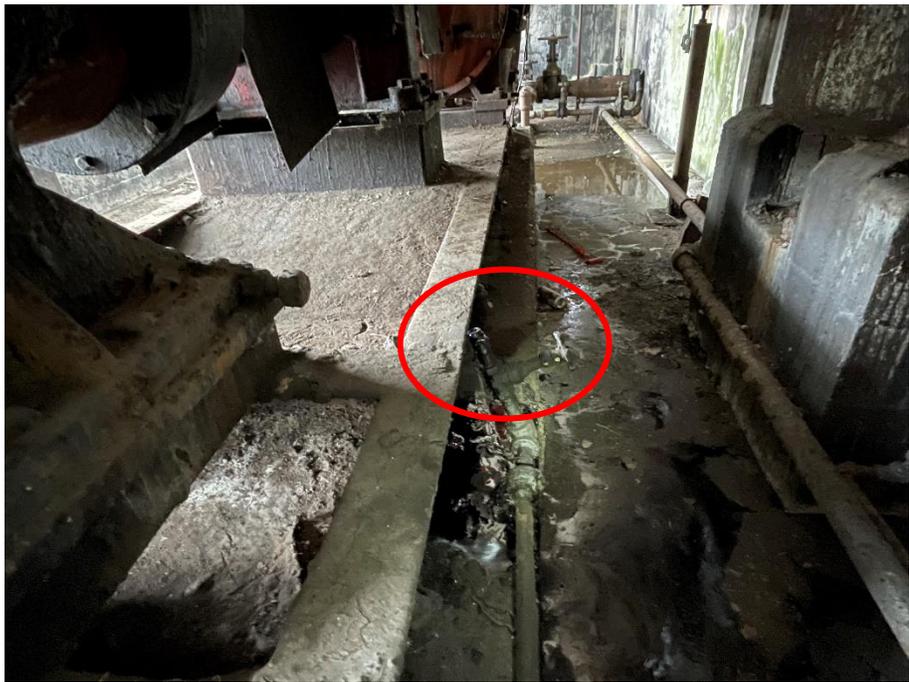
<p>Description: Source of tar leak. An open ended one inch pipe with a gate valve was the identified as the source of the leak. The valve was slightly open, when tightened, the leak stopped.</p>
