**POTENTIAL HAZARDOUS WASTE SITE  
PRELIMINARY ASSESSMENT**

| <u>Land Reclamation, Inc.</u><br>Site Name | <u>NYD000513929</u><br>EPA Site ID Number |
| <u>Indian Road, Depew, NY</u><br>Address | <u>02-8601-35</u><br>TDD Number |

Date of Site Visit: Off-site reconnaissance, 2/26/86

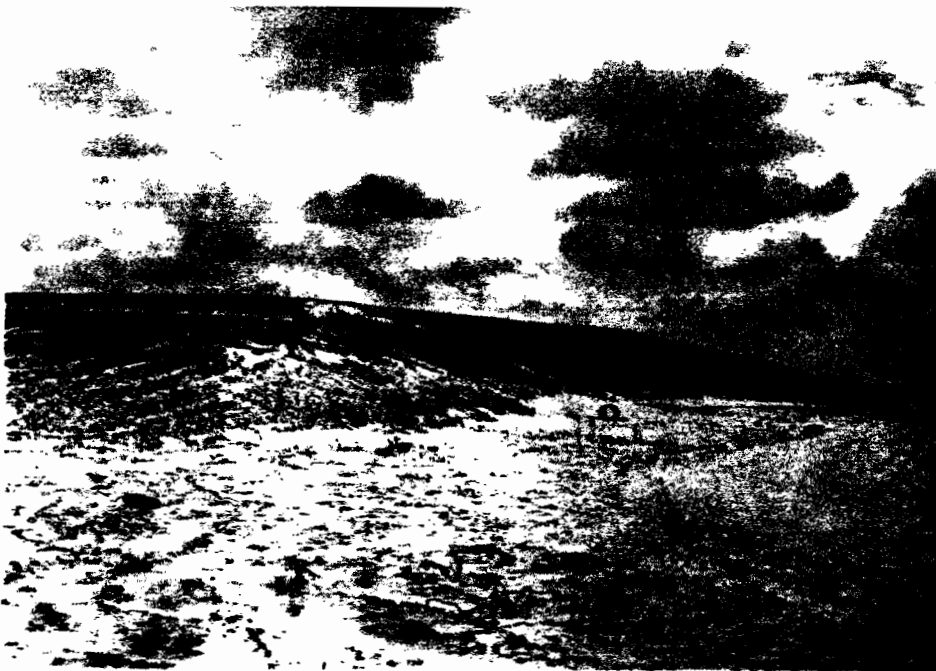
| <u>Photo Number</u> | <u>Description</u> | <u>Time</u> |
|---|--|---|
| 2P-14 | Main fill area of Land Reclamation facing south from Indian Road. | 1155 |

2P-14 February 26, 1986 1155  
Main fill area of Land Reclamation facing south from Indian Road.  
Photographer: Joe Mayo.

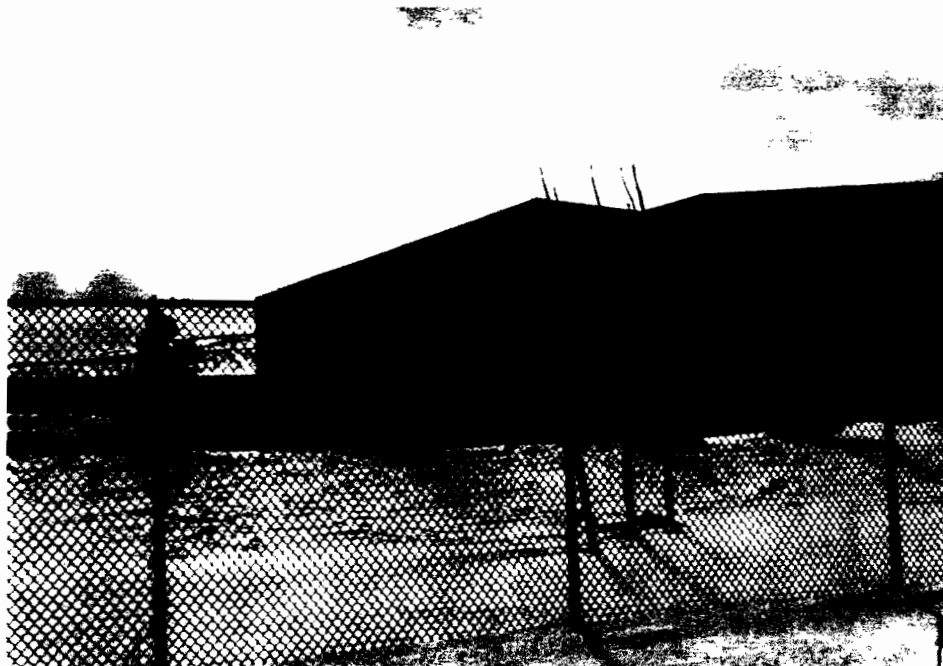
| <u>Photo Number</u> | <u>Description</u> | <u>Time</u> |
|---|--|---|
| 2P-16 | East end of waste transfer station, facing southwest from Indian Road. Truck can be seen unloading material into open bay of transfer station. | 1156 |

2P-16 February 26, 1986 1156  
East end of waste transfer station, facing southwest from  
Indian Road. Truck can be seen unloading material into open  
bay of transfer station.  
Photographer: Joe Mayo.
