**PERIODIC REVIEW REPORT
OCTOBER 31, 2017-OCTOBER 31ST, 2020**

**FORMER AMERON SITE
113 & 119 COLGATE AVENUE
BUFFALO, NEW YORK
NYSDEC SITE NO. 915133**

November 2020

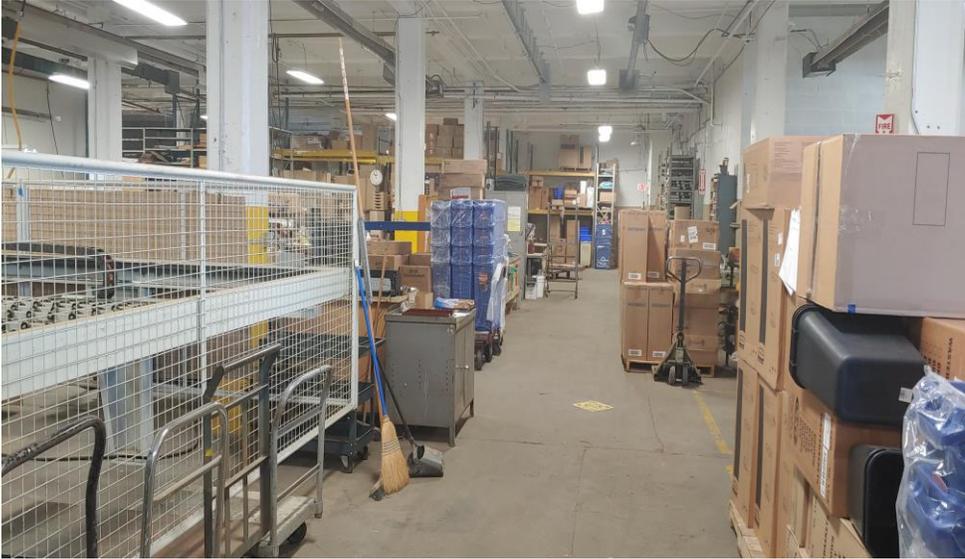
1. First floor warehousing

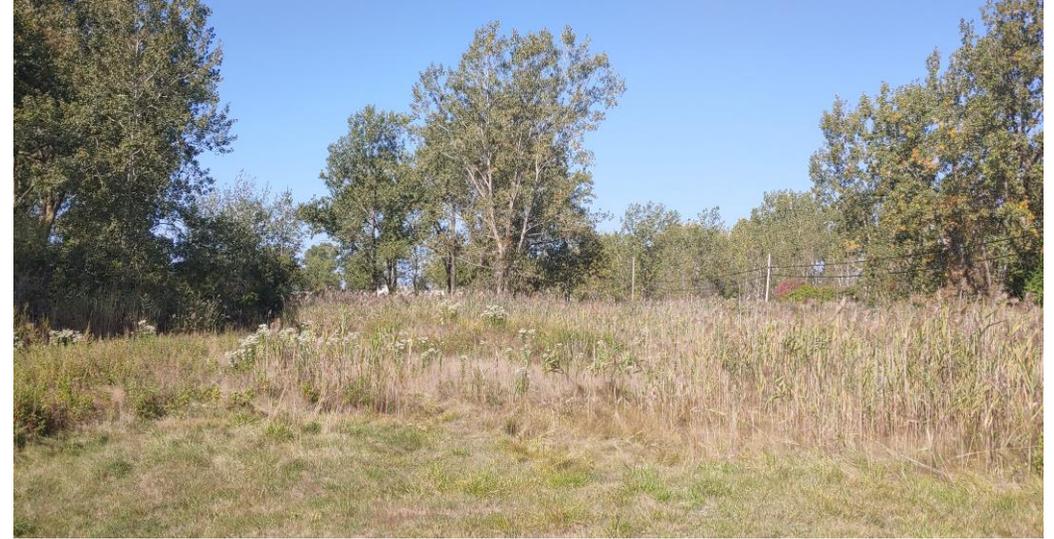
2. View of west end of property facing west

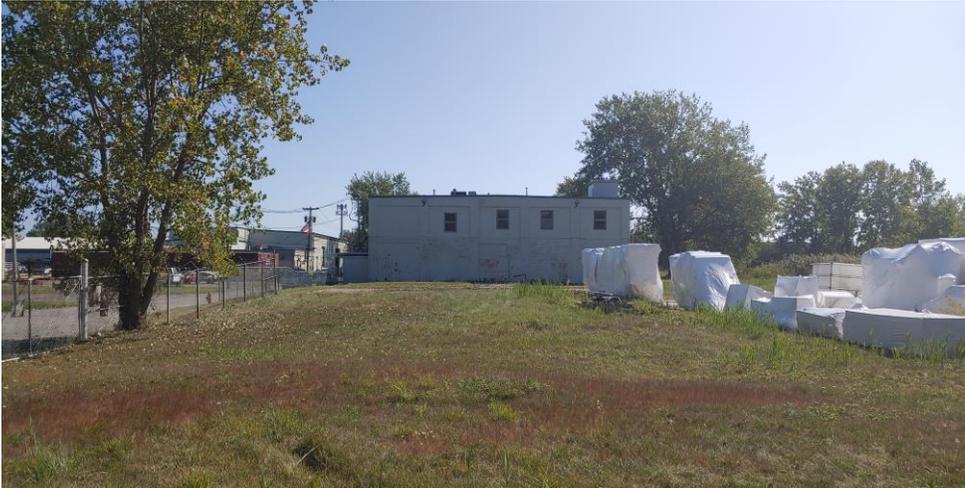
3. View of northern half of property from western end facing east at the building

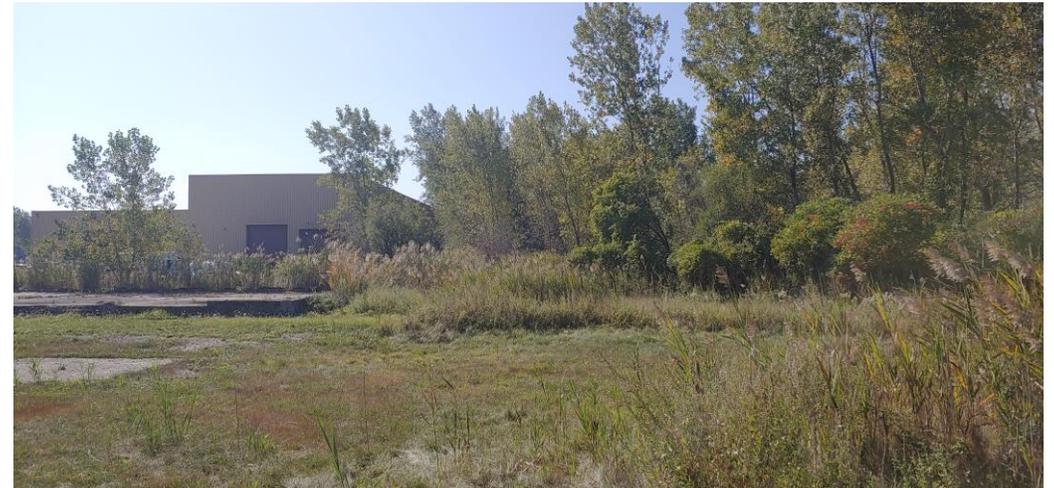
4. View of southwestern end of property and adjacent southern property

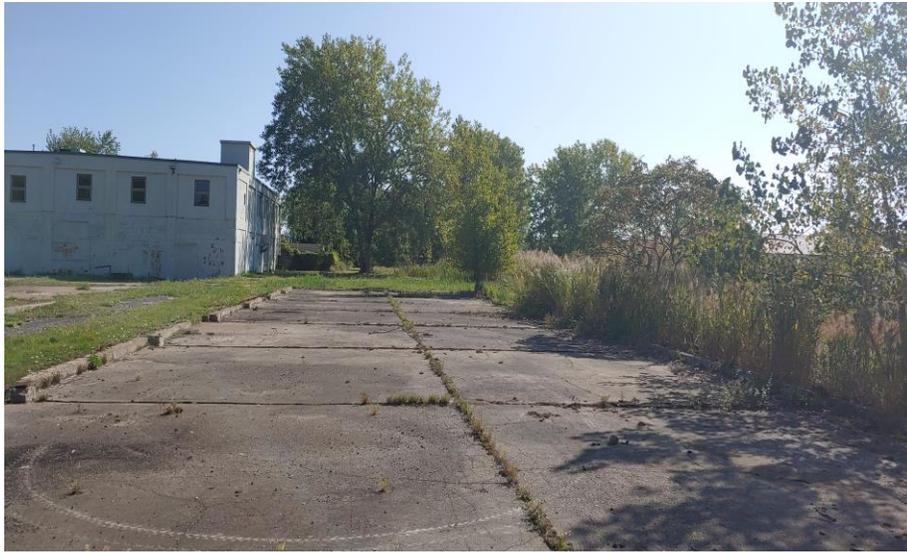
5. View of south side of property from west facing east

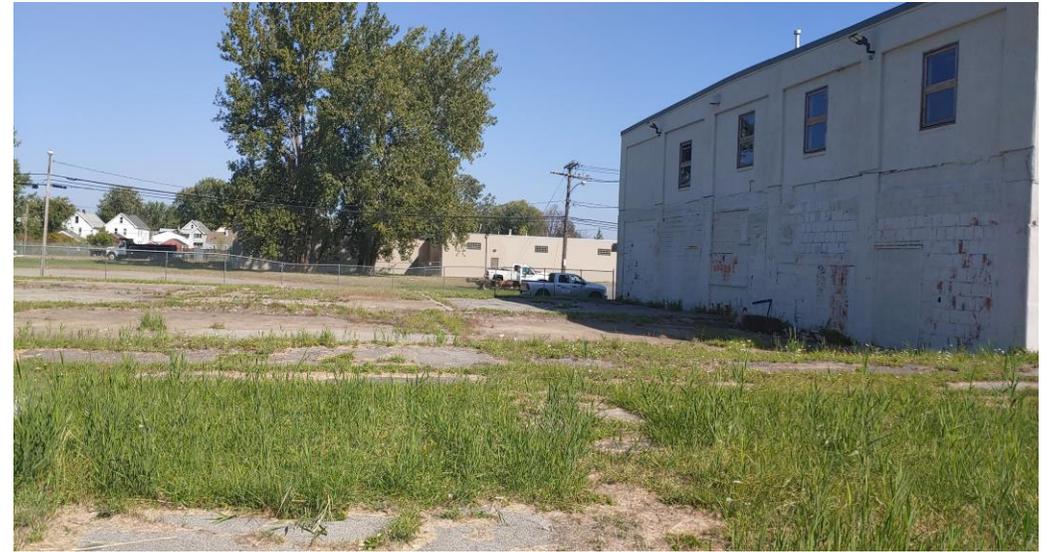
6. View of property along the western side of the building facing north

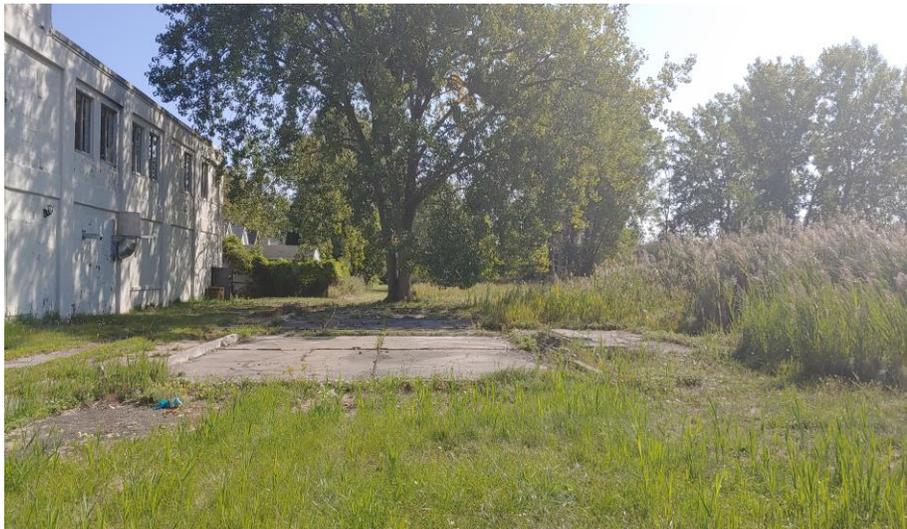
7. View of property along southern side of building facing east

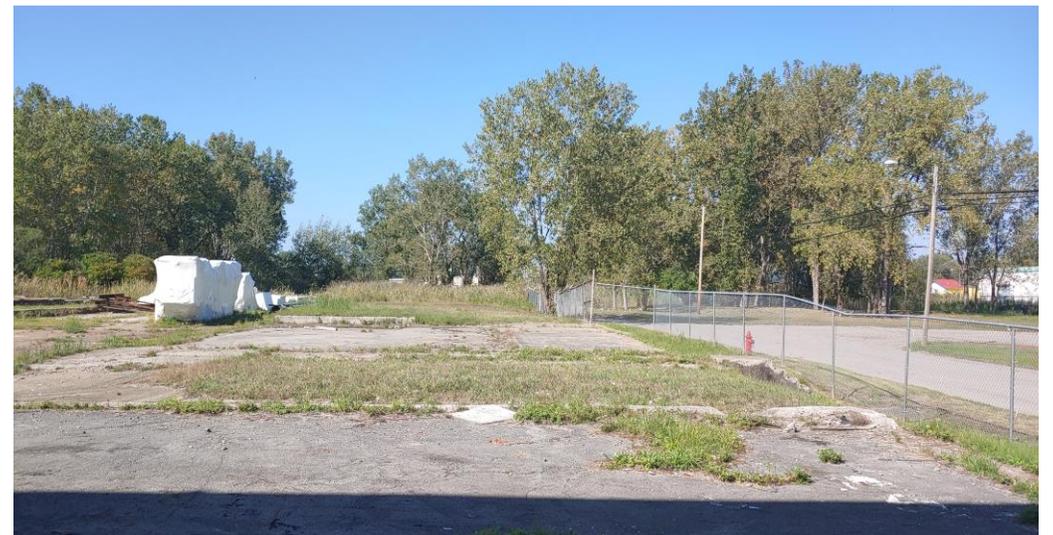
8. View of property from western side of building facing west

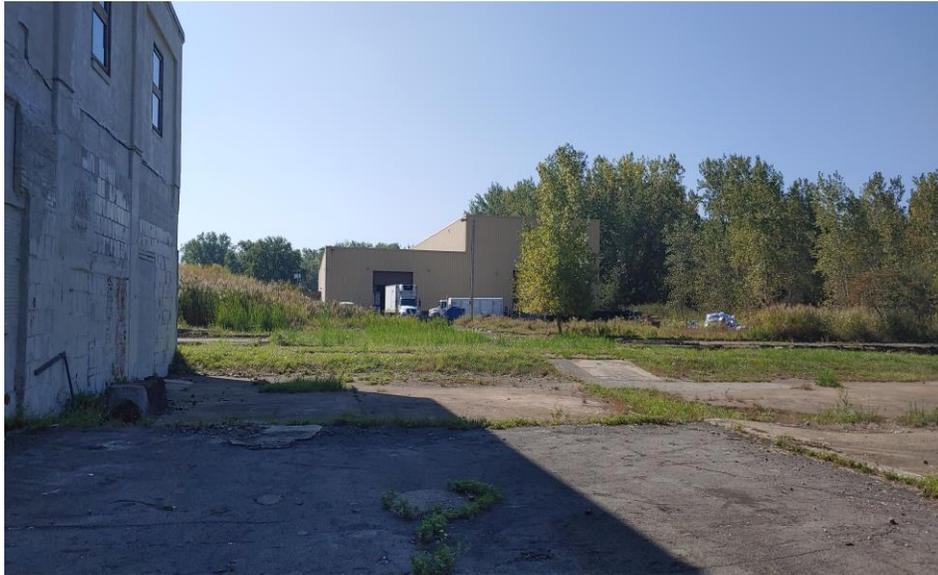
9. View of western side of building from north facing south

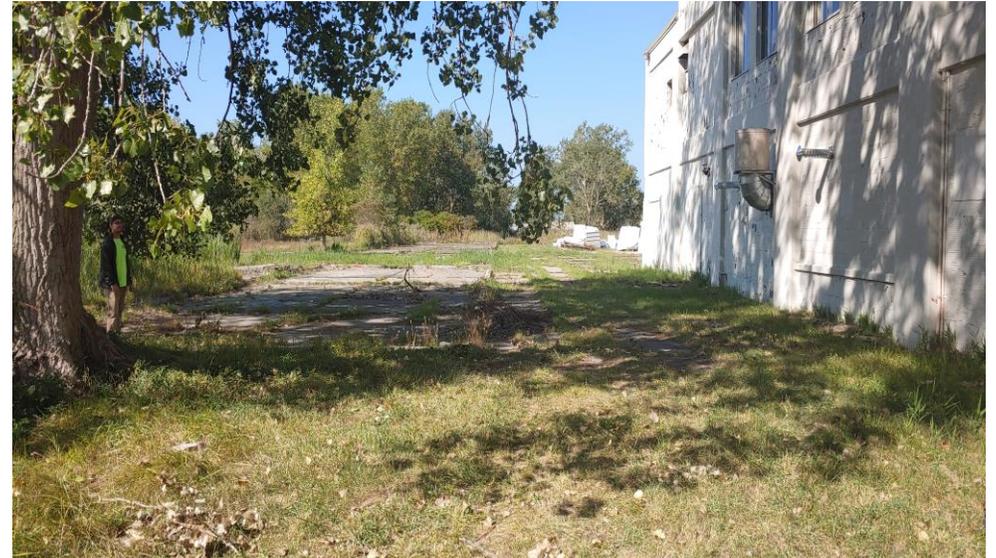
10. Southeast portion of property facing west

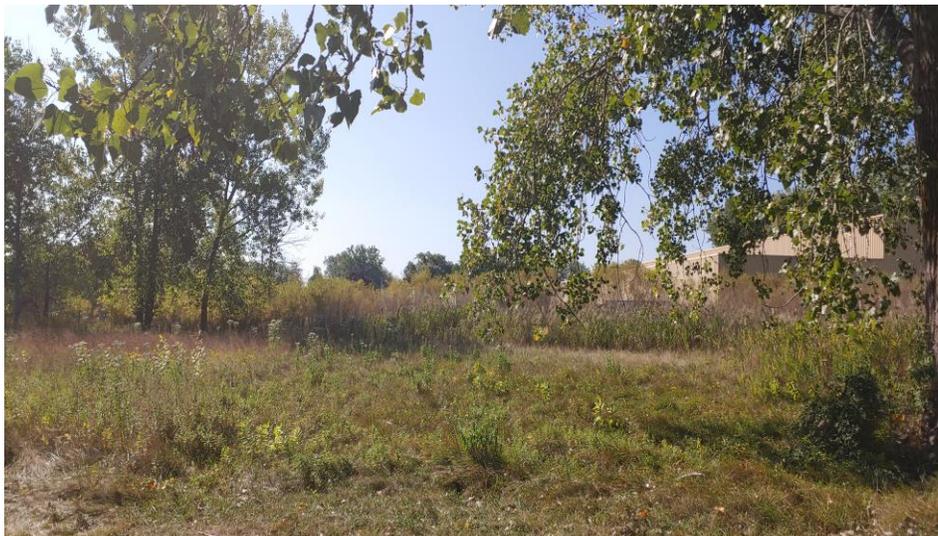
11. Southeast portion of property facing south
