CLEANUP PLAN IMPLEMENTATION REPORT
C&D CHARTER POWER SYSTEMS
FORMER SALES OFFICE
BUFFALO, NEW YORK

MARCH 1989

ERM-NORTHEAST 88 SUNNYSIDE BOULEVARD PLAINVIEW, NEW YORK 11803

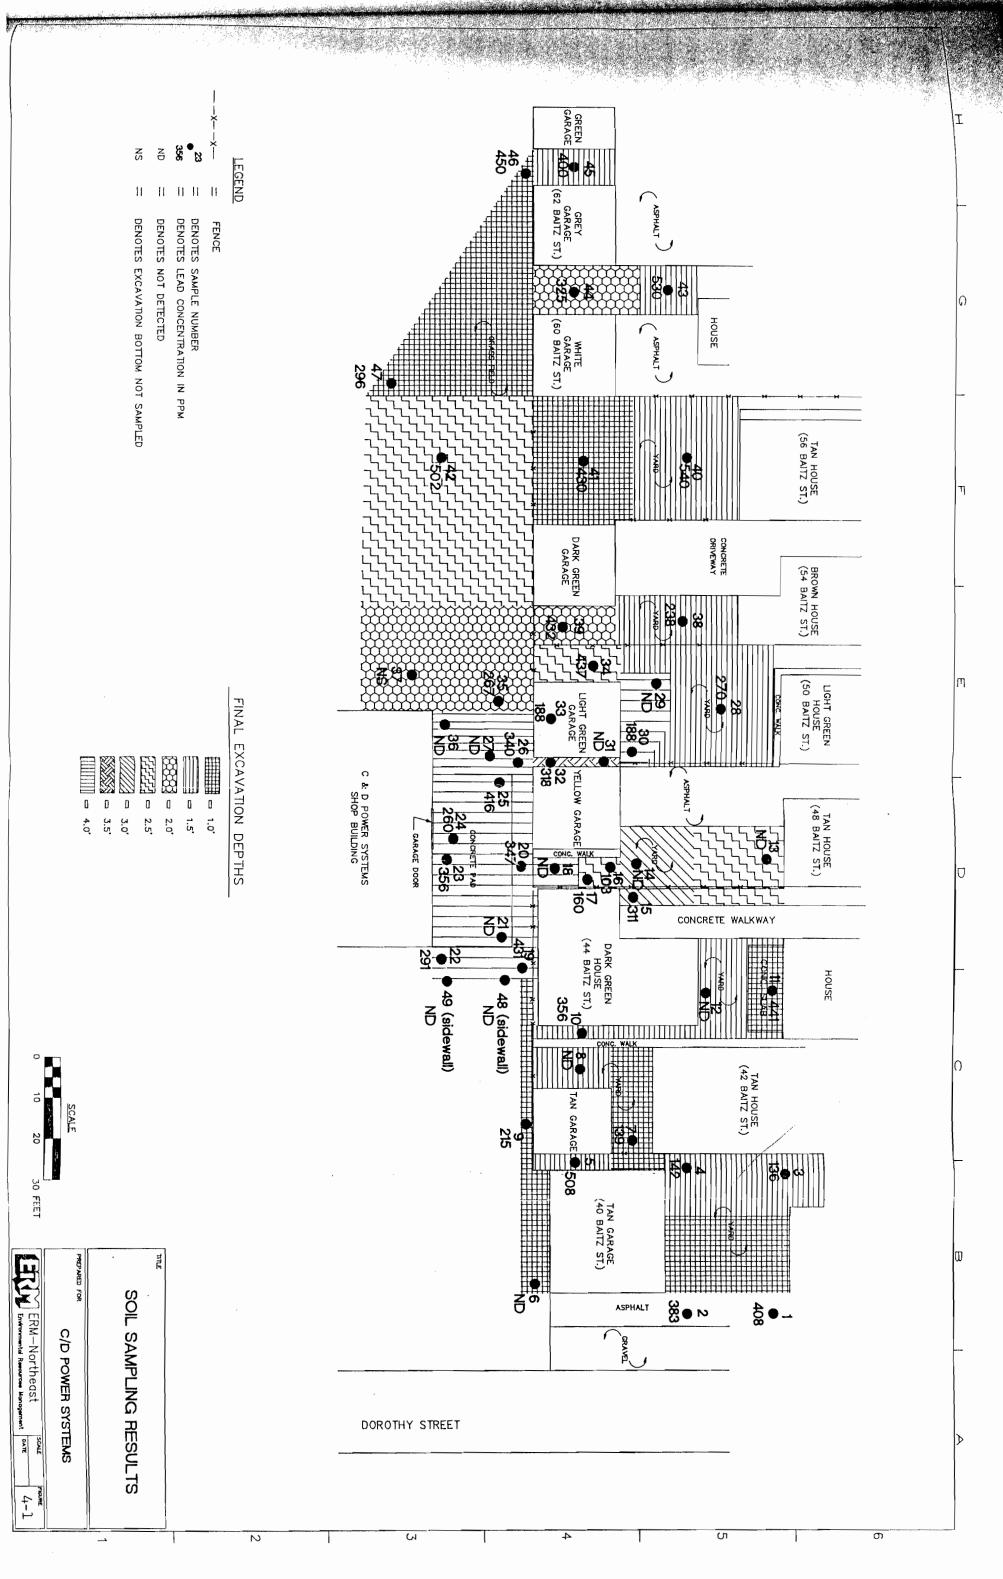
The final depths in each excavation area are shown on Figure 4-1. In general, the area around the former concrete pad was excavated to the greatest depth (approximately four feet) and the areas radially outward from the pad were excavated to lesser

depths. Several of the excavation areas had to be extended to depths greater than initially proposed because of the post-excavation sampling results.

Post-excavation sampling results indicate that the excavation program was successful in removing the soil with lead concentrations above 500 ppm. The laboratory data is summarized in Table 4-1, and is shown on Figure 4-1 at the actual locations of sampling. Laboratory reports for the post-excavation samples are contained in Appendix A, while the report for the backfill soil is contained in Appendix B. Personnel from NYSDEC's Region 9 office were on-site to direct and observe the sampling procedures, and to obtain sampling splits. As shown on Table 4-1, when postexcavation samples exceeded 500 ppm, an additional 0.5' of soil was removed from the floor of the excavation and the excavation area was resampled at this greater depth.

cleanup level. These five exceptions include Sample 5 (508 ppm), Sample 40 (540 ppm), Sample 42 (502 ppm), Sample 43 (530 ppm) and Sample 37 (not sampled). The four samples in which lead was detected slightly above the 500 ppm level were well below the surface (1.5 feet or greater) and were so close to the cleanup level that a field decision was made (based upon discussions with NYSDEC) to cease excavating in these areas. The one location which was not resampled (Sample 37) was an oversight that occurred during the field program, and was not recognized until after backfilling was completed.

Upon completion of the entire excavation, the excavation areas were then backfilled with bank-run soil and regraded to the surface. At the request of the NYSDEC, the backfill soil was analyzed for metals and volatile organics, and was determined to be clean by the NYSDEC (Appendix B). The excavation area to the southeast of the building was resurfaced with gravel, while the placement of sod and shrubs for the remainder of the site is scheduled to begin May 1, 1989. Property-boundary fences were installed around the individual backyards, and all efforts were made to use fencing material similar to that removed from the property boundaries prior to excavating.
