CITY OF BUFFALO
DEPARTMENT OF
PUBLIC WORKS, PARKS & STREETS

RE: *Bern Metal Corp./Universal Iron & Metal Site 915135*
22 Bender Street, Buffalo, NY
Operations, Maintenance and Monitoring Plan, March 2003; Revised April/May 2003
(O&M Plan)
Consent Decree 02-CV-0277 (SC) July 19, 2002

The City of Buffalo is in receipt of your letter dated December 6, 2011 and in response, submits the following comprehensive Corrective Measures Work Plan:

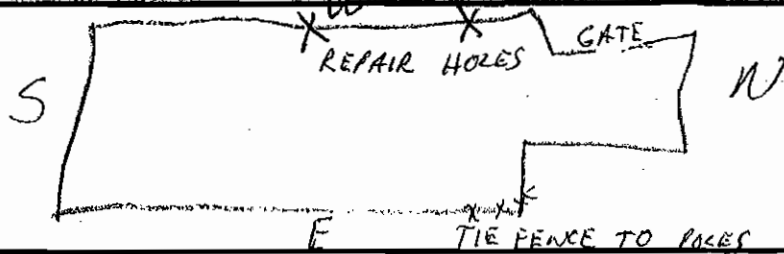
Inspection Items	Acceptable		Comments/Work Performed
	YES	NO	
1. General Site Conditions			
Gates Locked and Secure			
Perimeter Fence/Warning Signs	✓		REPAIRED TWO HOLES IN FENCE N. EAST SIDE - WIRE TIES EAST SIDE WEST
Perimeter Vegetation			
Trash or Litter			
Survey Control Monuments			
2. Maintenance Road Conditions			
Surface			
Accessibility			
3. Final Cover Vegetation			
General Grass Growth			
Stressed Vegetation			
Animal Burrows			
Tree or Bush Growth			
Protruding Objects/Settlement			
Ponding Water			
Erosion			
4. Storm Water Drainage System			
Mid-Slope Drainage Swales			
Perimeter Drainage Ditch			
Outlet Drainage Ditch			
Catch Basins			
5. Groundwater Monitoring Wells			
Casings Secure and Locked			
6. Other Items

12-16-11
DAN MALONEY

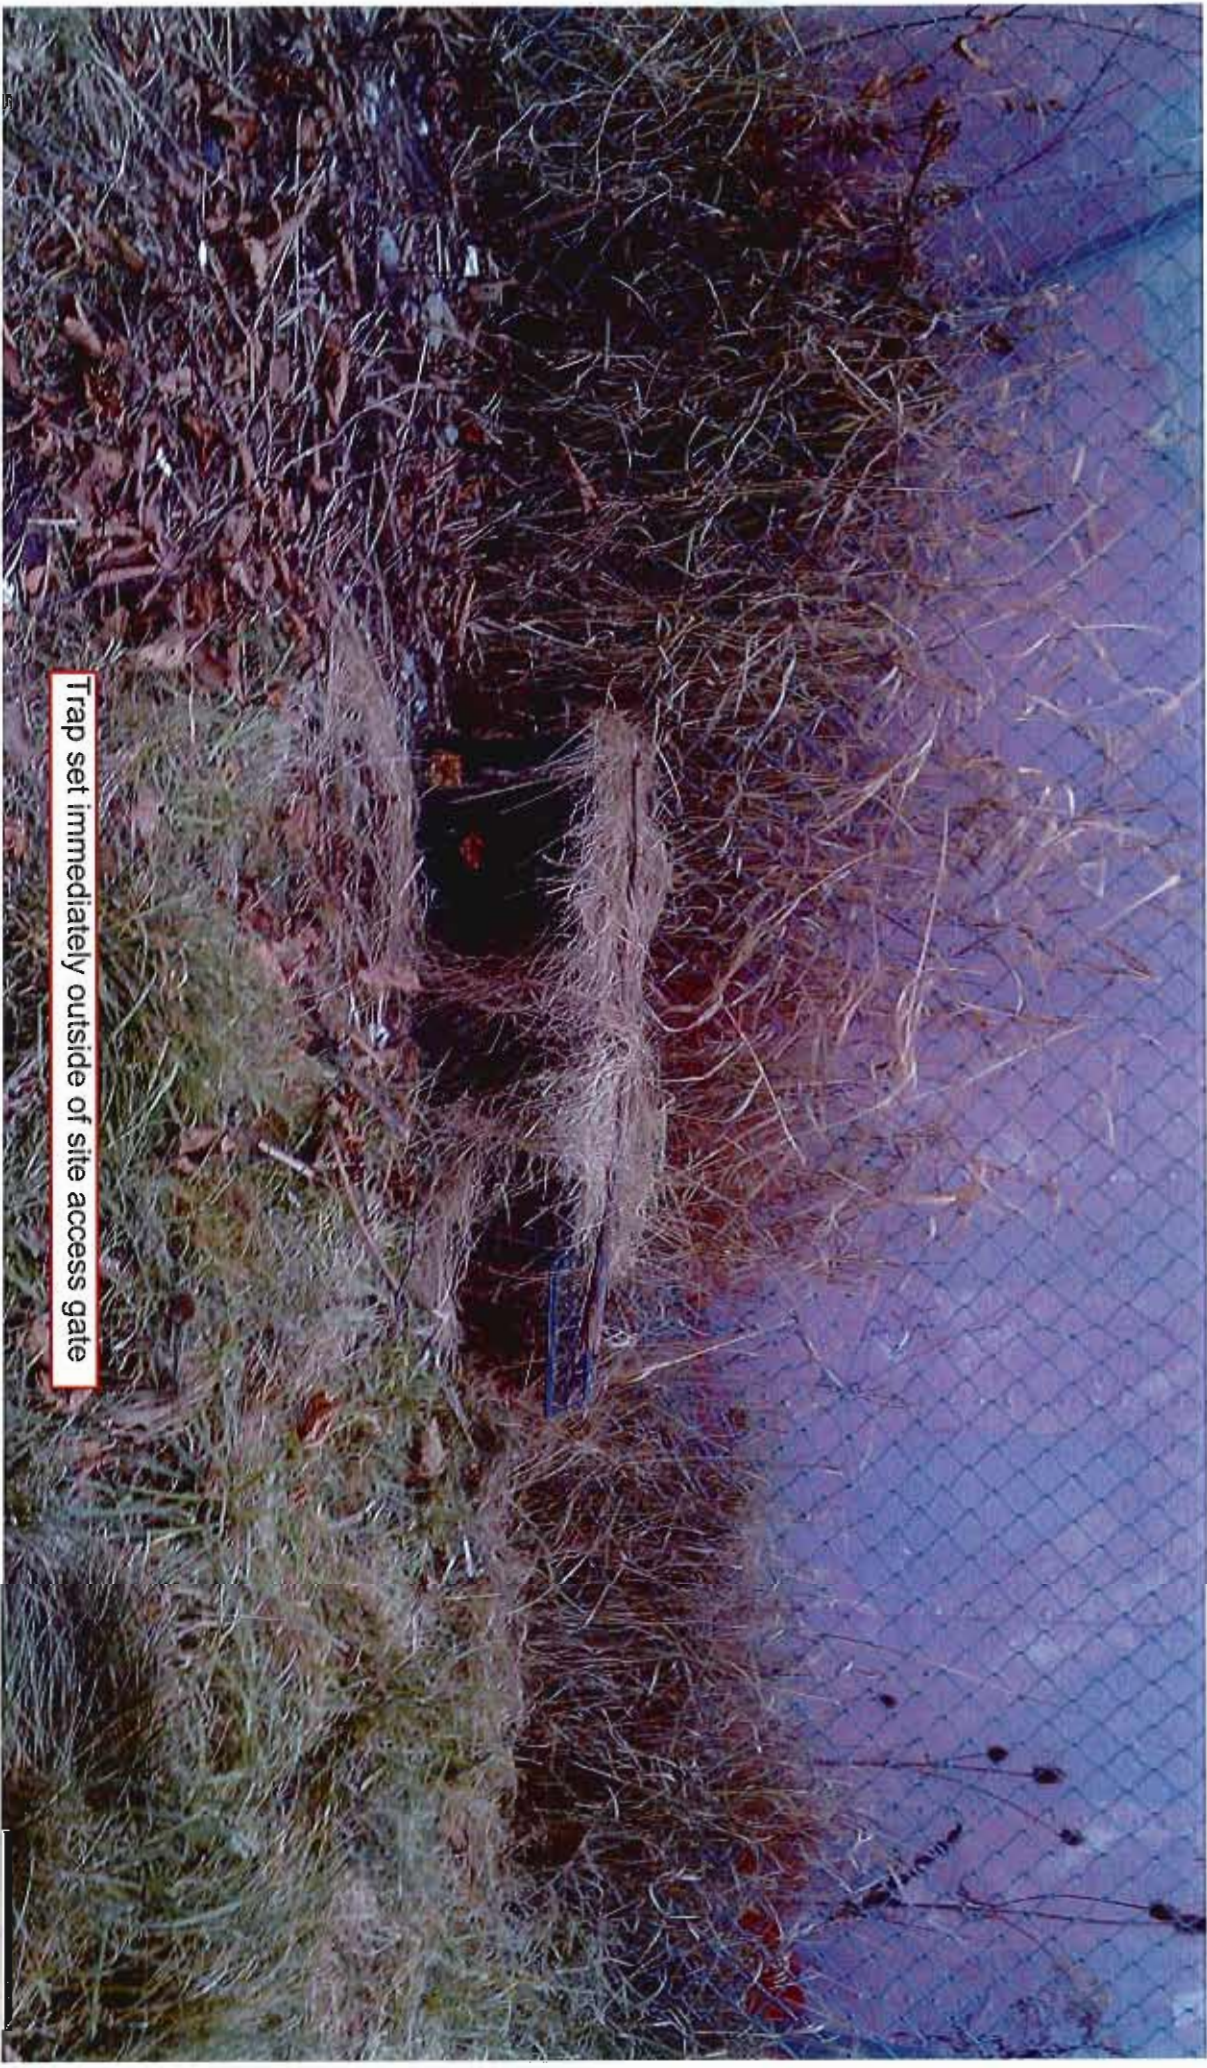
Trap set immediately outside of site access gate

1. As of 12/23/11 the City has filled all apparent woodchuck holes on the site as best as possible at this time. Some of the holes are deep and the soil that was used to fill them continues to settle and the City will return to the site in the Spring of 2012 to fill these holes with more soil as necessary. The City will, in the Spring of 2012, resume monitoring for new burrows on a monthly basis and new holes that are discovered will be filled within 5 business days. The City has, and will continue to, set and maintain three traps for woodchucks at various locations around the subject site. The traps will be monitored daily and any woodchucks that are caught will be removed from the site. These traps will be set and maintained on a daily basis until the City and DEC agree that burrowing of the cover system is no longer a concern. At that point the matter will be readdressed as needed and the frequency of trapping increased or decreased to an agreed upon level to be reasonably satisfactory to the DEC.

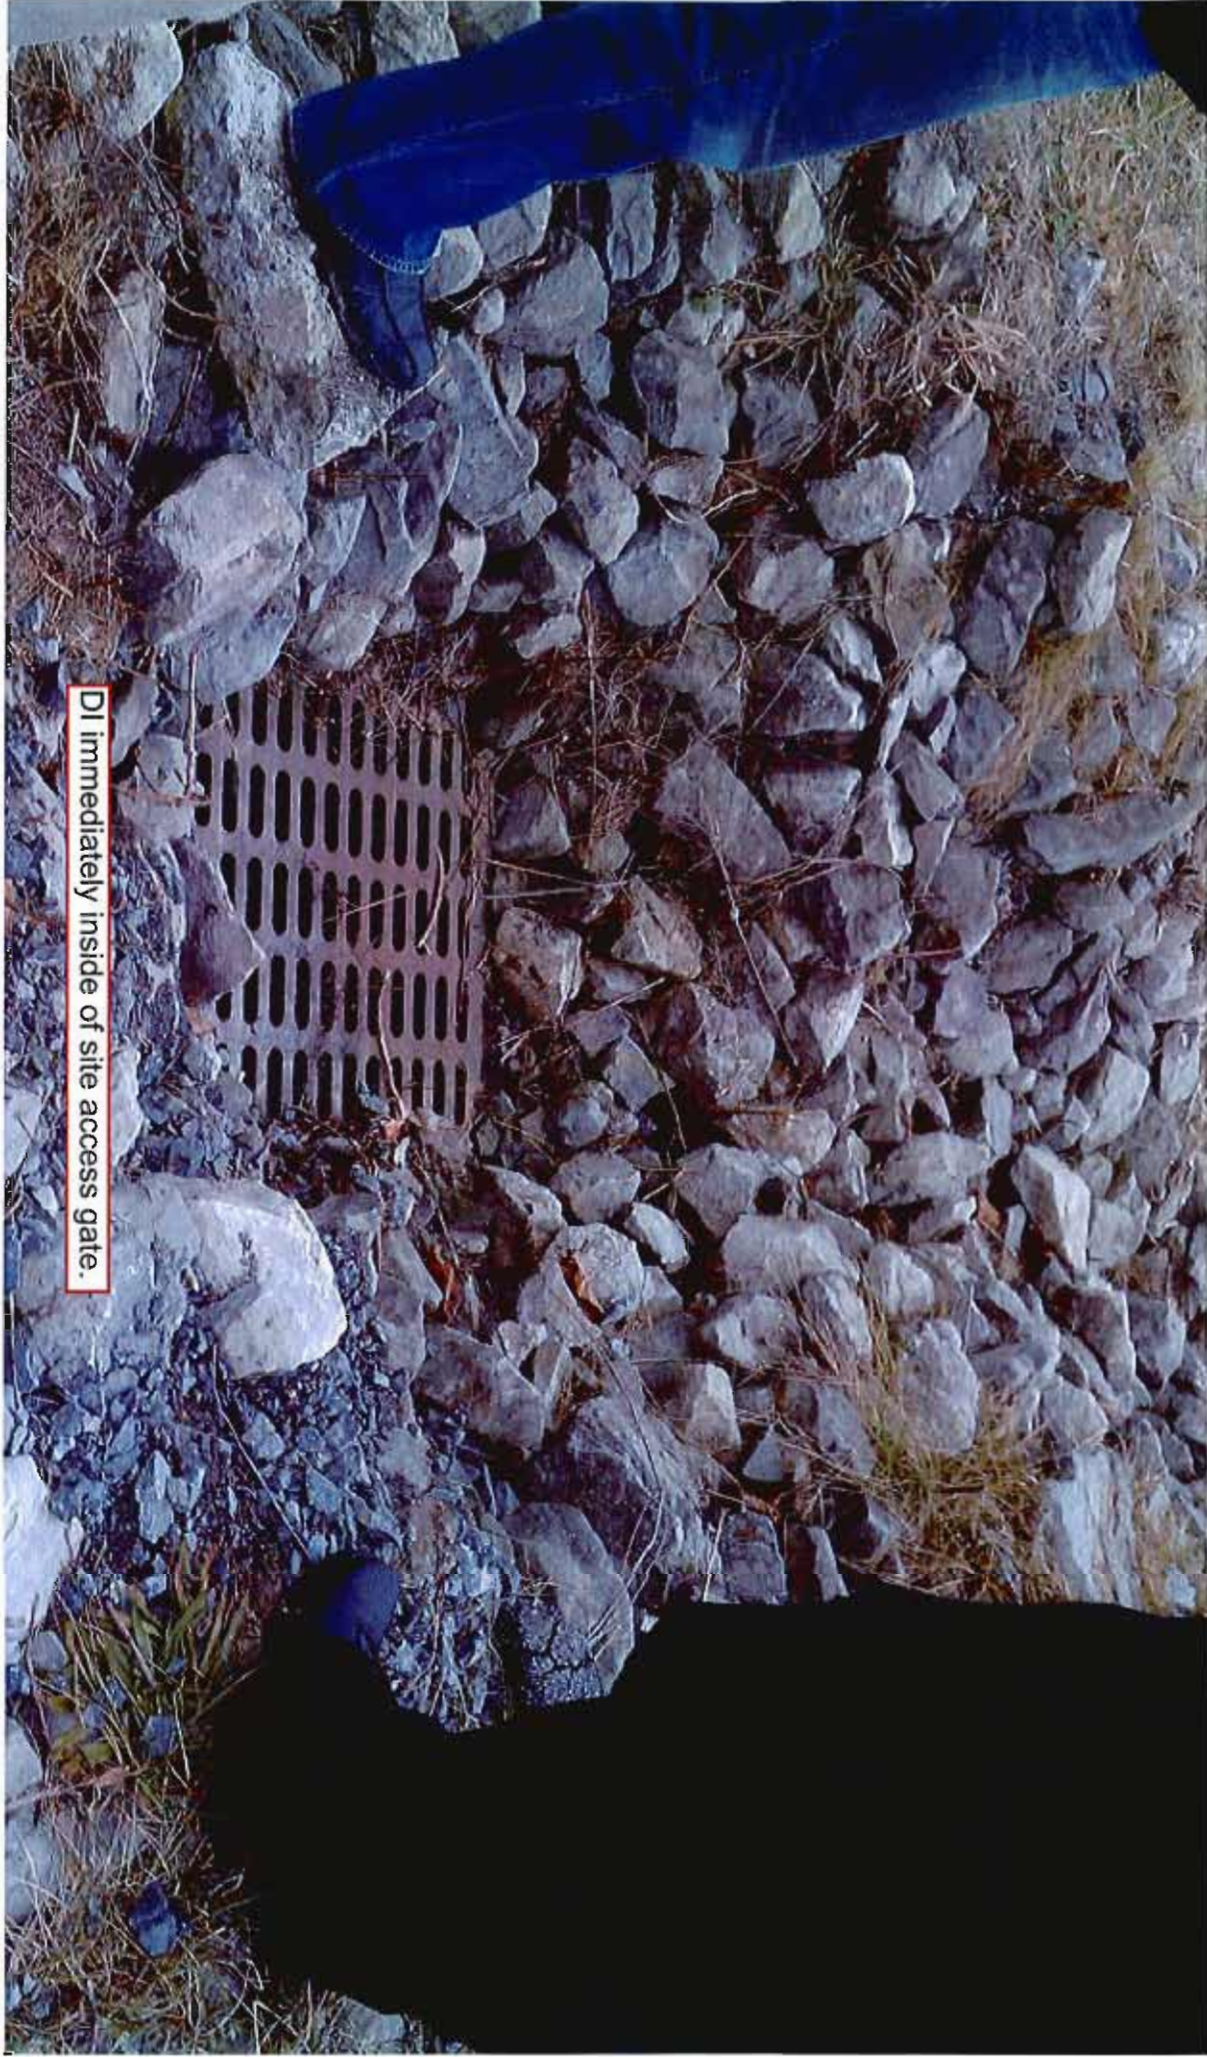
DI immediately inside of site access gate.

3. As of 12/23/11 the City has removed all plants in the perimeter swale down to the base of the plants.
4. As of 12/23/11 the City has removed all rock and stone that collapsed into the drainage inlets near the site gate.

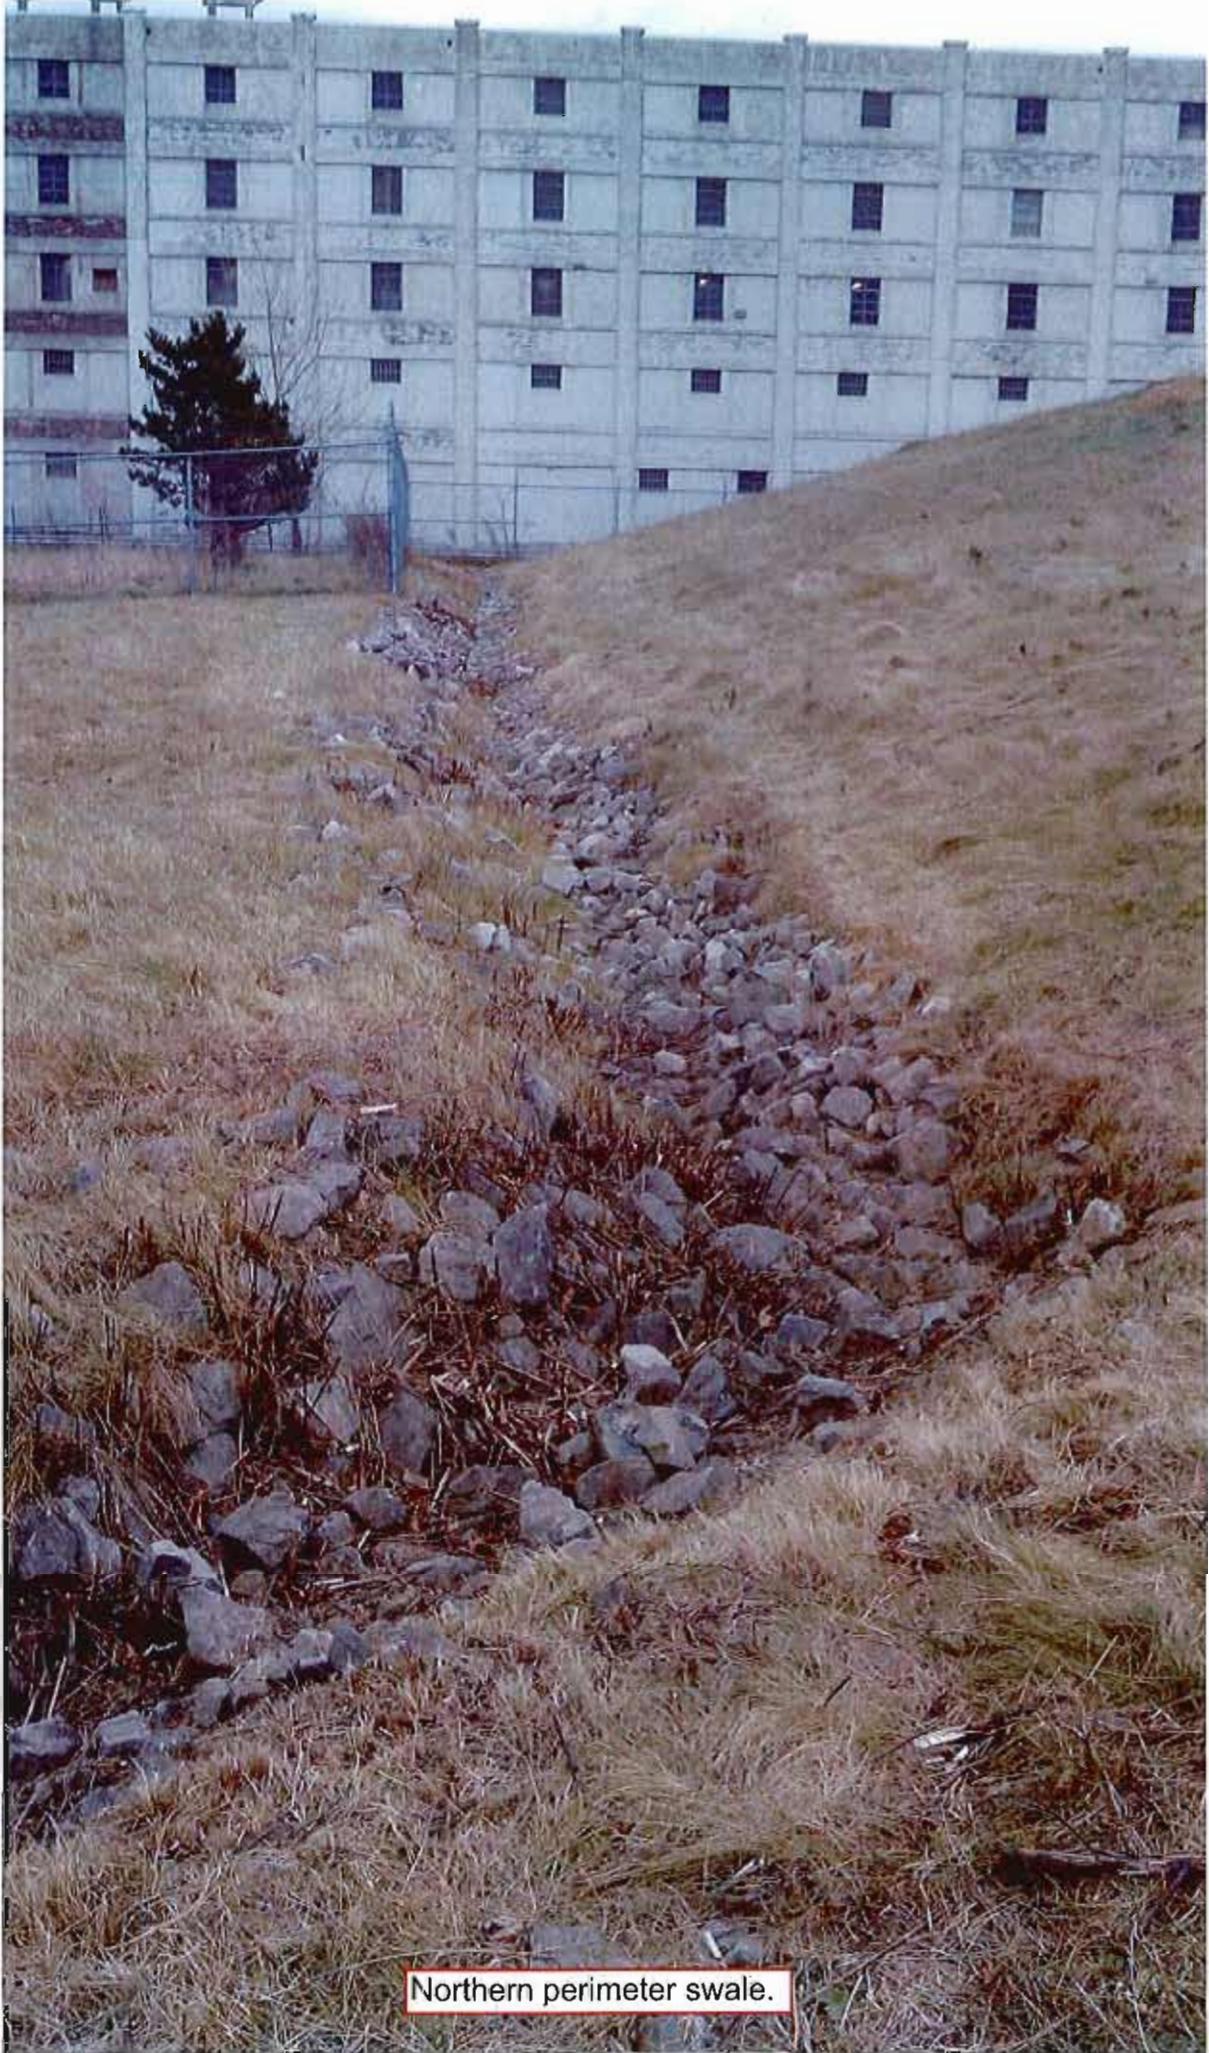
Northern perimeter swale.

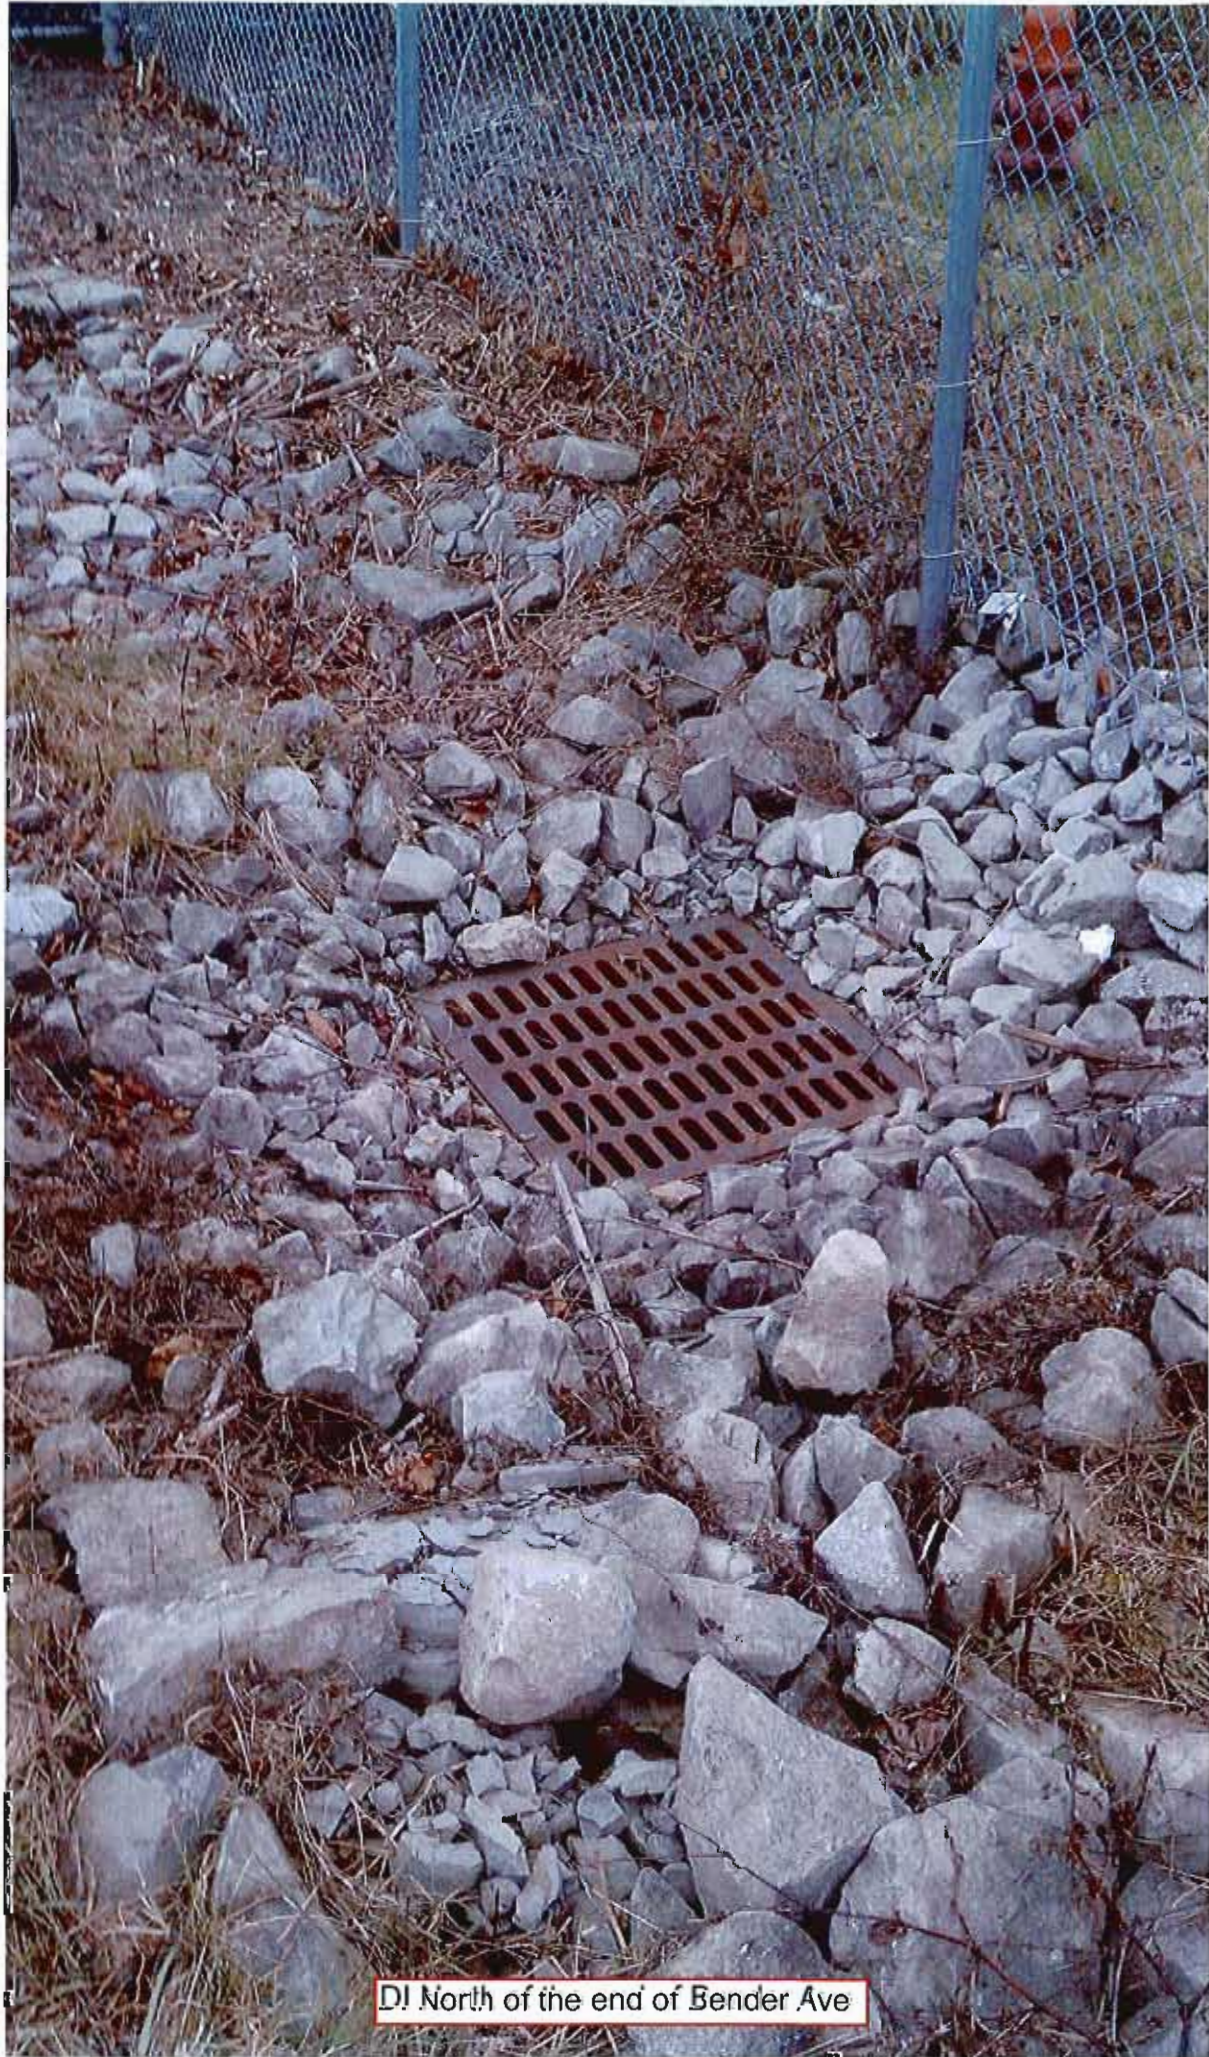
D! North of the end of Bender Ave

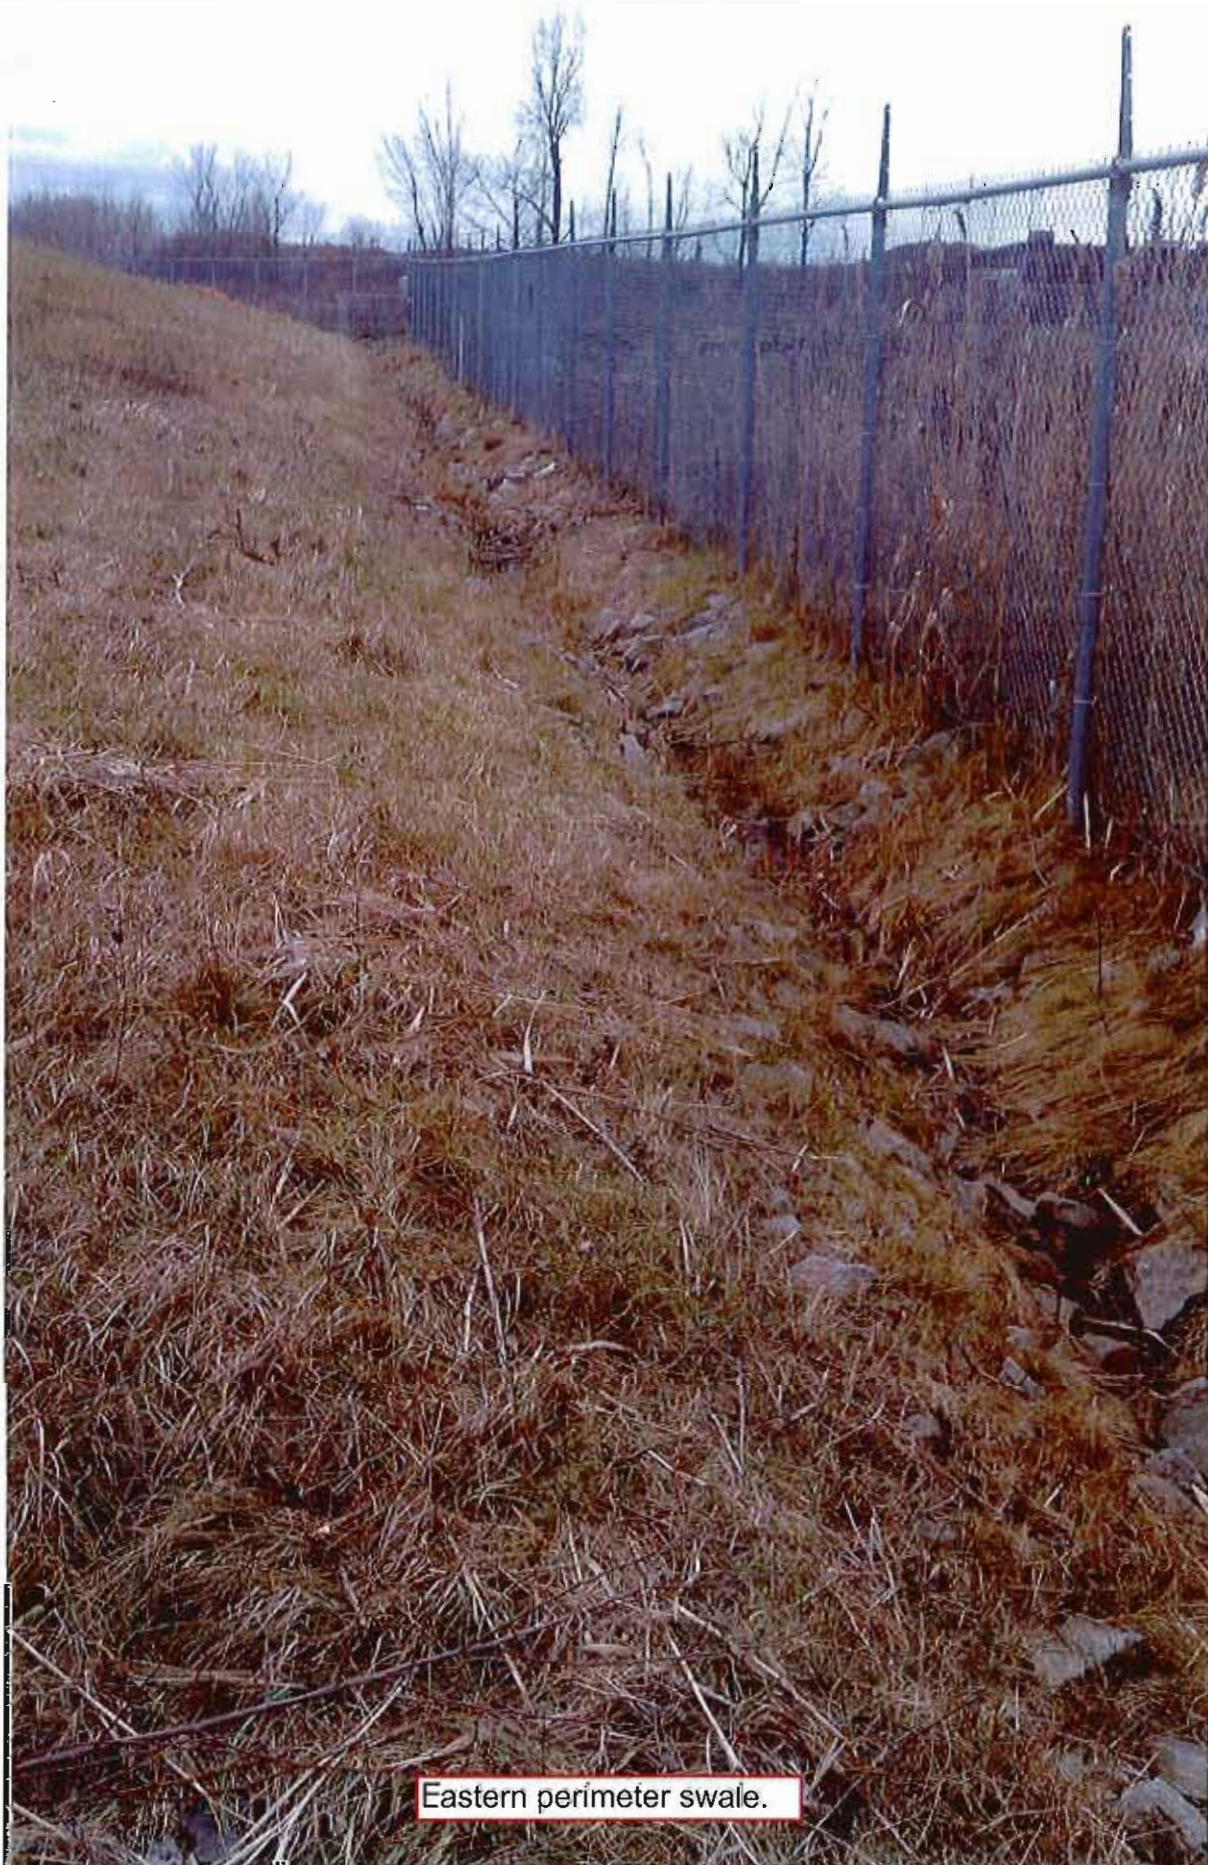
Eastern perimeter swale.

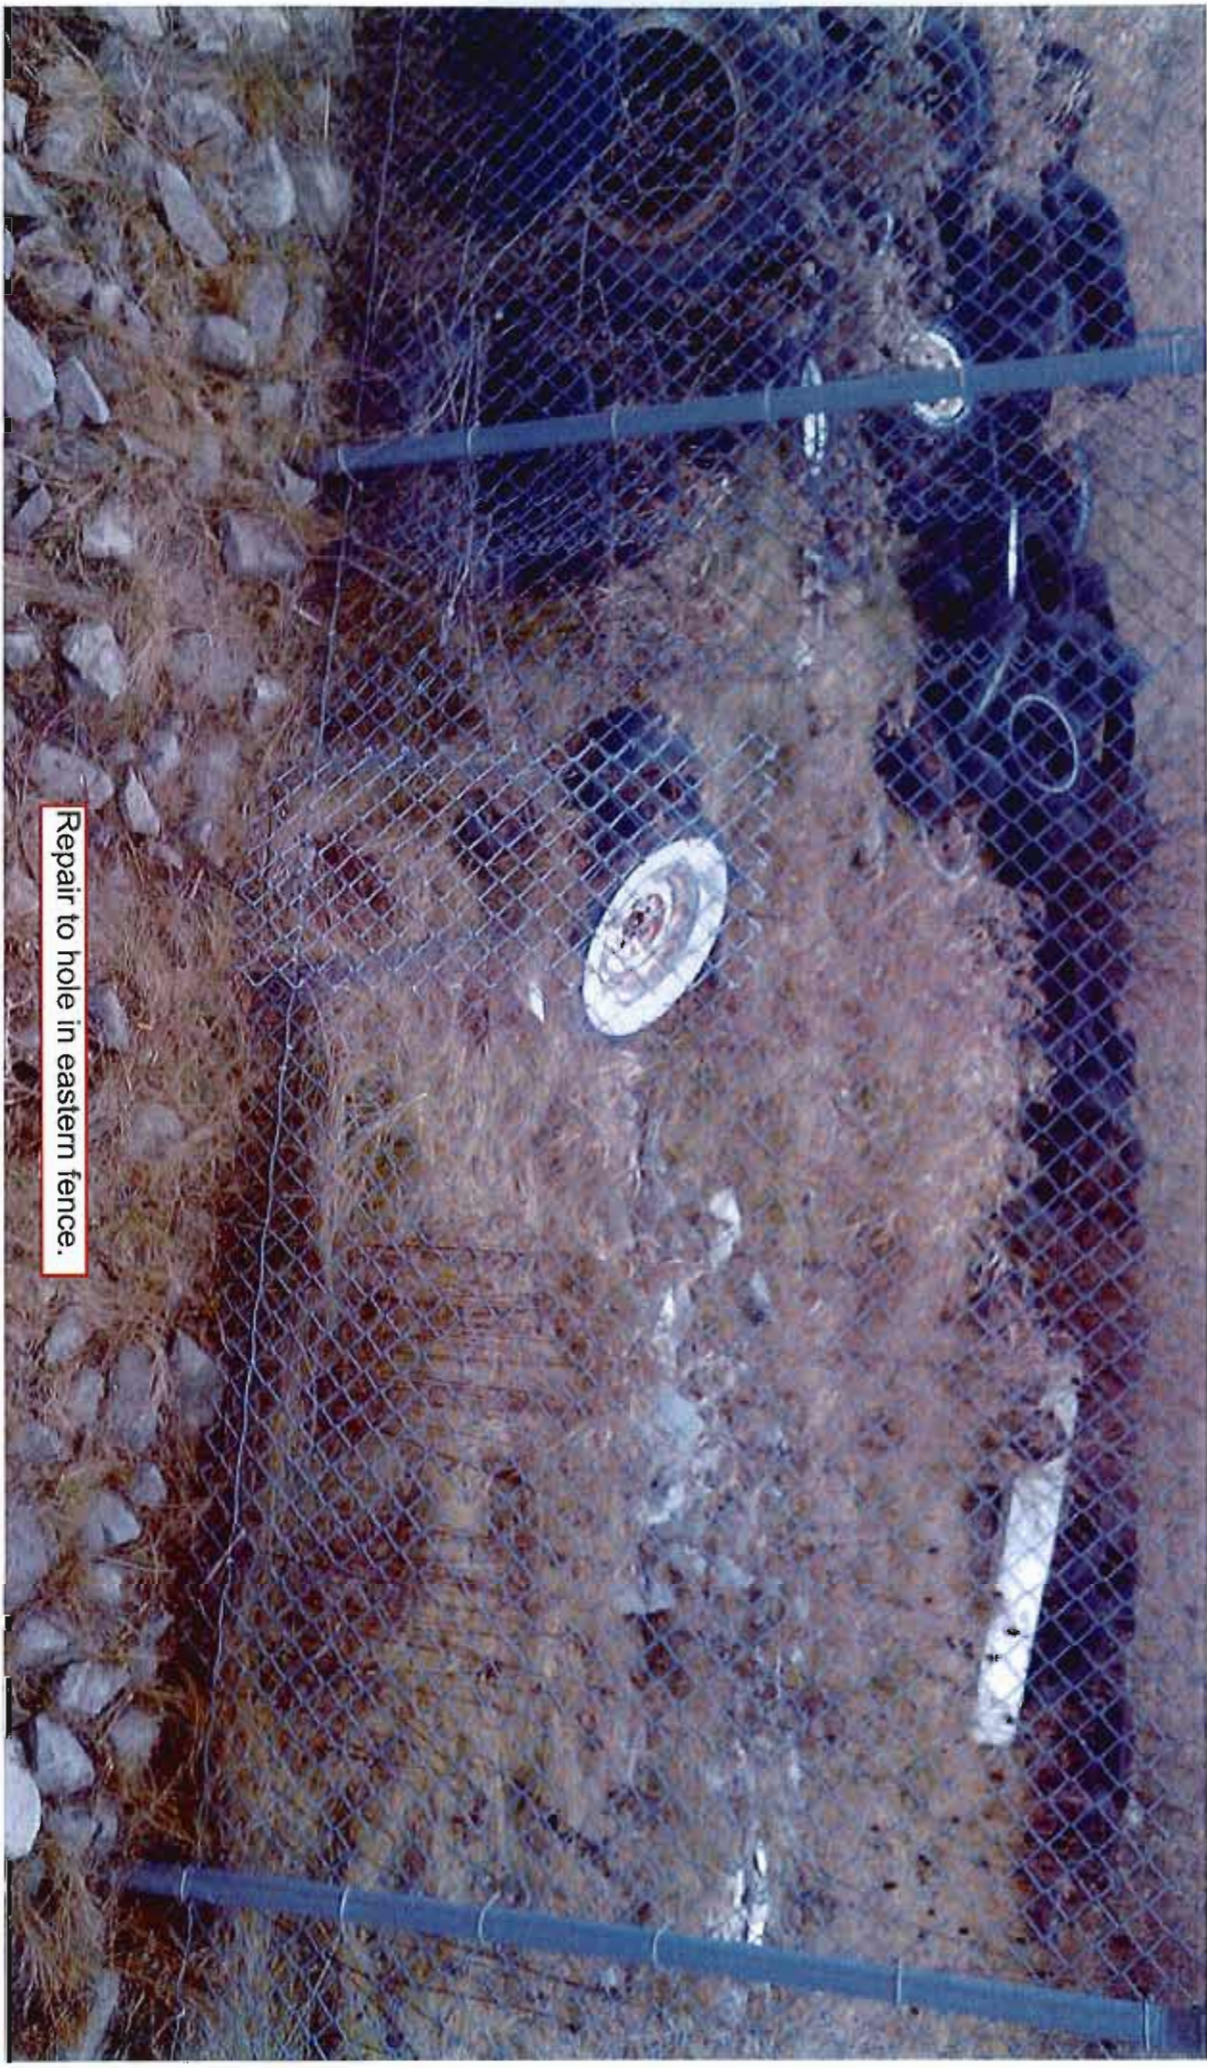
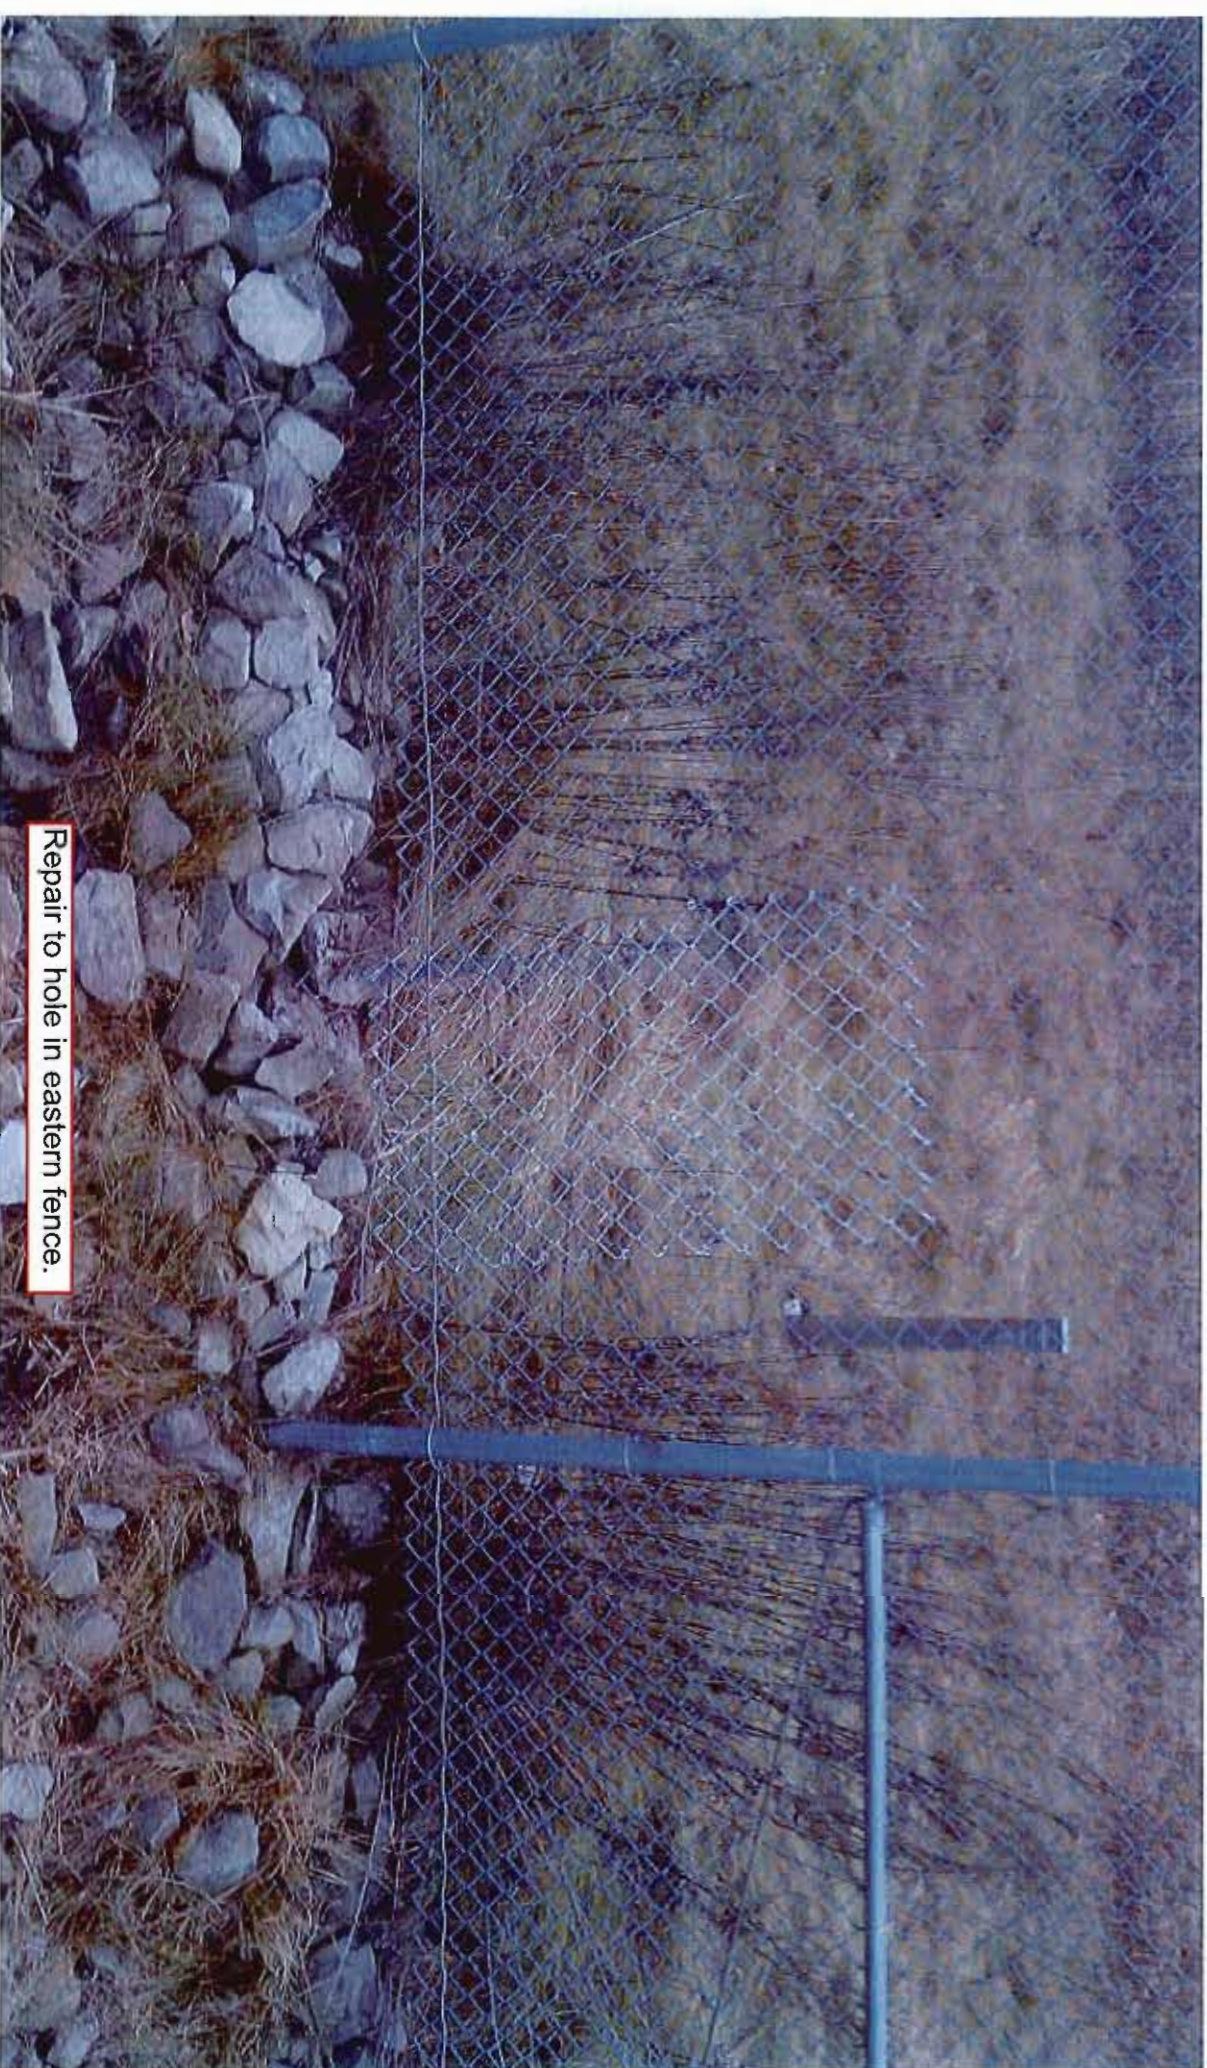
Repair to hole in eastern fence.

5. As of 12/23/11 the City has removed trees or other woody growth that was growing into the fencing. At some locations, the trees or woody growth were only removed as much as was possible given that access was limited to the site's side of the fence and in any event will control the trees and woody growth as access to same permits. The City will seek access from adjacent property owners for further removal as necessary.
6. As of 12/23/11 the fencing that was bent along the base has been resecured to the ground by securing the bottom of the fence fabric to stakes that have been driven into the ground. Holes in the fencing have also been repaired as necessary.
