CITY OF BUFFALO
DEPARTMENT OF
PUBLIC WORKS, PARKS & STREETS

RE: *Bern Metal Corp./Universal Iron & Metal Site 915135*
22 Bender Street, Buffalo, NY
Operations, Maintenance and Monitoring Plan, March 2003; Revised April/May 2003
(O&M Plan)
Consent Decree 02-CV-0277 (SC) July 19, 2002

The City of Buffalo is in receipt of your letter dated December 6, 2011 and in response, submits the following comprehensive Corrective Measures Work Plan:

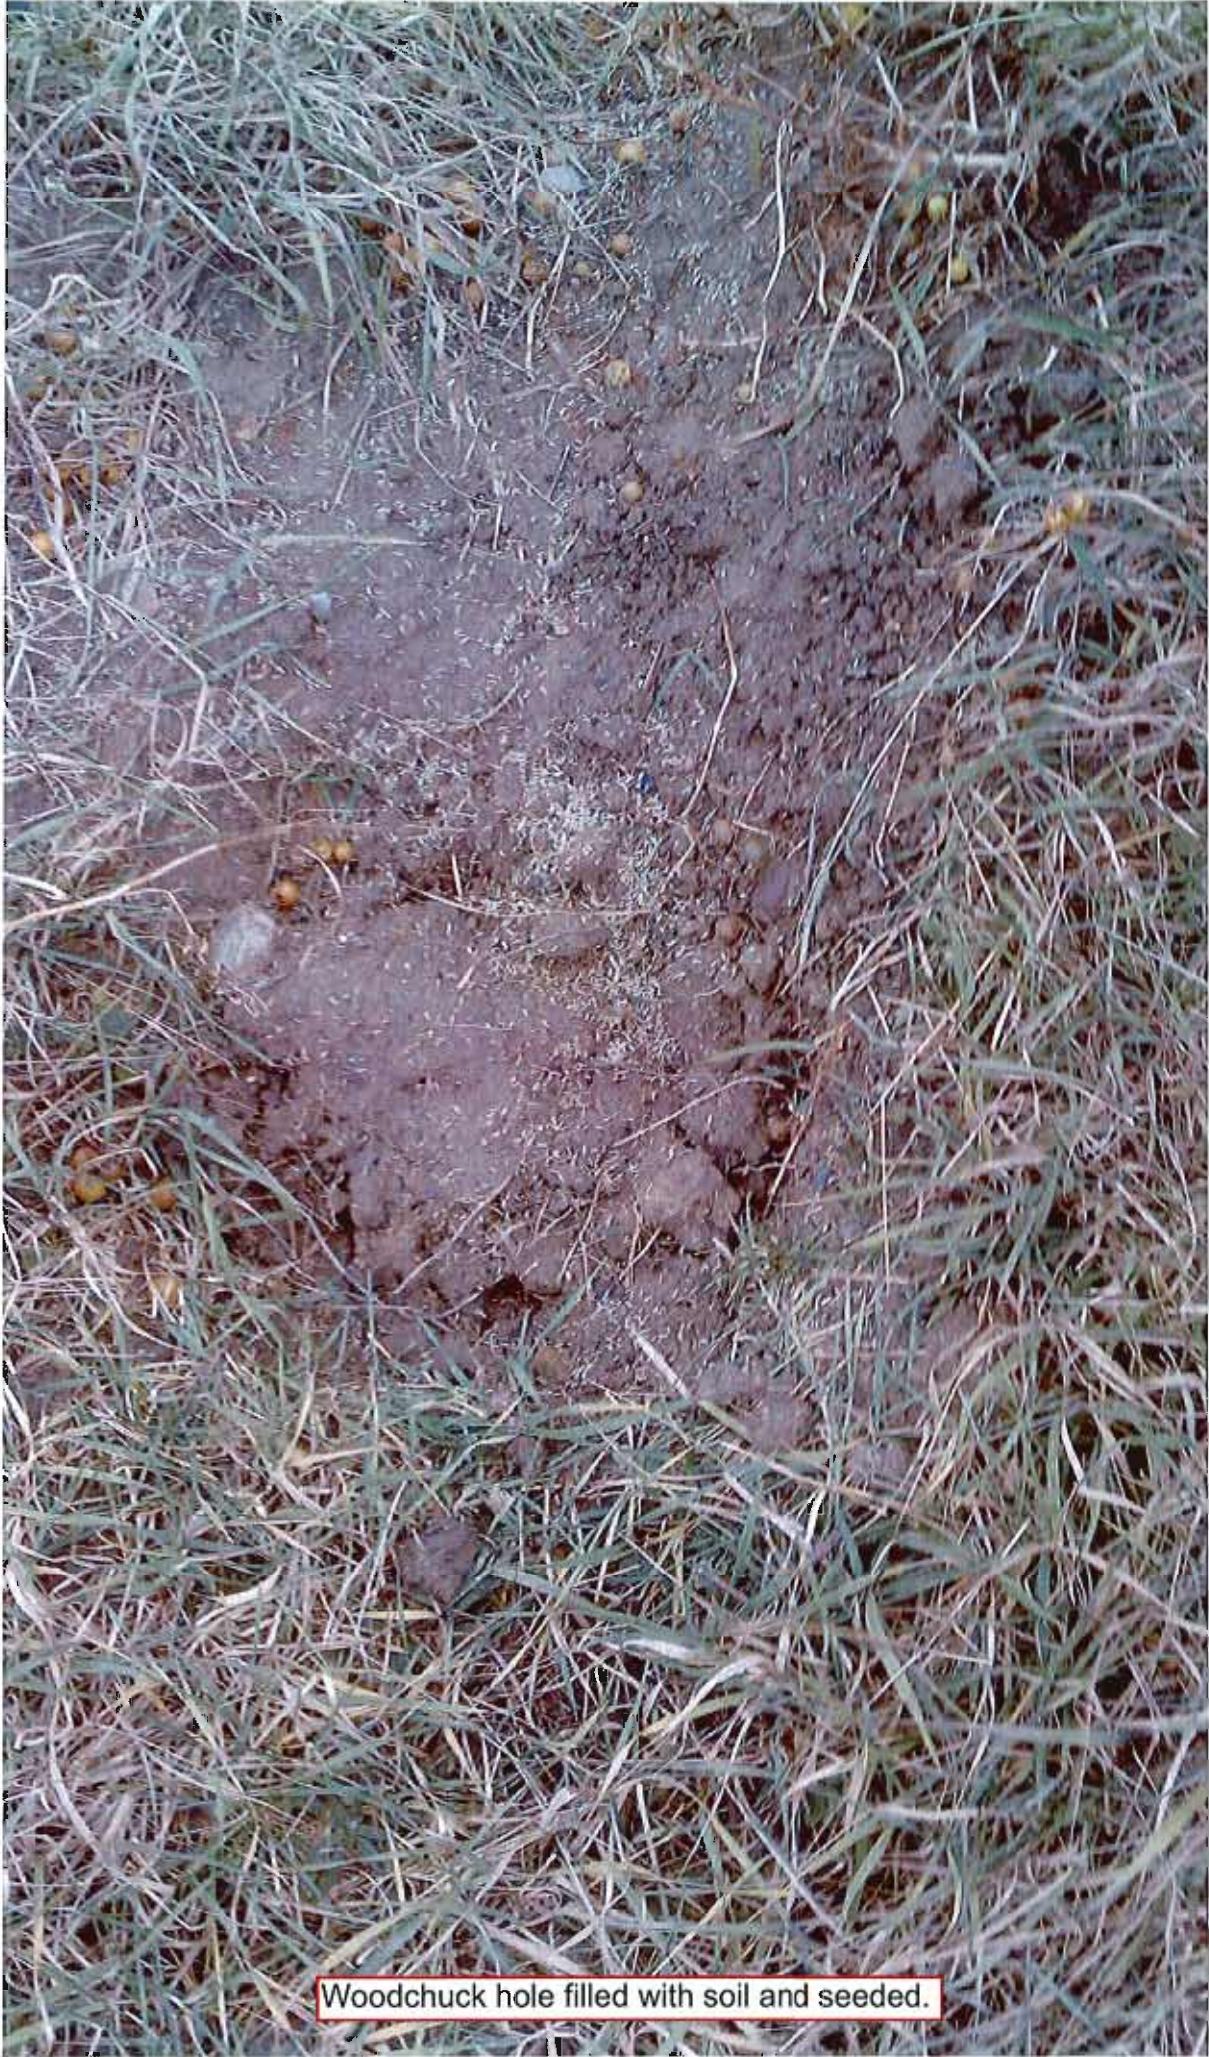
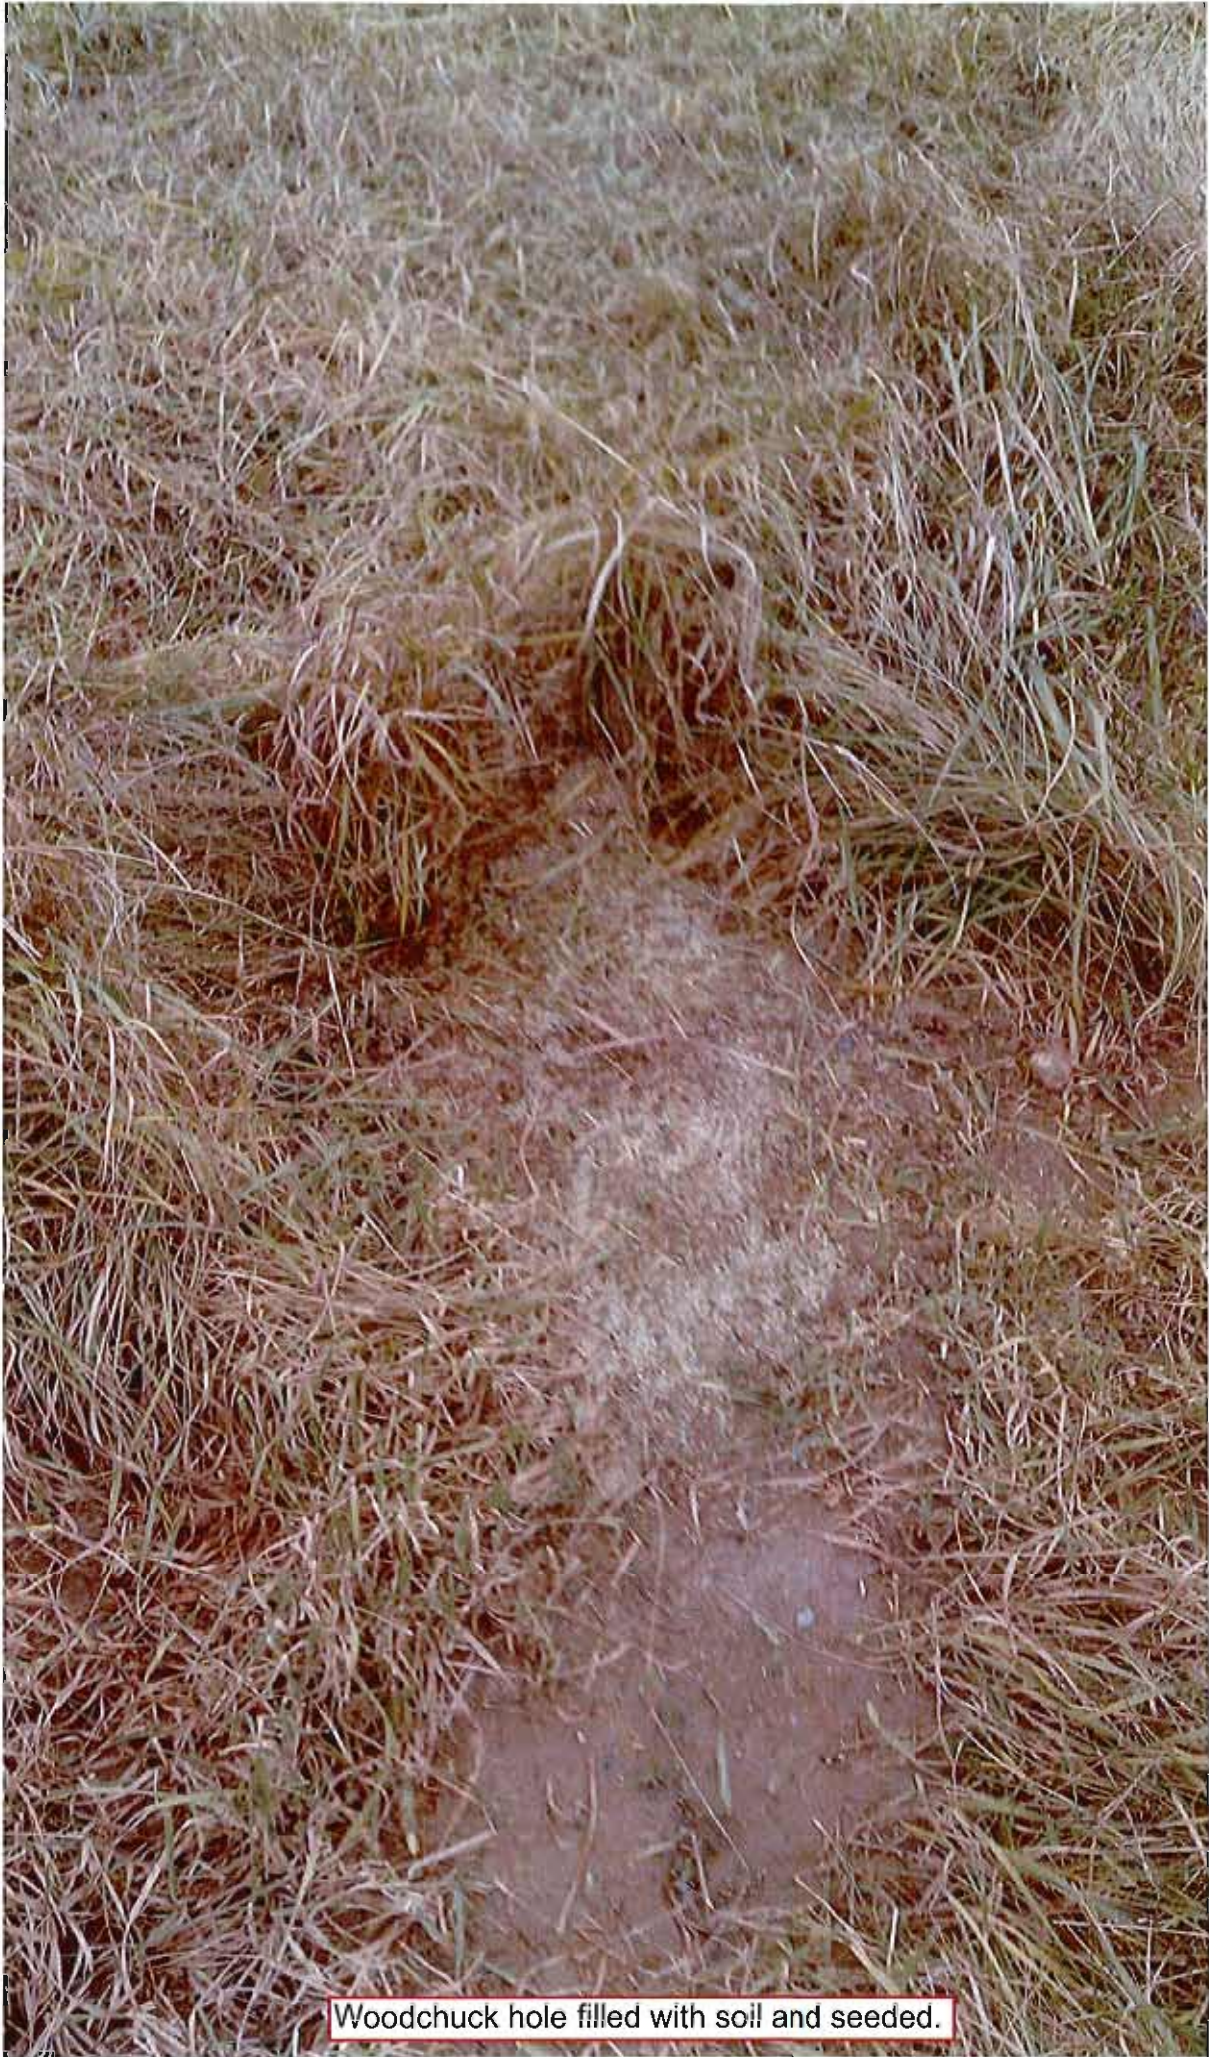
Woodchuck hole filled with soil and seeded.

1. As of 12/23/11 the City has filled all apparent woodchuck holes on the site as best as possible at this time. Some of the holes are deep and the soil that was used to fill them continues to settle and the City will return to the site in the Spring of 2012 to fill these holes with more soil as necessary. The City will, in the Spring of 2012, resume monitoring for new burrows on a monthly basis and new holes that are discovered will be filled within 5 business days. The City has, and will continue to, set and maintain three traps for woodchucks at various locations around the subject site. The traps will be monitored daily and any woodchucks that are caught will be removed from the site. These traps will be set and maintained on a daily basis until the City and DEC agree that burrowing of the cover system is no longer a concern. At that point the matter will be readdressed as needed and the frequency of trapping increased or decreased to an agreed upon level to be reasonably satisfactory to the DEC.

2. As of 12/23/11 the City has placed grass seed on all filled/regraded/bare areas of the site. In the growing season of Spring of 2012, the City will place seed again and continue to reapply seed until sufficient vegetative cover is established.

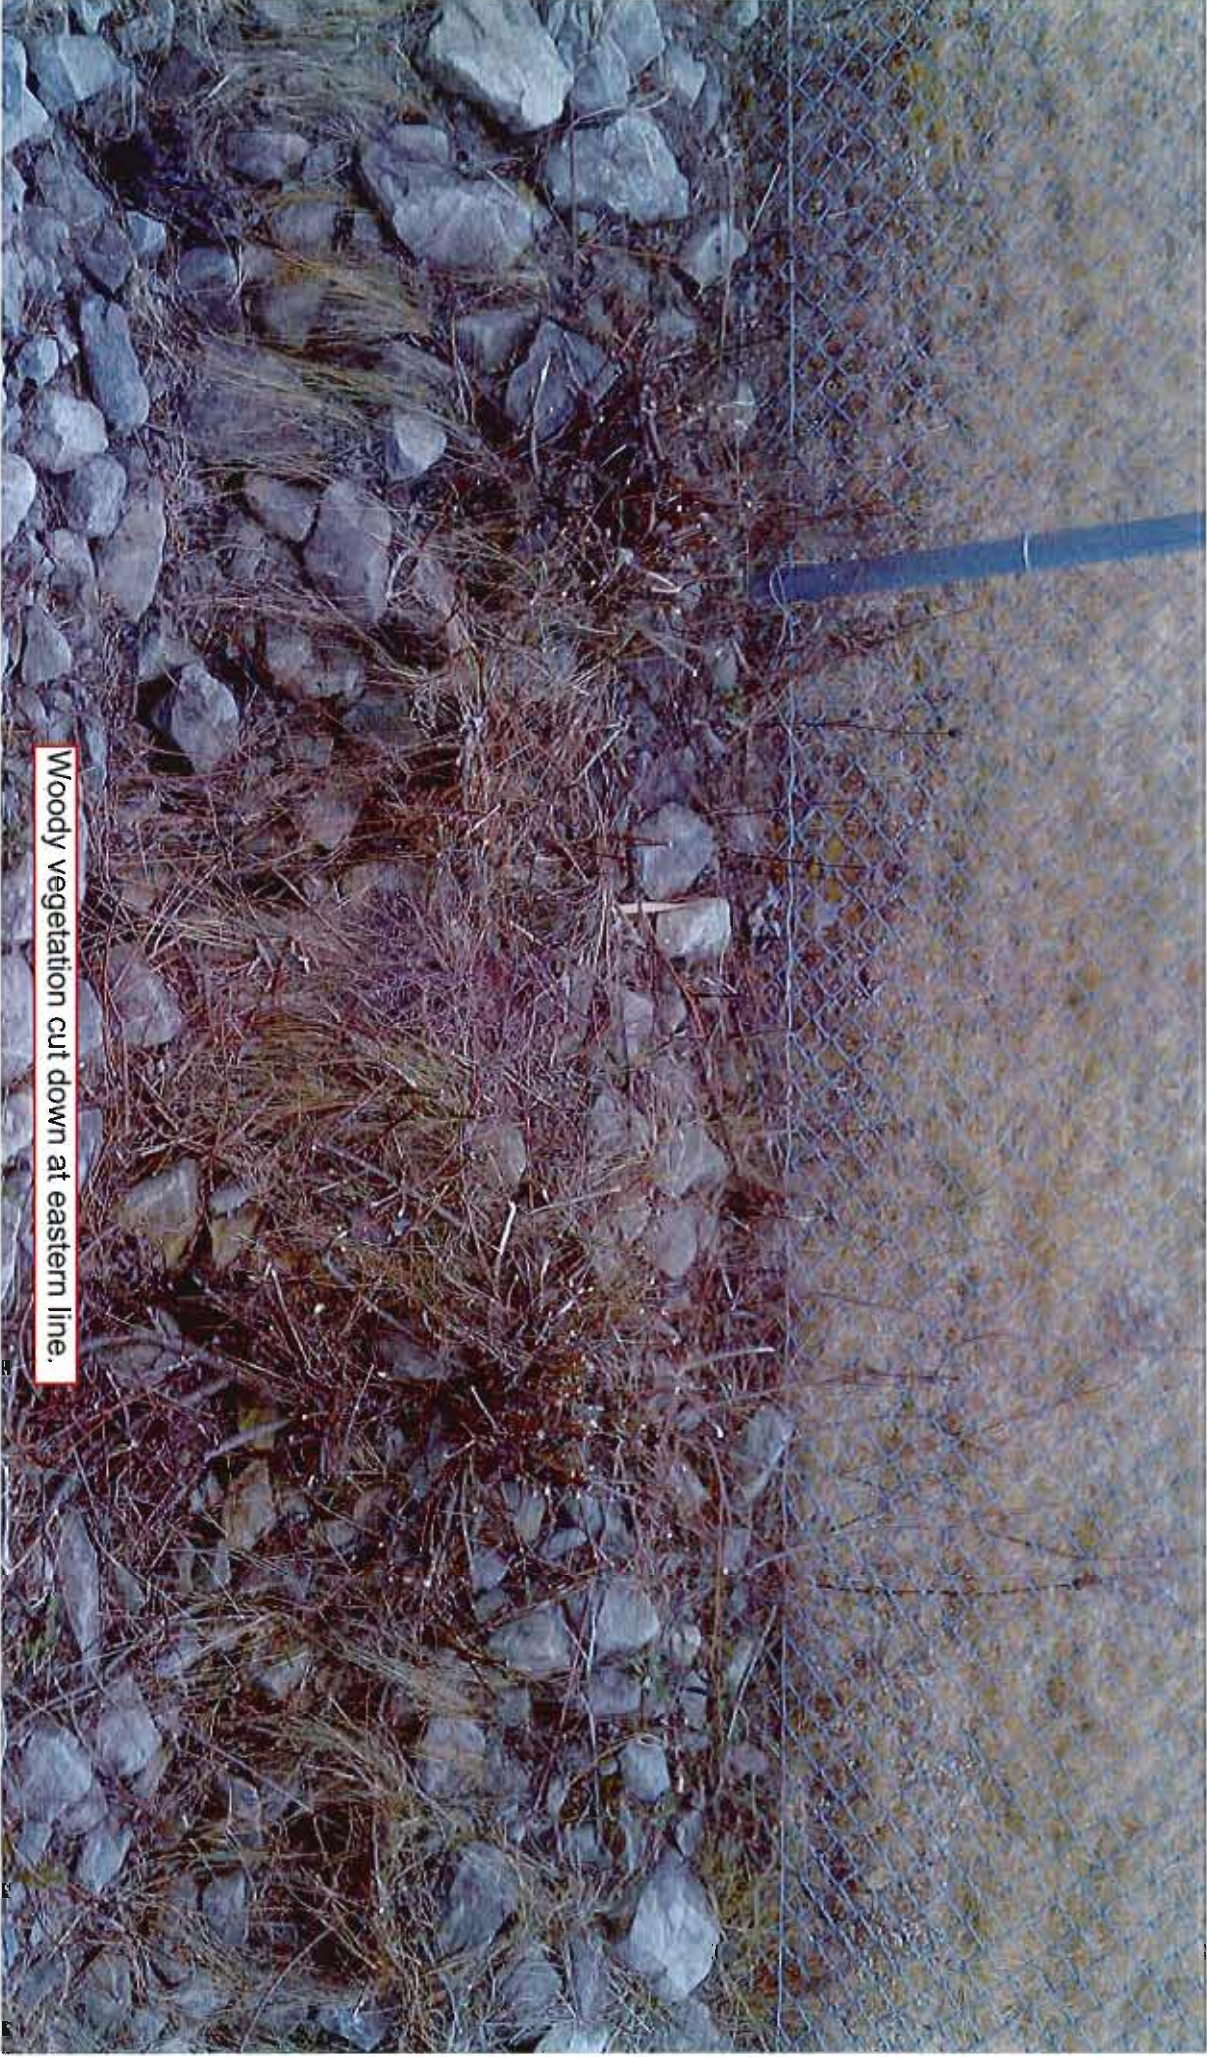
Woody vegetation cut down at eastern line.

5. As of 12/23/11 the City has removed trees or other woody growth that was growing into the fencing. At some locations, the trees or woody growth were only removed as much as was possible given that access was limited to the site's side of the fence and in any event will control the trees and woody growth as access to same permits. The City will seek access from adjacent property owners for further removal as necessary.
6. As of 12/23/11 the fencing that was bent along the base has been resecured to the ground by securing the bottom of the fence fabric to stakes that have been driven into the ground. Holes in the fencing have also been repaired as necessary.

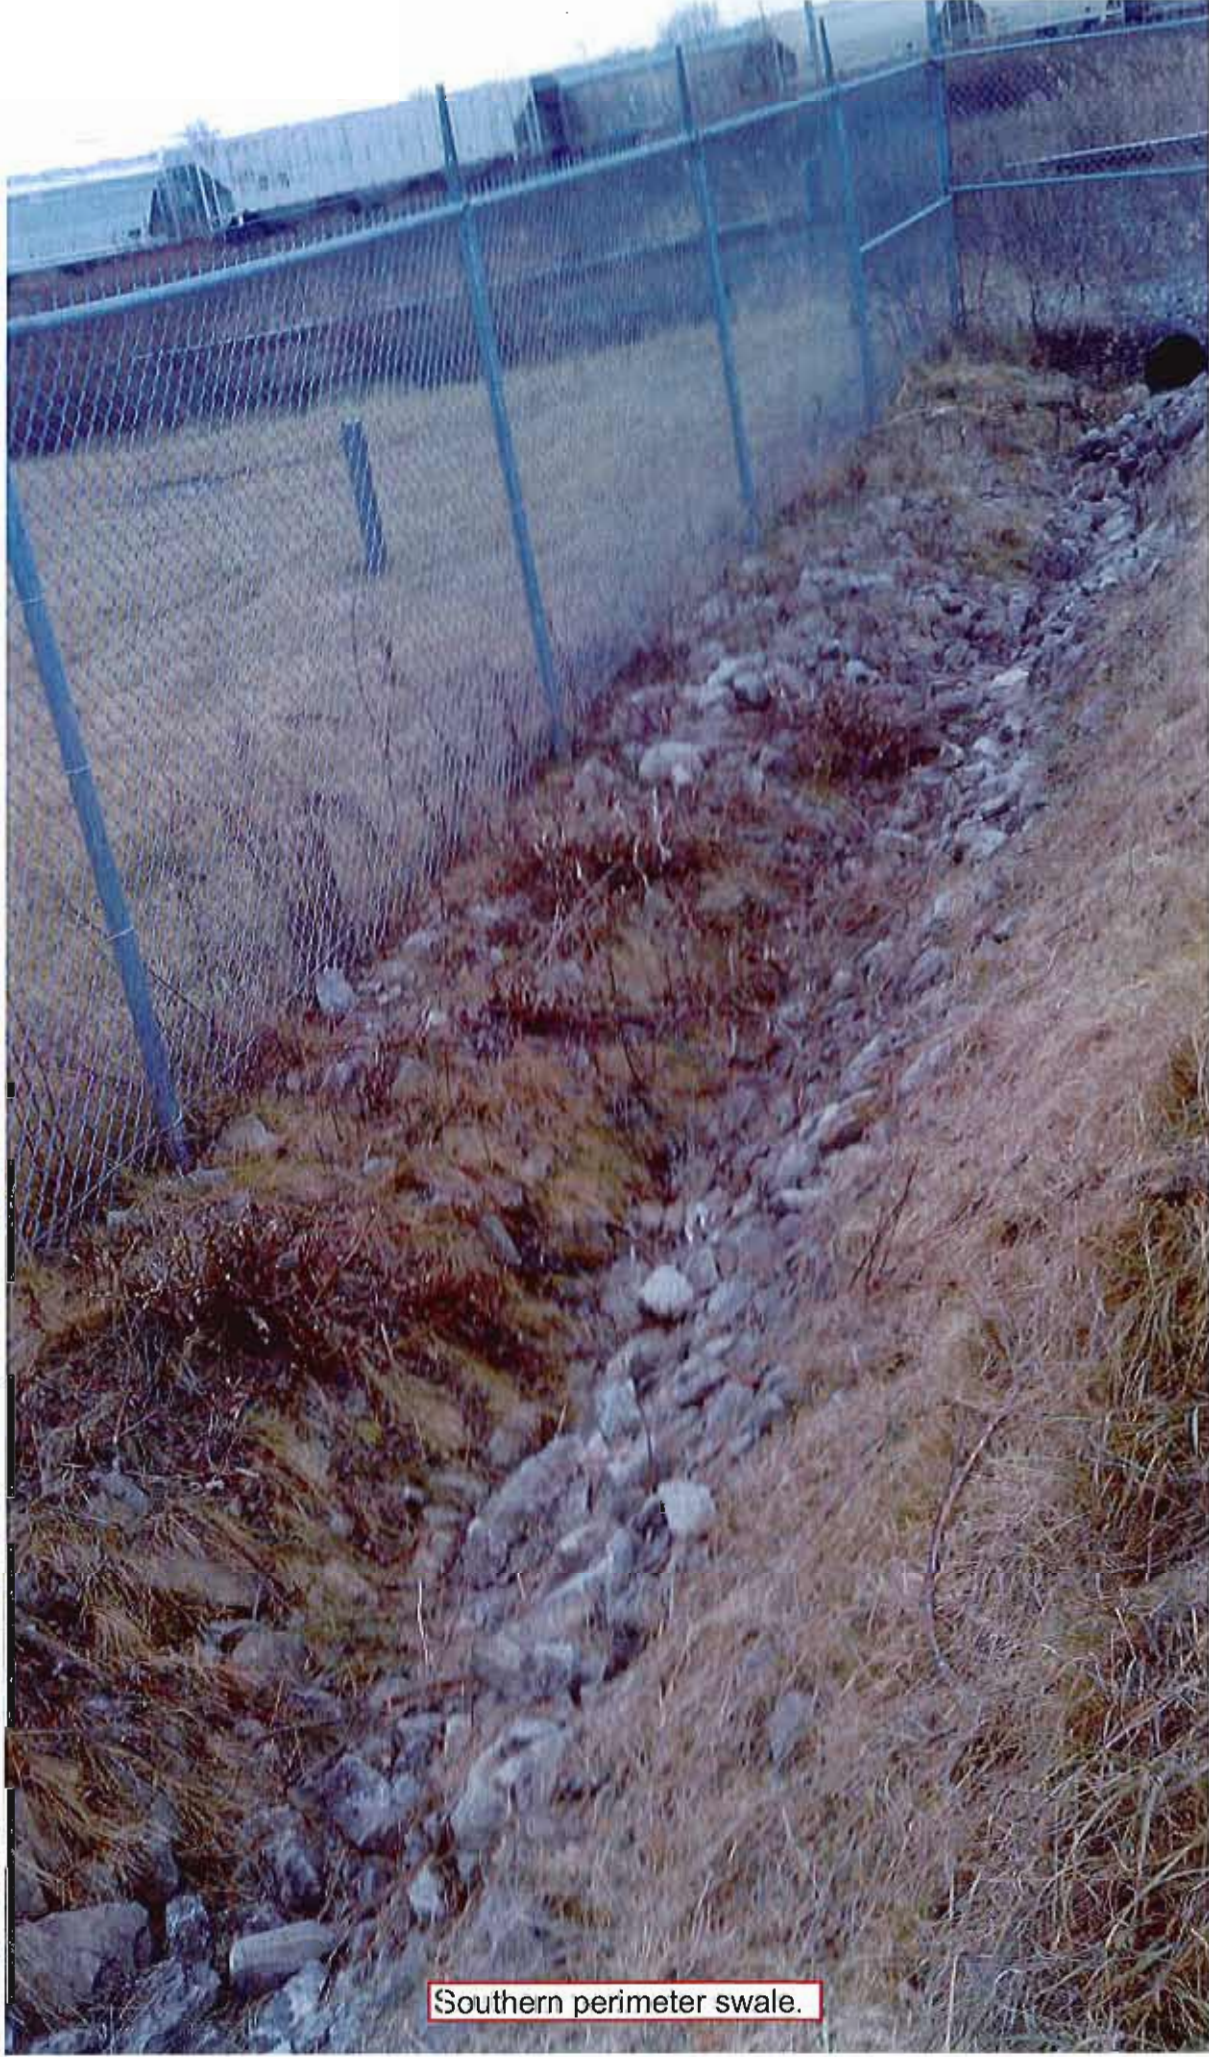
Southern perimeter swale.

3. As of 12/23/11 the City has removed all plants in the perimeter swale down to the base of the plants.
4. As of 12/23/11 the City has removed all rock and stone that collapsed into the drainage inlets near the site gate.

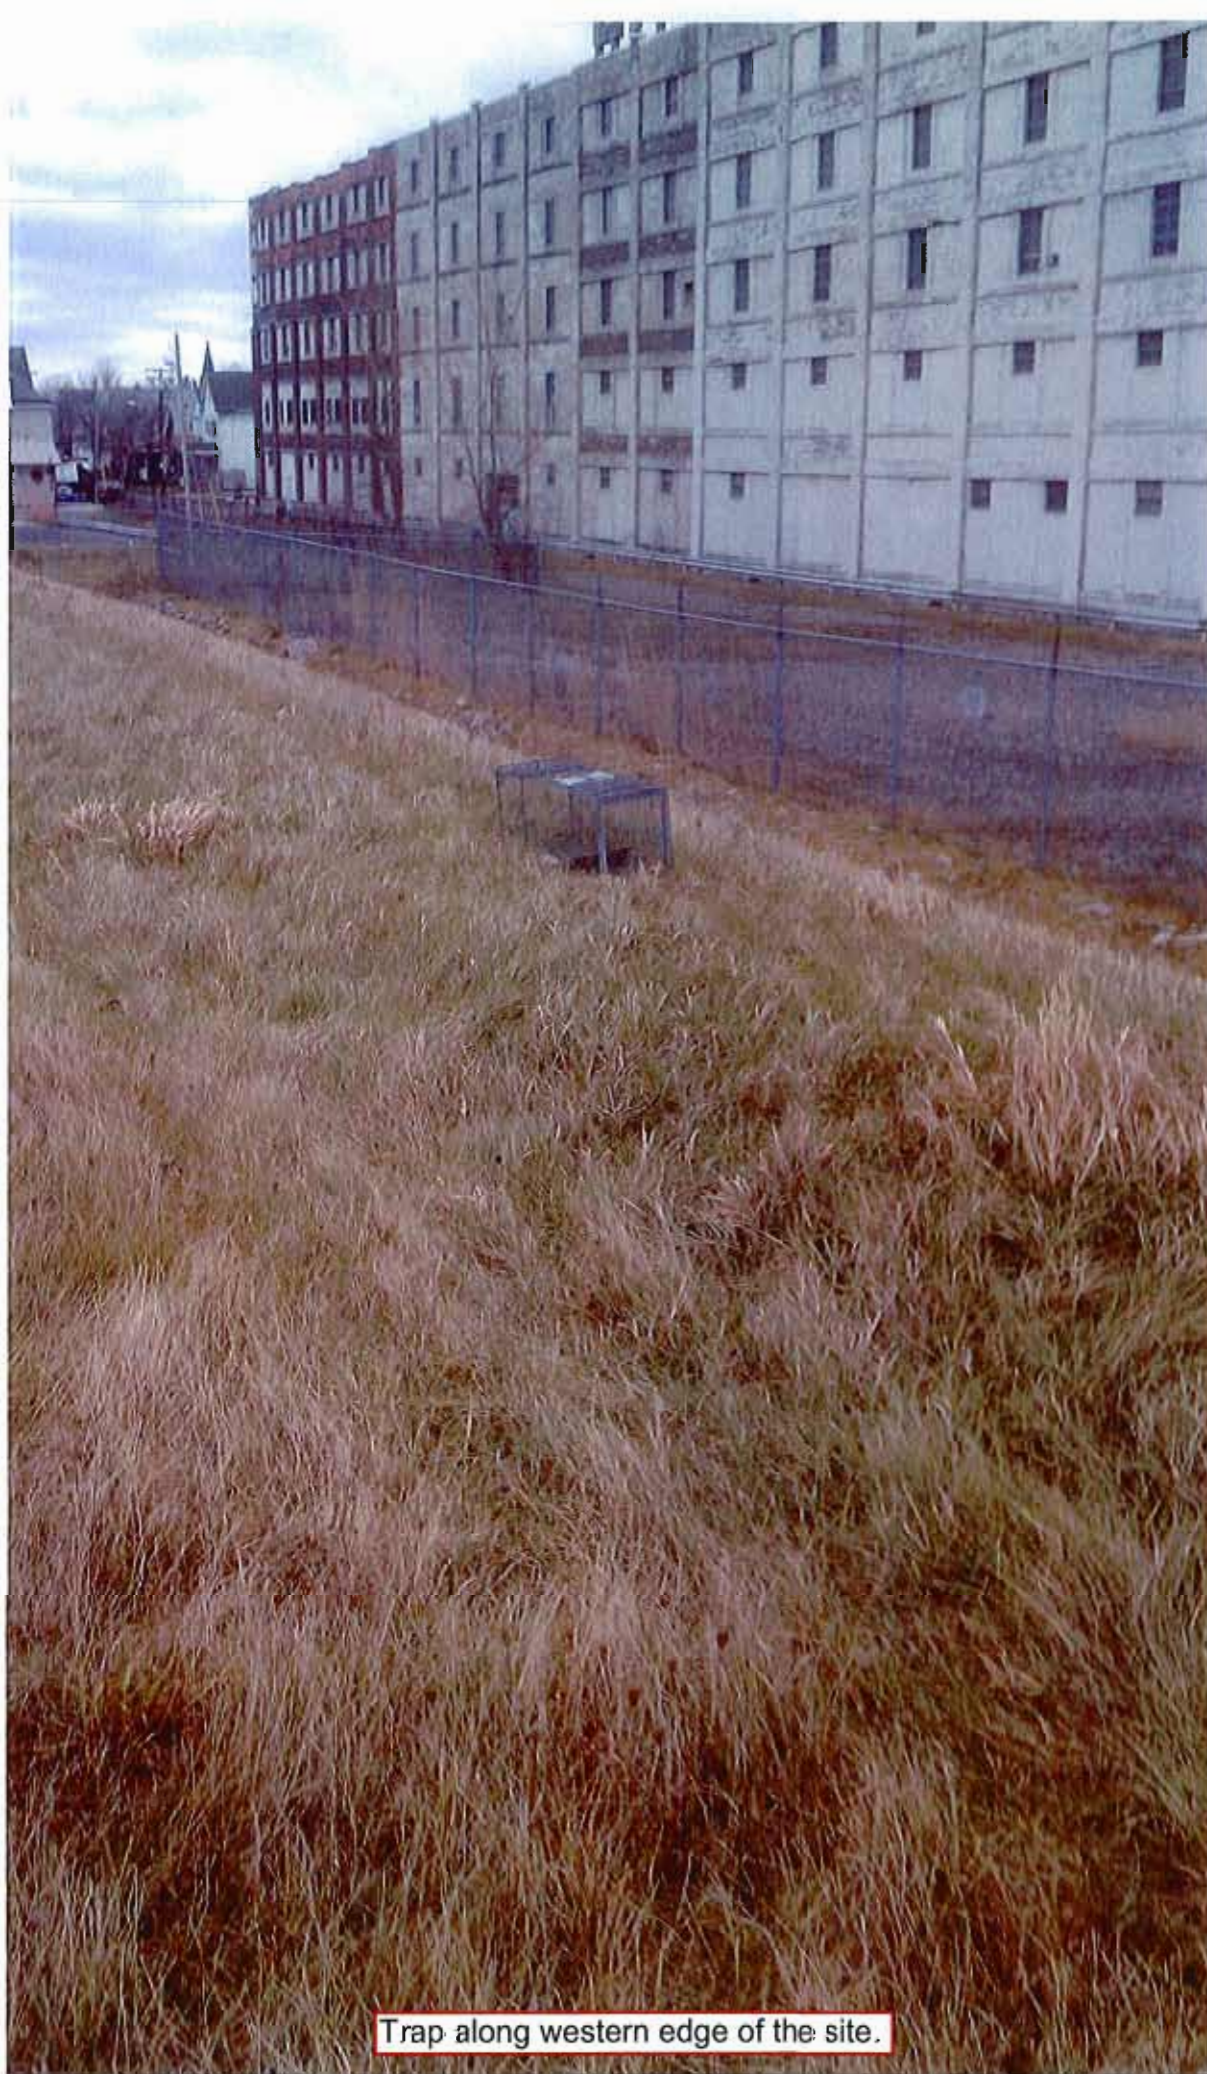
Trap along western edge of the site.

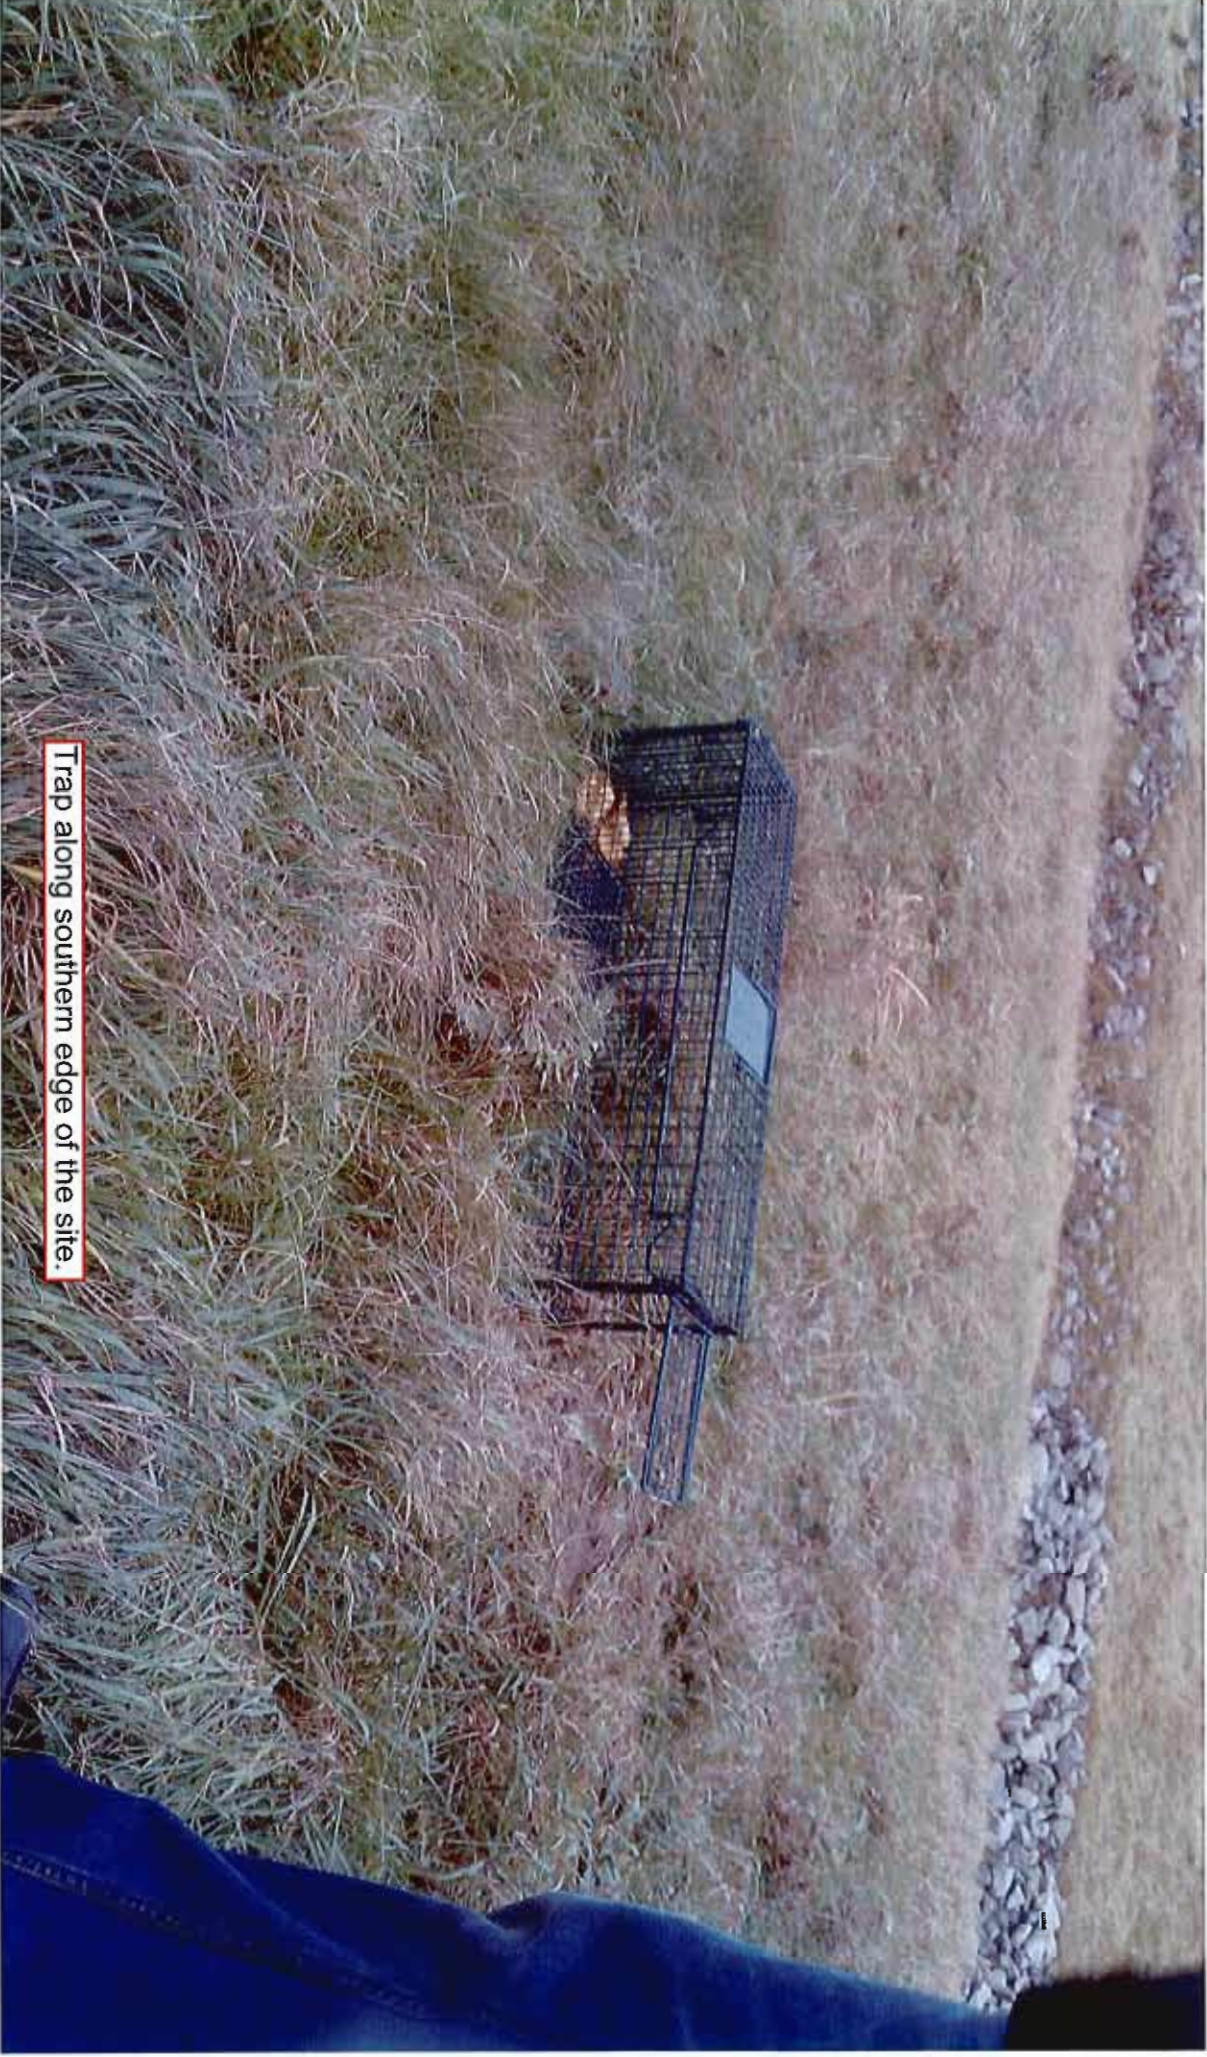
Trap along southern edge of the site.
