**SHEET PILE WALL
CONSTRUCTION COMPLETE REPORT**

**IROQUOIS GAS/WESTWOOD PHARMACEUTICAL SITE
BUFFALO, NEW YORK**

RETEC Project No. 1-2700-300

MARCH 1997

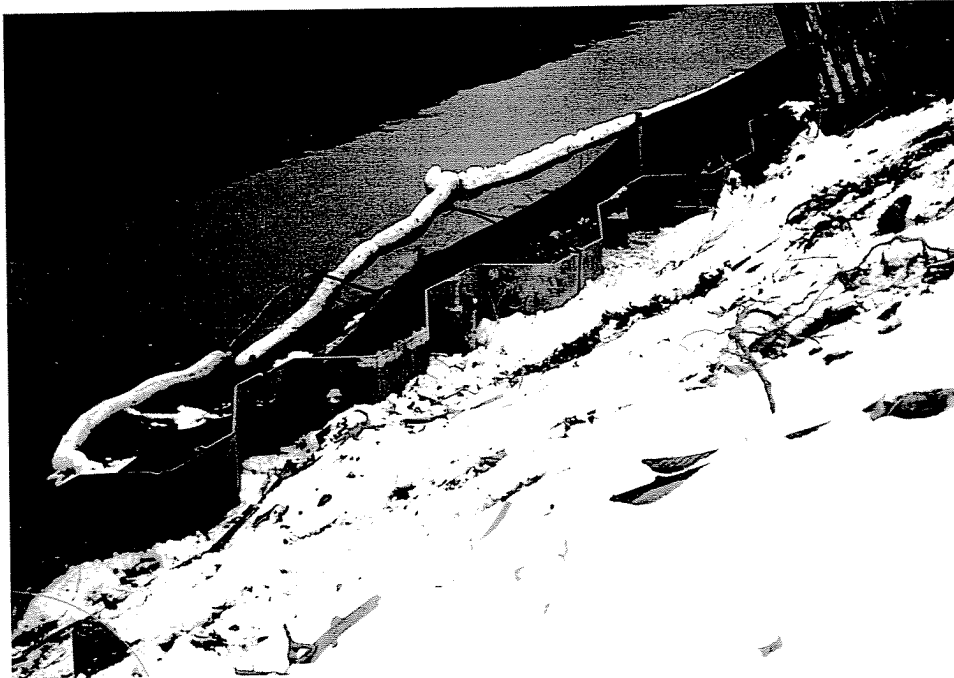
Figure 2
Top of wall prior to backfill

- Significant soil subsidence occurred around the sheets during installation, causing up to 18 inches of sheet face to remain exposed after being driven to the appropriate approximate top elevation. This is evident from the exposed steel along the water's edge (see Figure 2). To avoid sharp metal edges and a low top elevation, Severson (at the request of RETEC and NFG) backfilled the cavity behind the wall with clean fill rather than cut the sheets off at grade as described in the Contract Documents.

- Due to the high water table, the sheet pile joints were grouted with bentonite pellets ($K=1.5 \times 10^{-9}$ cm/sec) rather than cement grout. The pellets rapidly sank and then swelled, filling all voids. Approximately one 5 gallon bucket of pellets was used per joint; this volume corresponds with the calculated minimum required volume. Prior to backfilling behind the sheets, each joint was inspected and found

to be satisfactorily sealed. Standing water was observed to be puddling behind the wall within two or three days of grouting.

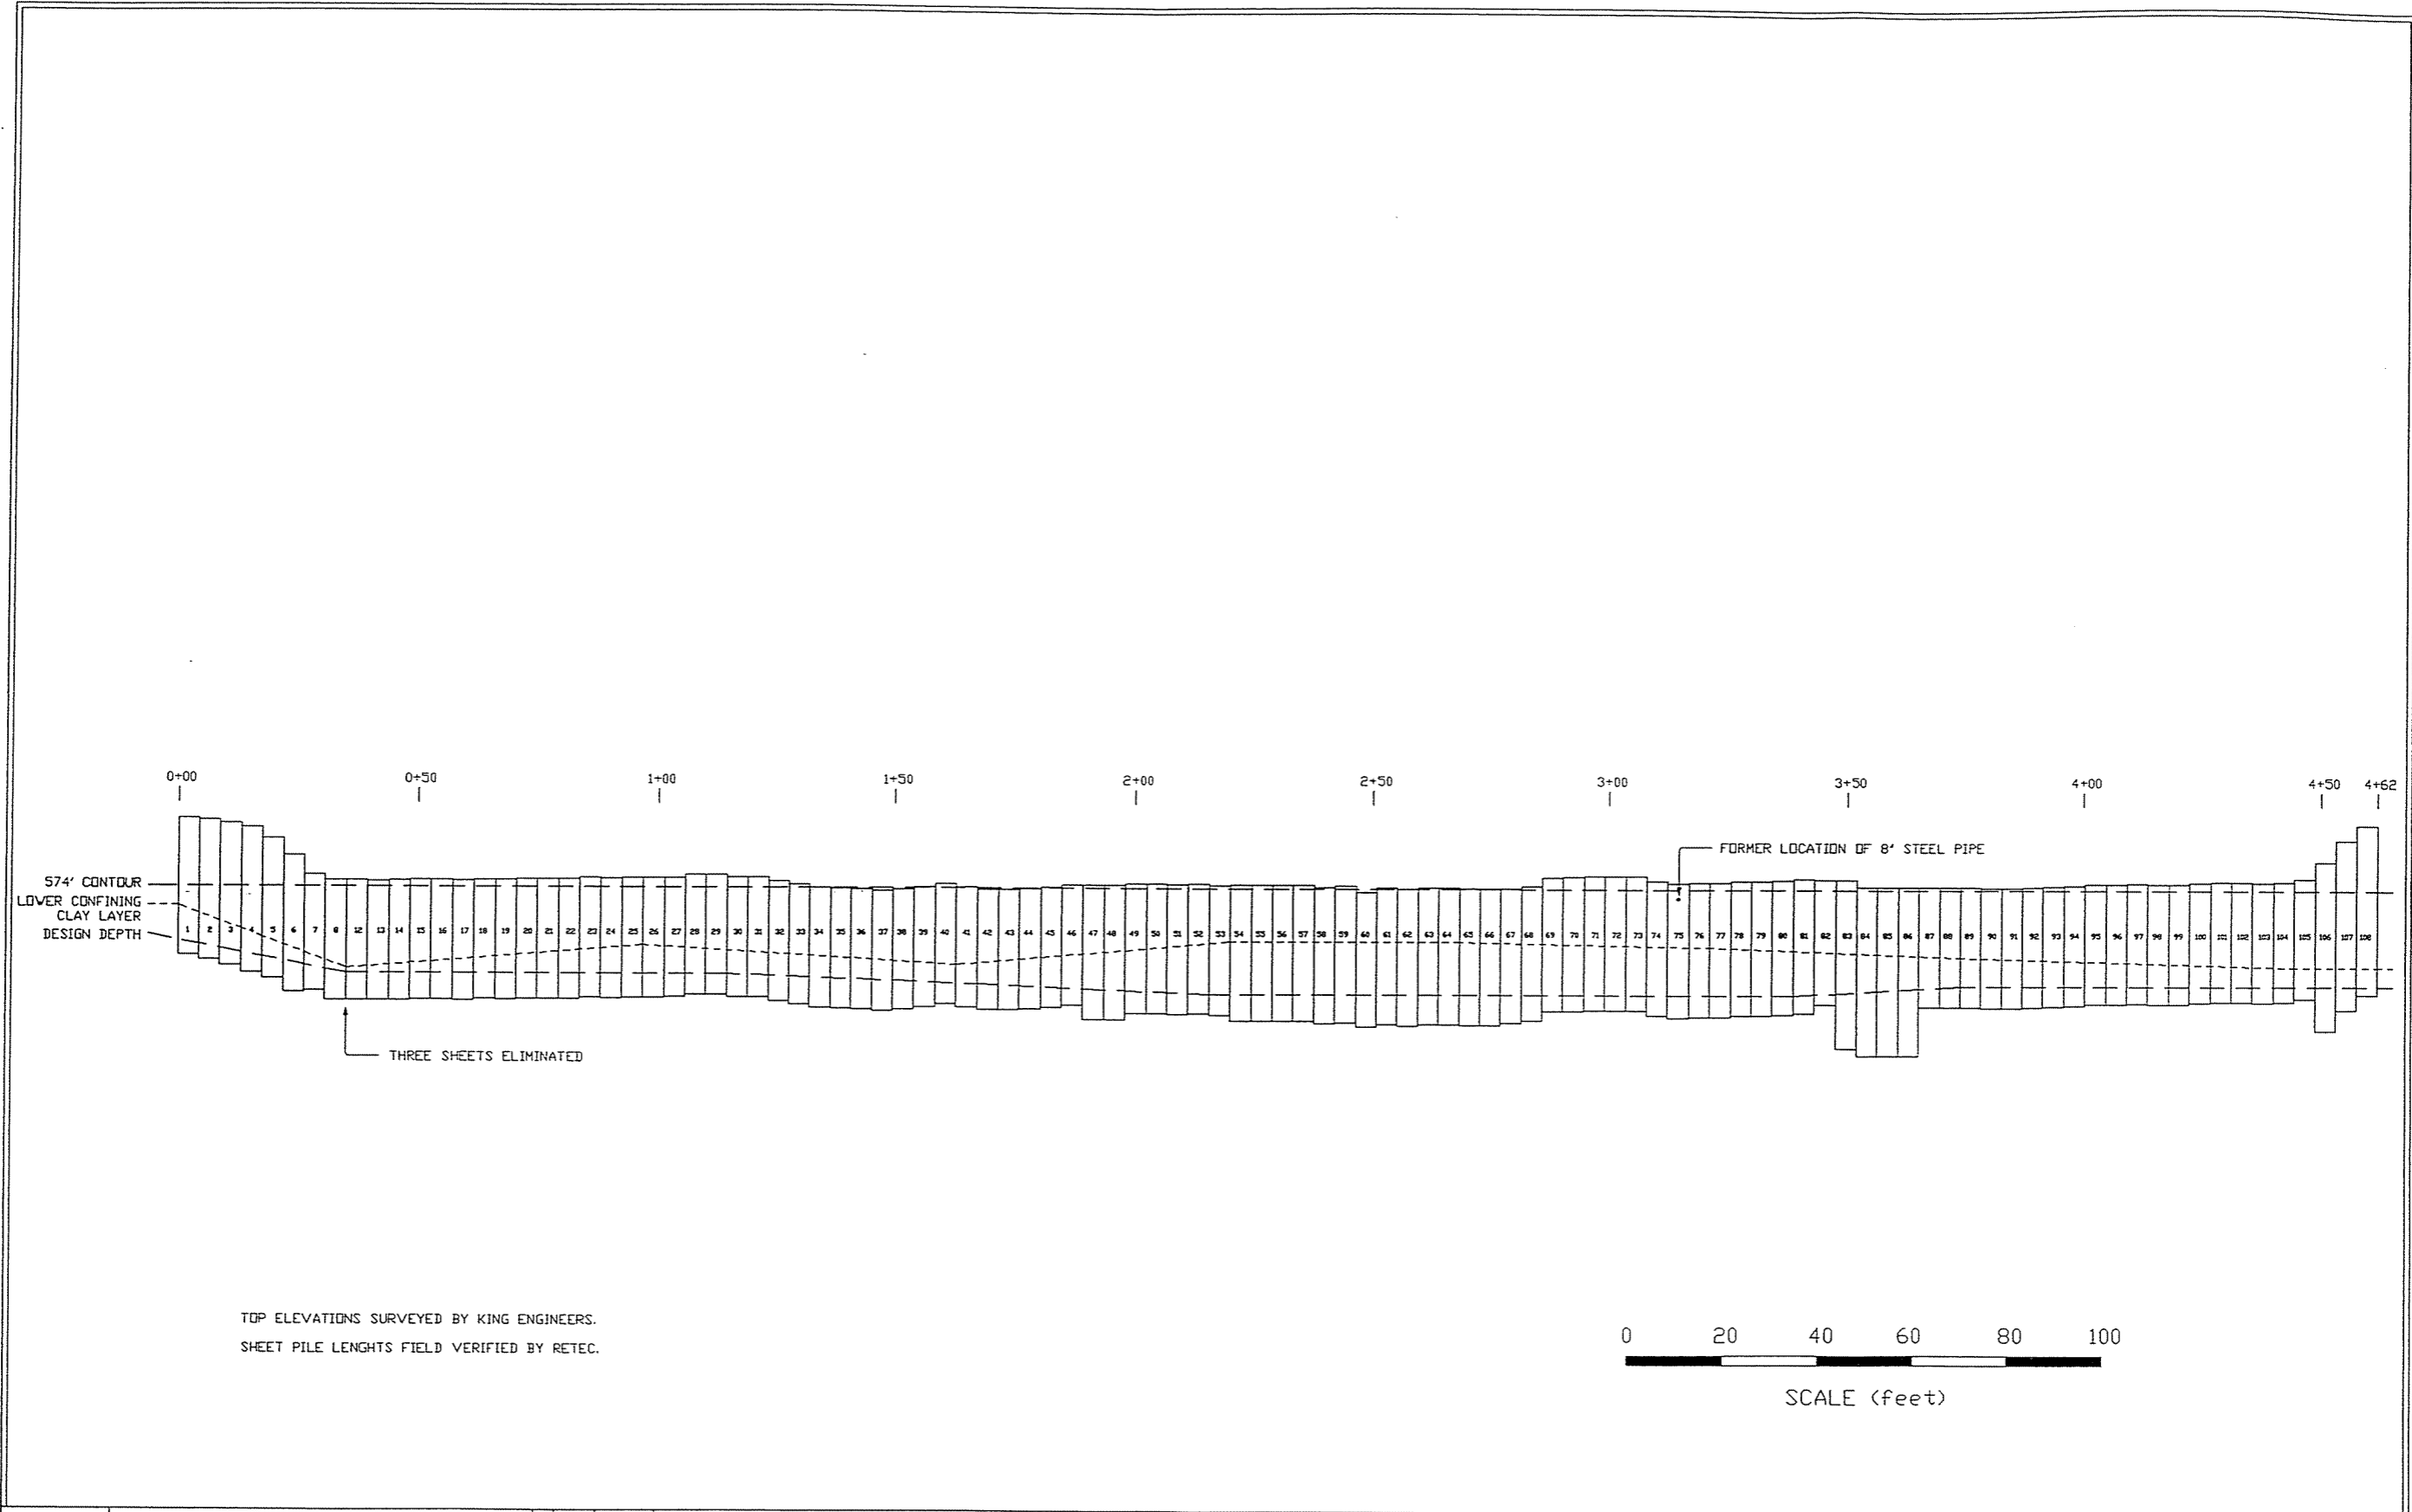
SCAJAQUADA CREEK
SHEET PILE WALL
AS-BUILT PROFILE

- The Contract Documents specified sheet piles (excluding wing walls) to be installed on the 574' contour and driven to grade. Actual top elevation of these piles, as-built, varies from 573.32' to 576.90' depending on bank stability and steepness.
