# Construction Complete Report

## Northern DNAPL Recovery System

### Scajaquada Creek Remediation Project Buffalo, New York

November 30, 2001

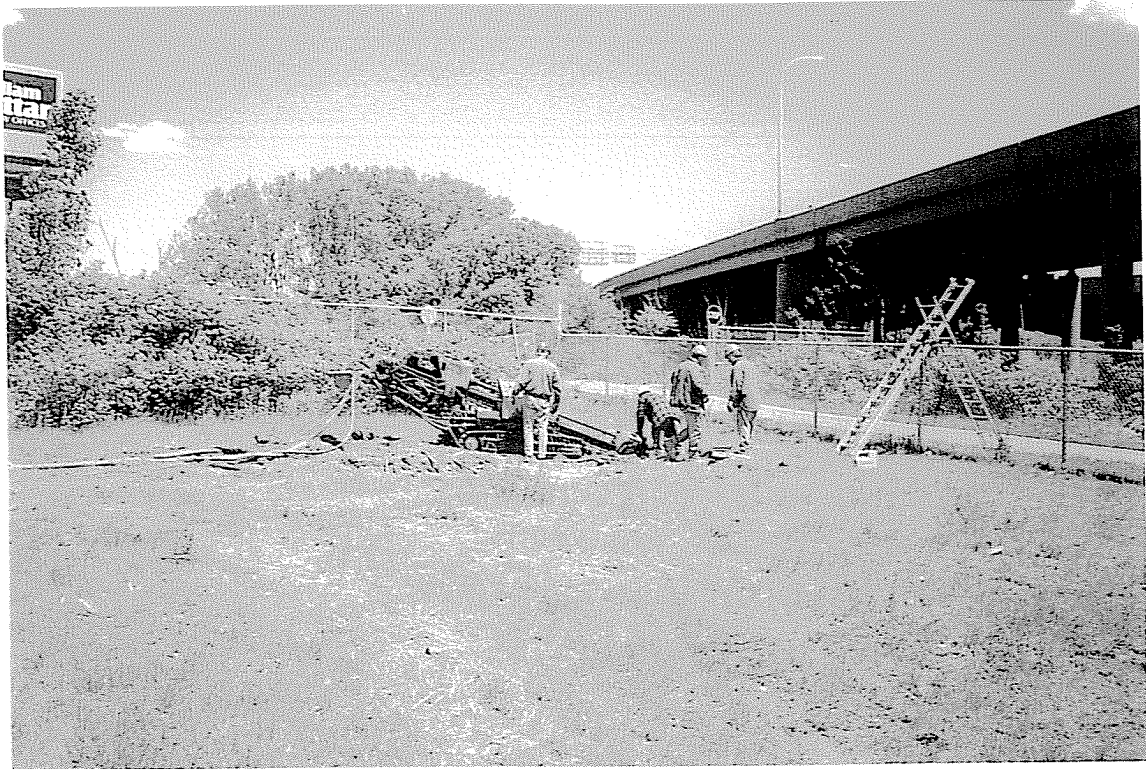
1A. Directional drilling to target area.

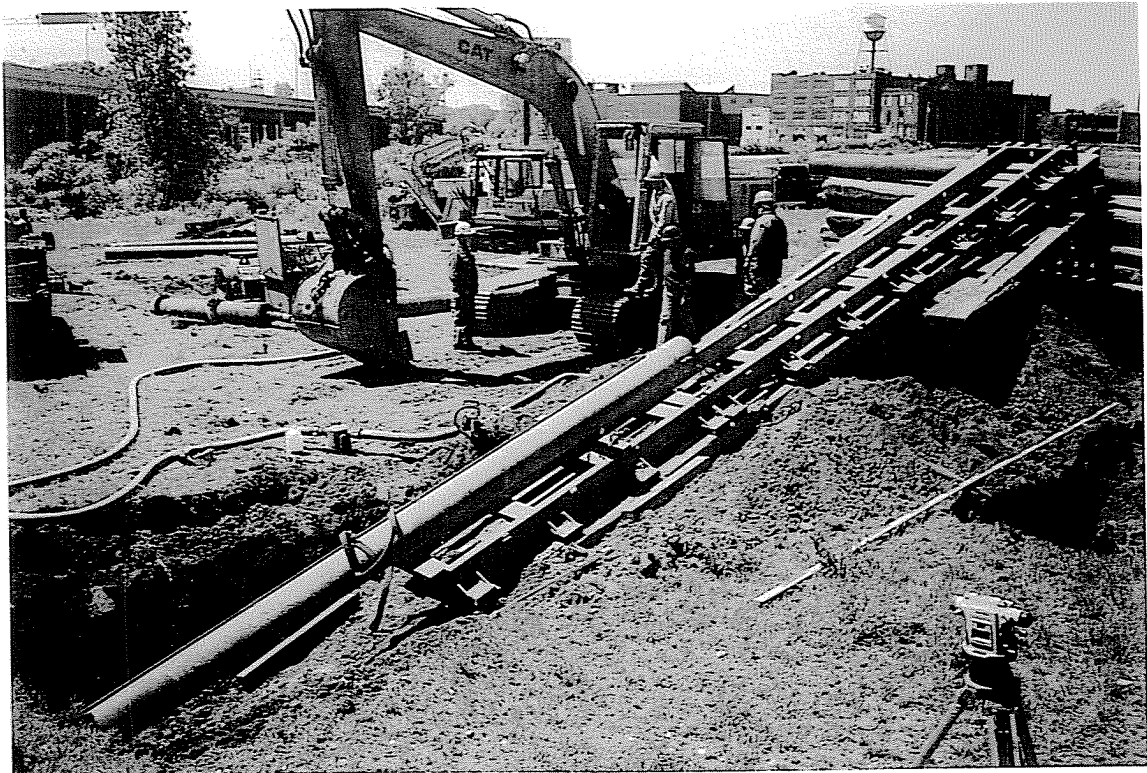
1B. Driving 12-inch casing over directional drill string.

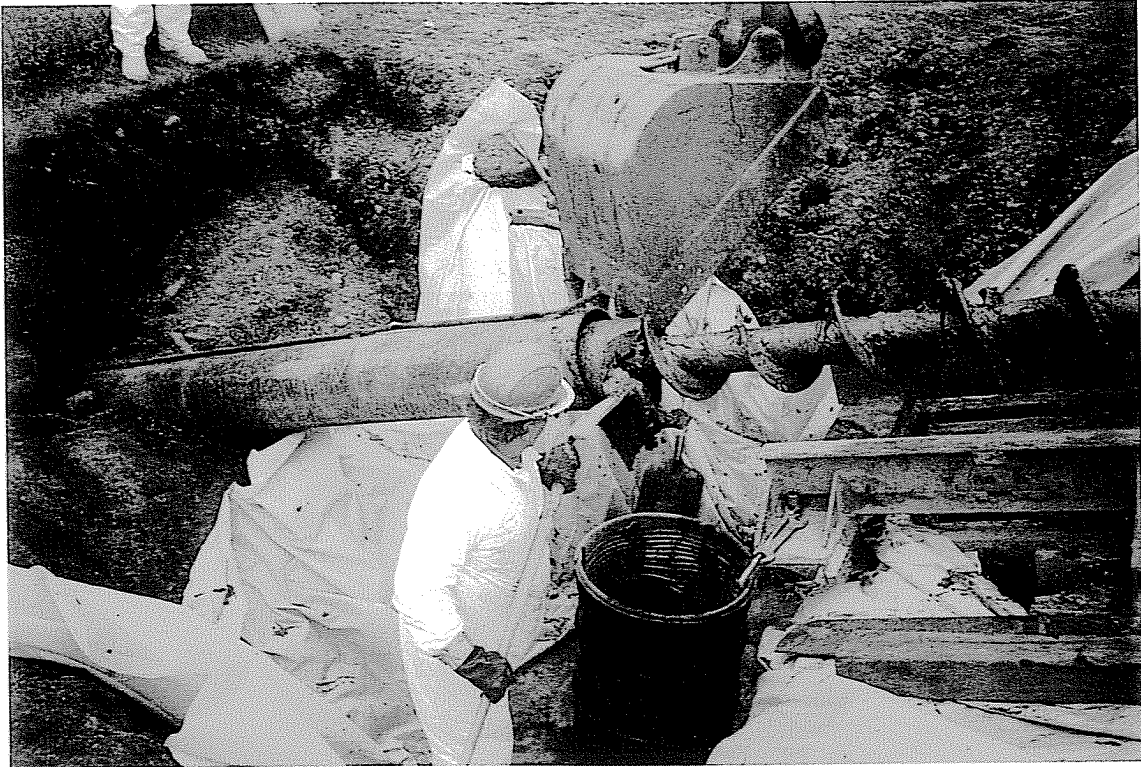
2A. Containerizing drill cuttings.

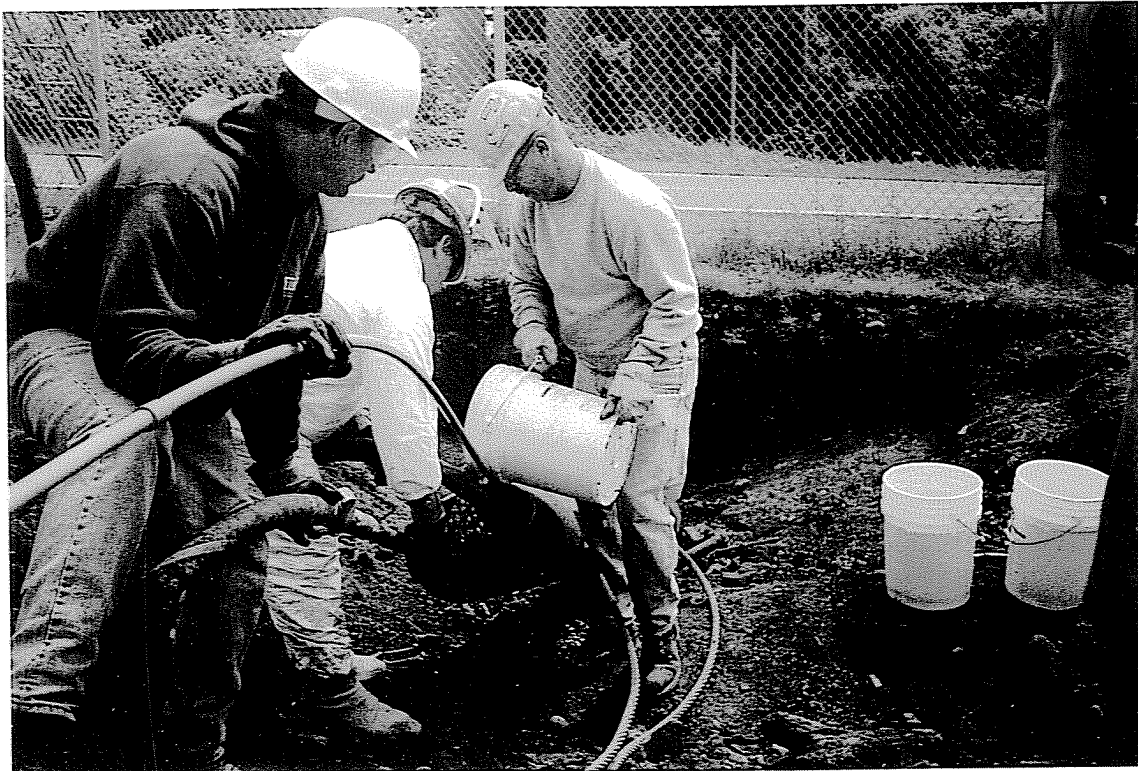
2B. Installing well materials.

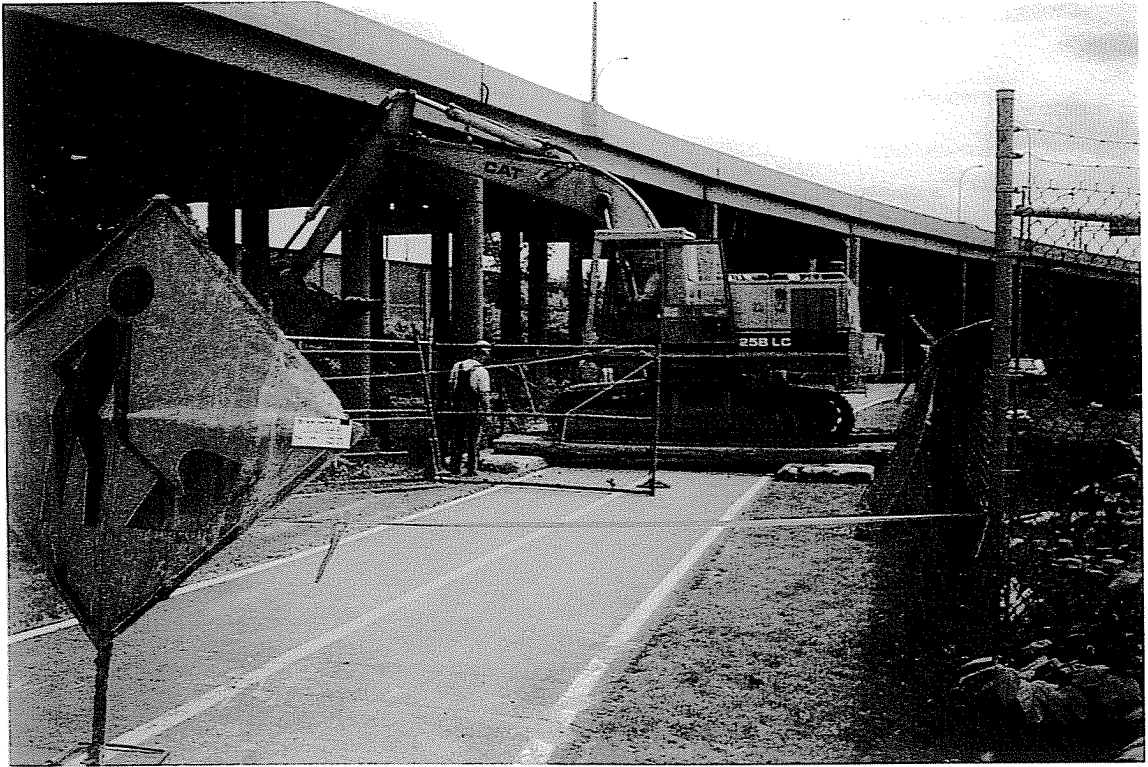
3A. Preparing for vault excavation.

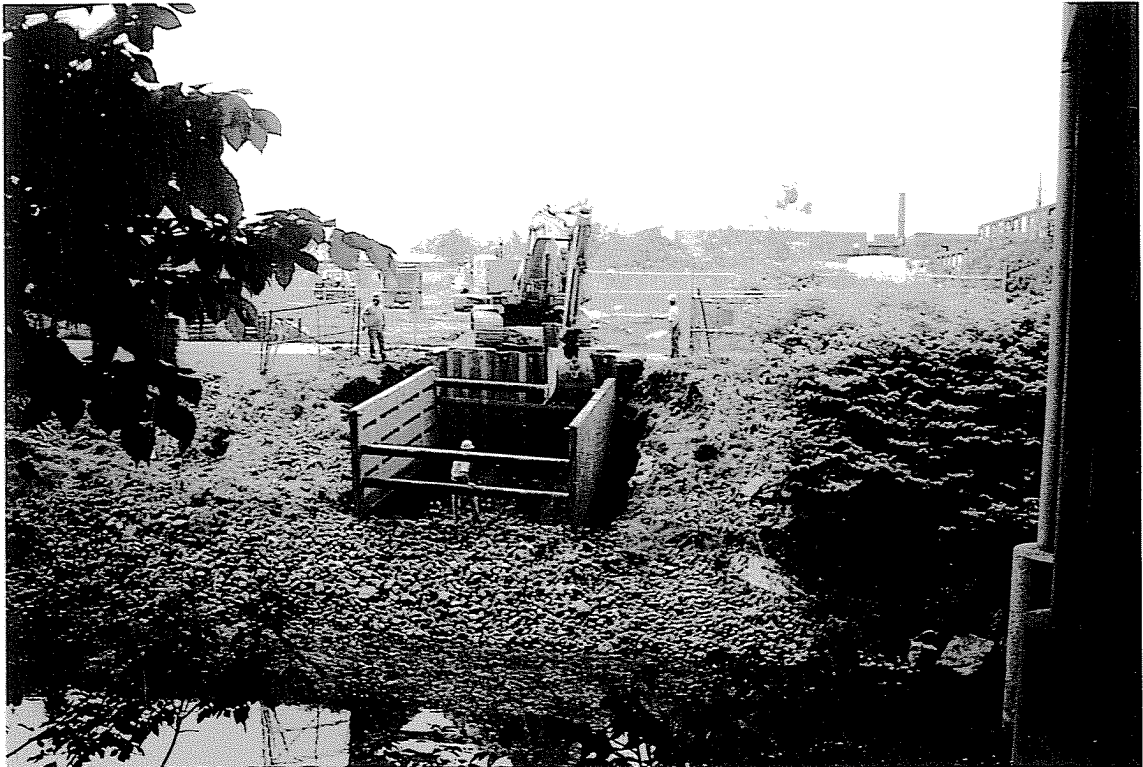
3B. Vault Excavation

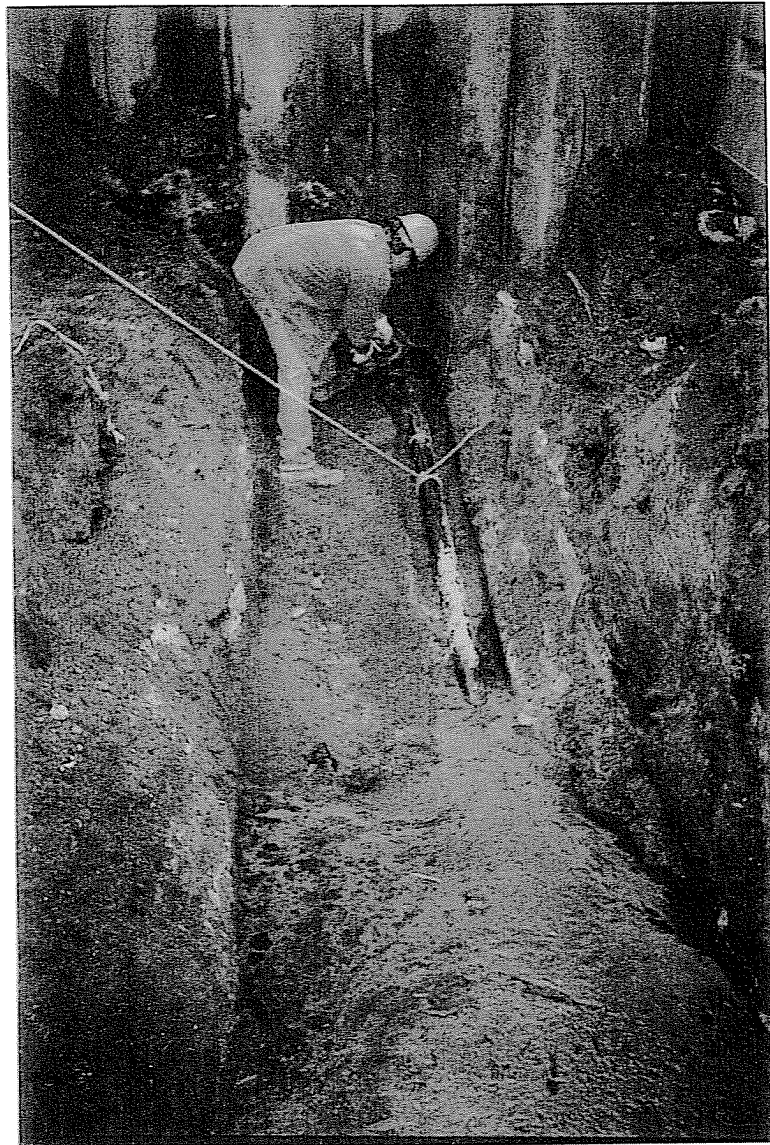
4A. Cutting HDPE pipe.

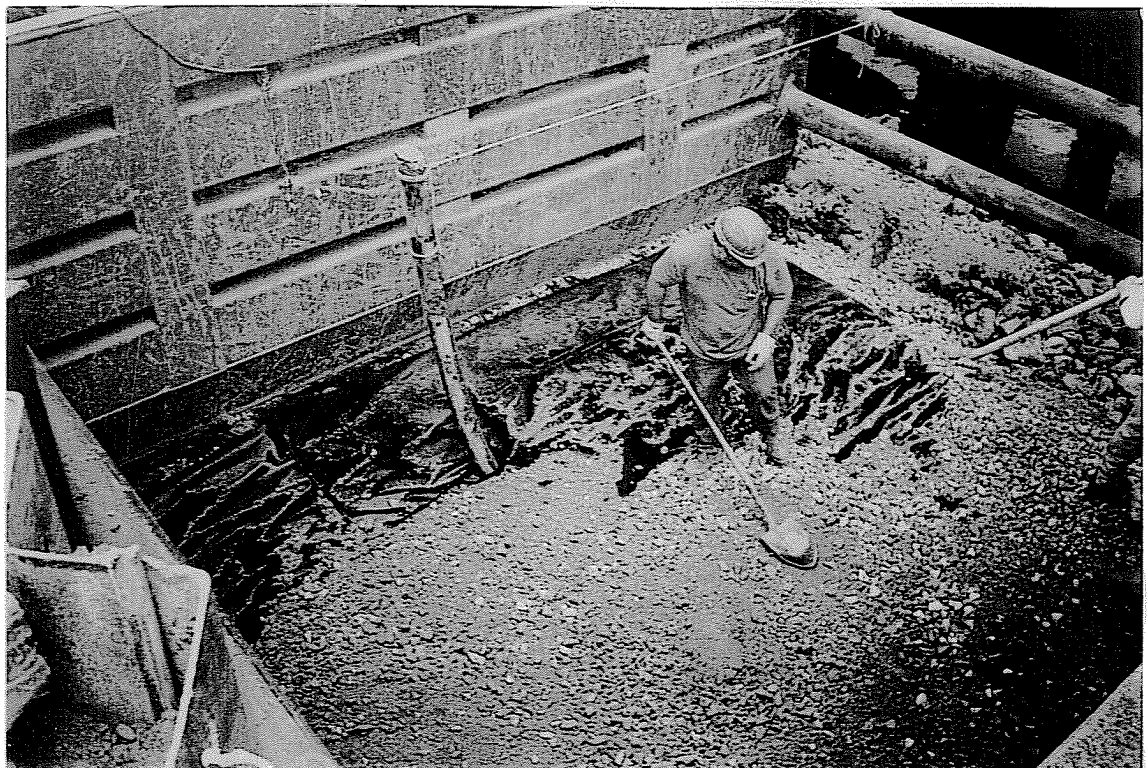
4B. Placing vault sub-base.

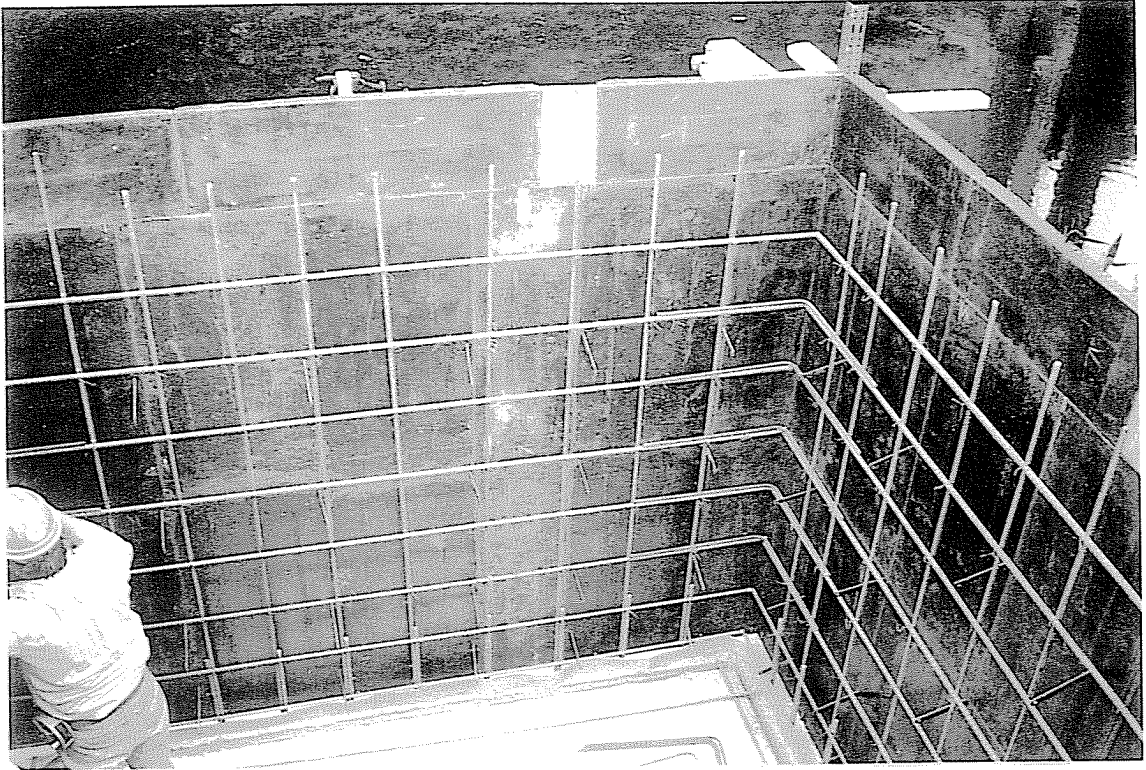
5A. Constructing vault form work.

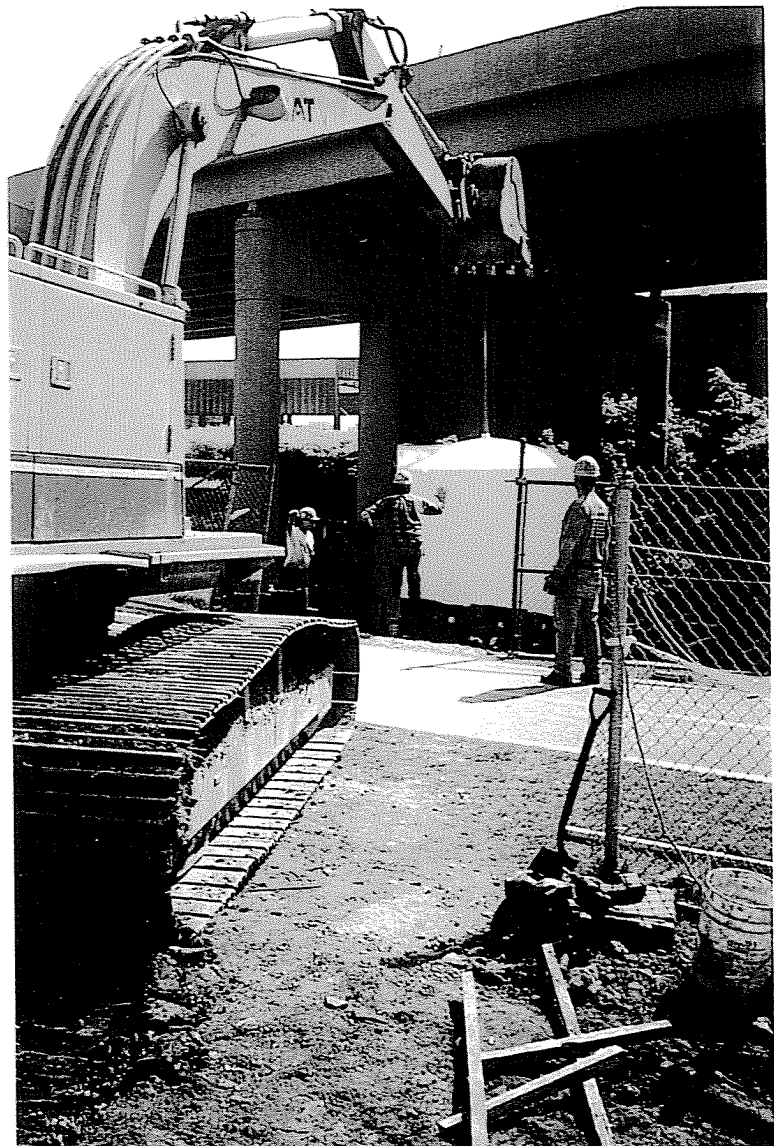
5B. Placing holding tank.

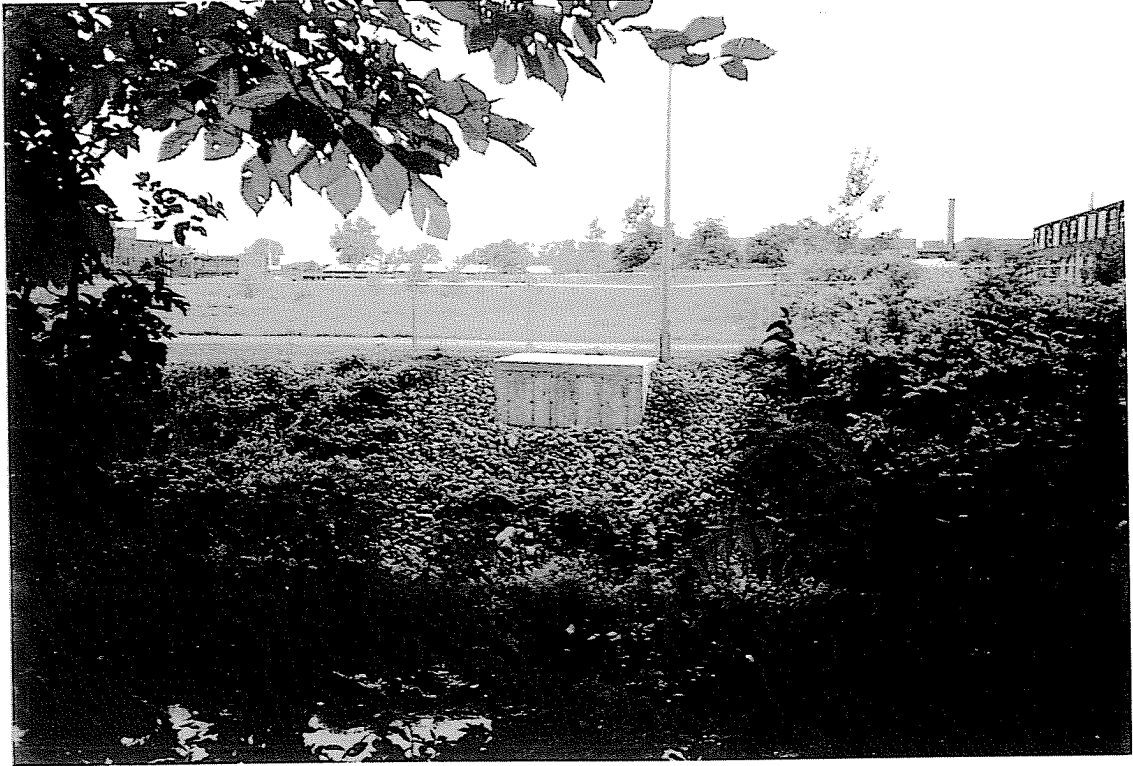
6A. Completed system (from east).

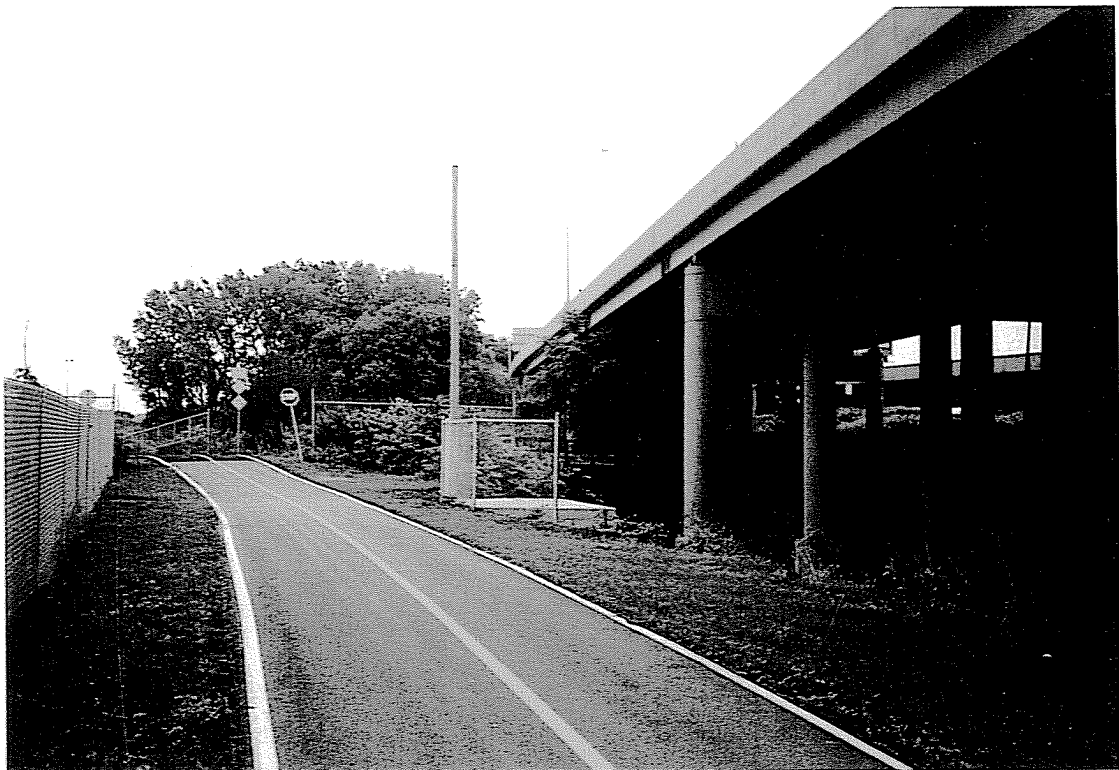
6B. Completed system (from south).
