**ecology and environment
engineering, p.c.**

TASK 2 - ADDITIONAL STUDIES REPORT
FOR THE REMEDIAL DESIGN
NIAGARA TRANSFORMER CORPORATION SITE

NYSDEC Site No. 9-15-146
Contract No. D002625-19

Issued September 1, 1994
Revised October 7, 1994

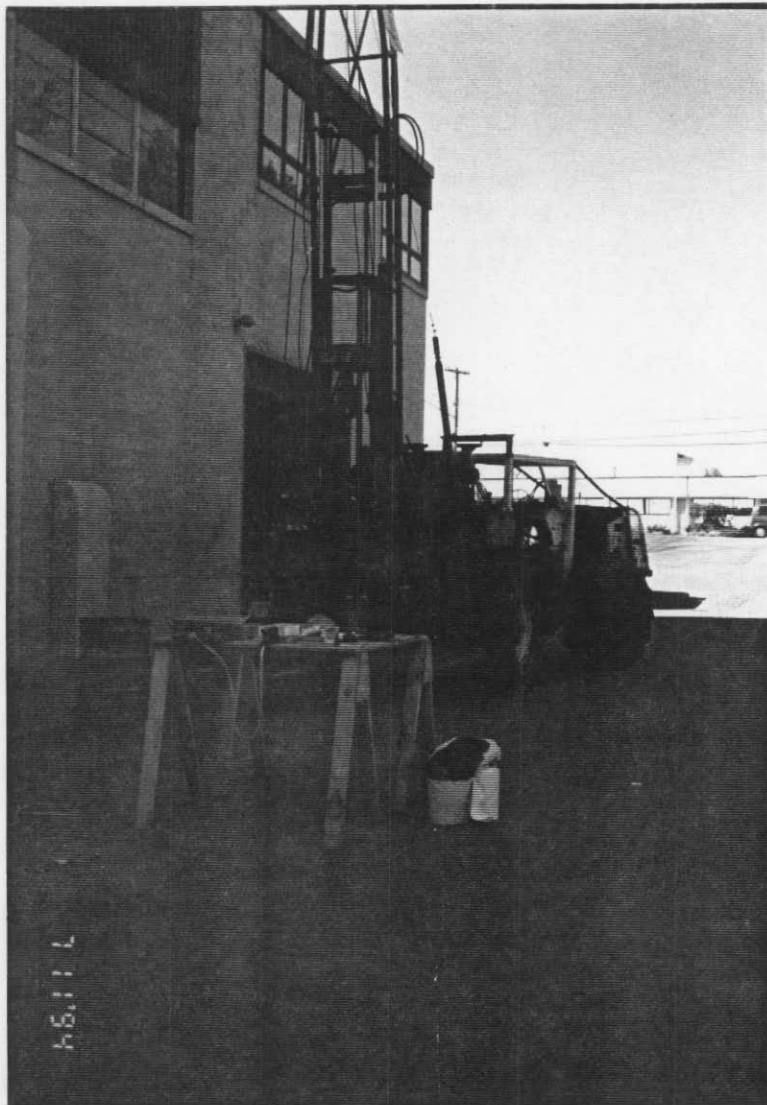
Comments*: Drill rig set up at Borehole-2
 (facing north)

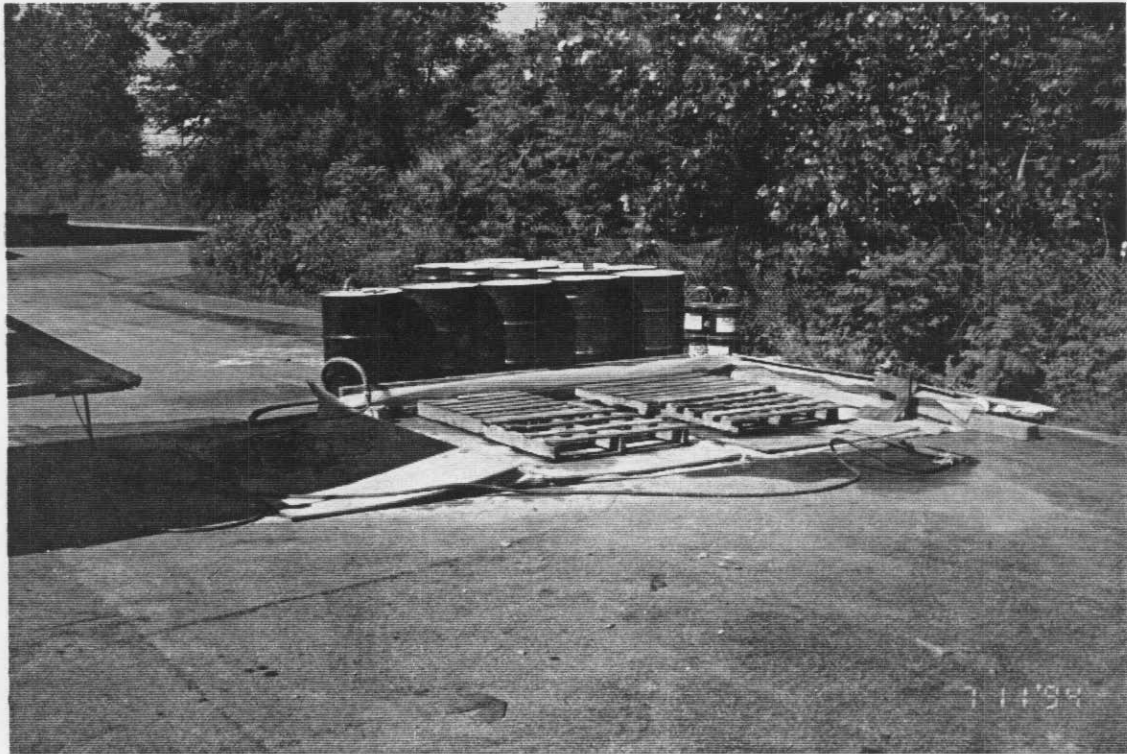
(Decon. pad later upgraded.)

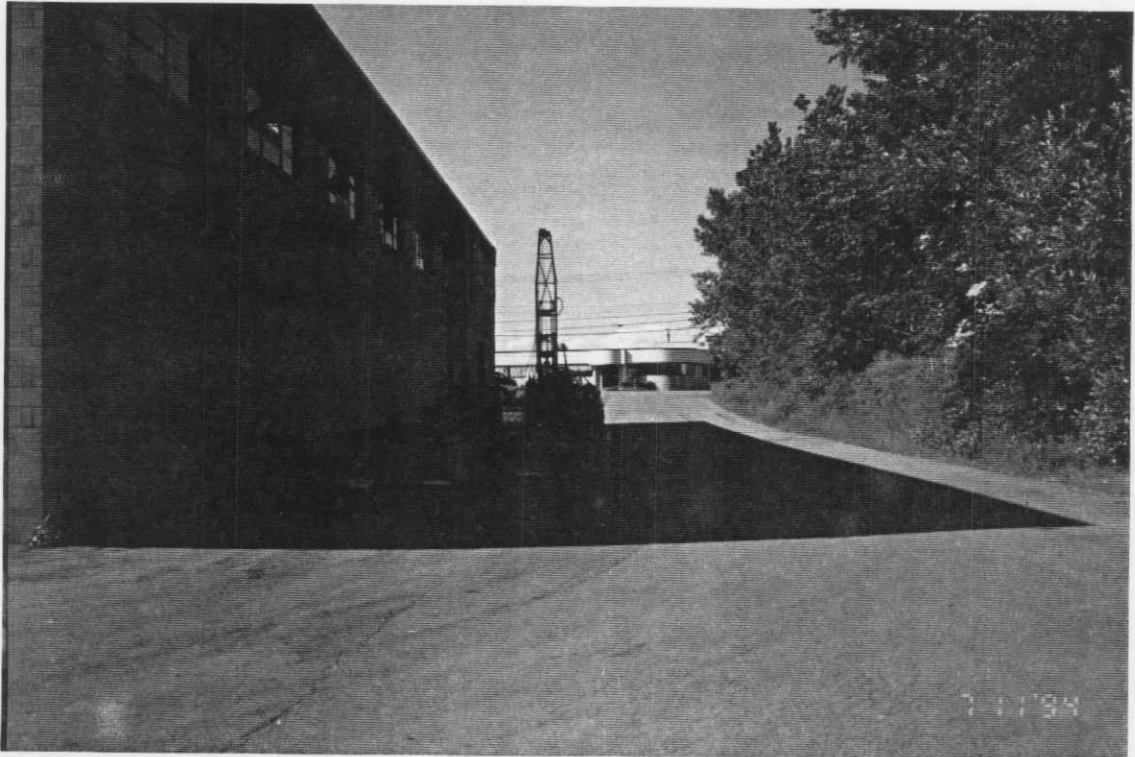
Comments*: East side of main building (facing north).

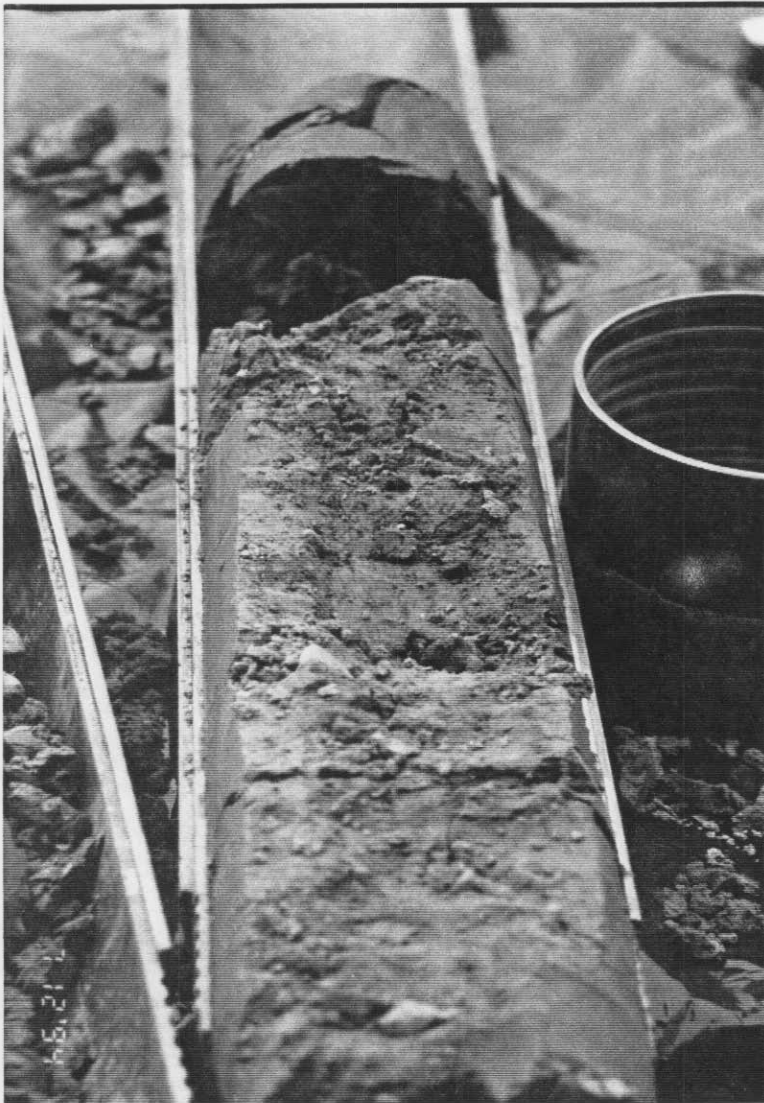
Time: 0910 Frame No.: 4

Comments*: Borehole 4 subsurface soil; 4 to 6-foot interval.

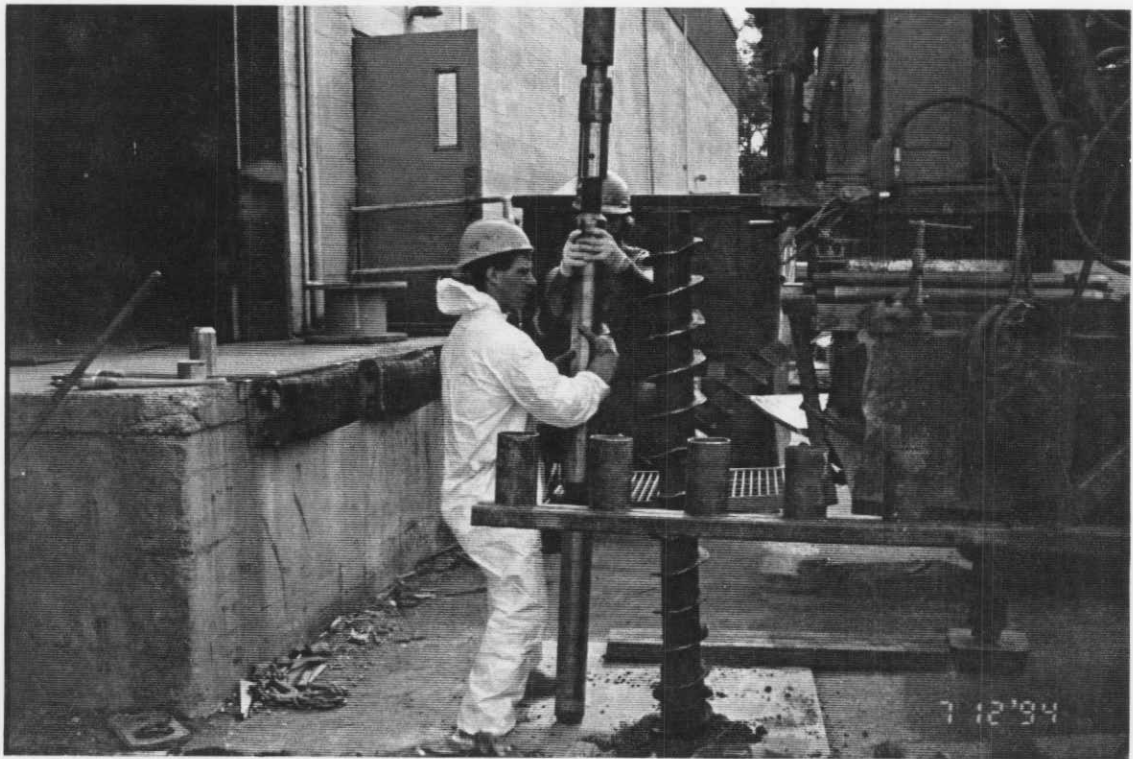
Client: NYSDEC	E & E Job No.: OC5021
Site: Niagara Transformer Site No. 9-15-146	
Camera: Make	SN
Lens Type	SN
	Photographer: Rick Watt Date: 7-12-94
	Time: 0915 Frame No.: 5
	Comments*: Pulling laskey sampler from borehole 4 (facing east).
*Comments to include location.

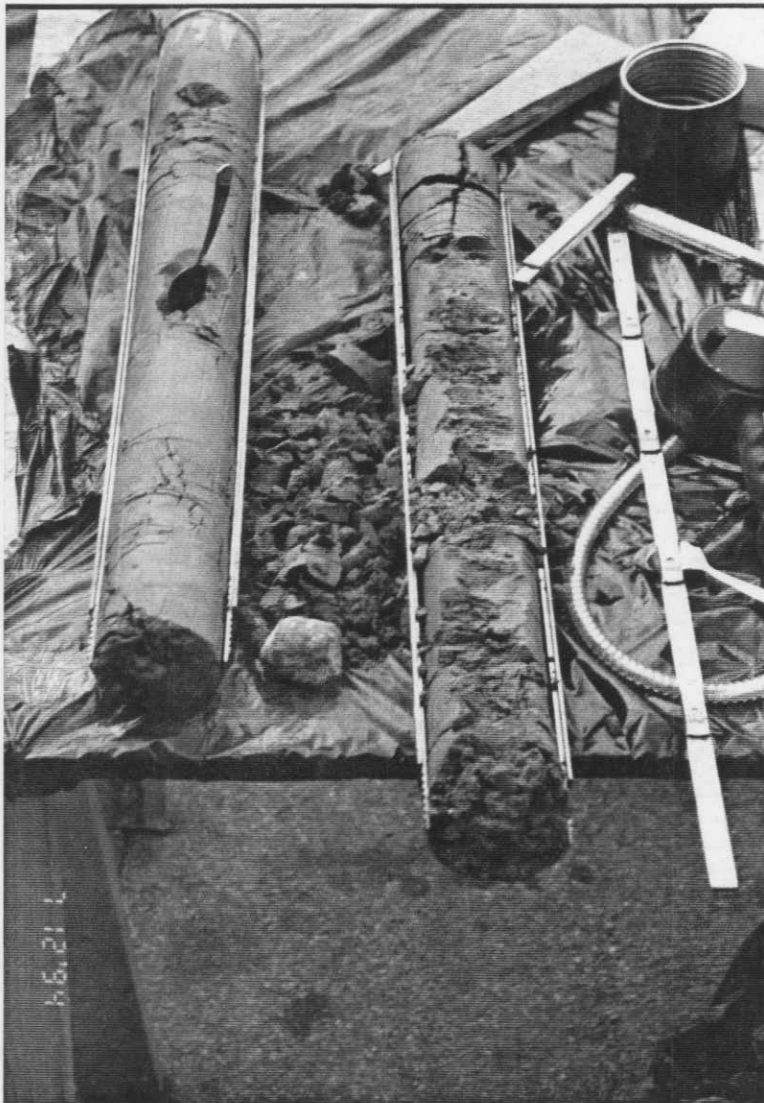
Time: 0945 Frame No.: 6

Comments*: Borehole 4 subsurface soil; 6-foot
(bottom right) to 11-foot (top left) interval.

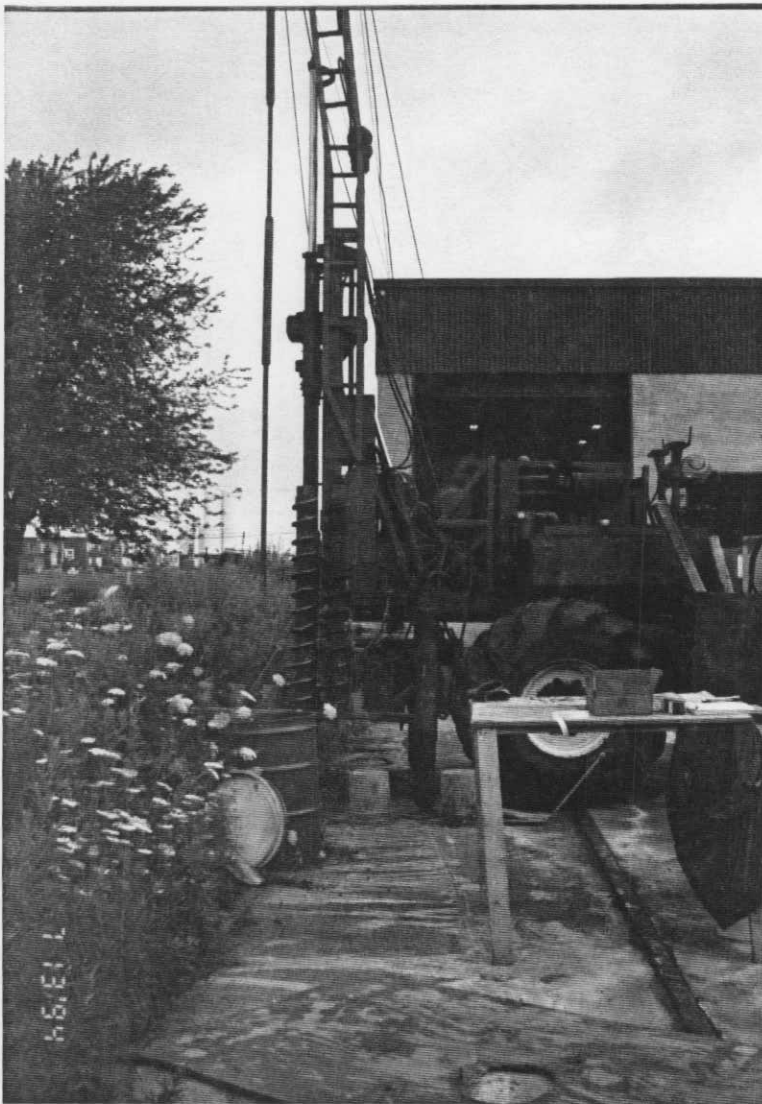
Time: 0915 Frame No.: 7

Comments*: Drill rig set up at Borehole 5 (facing north).

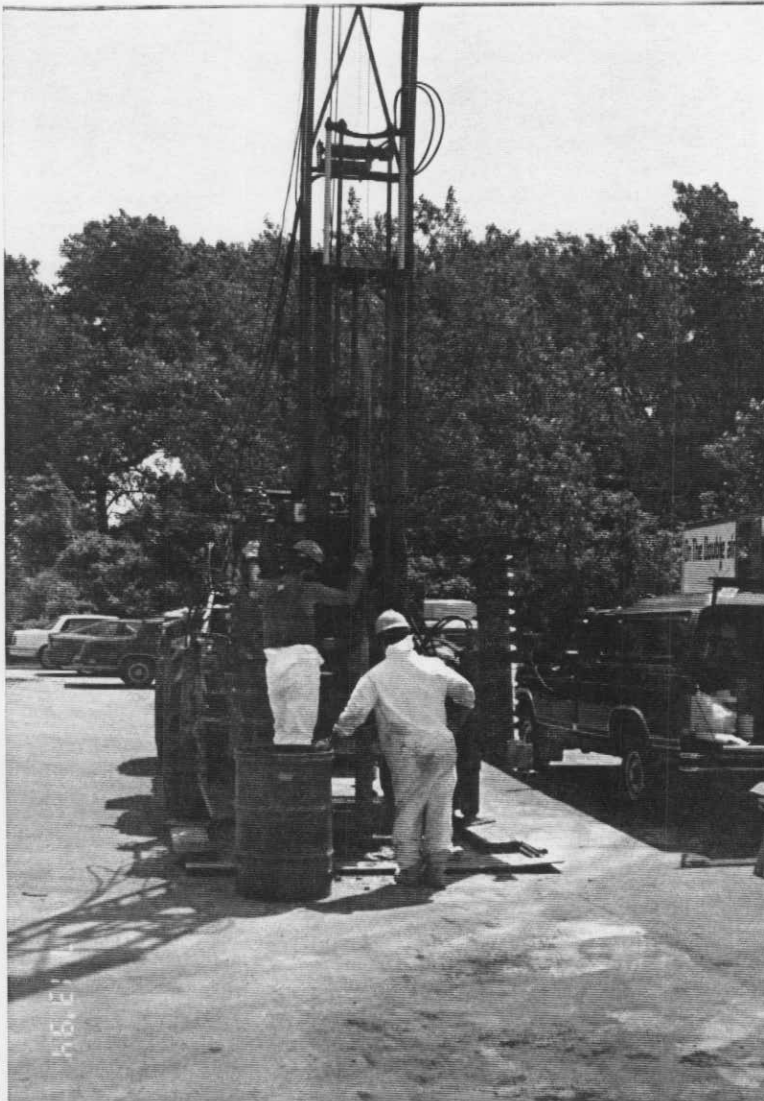
Comments*: Drill rig set up at Borehole 7 (facing east).

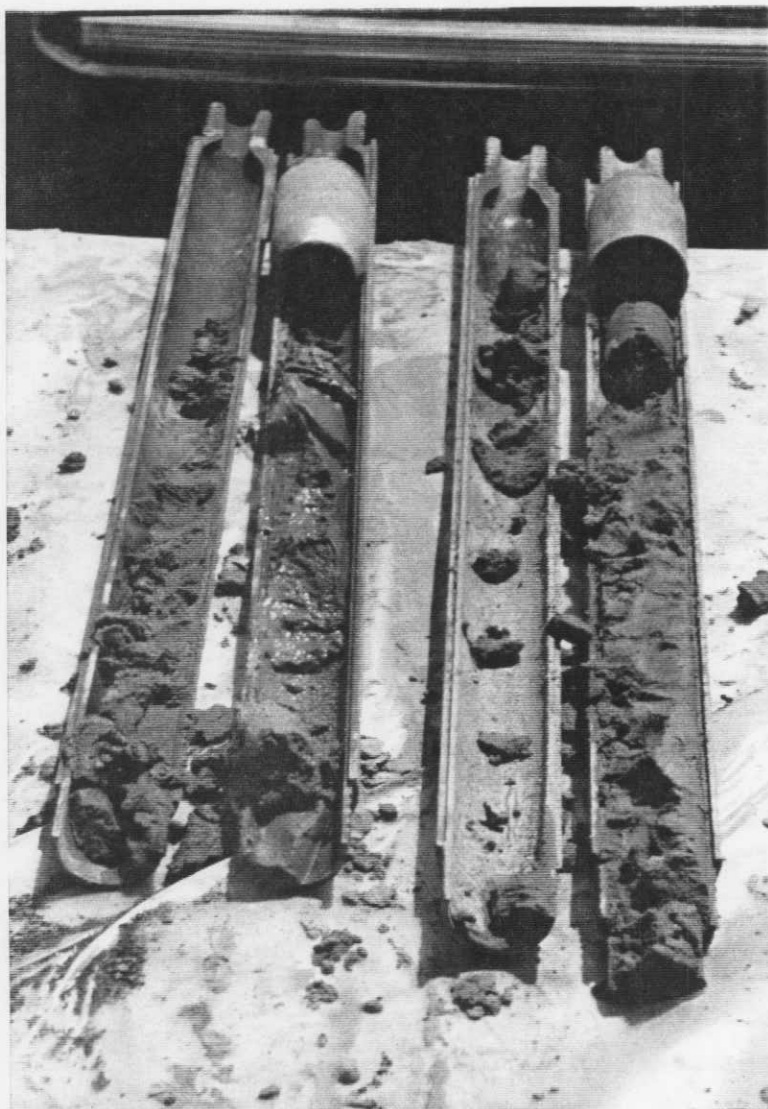
Time: 1152 Frame No.: 9

Comments*: Borehole 7 subsurface soil; upper split-spoon is from the 2- to 4-foot interval (bottom to the right), and the lower split-spoon is from the 4- to 6-foot interval (bottom to the right).

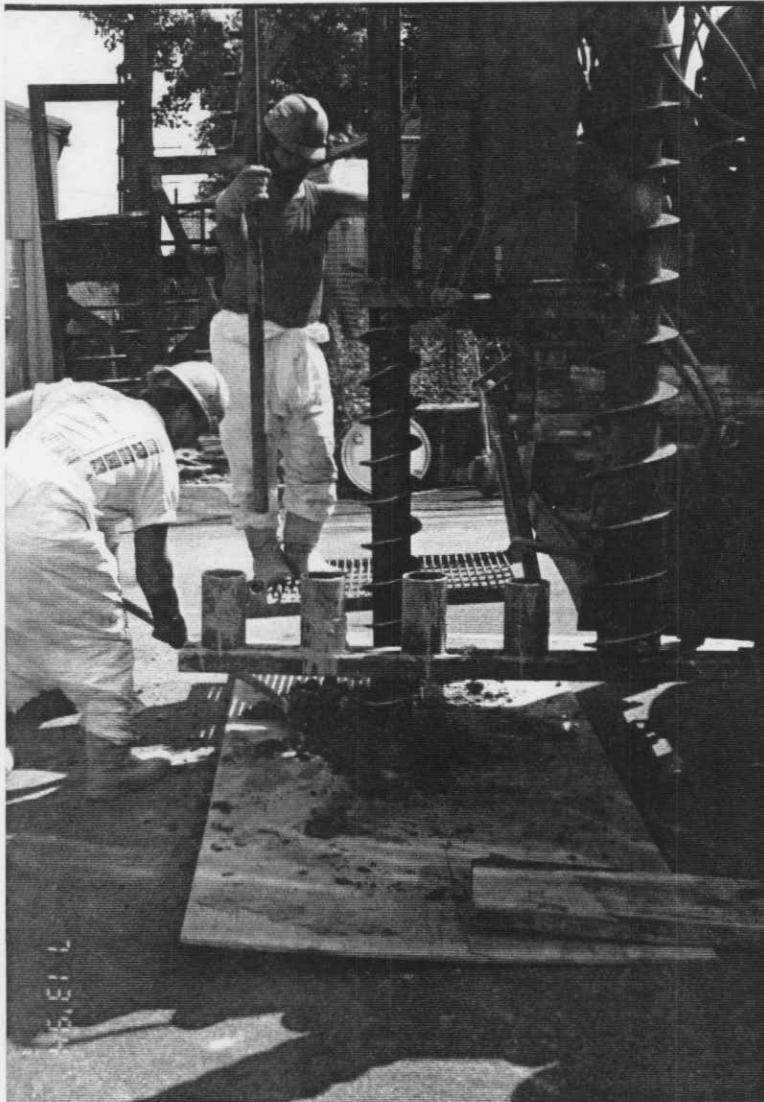
Time: 1540 Frame No.: 10

Comments*: Drilling at Borehole 8 (facing south).

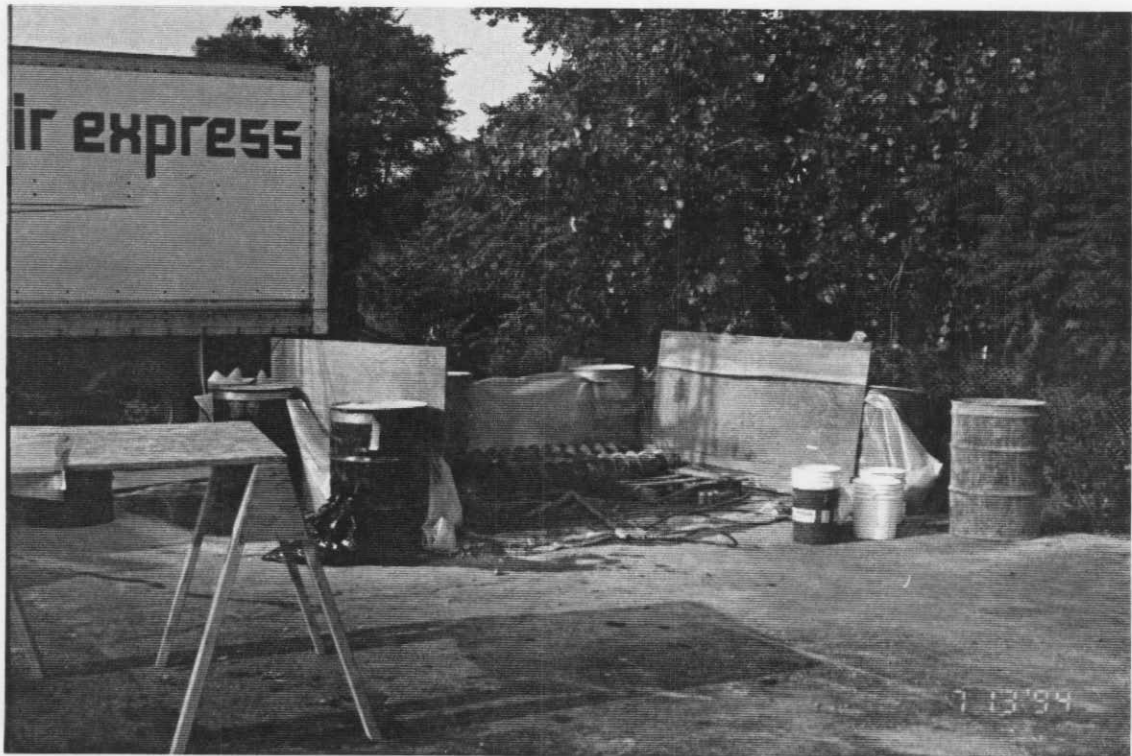
Client: NYSDEC	E & E Job No.: OC5021
Site: Niagara Transformer Site No. 9-15-146	
Camera: Make	SN
Lens Type	SN
	Photographer: Rick Watt Date: 7-13-94
	Time: 1700 Frame No.: 11
	Comments*: Upgraded decontamination pad (facing northeast).
*Comments to include location.

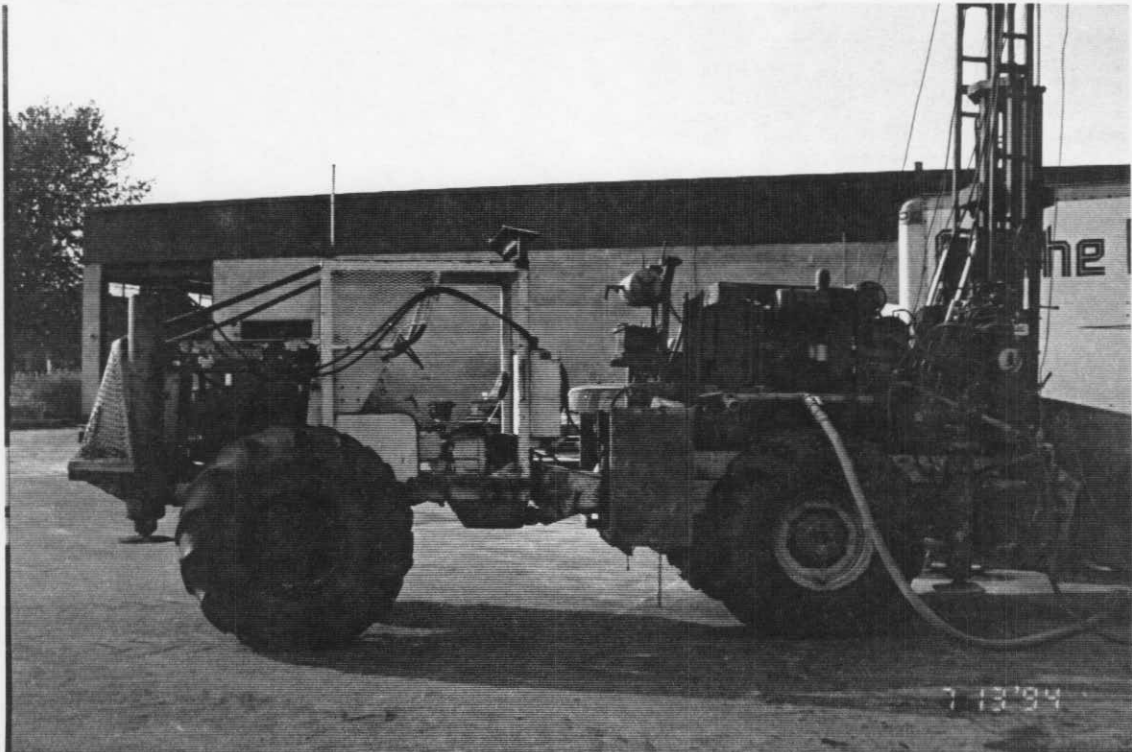
Comments*: Mobile drill rig used on site (facing north).

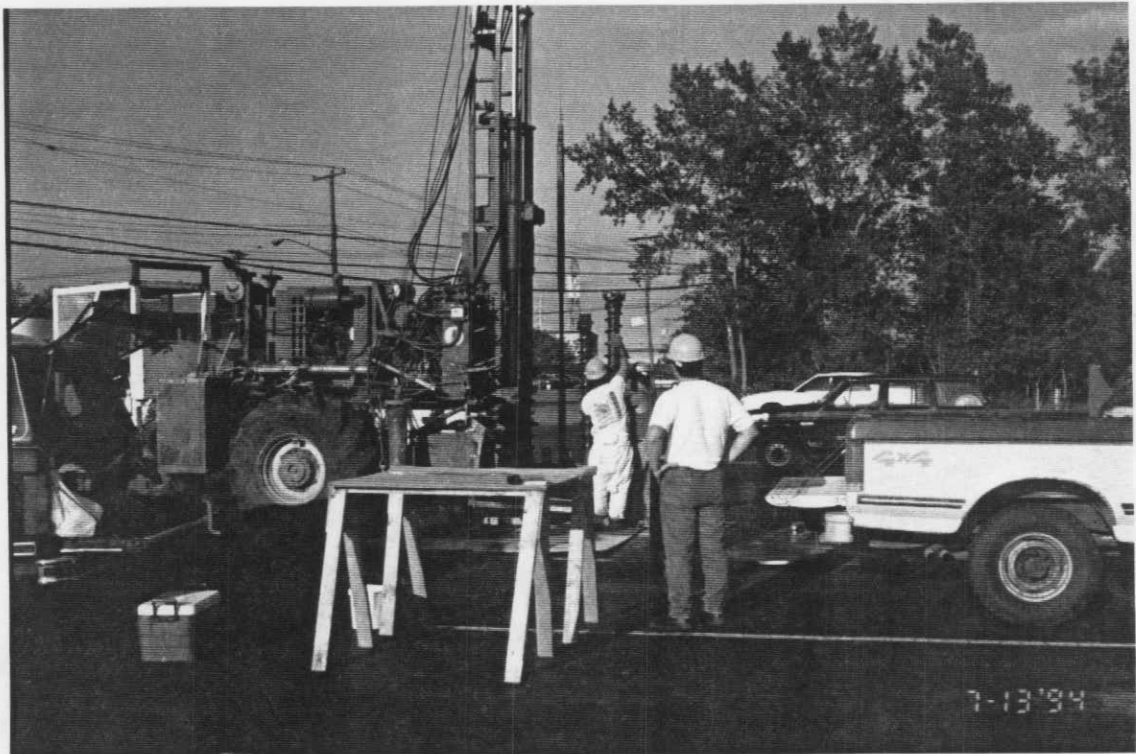
Comments*: Drill rig set up at Borehole 1 (facing east).

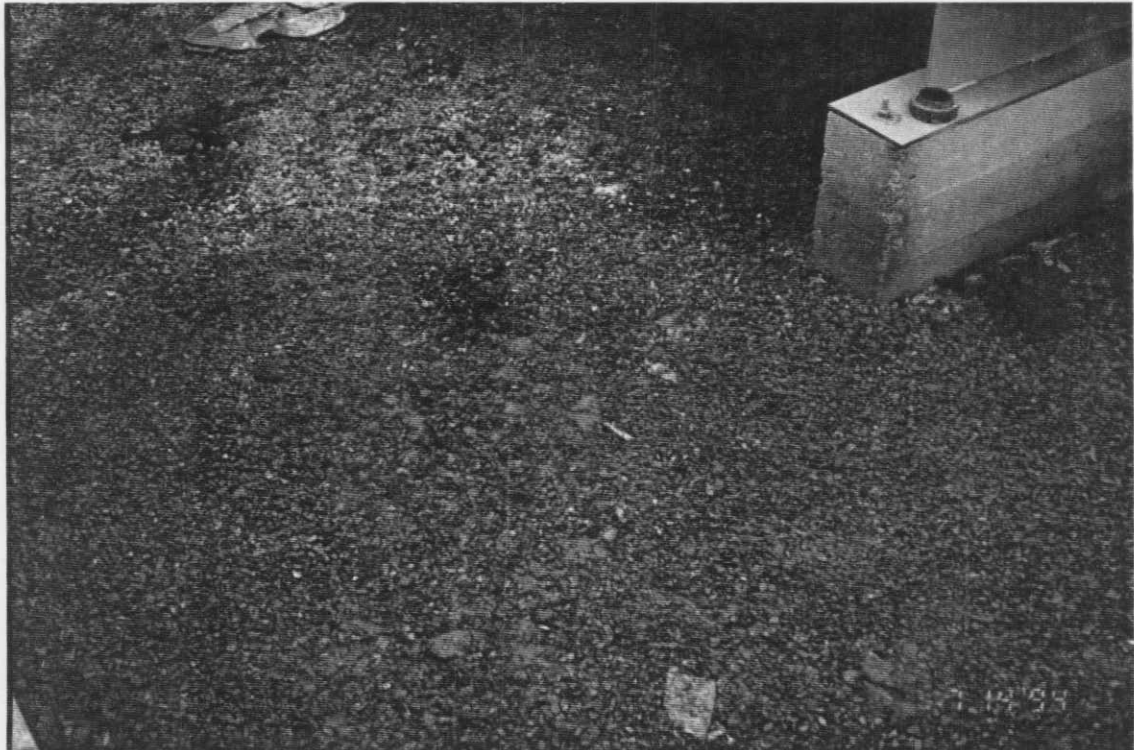
One subsurface soil boring was augered in the aboveground tank farm northwest of the metal storage building. This borehole (BH10) was hand-driven and sampled only to 5 feet BGS due to the limited work area to perform augering. Five soil samples were collected from BH10 at one-foot depth intervals. All five samples were screened using 10 ppm test kits; PCB concentrations were found to exceed 10 ppm in all five samples. Stained soil material and an oily petroleum-like odor was encountered throughout the entire boring interval.

Client: NYSDEC	E & E Job No.: OC5021
Site: Niagara Transformer Site No. 9-15-146	
Camera: Make	SN
Lens Type	SN
	Photographer: Rick Watt Date: 7-14-94
	Time: 0940 Frame No.: 14
	Comments*: Location of Borehole 10 after sampling in tank farm.

Based on these results, remediation will be recommended for this area; however, additional characterization may be required since the lowest vertical sample screening remained above the cleanup goal of 10 ppm.

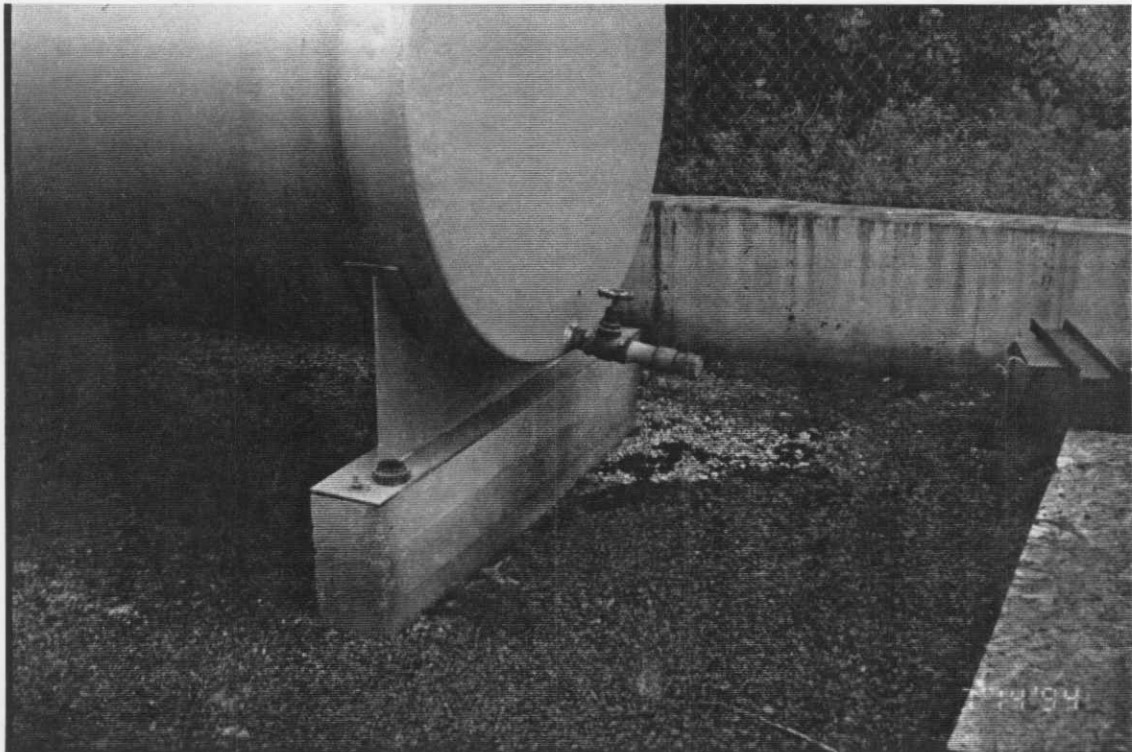
Client: NYSDEC	E & E Job No.: OC5021
Site: Niagara Transformer Site No. 9-15-146	
Camera: Make	SN
Lens Type	SN
	Photographer: Rick Watt Date: 7-14-94
	Time: 0941 Frame No.: 15
	Comments*: Oily gravel around south tank.
	Borehole 10 location is just off bottom left of photo.
*Comments to include location.

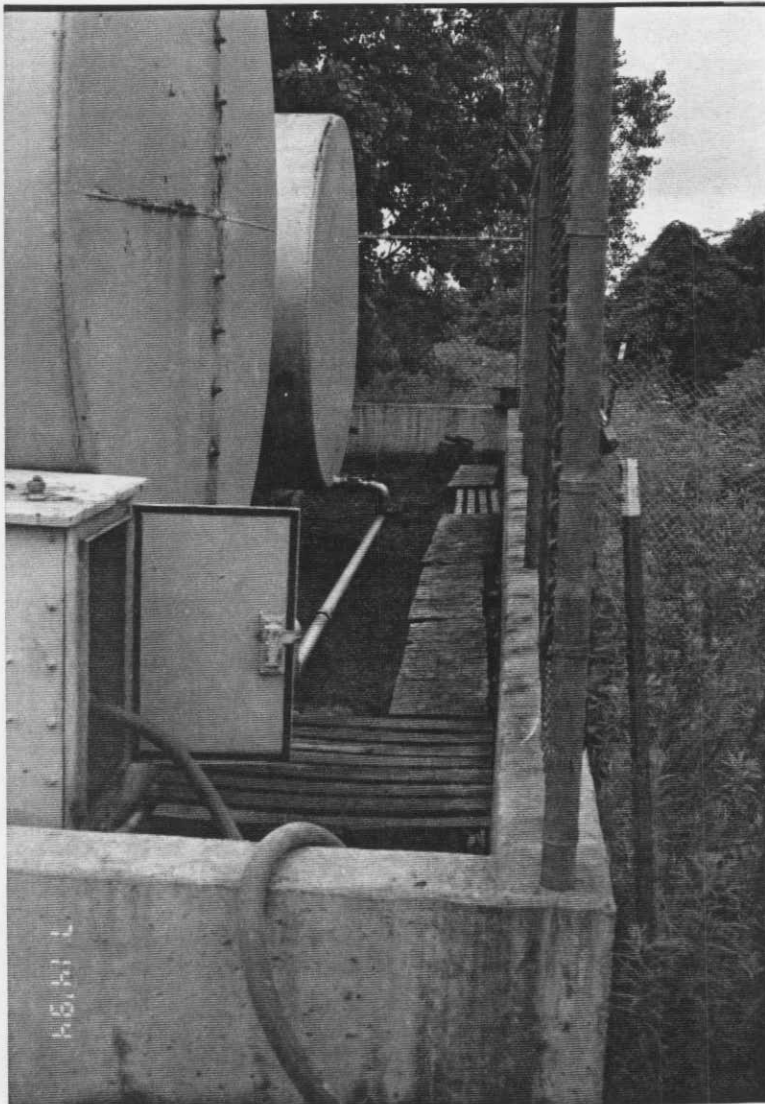
Time: 0943 Frame No.: 16

Comments*: West side of tanks. Cannot see third
 small tank adjacent to Borehole 10 (facing south).

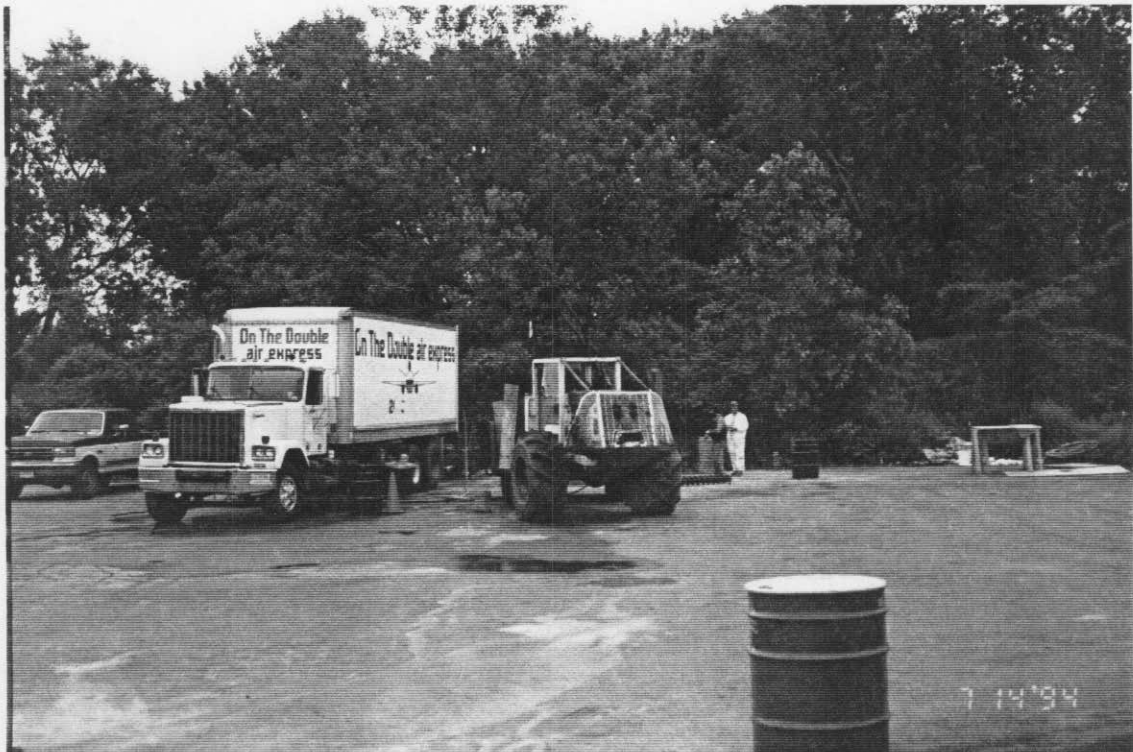
Client: NYSDEC	E & E Job No.: OC5021
Site: Niagara Transformer Site No. 9-15-146	
Camera: Make	SN
Lens Type	SN
	Photographer: Rick Watt Date: 7-14-94
	Time: 1000 Frame No.: 17
	Comments*: View facing east across parking lot, toward decontamination pad, after completion of drilling activities.
*Comments to include location.

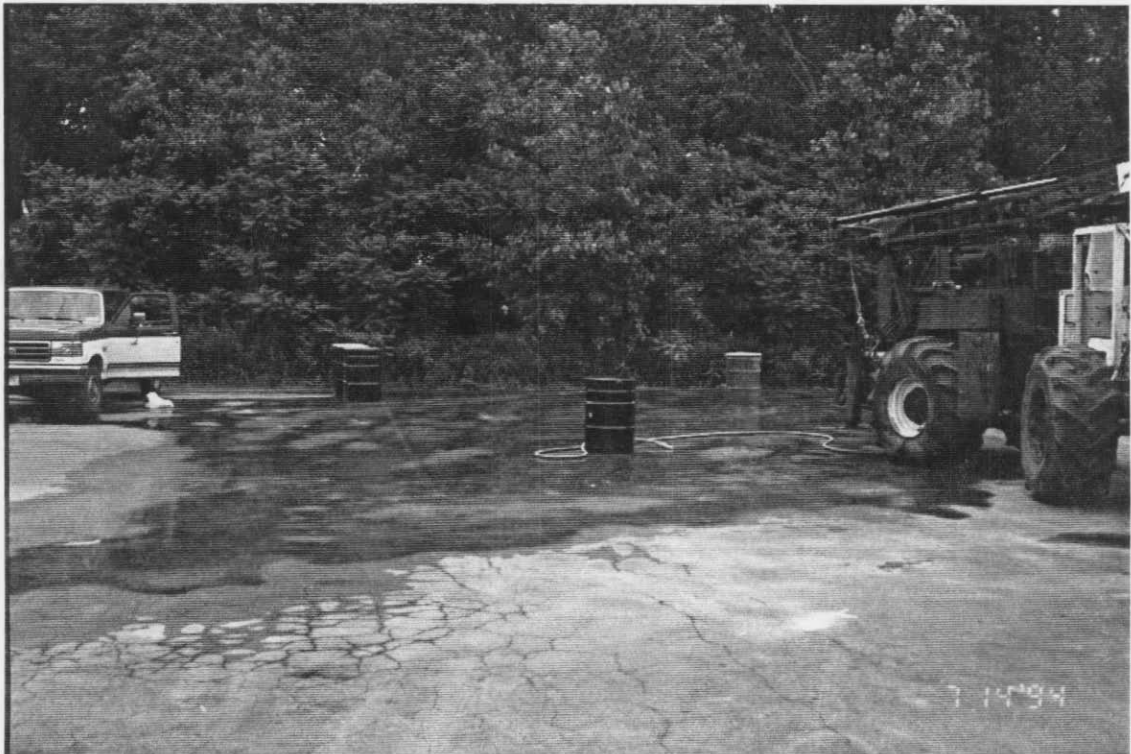
Comments*: View facing east; area formerly occupied
by decontamination pad, after final clean up.

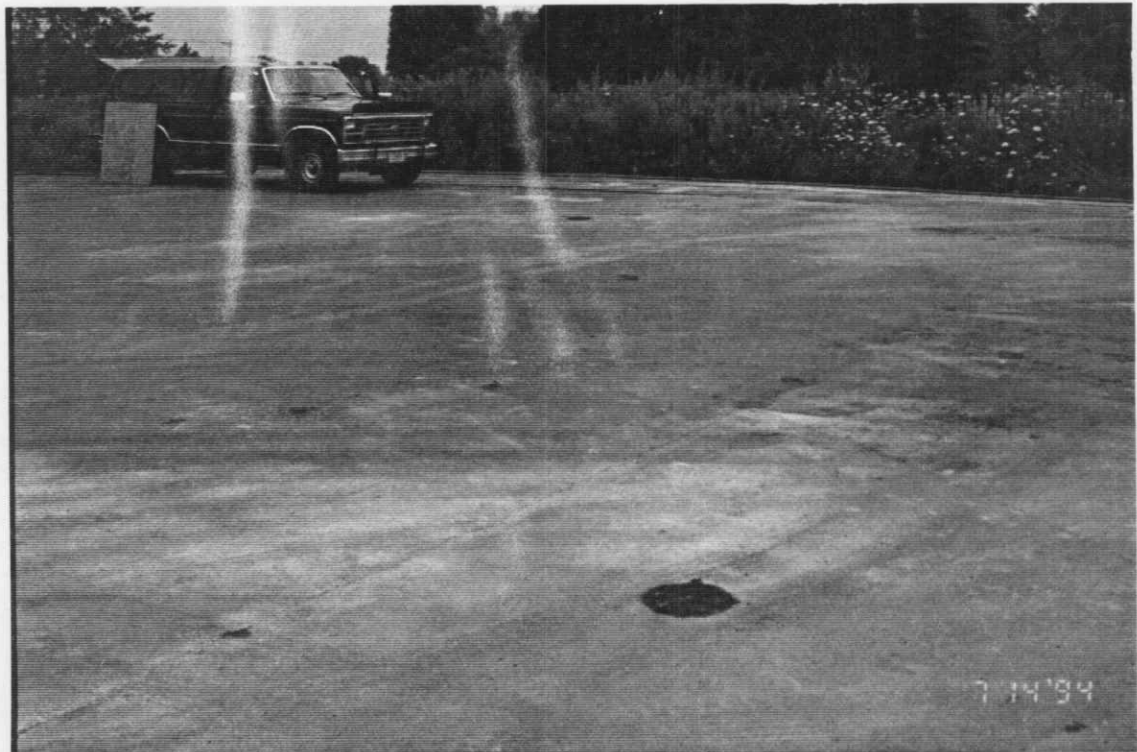
Client: NYSDEC	E & E Job No.: OC5021
Site: Niagara Transformer Site No. 9-15-146	
Camera: Make	SN
Lens Type	SN
	Photographer: Rick Watt Date: 7-14-94
	Time: 1135 Frame No.: 19
	Comments*: View facing west-southwest of parking lot after completion. Asphalt patch in foreground is Borehole 7 and patch in background is Borehole 6.
*Comments to include location.
