# **318 Urban Street Site**

## **Periodic Review Report**

### **September 2012 through October 2013**

**NYSDEC Site Number: 9-15-151**

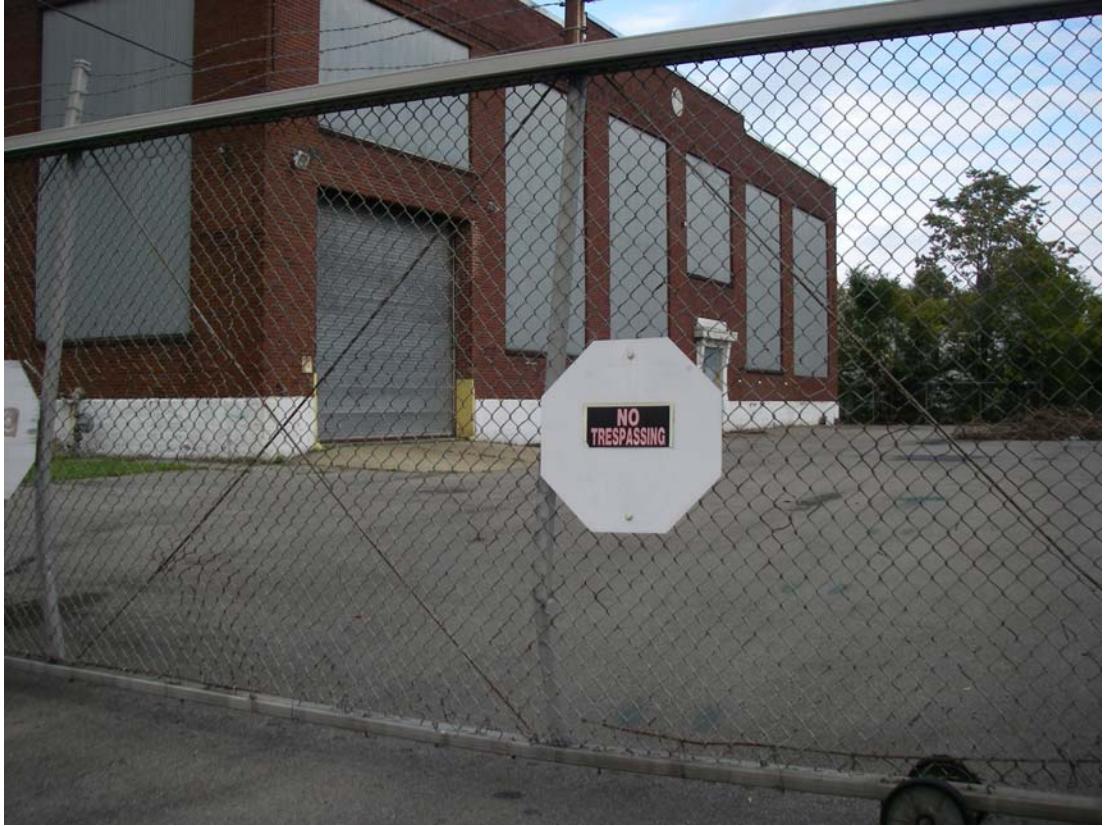
**PHOTO NO: 1**

Site entrance with secured gate.

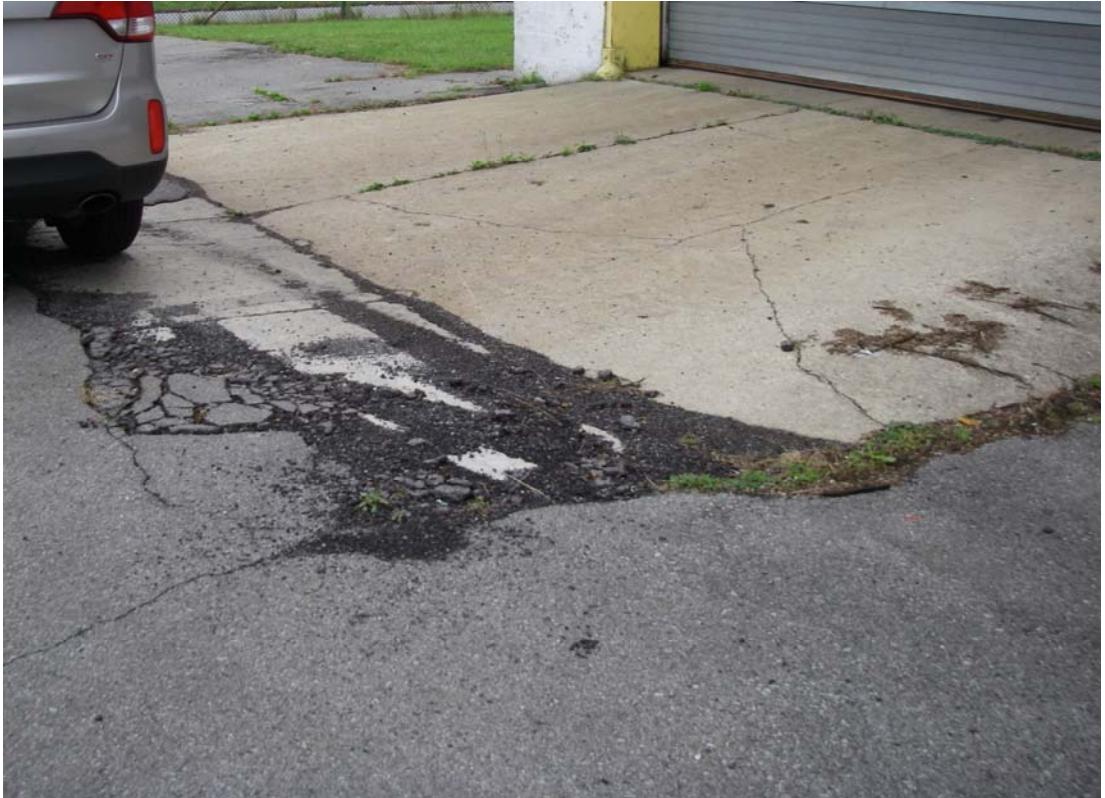
**PHOTO NO: 2**

- The turf grass south of the building is intact and maintained. There was no evidence of disturbance.
- The asphalt pavement is in generally good condition and there was no indication (such as patching) that the pavement has been disturbed. A small area of deteriorated pavement was observed near the concrete pad to the loading dock. This area of pavement is underlain with additional concrete pad structure and no soil is exposed. The deterioration should be monitored. Repair may be necessary in the future.

Pavement deterioration observed at junction of asphalt pavement and concrete pad. Soil is not exposed. Additional concrete underneath pavement.

Is maintenance needed? <input checked="" type="checkbox"/> Yes <input type="checkbox"/> No				
Recommendations for maintenance: <b>Monitor condition of deteriorated pavement and damaged fence post. These items may require corrective action in the future. Sealing cracks near southeast building corner may extend life of pavement. Post-pone the need for repairs.</b>				
Additional comments: <b>① First access in 14 years. No evidence of surface disruption was observed. Property owner interview relied upon regarding site use and changes since 1999. ② First inspection. Therefore, no records needed to be maintained at the site up to this point. ③ Site has been broken into. Owner is maintaining fence and fence fabric has been reattached.</b>				
Corrective Measures necessary? <b>Another copy of the site management plan will be provided to owner to be kept at the site.</b>				
Residually impacted material remains undisturbed? <input checked="" type="checkbox"/> Yes <input type="checkbox"/> No

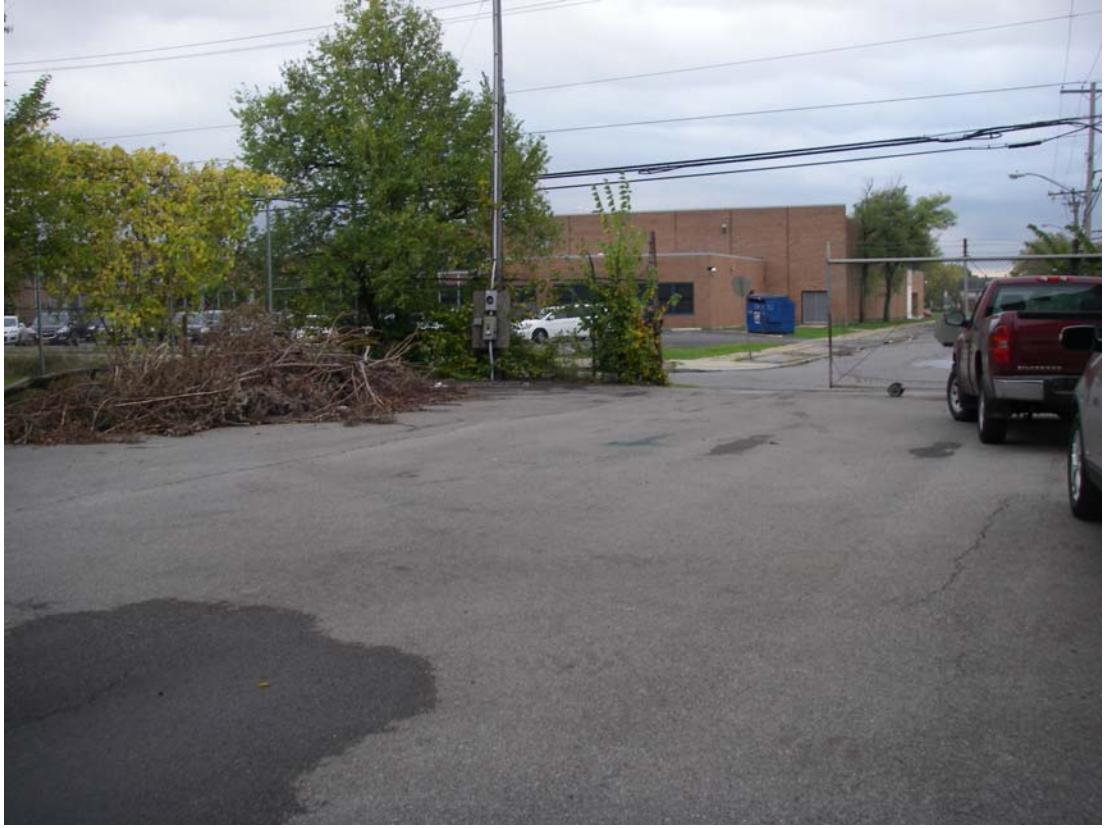
**PHOTO NO: 3**

Owner has trimmed brush along fence lines and is reportedly coordinating with the City of Buffalo to have the brush picked up.

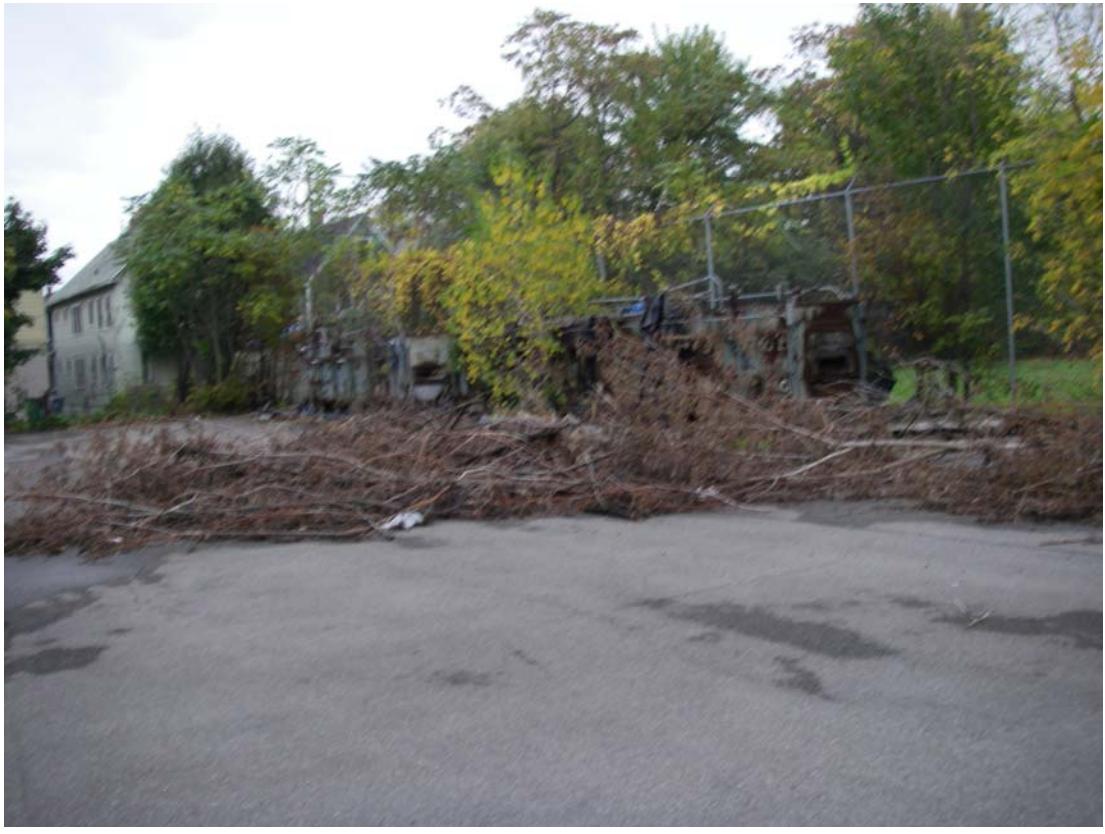
**PHOTO NO: 4**

Brush removed from property perimeter. Larger equipment stored along fence.

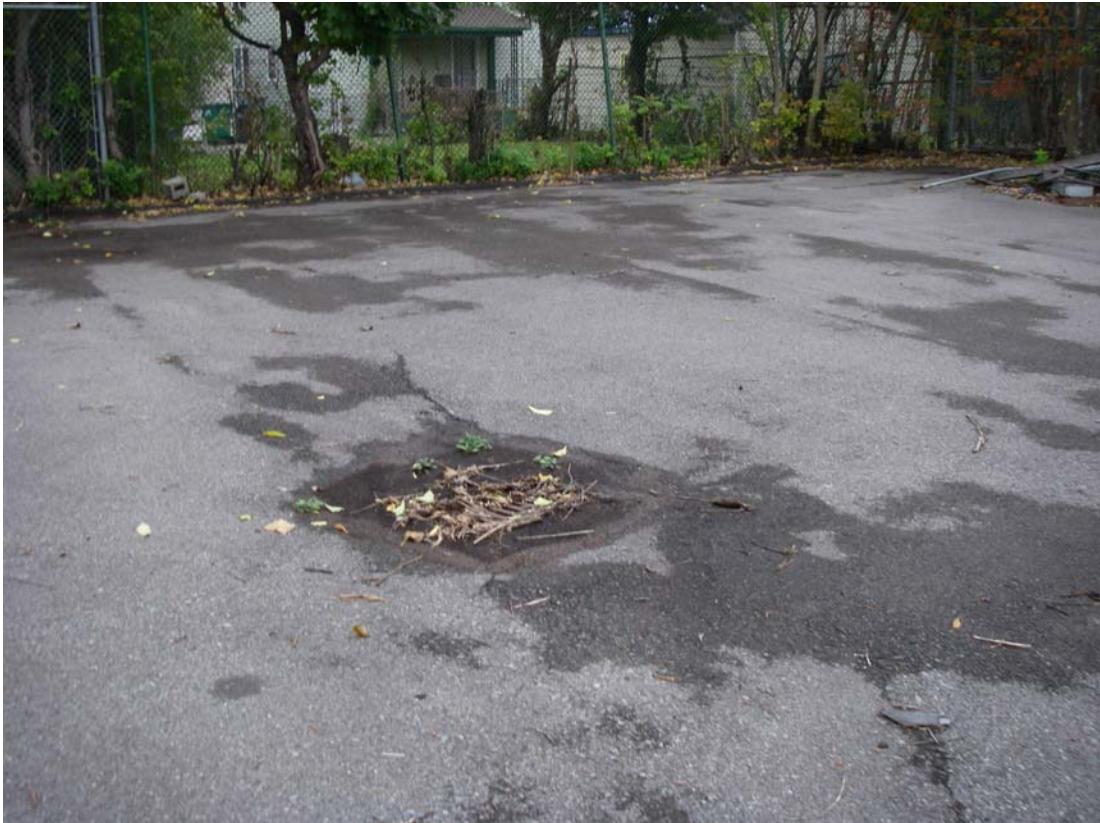
**PHOTO NO: 5**

Pavement and catch basin in northeast portion of site.

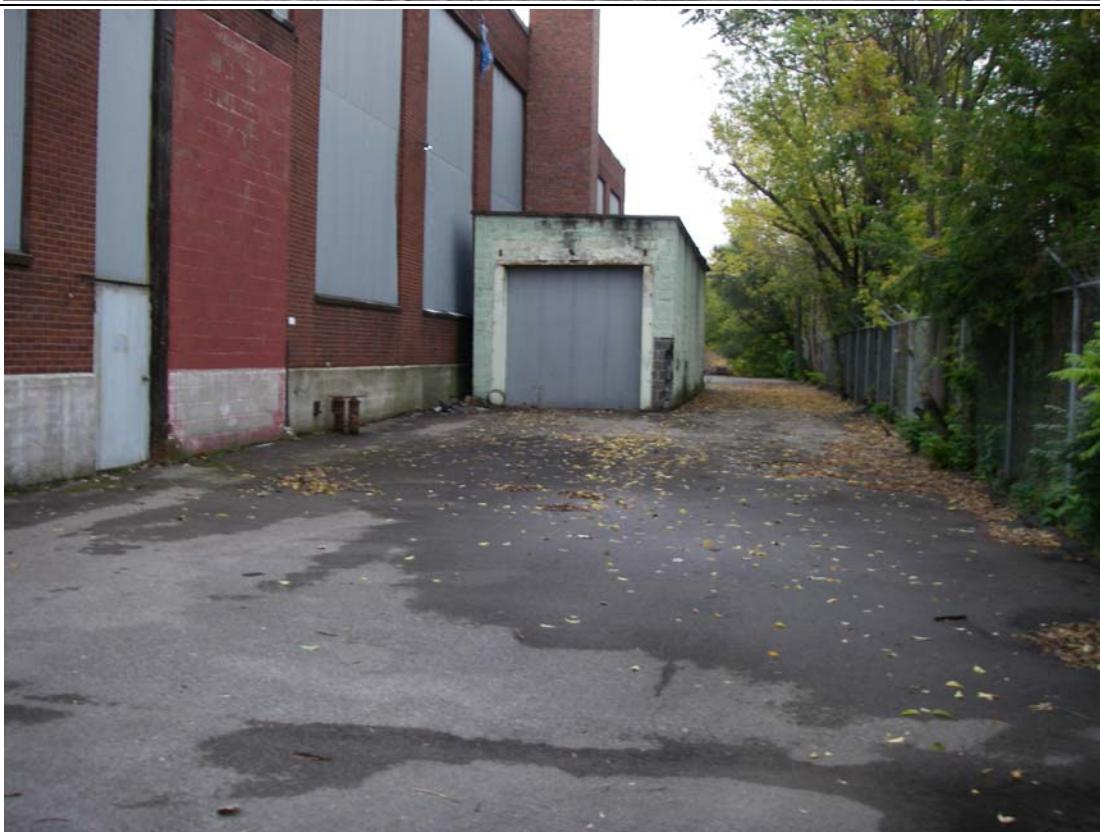
**PHOTO NO: 6**

View along fence line north of building.

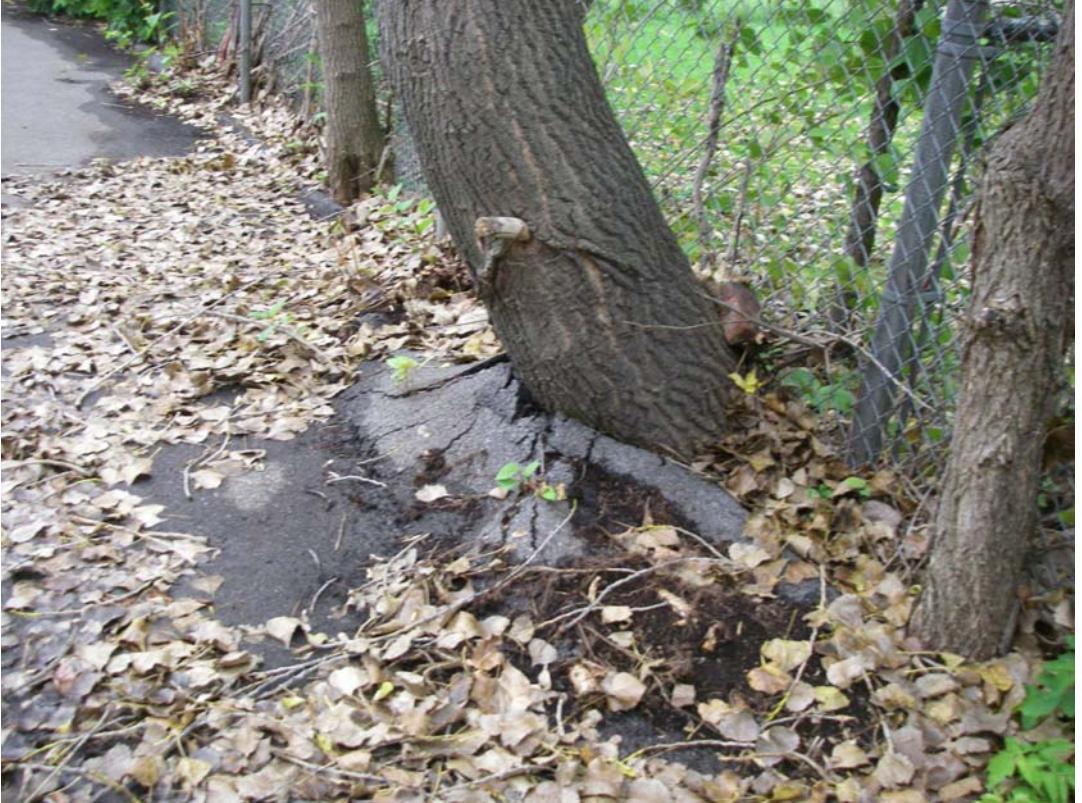
<b>PHOTO NO: 7</b>

<b>Date:</b> 10/17/13	
<b>Direction:</b> Northwest	
<b>Description:</b> Pavement around trees along northern fence line.	
<b>PHOTO NO: 8</b>

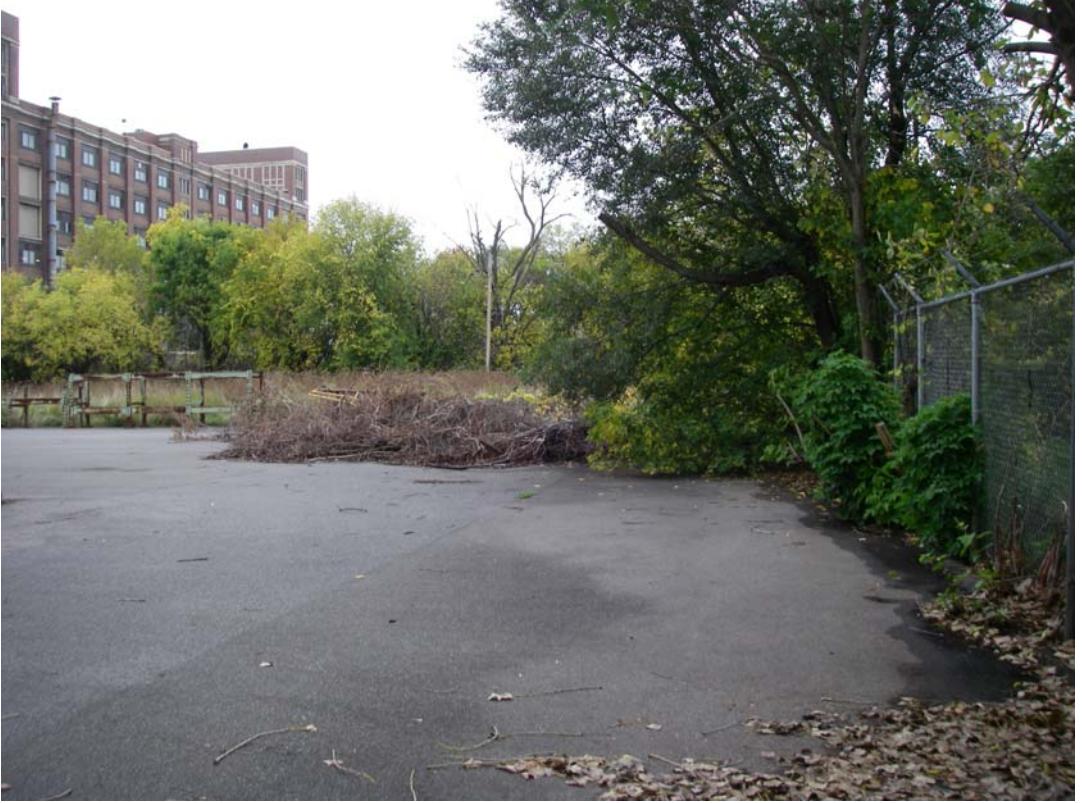
<b>Date:</b> 10/17/13	
<b>Direction:</b> West	
<b>Description:</b> Pavement and pile of removed brush in northwestern portion of paved area.

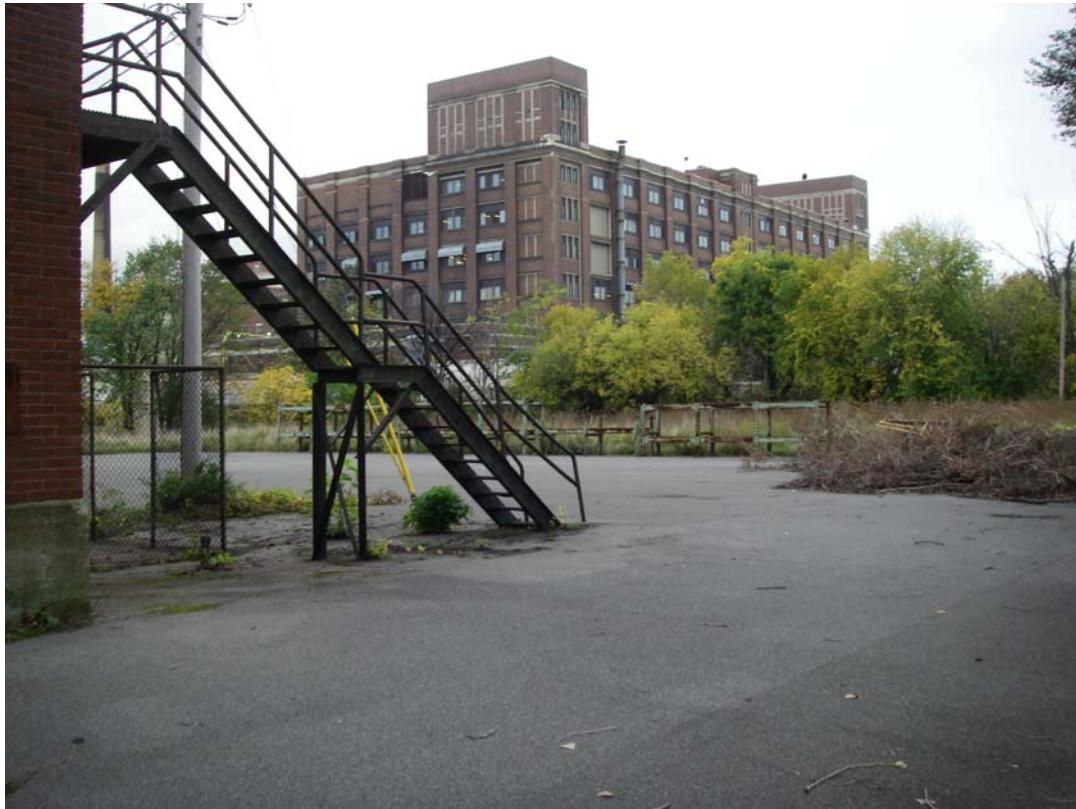
<b>PHOTO NO: 9</b>
<b>Date:</b> 10/17/13
<b>Direction:</b> Southwest
<b>Description:</b> Pavement near northwest building corner.

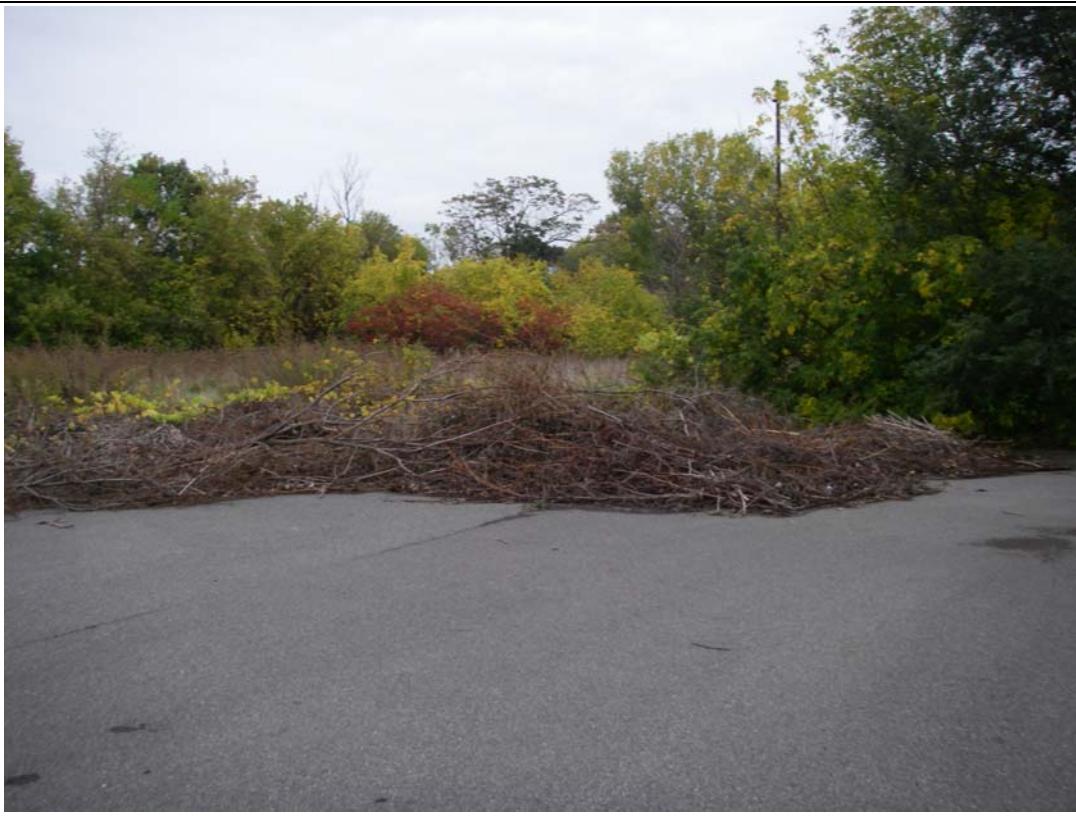
<b>PHOTO NO: 10</b>
<b>Date:</b> 10/17/13
<b>Direction:</b> Northwest
<b>Description:</b> Grass in western portion of site has been allowed to grow.

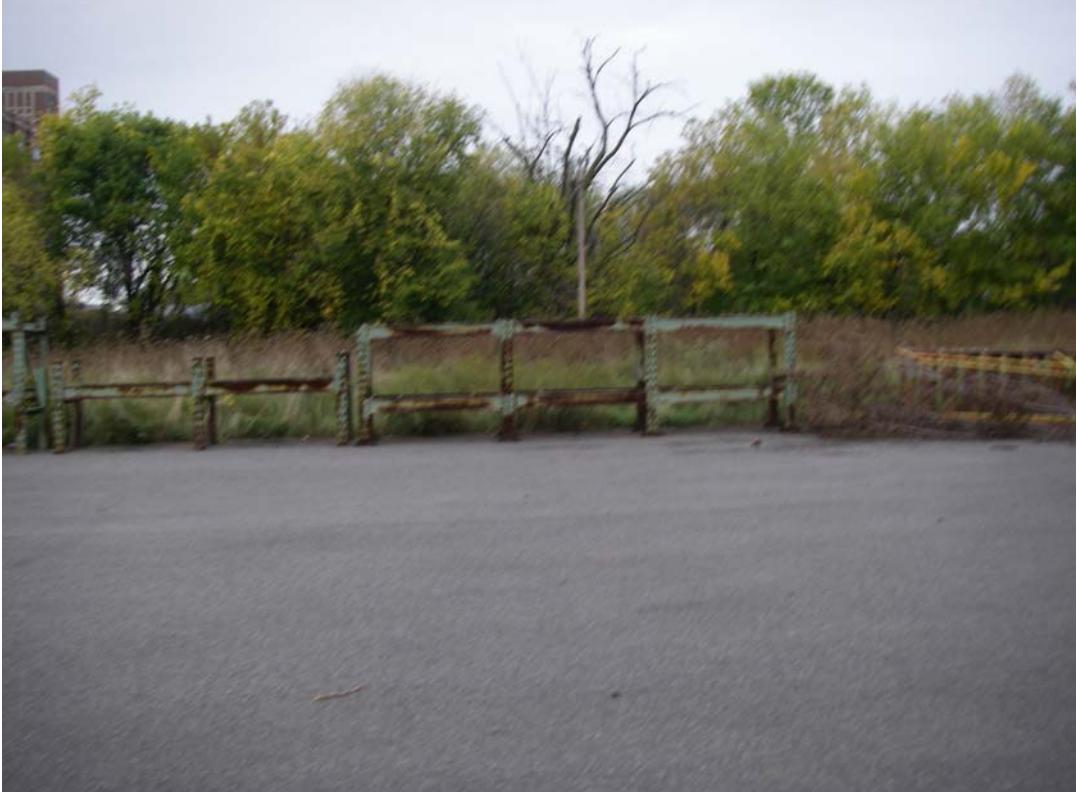
<b>PHOTO NO: 11</b>

<b>Date:</b> 10/17/13	
<b>Direction:</b> West	
<b>Description:</b> Large equipment stored along western pavement boundary with tall grass beyond the paved area.	
<b>PHOTO NO: 12</b>

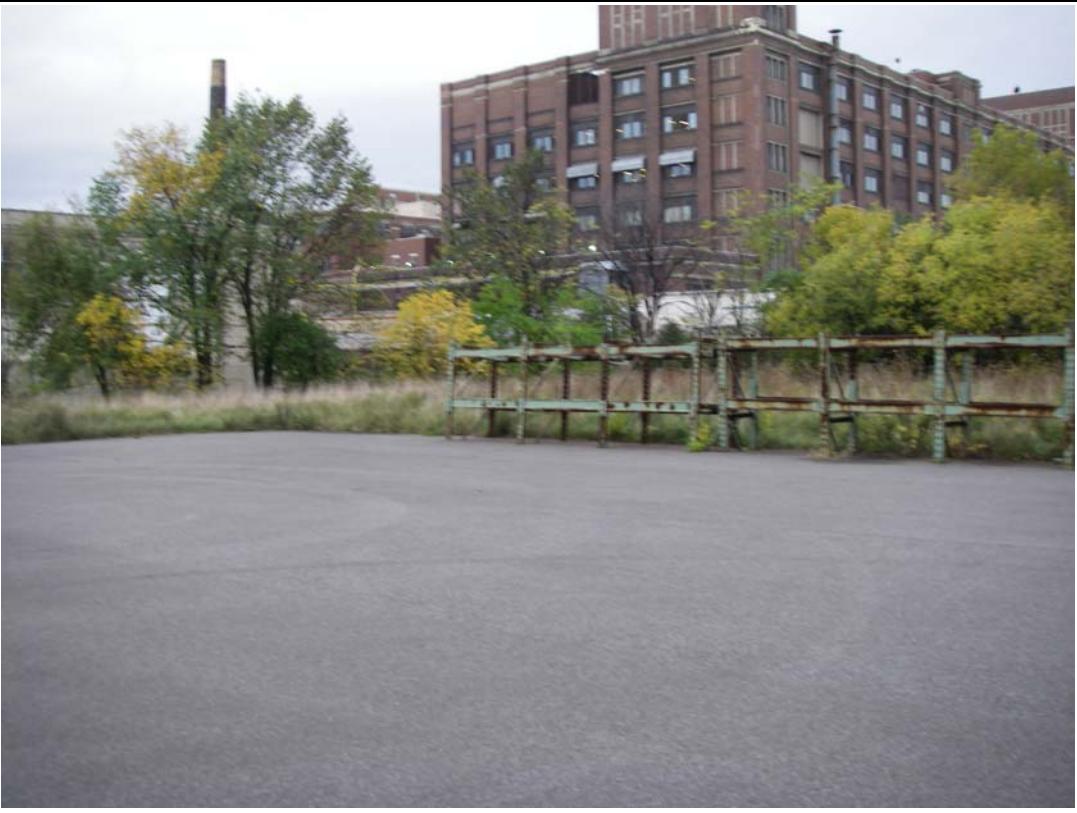
<b>Date:</b> 10/17/13	
<b>Direction:</b> Southwest	
<b>Description:</b> Pavement condition in southwestern portion of paved area with high grass beyond pavement.

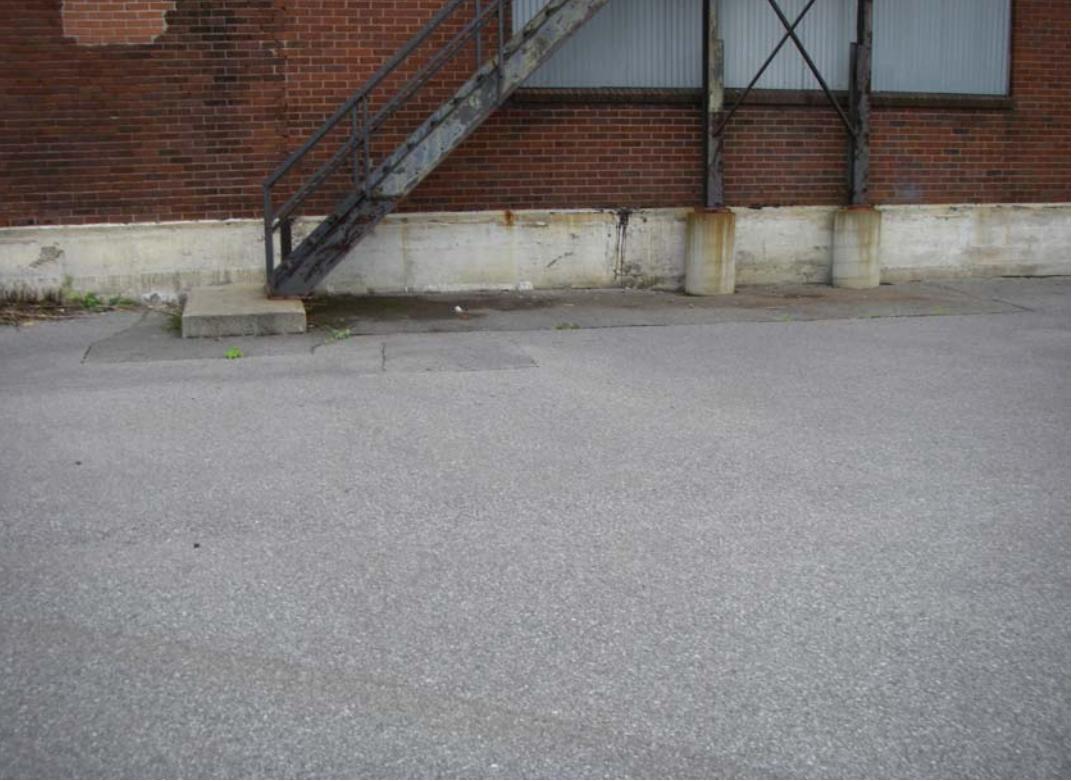
<b>PHOTO NO: 13</b>

<b>Date:</b> 10/17/13	
<b>Direction:</b> East <b>Description:</b> Pavement seams along west building wall.	
<b>PHOTO NO: 14</b>

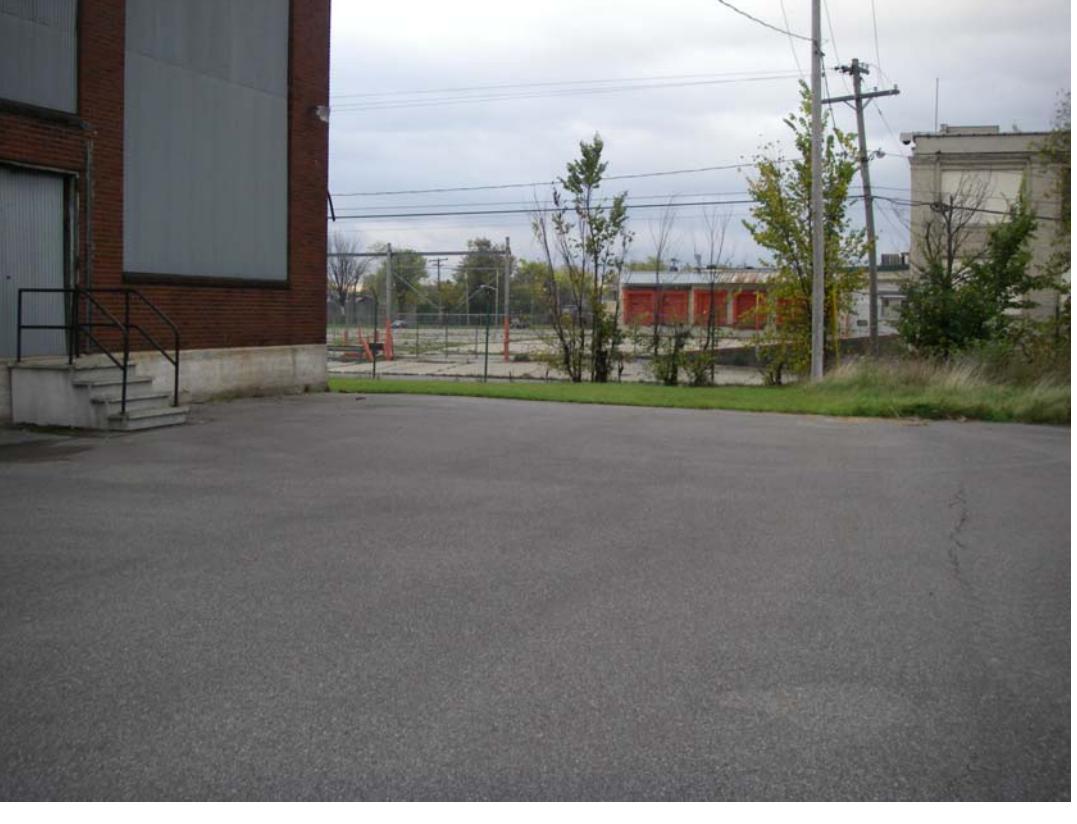
<b>Date:</b> 10/17/13	
<b>Direction:</b> Southeast <b>Description:</b> Condition of pavement near southwest building corner. Mowed grass is present along south side of building.

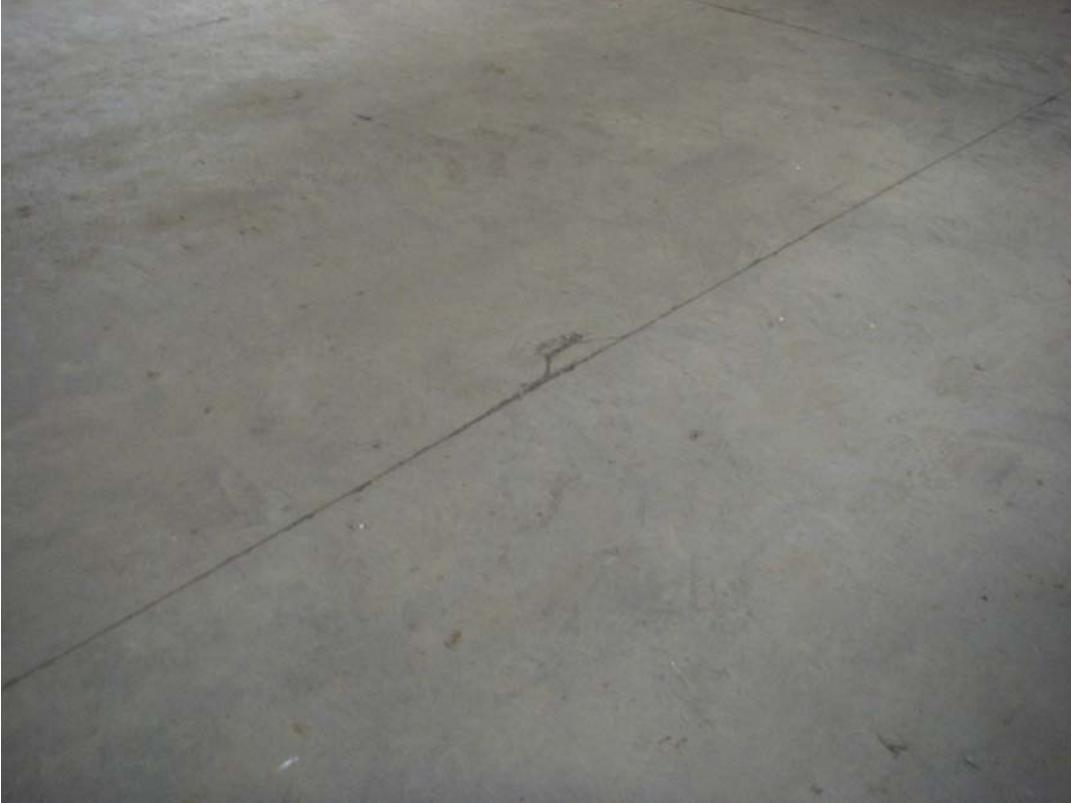
<b>PHOTO NO: 15</b>

- The concrete floor slab within the building is intact and there were no indications (such as patching) that the slab had been disturbed. Minor cracking and chipping was observed at some expansion joints and along seam with the old floor slab, but the slab is intact and effectively serving as a cover.

<b>Date:</b> 10/17/13	
<b>Direction:</b> Southwest	
<b>Description:</b> <p>Floor slab in building. Occasional small cracks near expansion joints were observed. Concrete slab intact.</p>	
<b>PHOTO NO: 16</b>

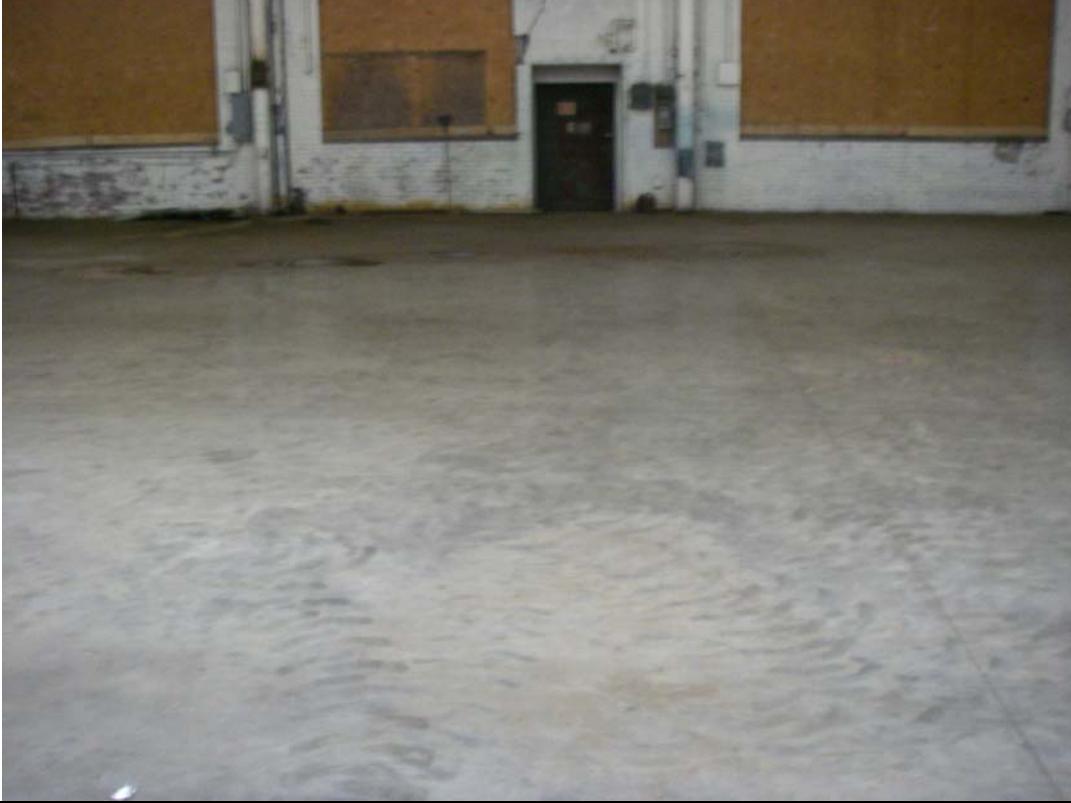
<b>Date:</b> 10/17/13	
<b>Direction:</b> North	
<b>Description:</b> <p>Condition of concrete floor slab over former transformer pit. Door to concrete block portion of building is shown for reference.</p>

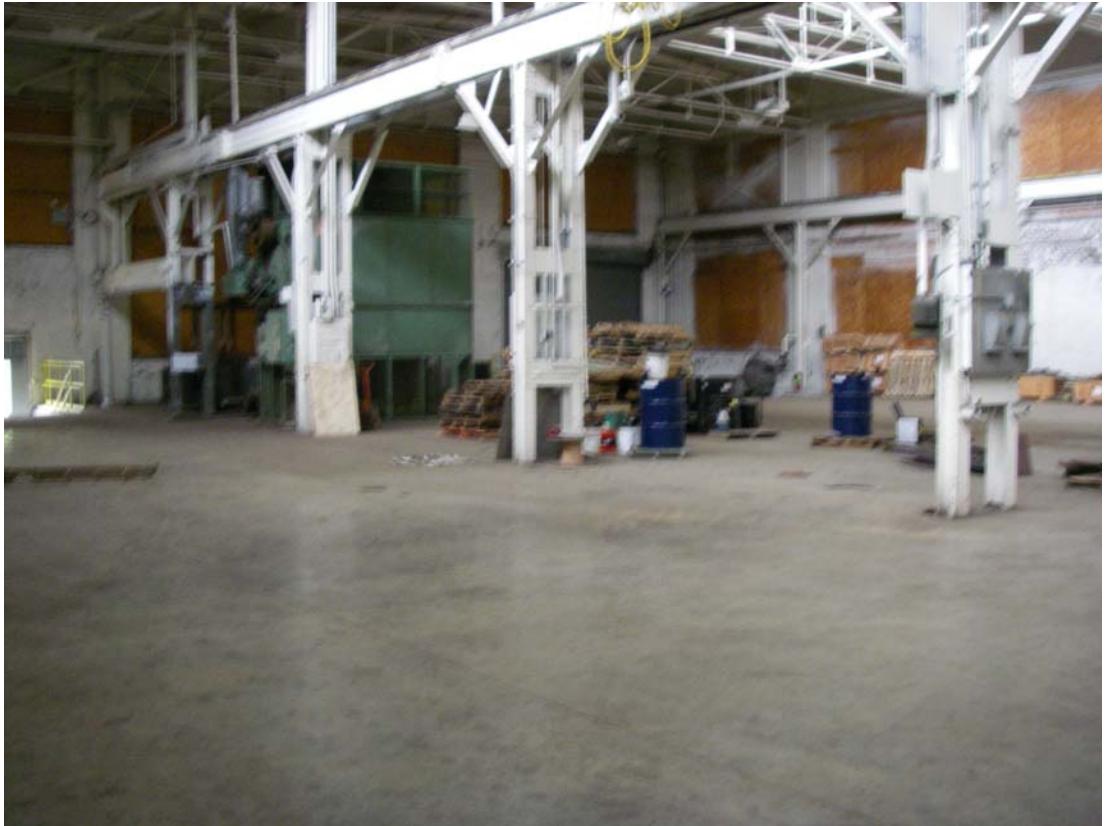
**PHOTO NO: 17**

Building interior.

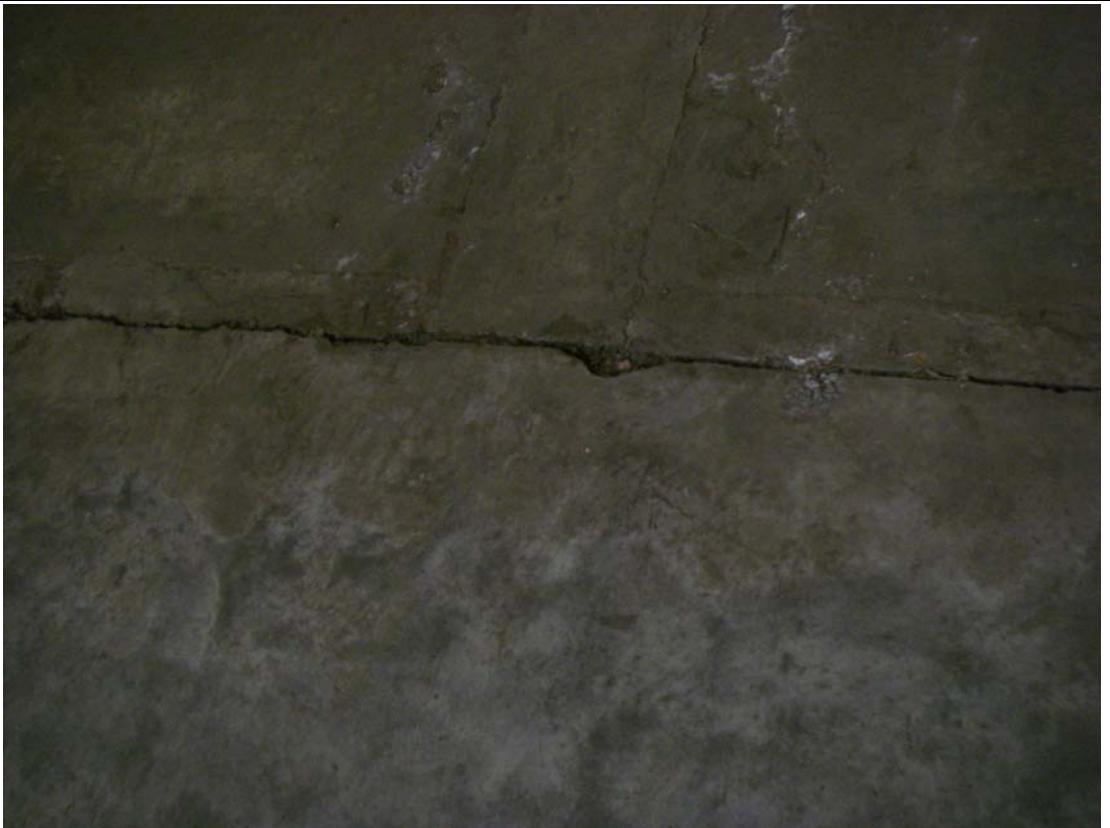
**PHOTO NO: 18**

Condition of joint between old slab and slab constructed in 1999. Minor cracking and chipping observed.

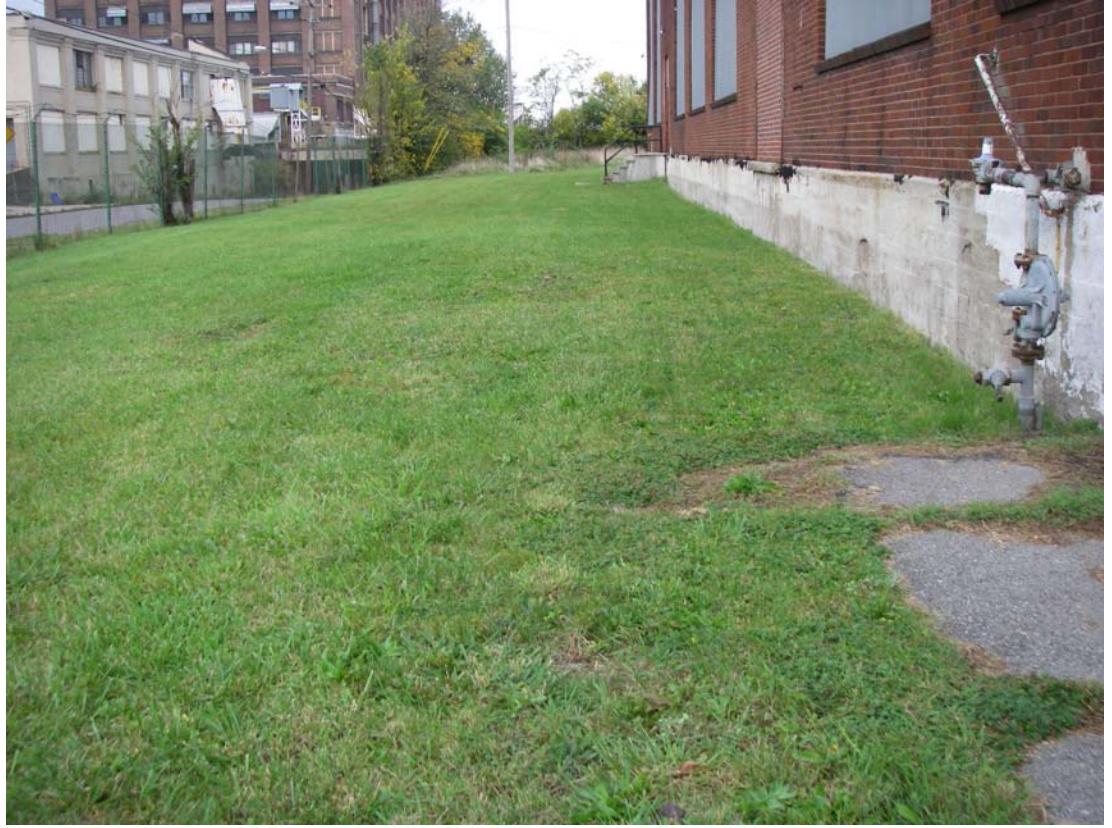
**PHOTO NO: 19**

Grass along south side of building.

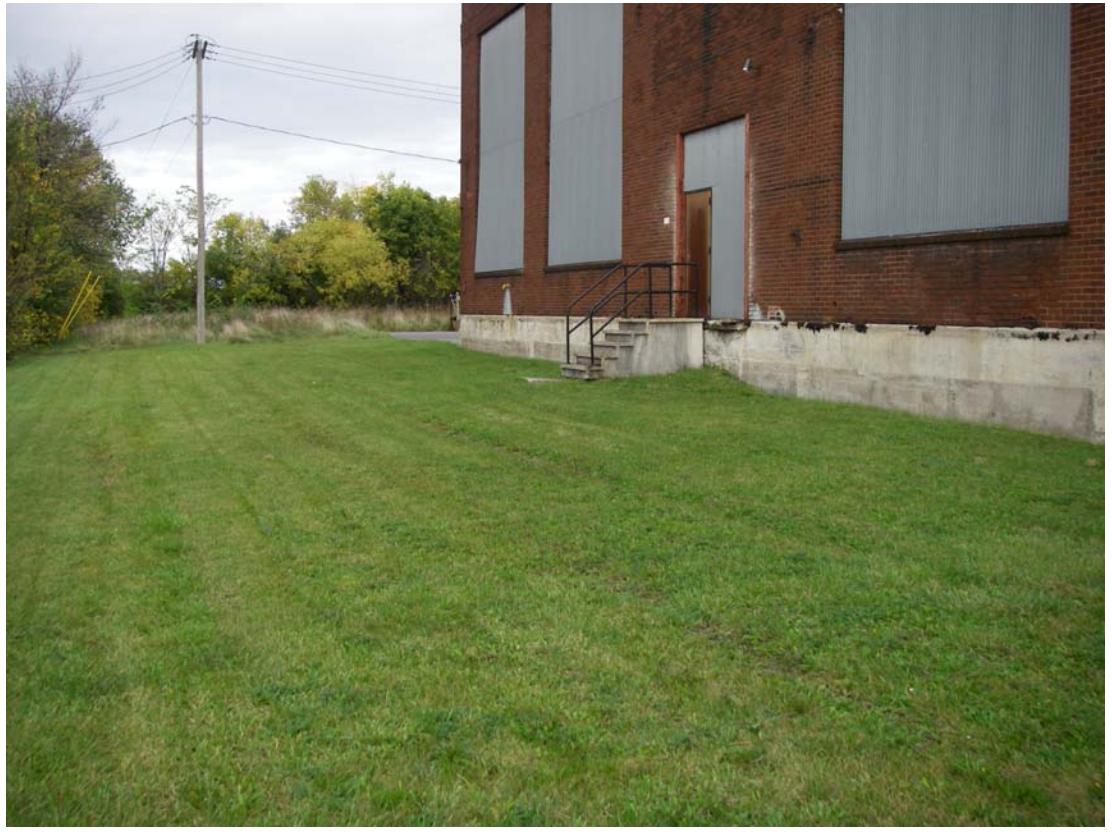
**PHOTO NO: 20**

Grass on south side of building.
