**Site Investigation &
Remedial Action Report
Riverview Industrial Center
Town of Tonawanda, Erie County
Site Number 9-15-225
Spill Number 0902367**

October 2010

Site Investigation & Remedial Action Report

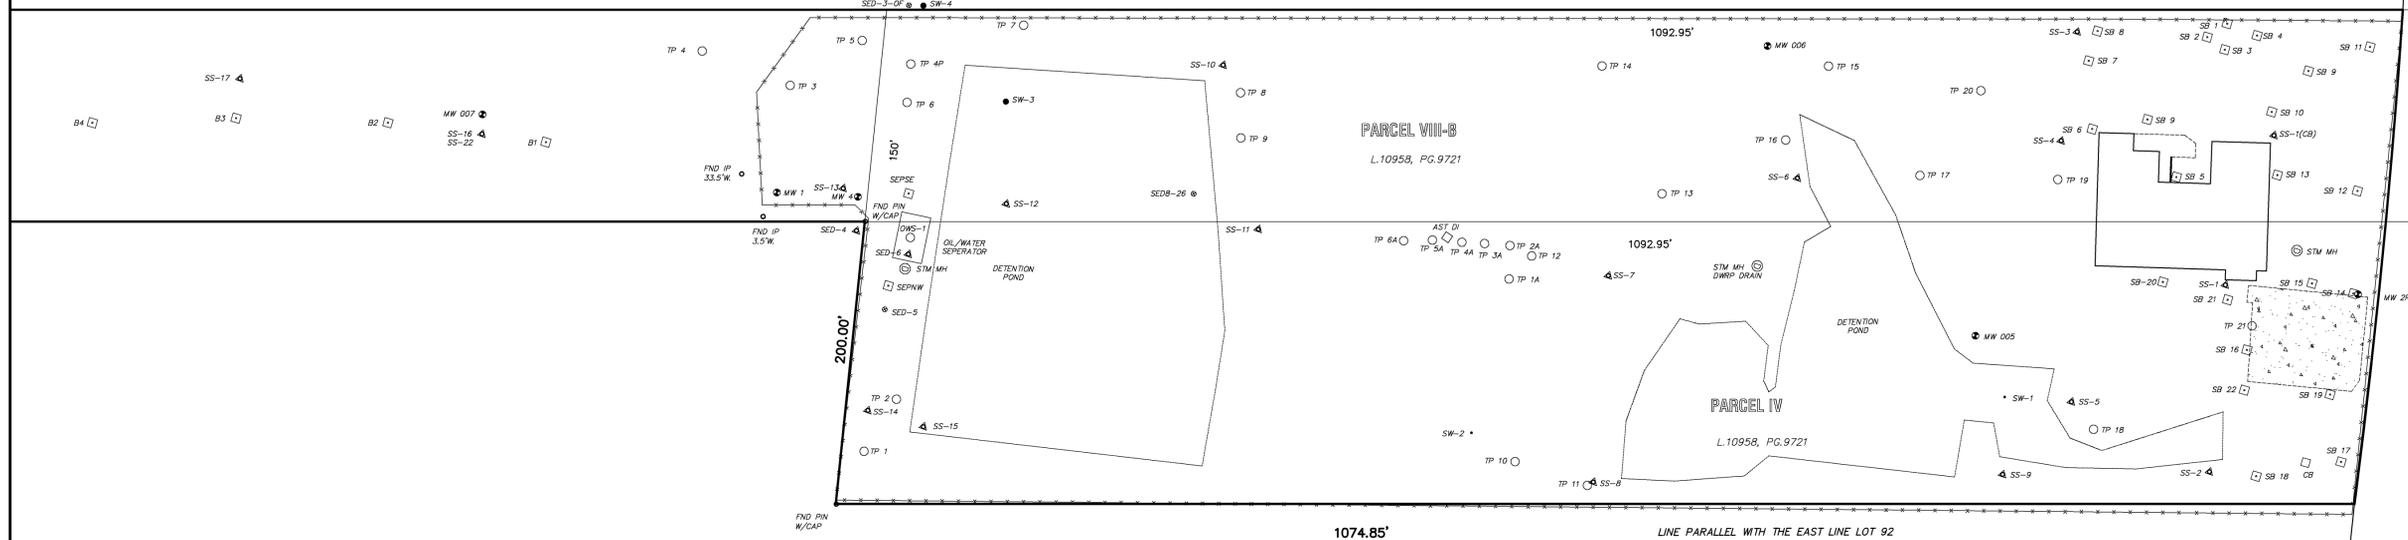
FIGURE 4

2.4 Surface Water Sampling - A total of 4 surface water samples were collected to assess the surface water contamination. Surface water samples were collected from three flooded containment dike areas and from the surface runoff into the western drainage ditch system. The surface water samples were analyzed for VOCs, SVOCs, pesticides, PCBs and metals. Refer to Figure 4 for the surface water sample locations.
