**TWO MILE CREEK LIMITED SEDIMENT
INVESTIGATION SAMPLING REPORT**

**GENERAL ELECTRIC INTERNATIONAL
GE INSPECTION AND REPAIR SERVICE CENTER
TONAWANDA, NEW YORK**

MARCH 20, 2003

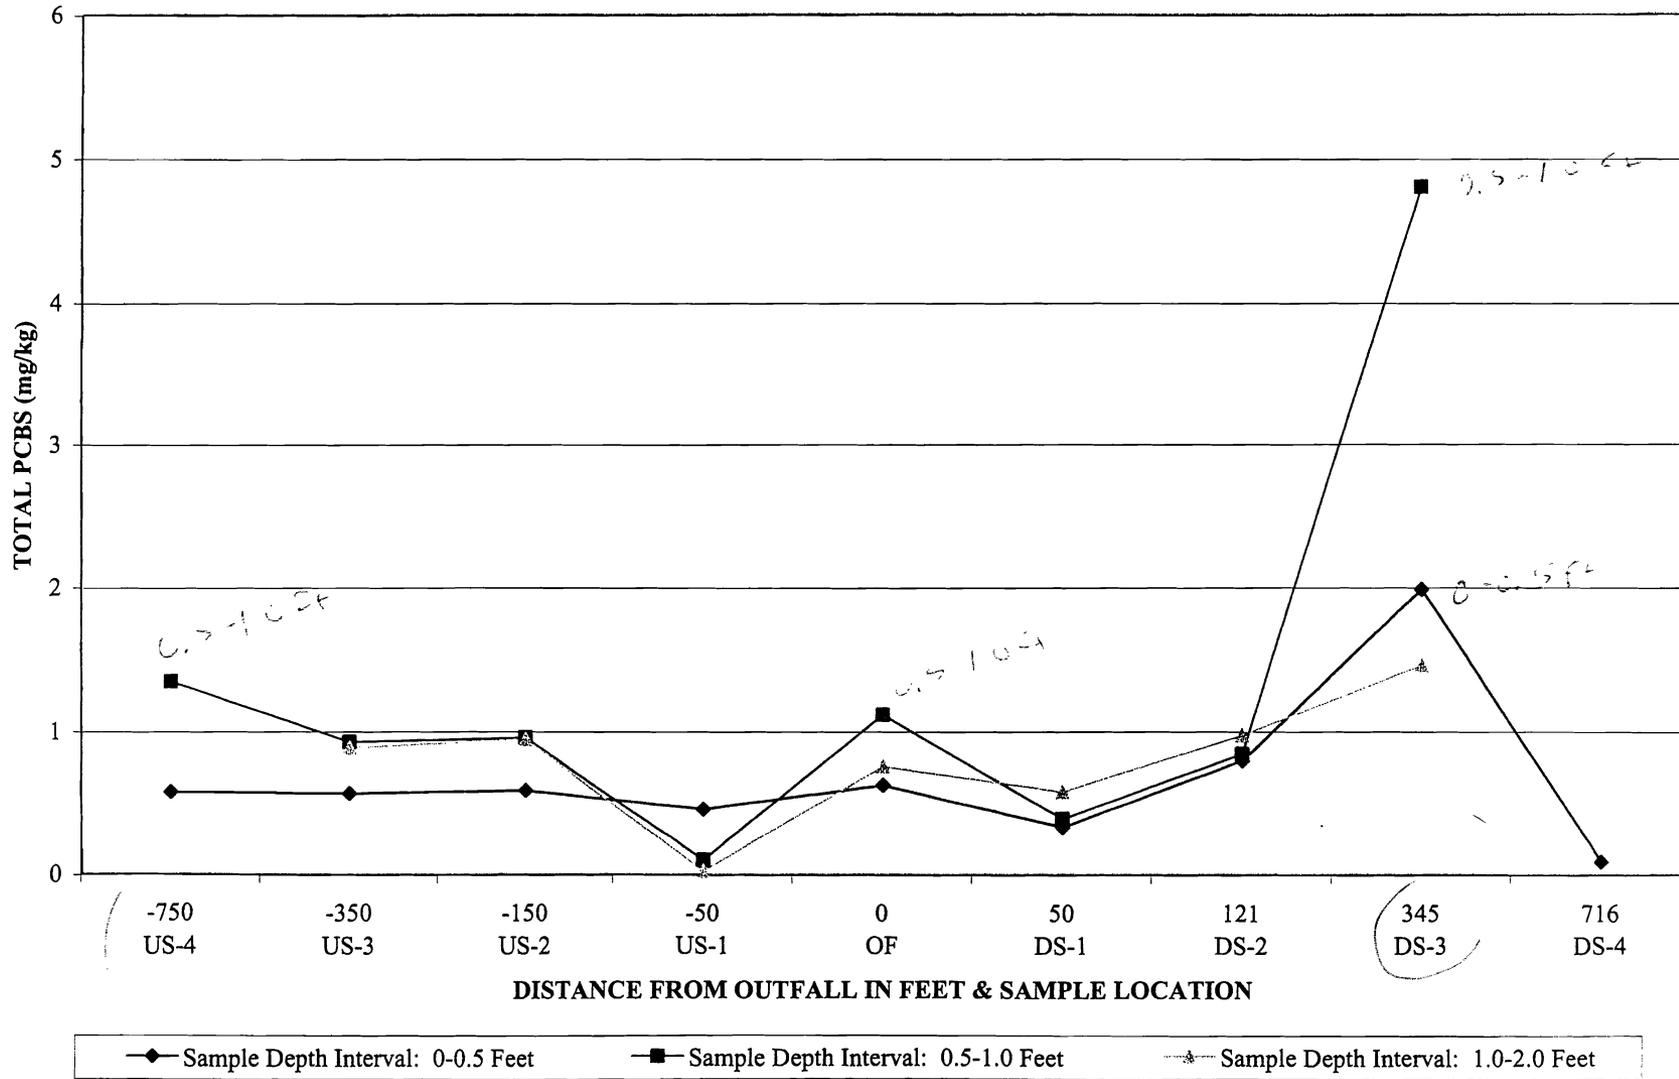
**FIGURE 4
PROFILE OF TOTAL PCBS BY DEPTH**

As shown in Table 3, PCBs were detected in sediment throughout the creek. The detected PCB concentrations ranged from an estimated value of 22 µg/kg in sample US-1 (1-2) to 4,800 µg/kg in sample DS-3 (0.5-1). As shown in Table 3, Arochlors 1248 and 1254 were the only Arochlors detected in the creek.

The concentrations of PCBs in sediment upstream of the storm sewer outfall ranged from an estimated value of 22 $\mu\text{g}/\text{kg}$ at US-1 to 1,340 $\mu\text{g}/\text{kg}$ at US-4, with an average detected concentration of 664 $\mu\text{g}/\text{kg}$ (321 $\mu\text{g}/\text{kg}$ of Arochlor 1248 and 402 $\mu\text{g}/\text{kg}$ of Arochlor 1254). The concentration of PCBs in sediment downstream of the storm sewer outfall ranged from 86 $\mu\text{g}/\text{kg}$ to 4,800 $\mu\text{g}/\text{kg}$, with an average detected concentration of 1219 $\mu\text{g}/\text{kg}$ (689 $\mu\text{g}/\text{kg}$ of Arochlor 1248 and 599 $\mu\text{g}/\text{kg}$ of Arochlor 1254). While the average concentration of PCBs almost doubled downstream of the outfall, the concentration of Arochlor 1254, which was detected in the storm sewers on GE's property, only rose by 33%. Thus, the relative concentration of Arochlor 1254 dropped at and downstream of the storm sewer outfall. This relationship is illustrated in Figure 5. Therefore, URS believes that the higher concentrations of total PCBs found downstream of the storm sewer outfall are largely due to migration of PCBs or PCB containing sediments from an unknown source further upstream.
