SUMMARY OF CLOSURE ACTIVITIES

**COMMERCIAL PCB STORAGE AREA
SITE INSPECTION AND
REPAIR SERVICE CENTER
TONAWANDA, NEW YORK**

February 6, 2006

URS CORPORATION – NEW YORK

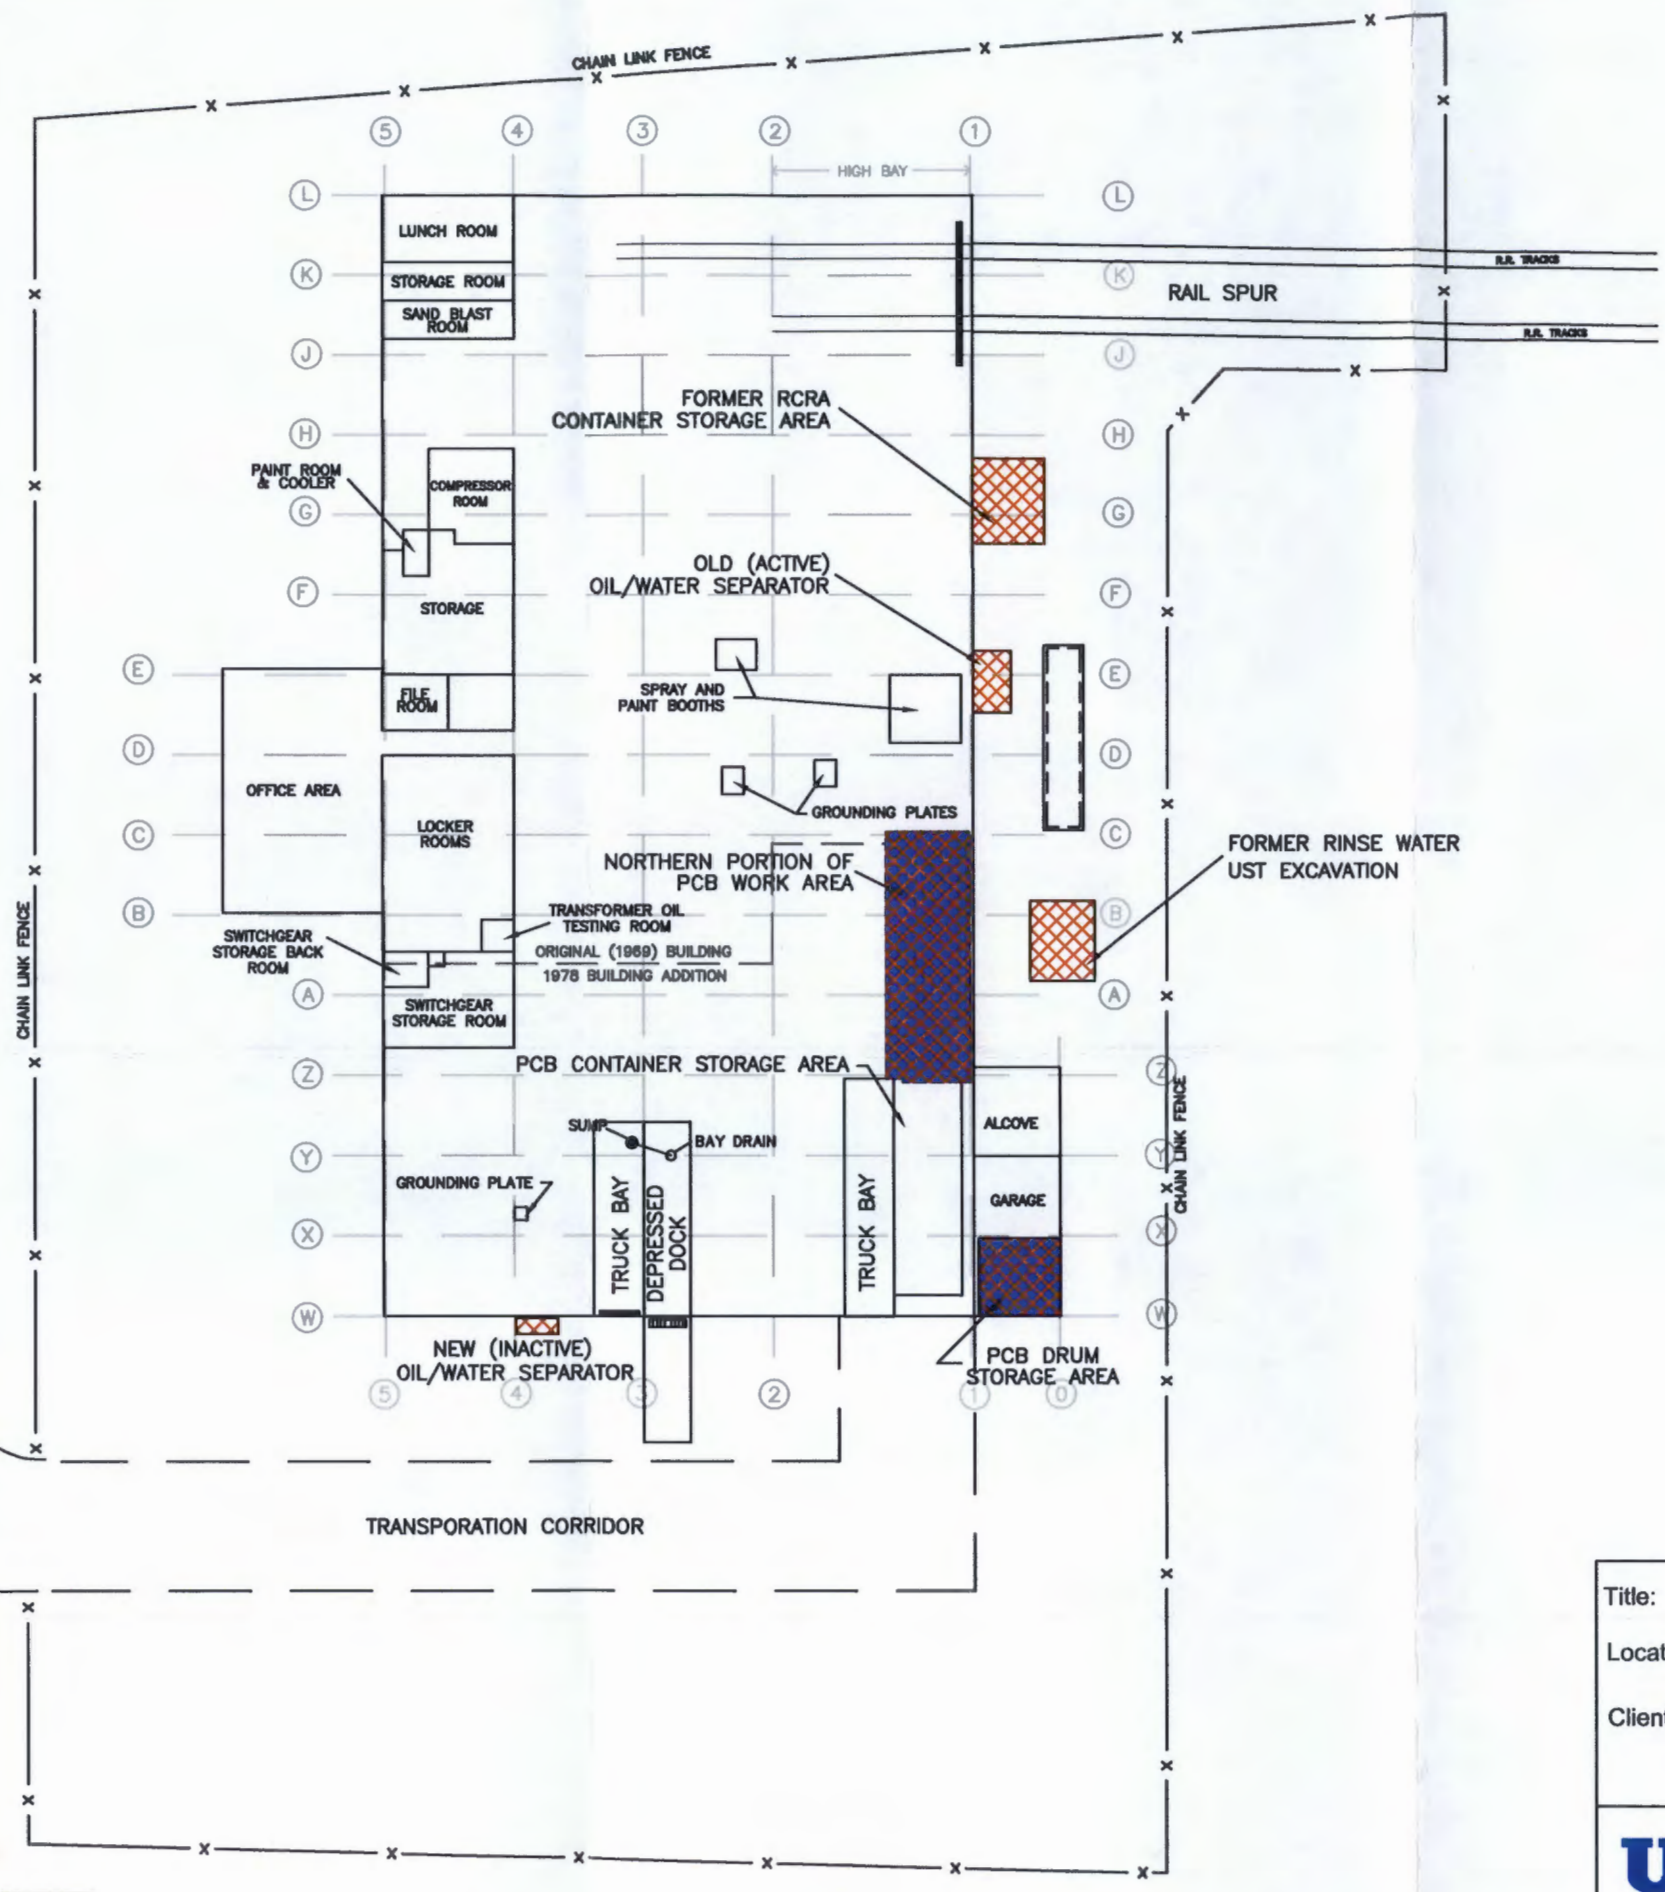
Title: SITE PLAN	
Location: 175 MILENS ROAD TONAWANDA, NEW YORK	
Client:	GE ENERGY
Drafter: KP	Date: February 2006
Drg. Size: 11 X 17	Job No.: 38394429.0000
URS <small>URS Corporation 28 Corporate Drive, Suite 200 Clifton Park, New York 12065</small>	
FIGURE 2

GE managed the PCB wastes in the southeast corner of the building (see Figure 2). GE managed other hazardous wastes in a RCRA Container Storage Area in the east side of the building. The remainder of this section provides background information on each of these two areas, as well as a summary of the RCRA Corrective Actions that GE has conducted at the site.

Each of these areas is shown on Figure 2. Concrete in poor condition in the southern rail bay and along the wall of the depressed dock was removed and repaired. Additionally, the shop elected to epoxy coat the former PCB CSA, from which they had removed the surrounding berm, to match the rest of the floor.

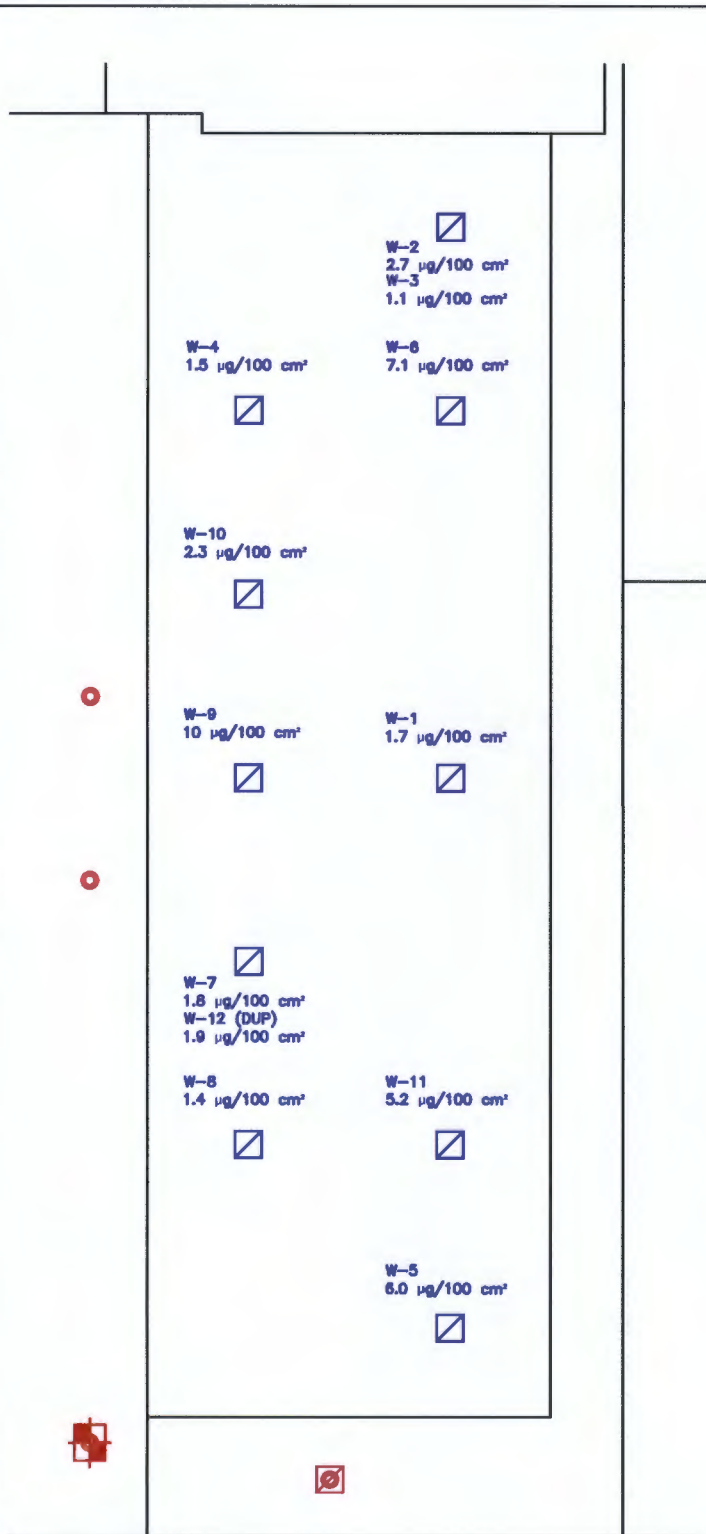
FIGURE 4

The PCB CSA was a bermed area with epoxy coated concrete floors. Field observations indicated that the integrity of the floor and the coating were both good. URS collected eleven wipe samples (W-1 through W-11) and one duplicate sample (W-12) from the area on November 15, 2000. The eleven wipe sample locations were selected based on randomly generated numbers. No discretionary samples were collected because field observations did not identify any locations meeting the requirements for discretionary sampling outlined in the *RCP*. Sampling was conducted in accordance with the procedures presented in the *RCP* and summarized in Section 4.0. Figure 4 shows the wipe sample locations.

None of the analytical results for the 12 wipe samples collected from the PCB CSA were greater than the cleanup objective of $10 \mu\text{g}/100 \text{ cm}^2$ for PCBs. The analytical results for the wipe samples are summarized in Table 1.

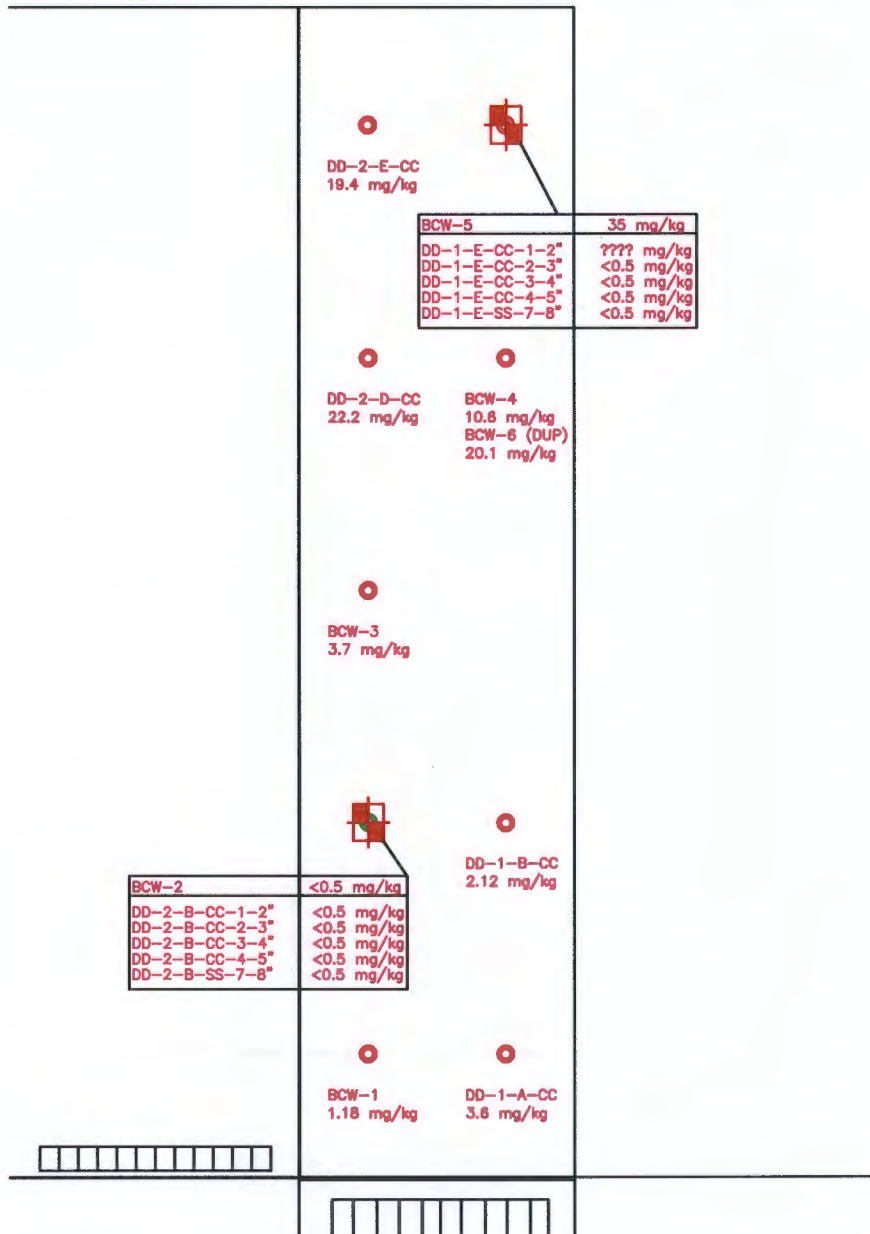
The depressed loading dock is approximately 14 feet wide by 50 feet long. The floor is concrete and was found to be heavily cracked and stained. Several of the cracks were deep and fairly major. Because the floor was not epoxy coated, concrete chip samples were collected. Six samples (BCW-1 through BCW-6), including one duplicate sample (BCW-6), were collected from the depressed dock on November 17, 2000. Three discretionary samples (BCW-1, BCW-3, and BCW-5) were collected from stained areas and the other two sample locations were selected randomly. Sampling was conducted in accordance with the procedures presented in the *RCP* and summarized in Section 4.0 except that the equipment used to collect the chip samples was not rinsed with hexane. Figure 6 shows the sampling locations.

The six concrete chip samples were analyzed for PCBs, and the analytical results are summarized in Table 2. Equipment rinsate blank results are summarized in Table 3. As shown in Table 3, PCBs were not detected in the equipment rinse blank (R-1). Thus, URS does not believe utilizing alternate decontamination procedures is a substantive variance from the procedures in the *RCP*. The analytical results for five of the six concrete chip samples exceeded the cleanup objective of 1 mg/kg for PCBs. Therefore, in accordance with the *RCP*, additional investigation (Task 7) and remedial measures (Task 8) were undertaken for this area.

- Depressed Dock – The west wall of the depressed dock, on which the concrete was degraded, was repaired. The removed concrete was drummed and disposed with the other remedial waste (Task 10). Additionally, the walls of the depressed dock received a base coat of medium grey epoxy and a top coat of dark grey epoxy to provide a better visual difference between the walls of the depressed dock and the floor of the shop.
