RE: Corrective Measure Completion Final Report
GE Parts and Repair Service Center
Tonawanda, New York
NYSDEC Site ID: 915244
EPA ID: NYD067539940
Permit ID: 9-1464-00044/00001

**PARTS AND REPAIR SERVICE CENTER
GENERAL ELECTRIC INTERNATIONAL, INC.**

**CORRECTIVE MEASURE COMPLETION
FINAL REPORT**

JUNE 3, 2016

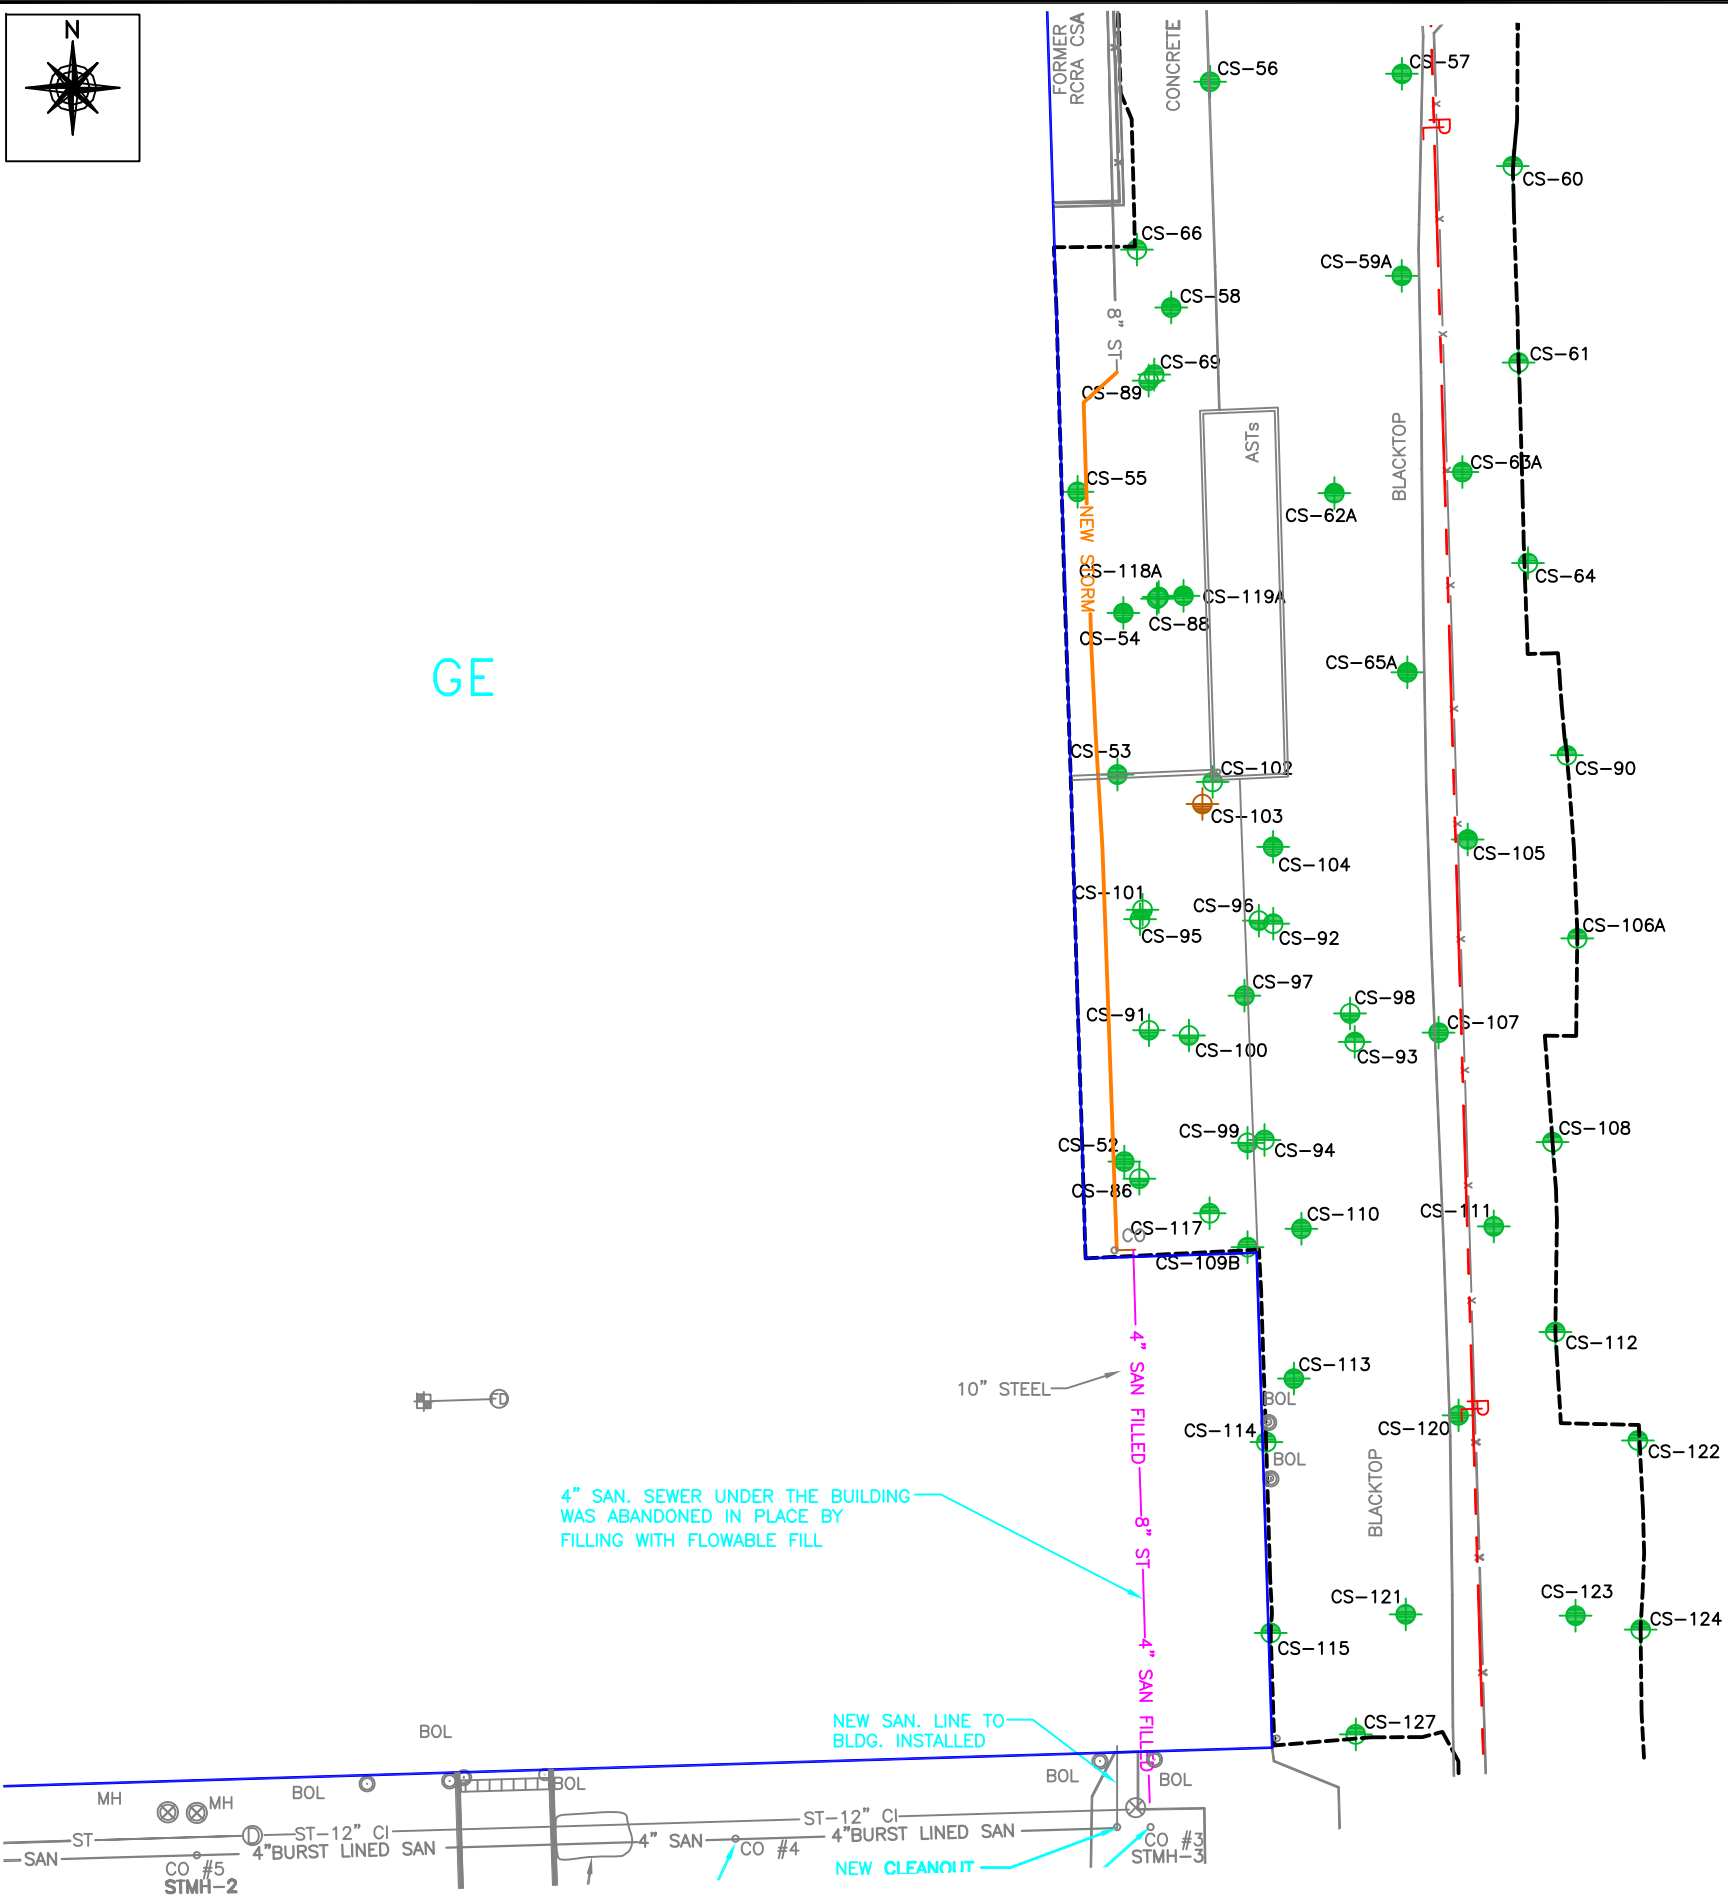
4" SAN. SEWER UNDER THE BUILDING WAS ABANDONED IN PLACE BY FILLING WITH FLOWABLE FILL

NEW SAN. LINE TO BLDG. INSTALLED

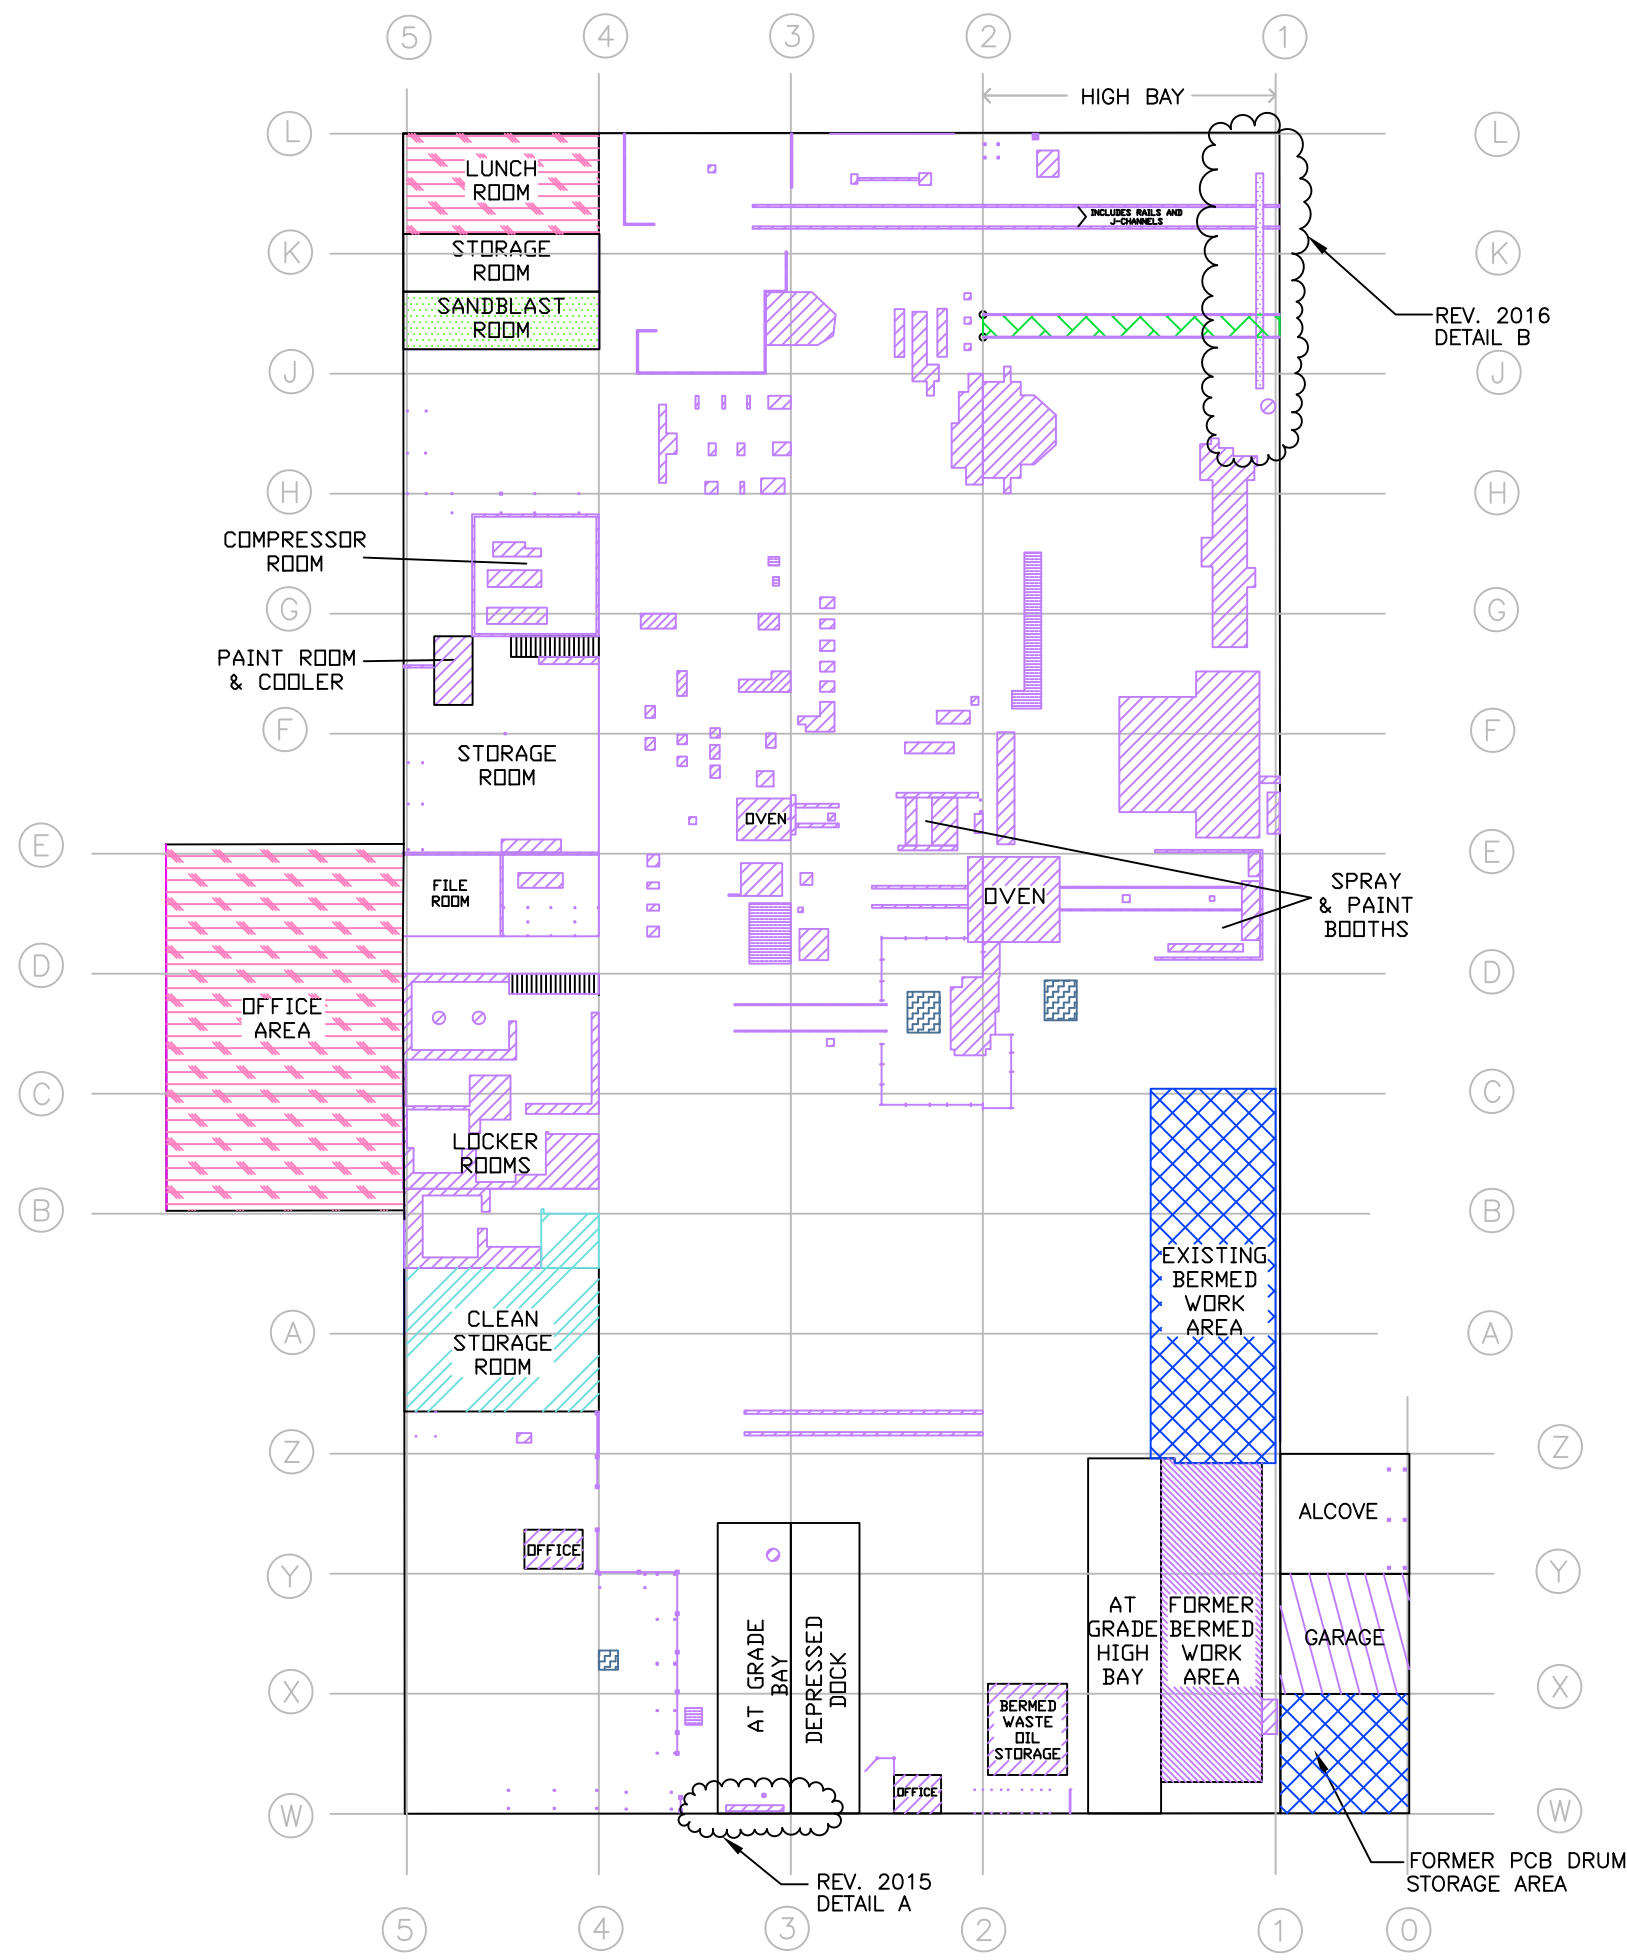
DETAIL A
2015 TRENCH DRAIN REMOVAL
(NOT TO SCALE)

DETAIL B
TRENCH DRAIN REHABILITATION
(NOT TO SCALE)
