2015-2016 Site Observations
Corrective Measure Implementation

| <p>AECOM Project No.: 60442945</p> | <p>GE Parts and Repair Service Center 175 Milens Road Tonawanda, New York</p> | <p>Client Name: General Electric International, Inc.</p> |

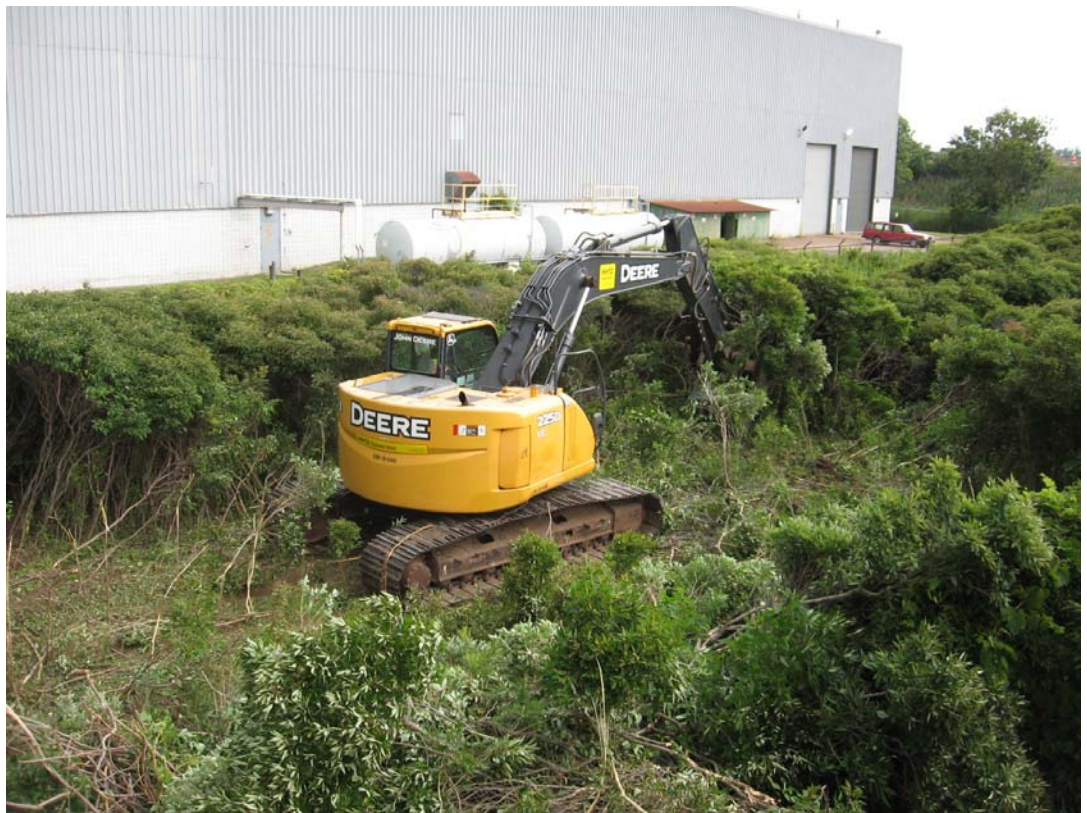
PHOTO NO: 1

Description:
View of an excavator removing brush in the area where a temporary fence will be installed.

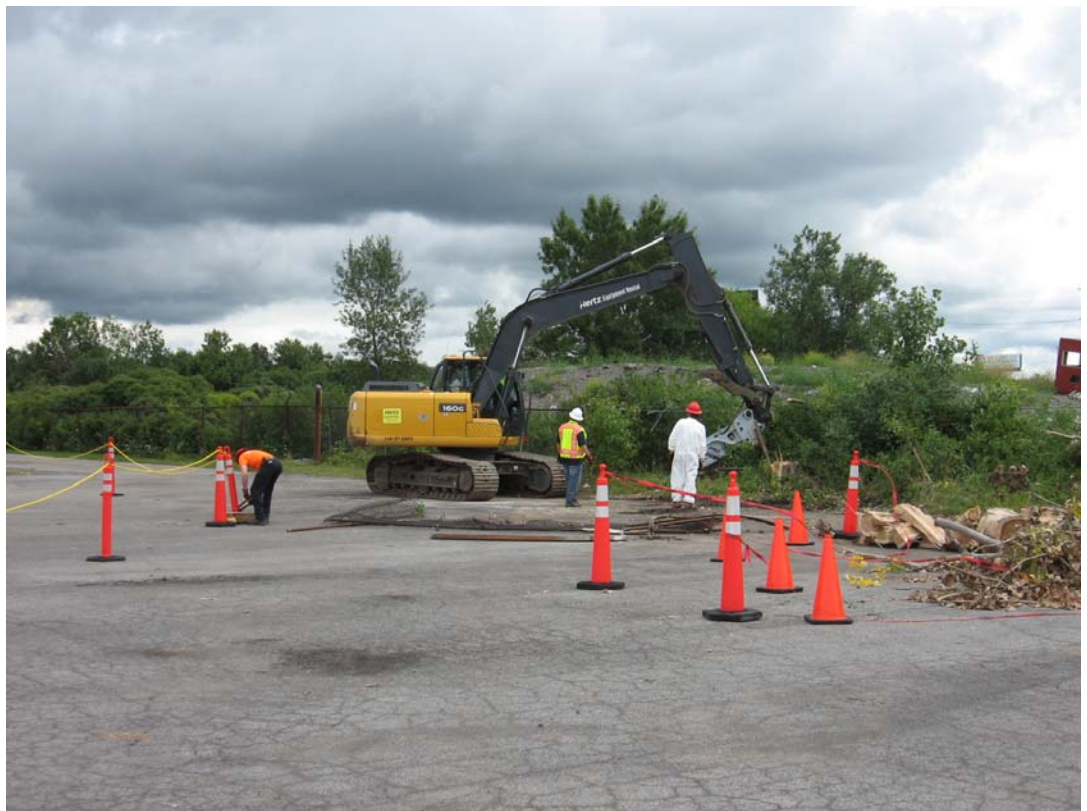
PHOTO NO: 2

Description:
View of an excavator removing existing facility fence near southeast corner of GE property.

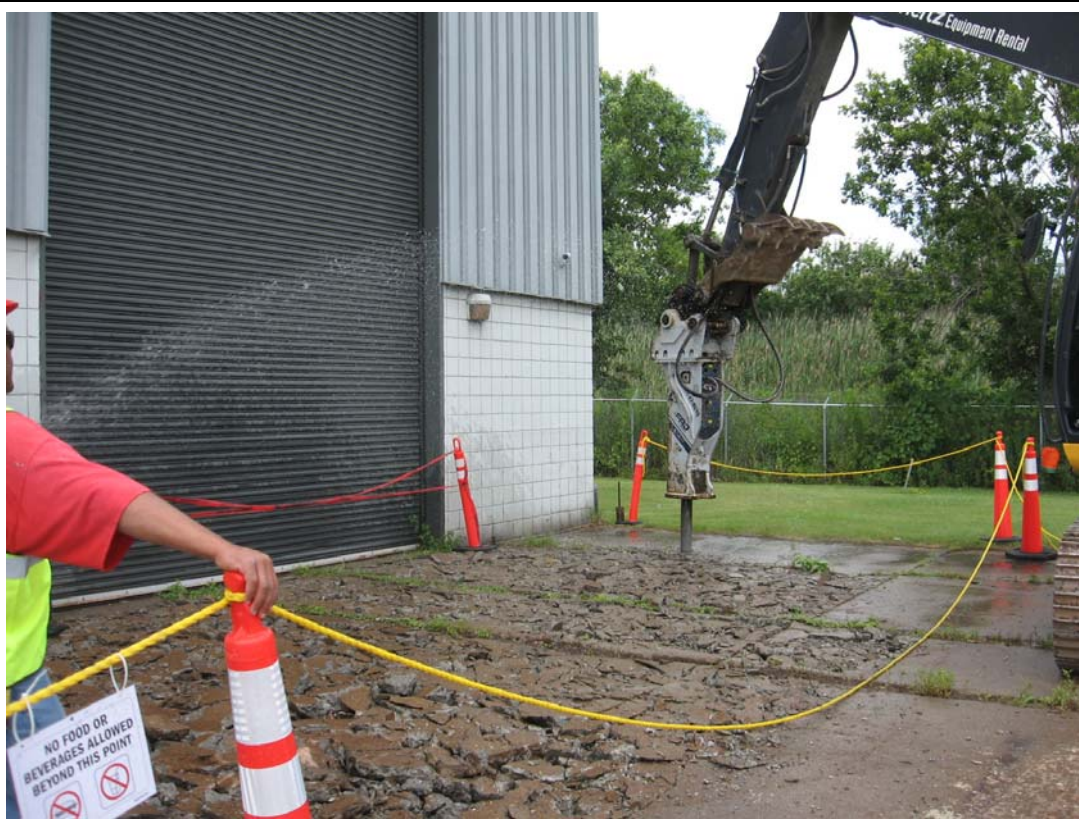
PHOTO NO: 3

Description:
Excavator with hydraulic hammer breaking up concrete at northeast corner of the GE building.

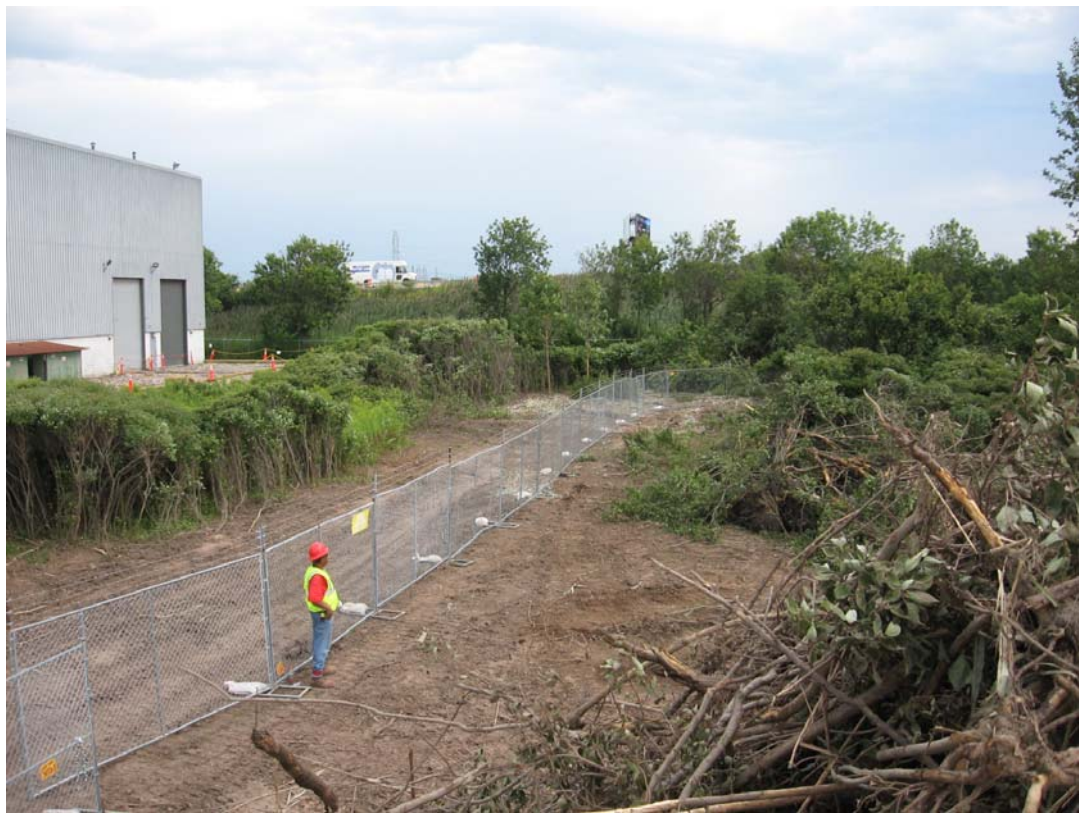
PHOTO NO: 4

Description:
View of newly installed temporary fence on DKP property.

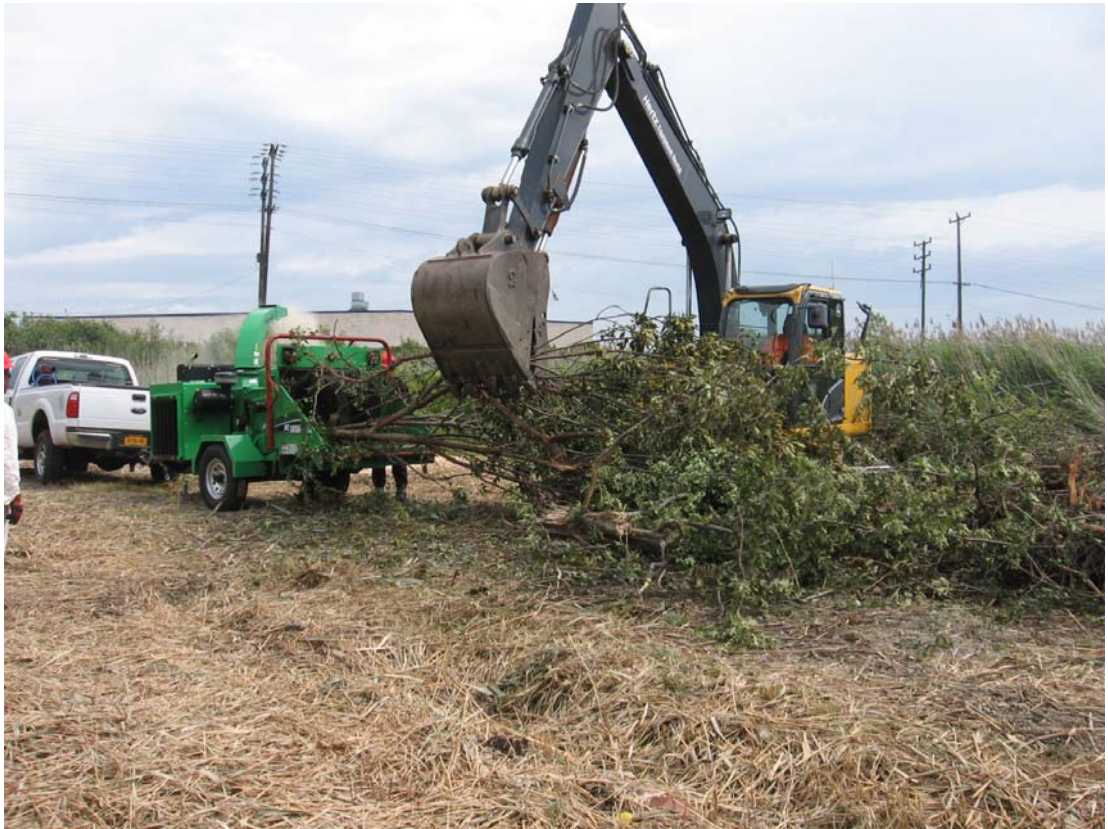
PHOTO NO: 5

Description:
View of a wood chipper being used to chip small trees and brush.

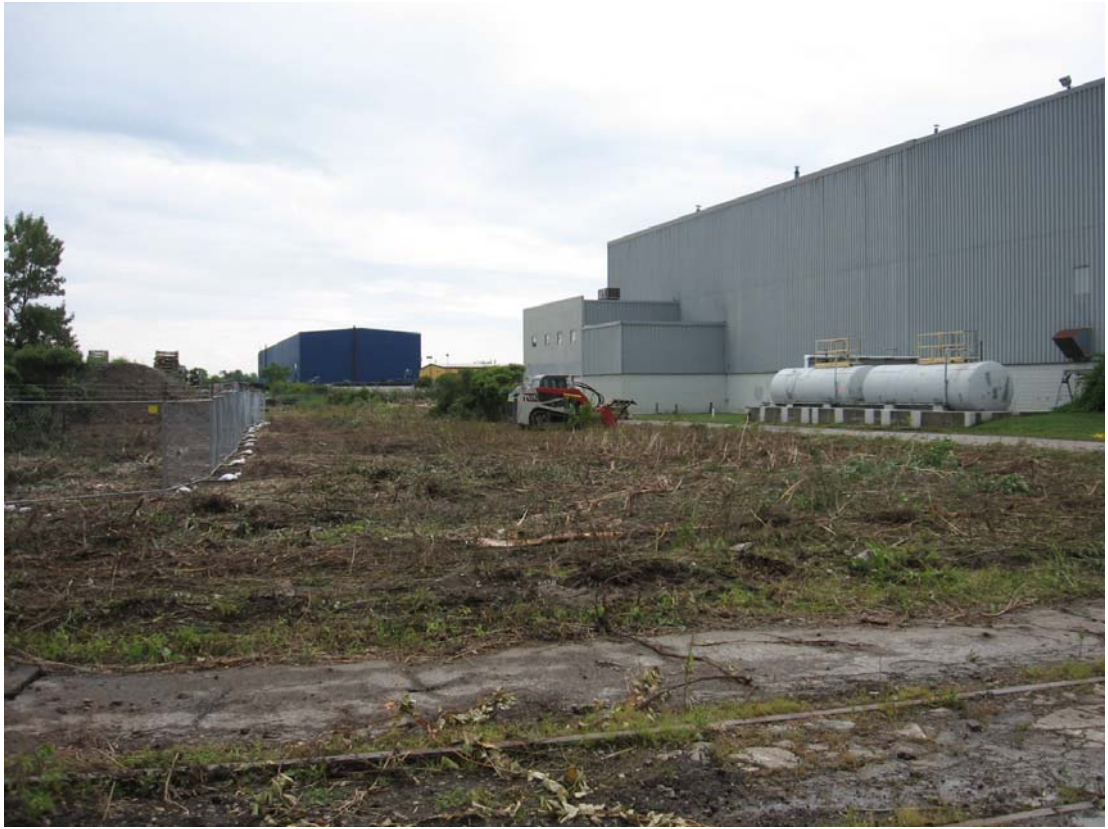
PHOTO NO: 6

Description:
Using a skid steer with forestry attachment to clear small brush.

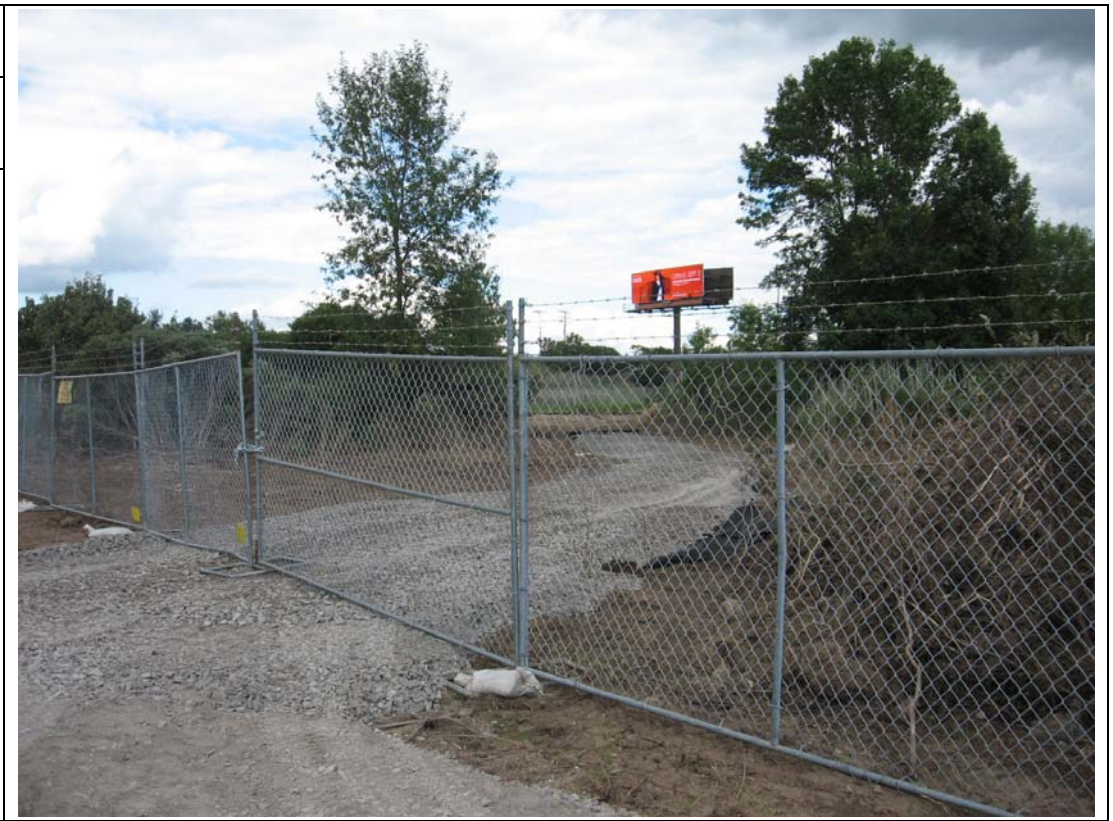
PHOTO NO: 9

Description:
Gate in the temporary fence where the road turns to the northeast towards the Lamar advertising sign.

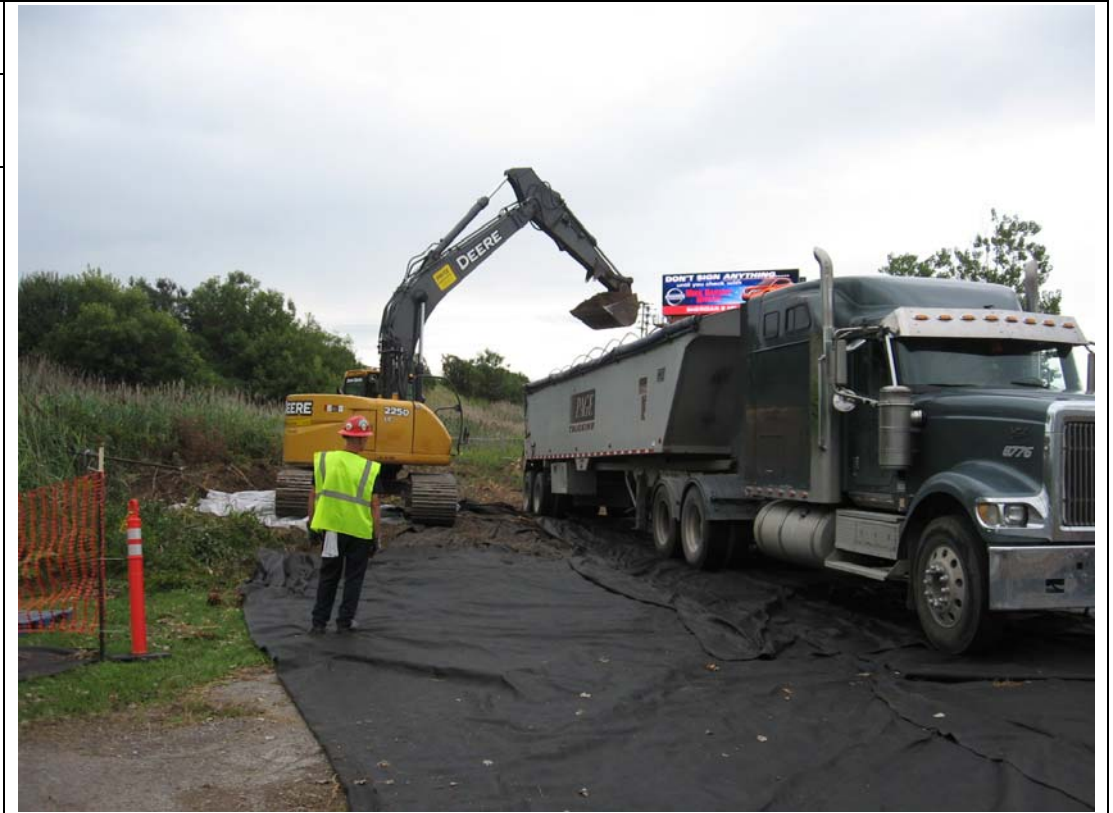
PHOTO NO: 10

Description:
Loading hazardous waste soil at northeast corner of the Site. Note that the equipment was placed on fabric to prevent contact of tracks and wheels with impacted soil.

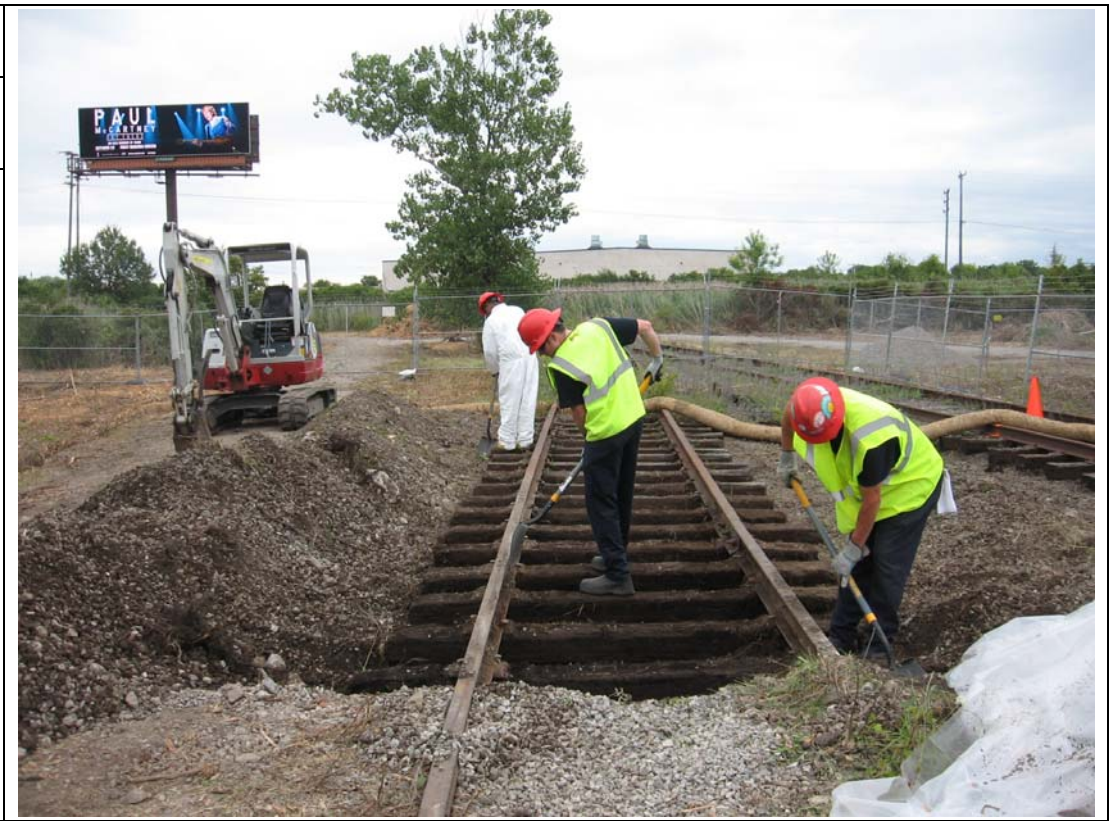
PHOTO NO: 11

Description:
One foot excavation of soil over and around the railroad tracks required hand digging. View is of the eastern most section of the railroad tracks.

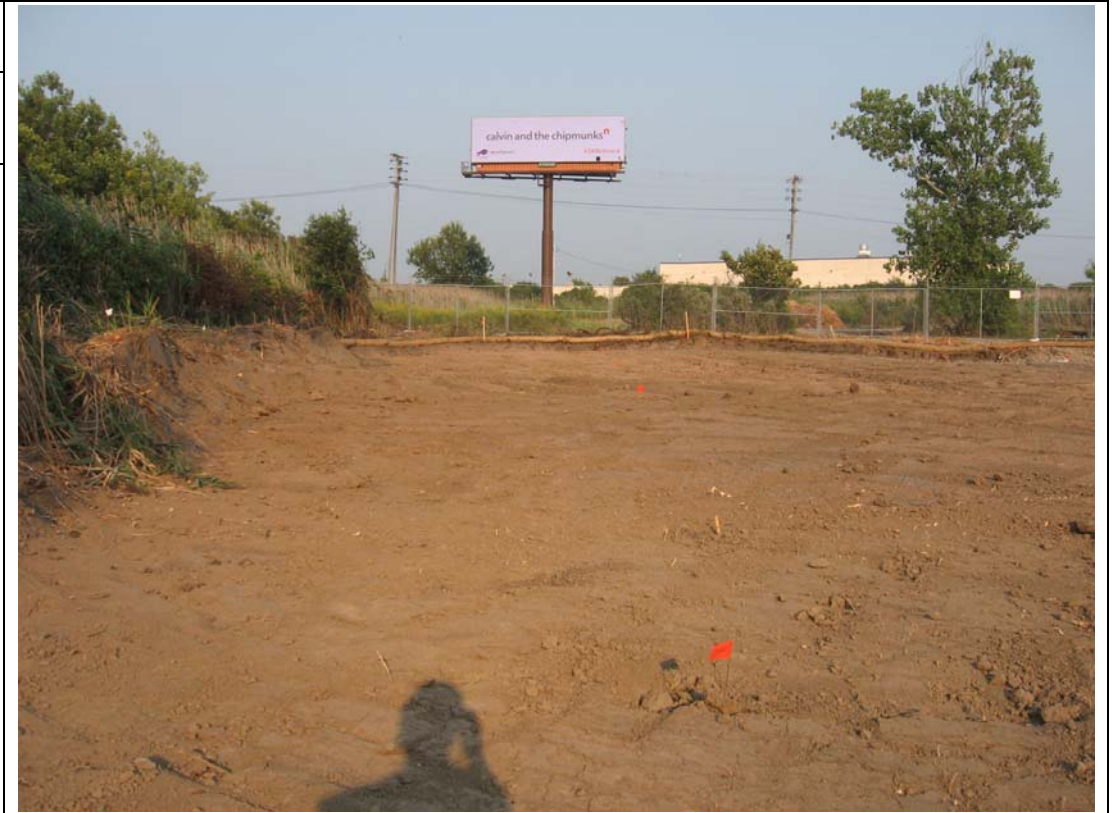
PHOTO NO: 12

Description:
View of the northeast corner of the Site after the one foot excavation. The orange flags mark confirmatory soil sample locations.

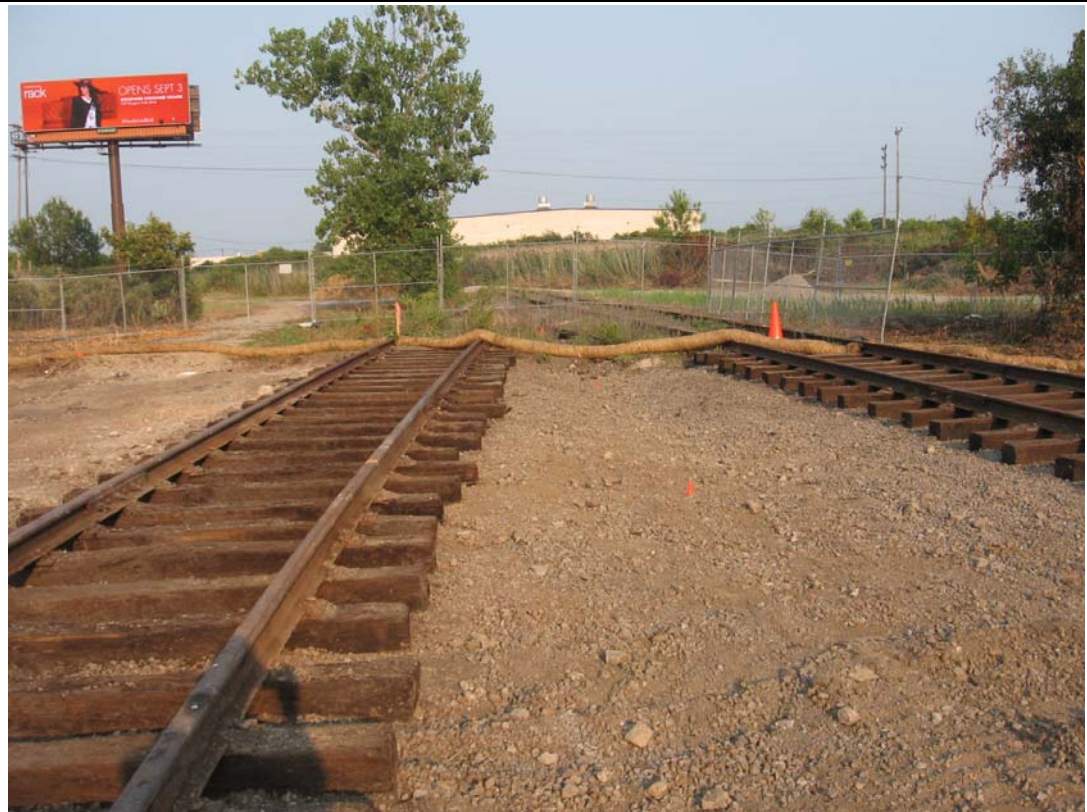
PHOTO NO: 13

View of northeastern portion of the Site after excavation. The orange flags mark confirmatory soil sample locations.

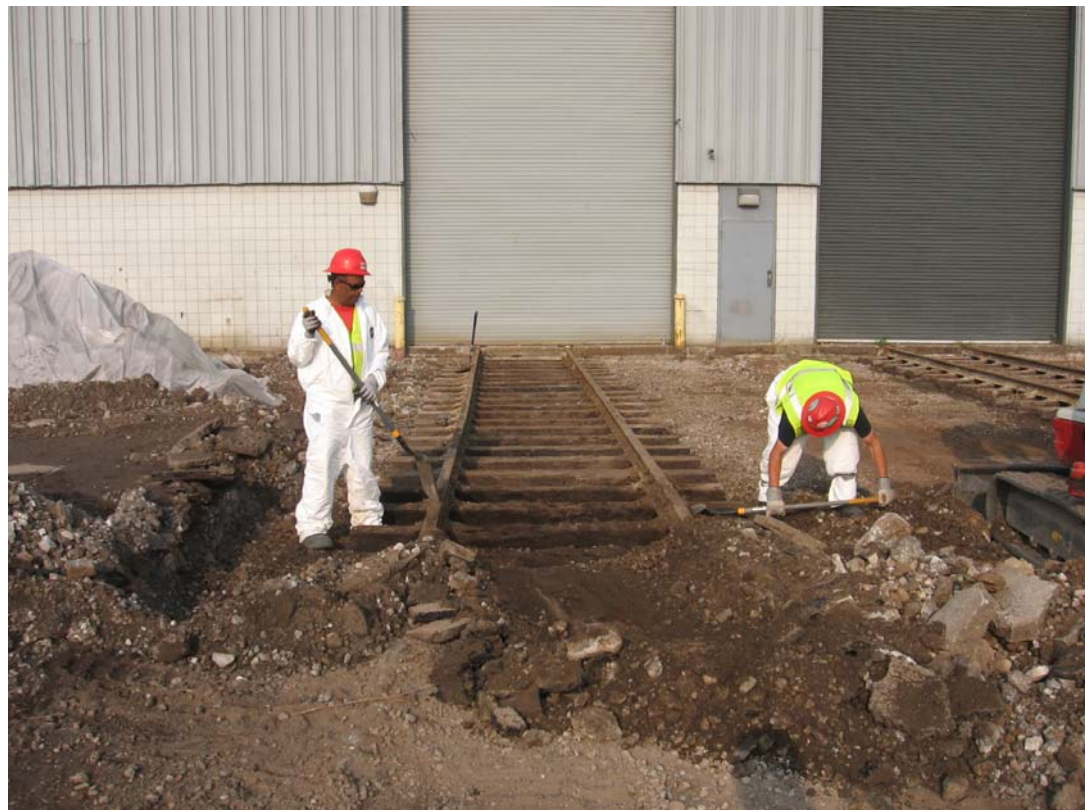
PHOTO NO: 14

One foot excavation of soil at railroad tracks adjacent to GE building.

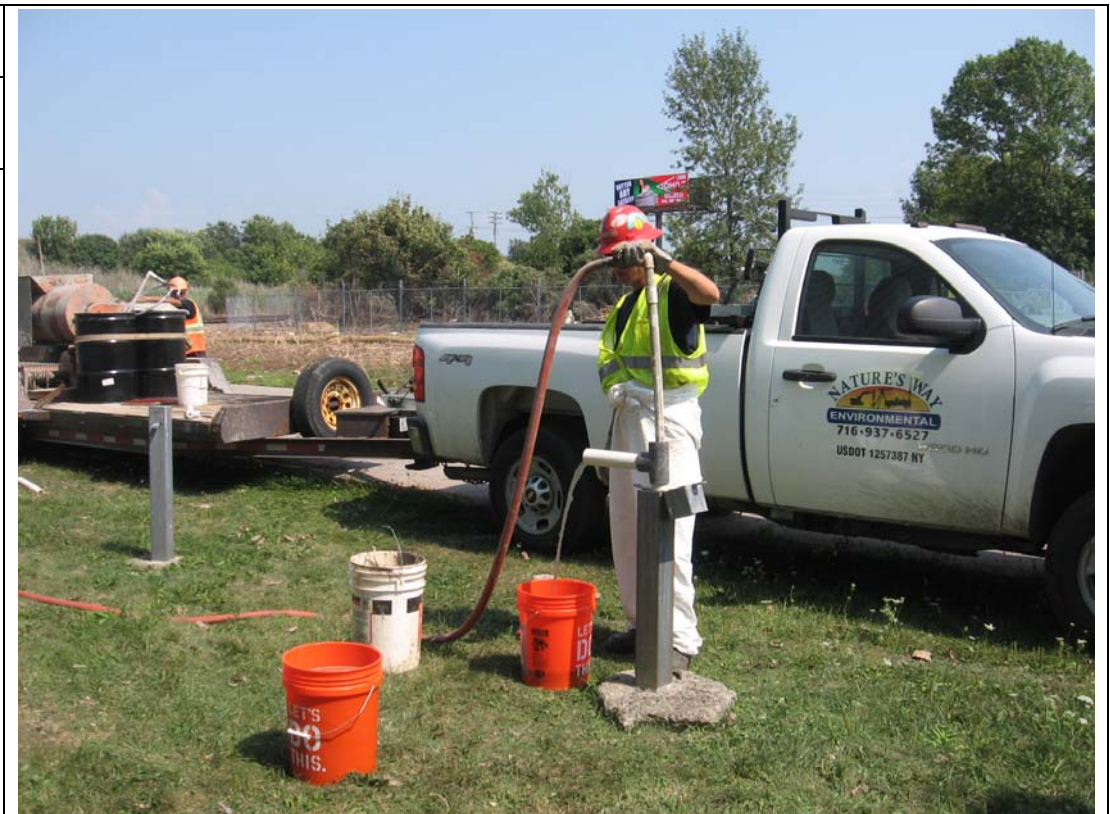
PHOTO NO: 15

Description:
Decommissioning of monitoring well MW-5 by filling the casing and screen with a bentonite and portland cement grout.

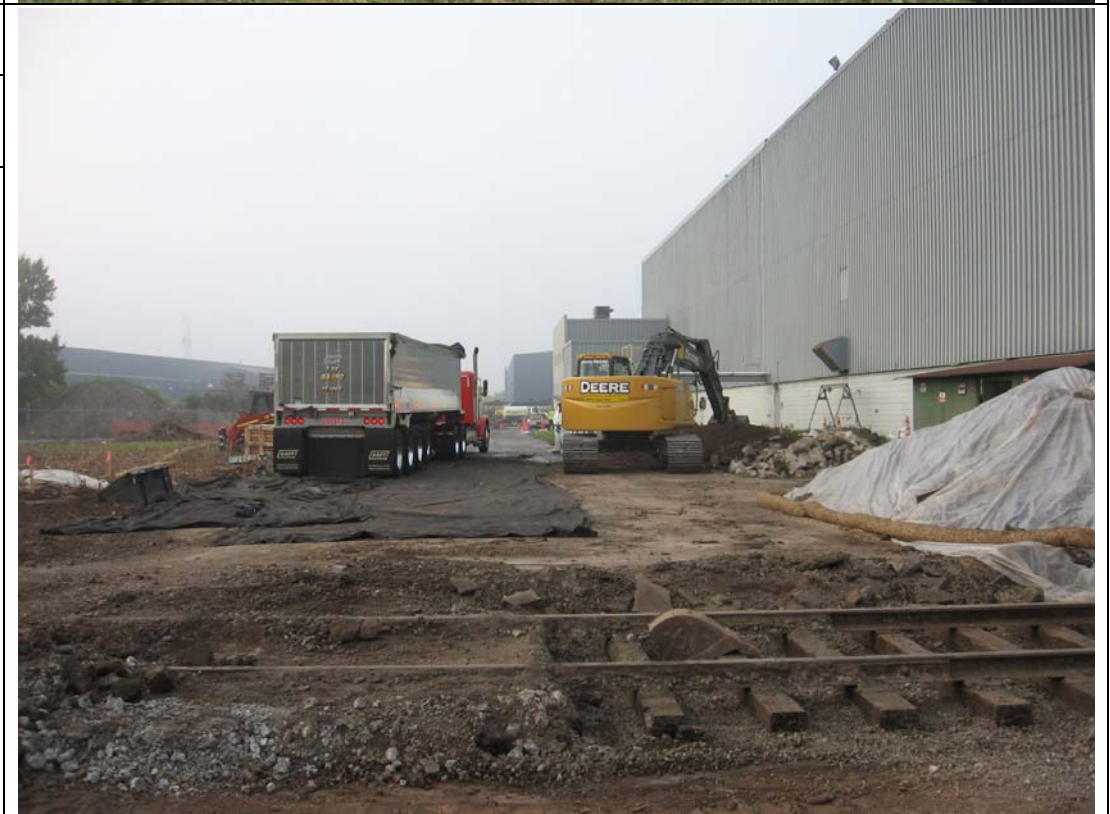
PHOTO NO: 16

Description:
Loading non-hazardous soil for shipment off-site. Note that the truck and trailer are parked on fabric to prevent contact of the truck and trailer tires with impacted soil.

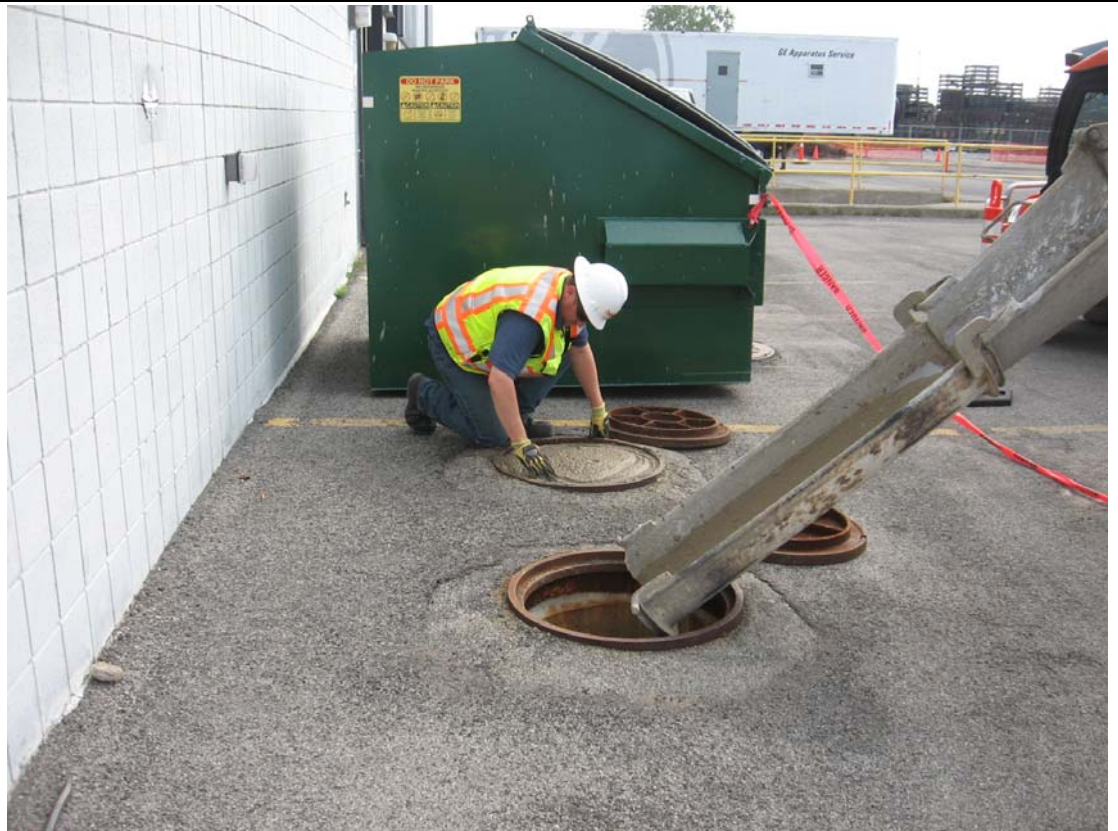
PHOTO NO: 17

Description:
New oil water separator (along south side of GE building) being filled with flowable fill to abandon in-place.

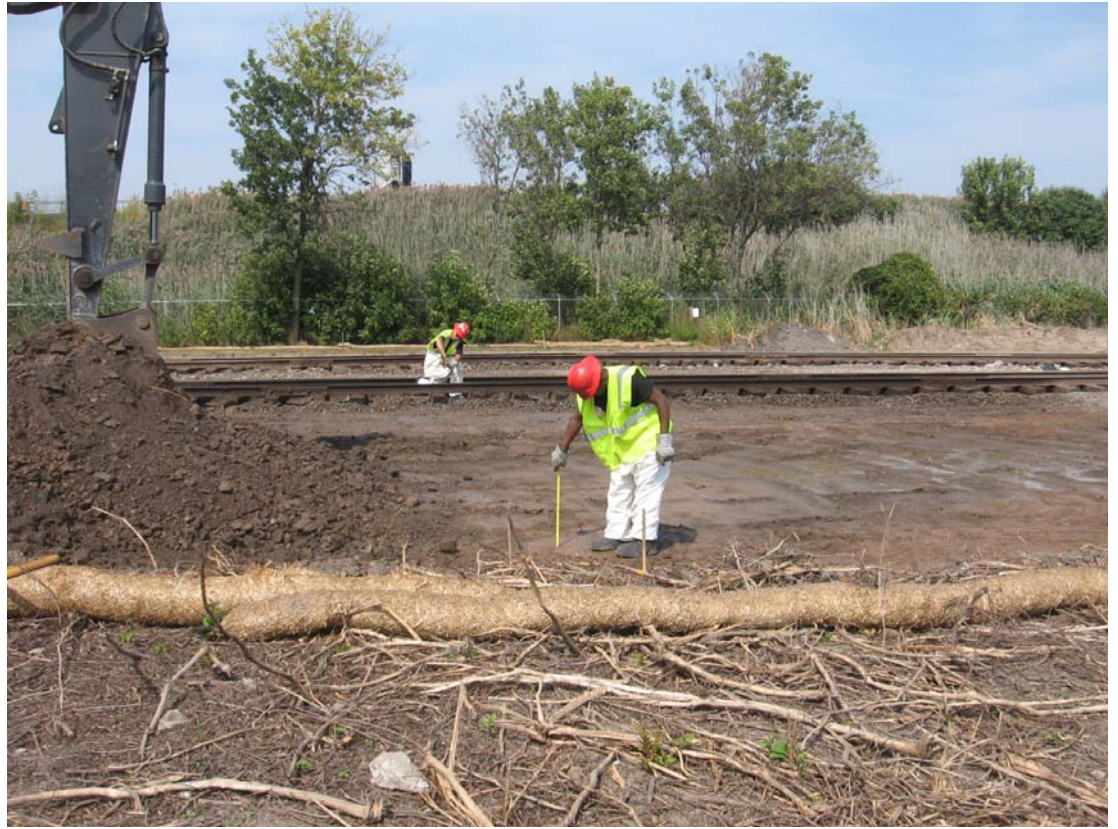
PHOTO NO: 18

Description:
Depth of excavation being measured by a string line and measuring tape.

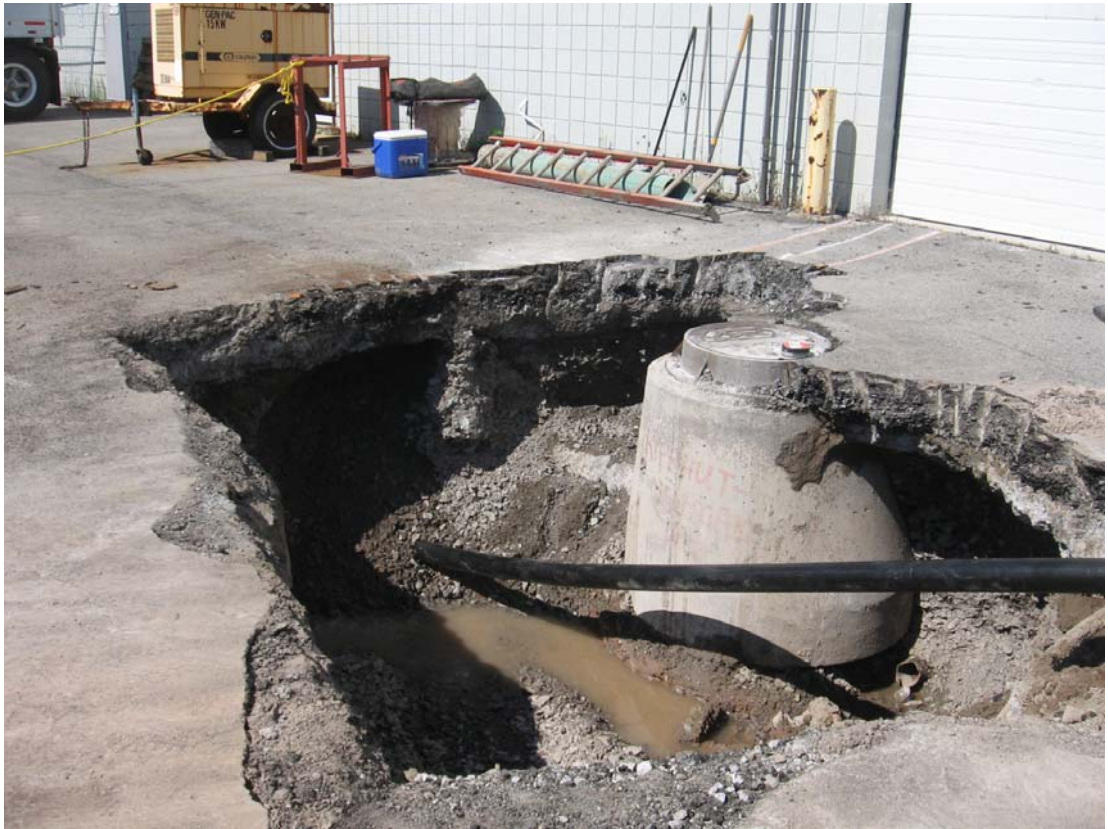
PHOTO NO: 21

Description:
Replacement sanitary sewer line being pulled through existing sanitary sewer line behind cutting head shown in Photo No. 20.

Note: Manhole is for storm sewer system.

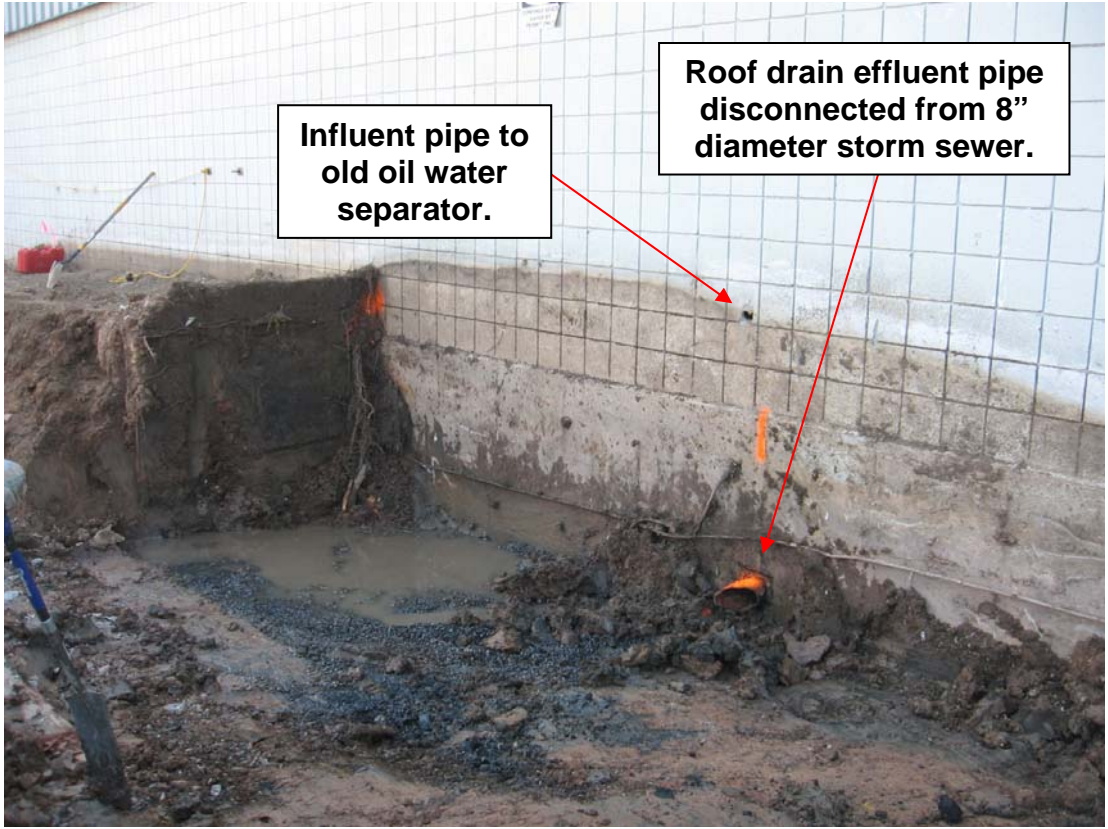
PHOTO NO: 22

Description:
View of soil below the old oil water separator. Note the locations of the old oil water separator influent pipe and the roof drain effluent pipe. Completed excavation is shown in Photo No. 25.

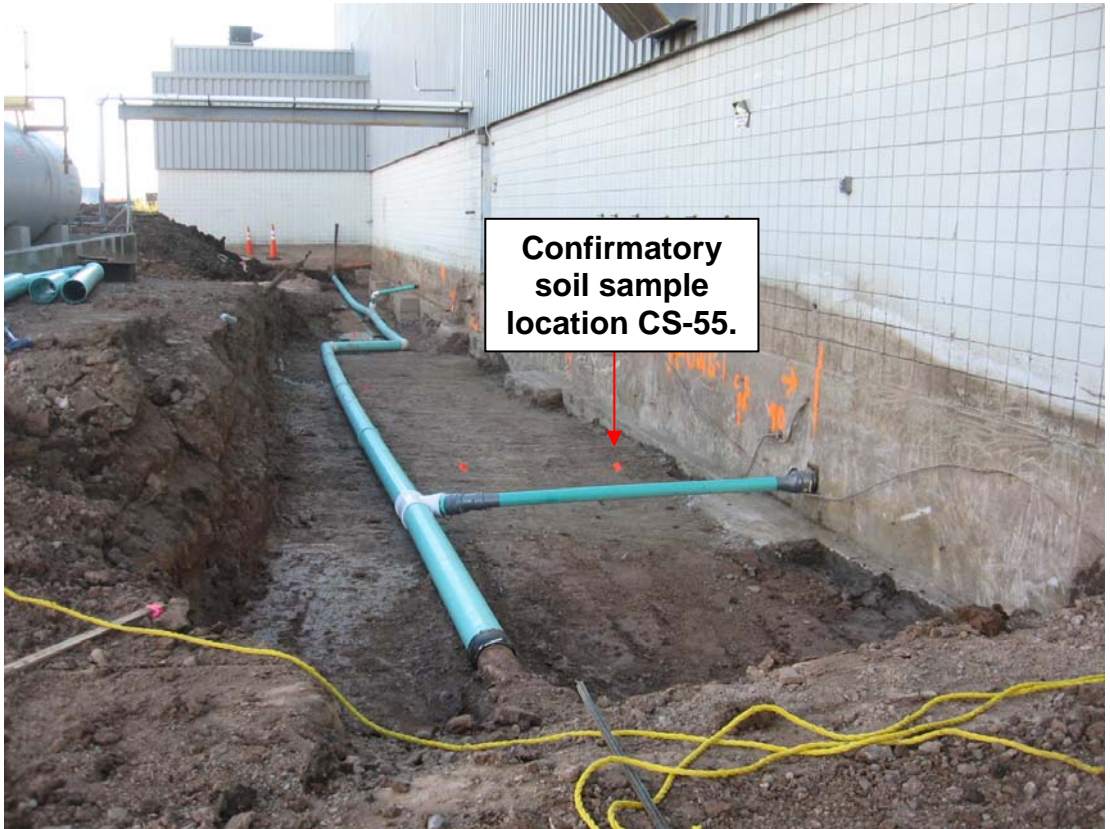
PHOTO NO: 25

Description:
View of the completed excavation along the former storm and sanitary sewer lines, and temporary 8" diameter storm sewer pipe. Note that base of excavation below former old oil water separator has reached native (undisturbed) and unstained clay. Orange flags mark confirmatory soil sample locations.

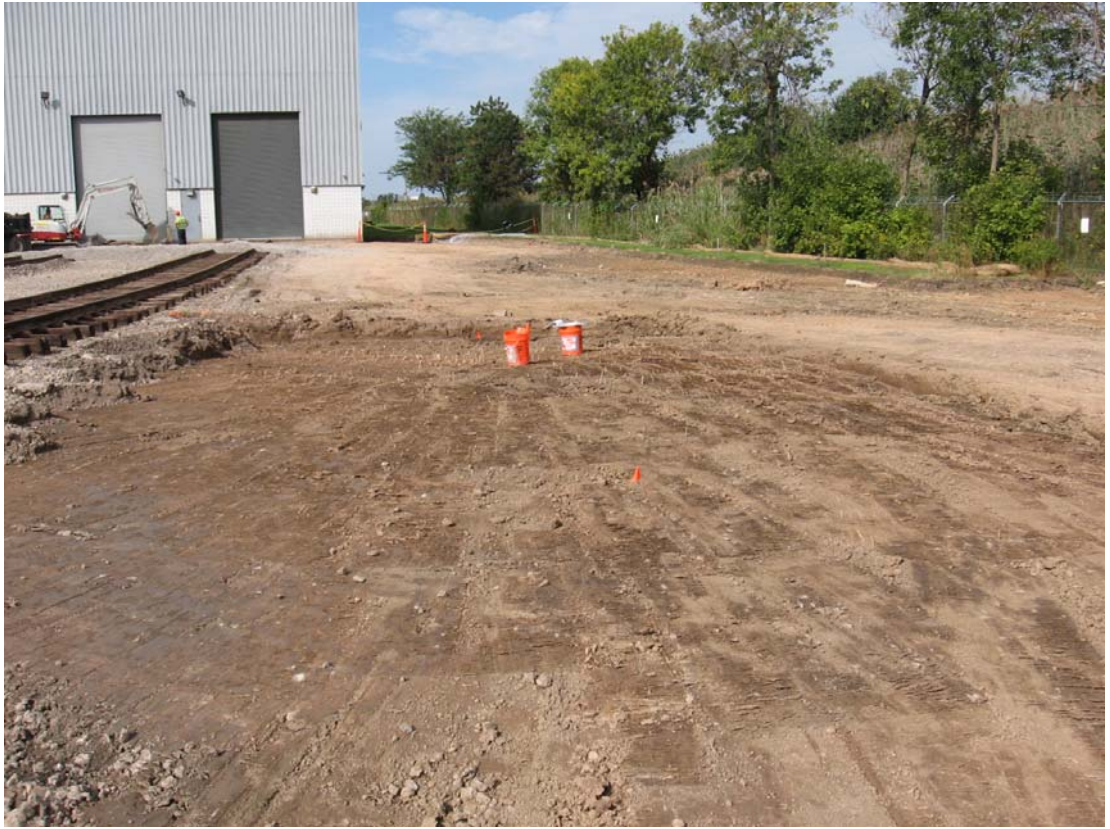
PHOTO NO: 26

Description:
View of an additional 0.5 foot excavation at the sample CS-24 and sample CS-25 areas, northeastern portion of the Site.

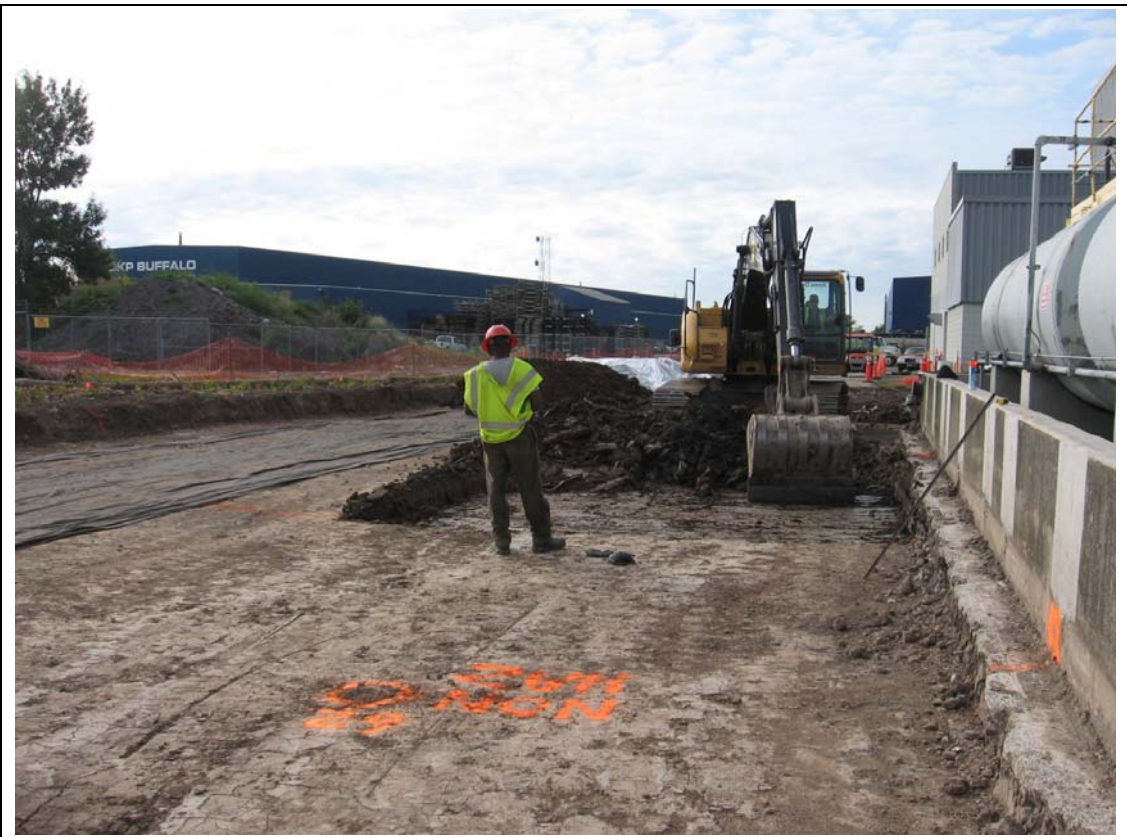
| <p>PHOTO NO: 27</p> | |

| <p>Direction: South</p> <p>Description: View of an additional 0.5 foot excavation at the sample CS-65 location. Additional removal planned for CS-62 location in foreground.</p> | |

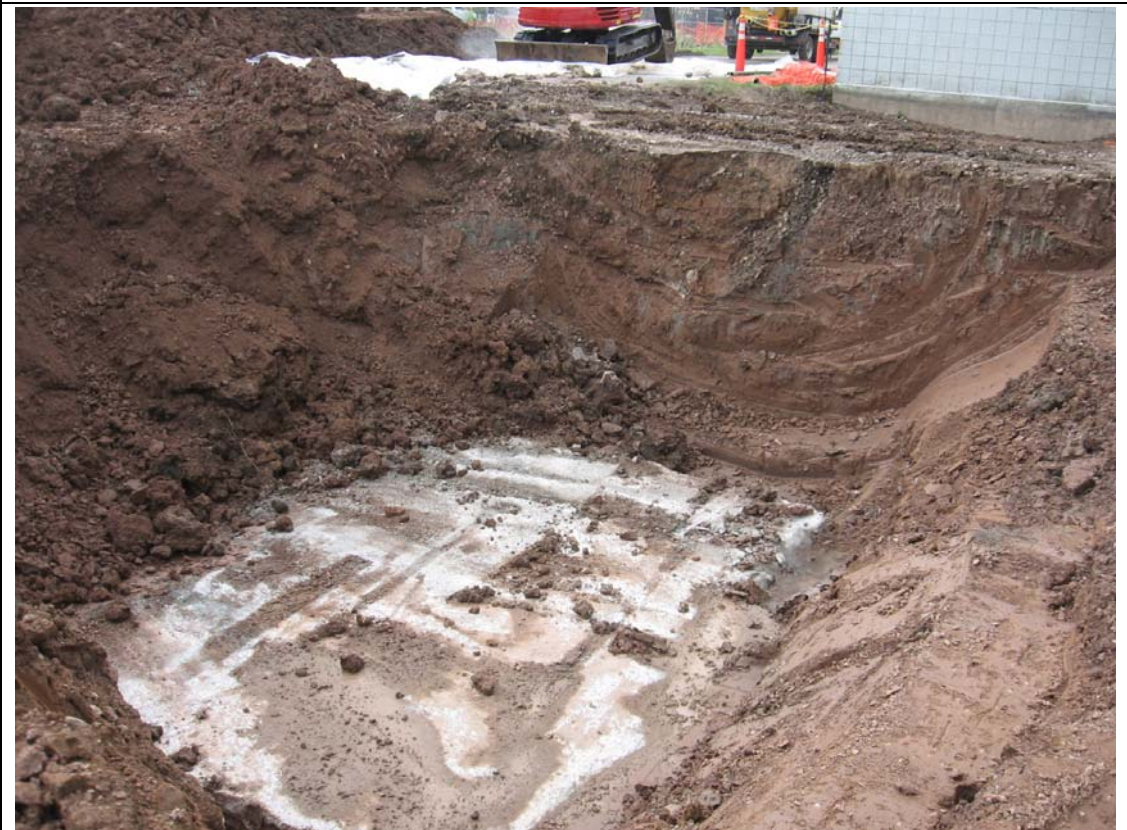
| <p>PHOTO NO: 28</p> | |

| <p>Direction: South</p> <p>Description: View of the concrete pad at the base of the former rinse water tank excavation.</p> | |

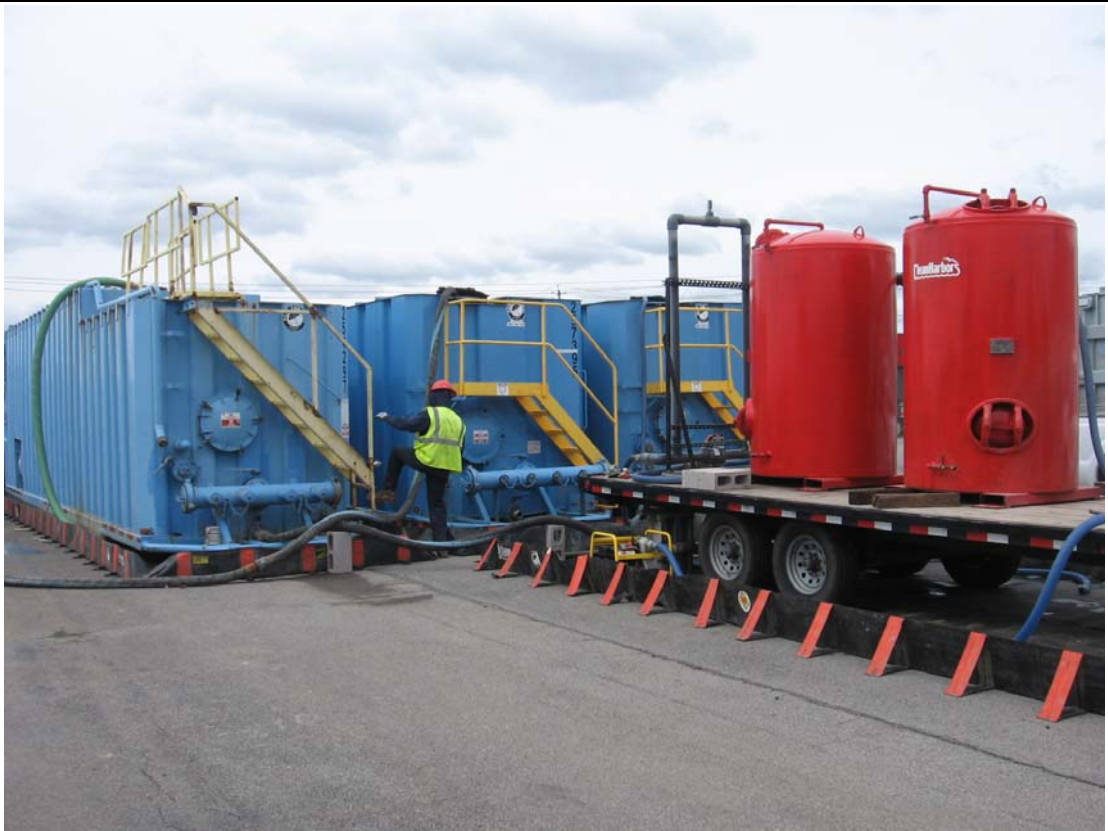
PHOTO NO: 31

Description:
View of the 3 on-site frac tanks and water treatment filter tanks. Note that all of the equipment lies within splash pads.

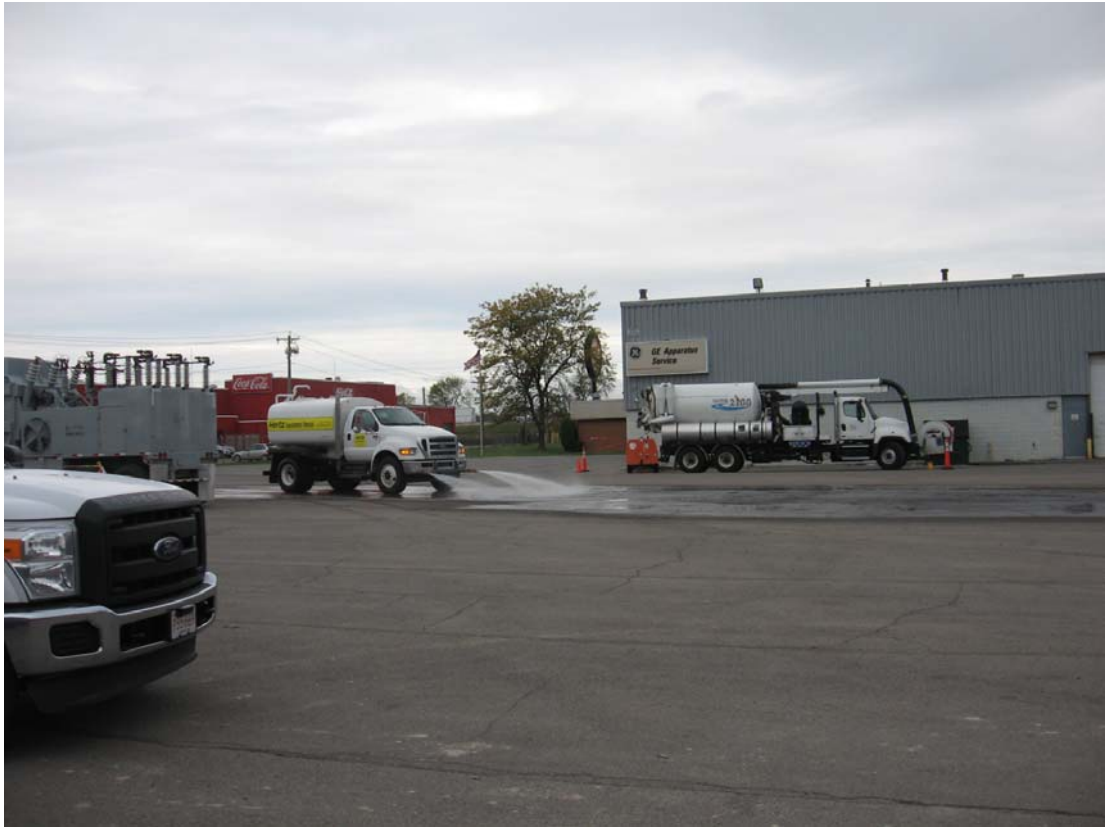
PHOTO NO: 32

Description:
View of the project water truck wetting down the parking lot.
