2015-2016 Site Observations
Corrective Measure Implementation

| <p>AECOM Project No.: 60442945</p> | <p>GE Parts and Repair Service Center 175 Milens Road Tonawanda, New York</p> | <p>Client Name: General Electric International, Inc.</p> |

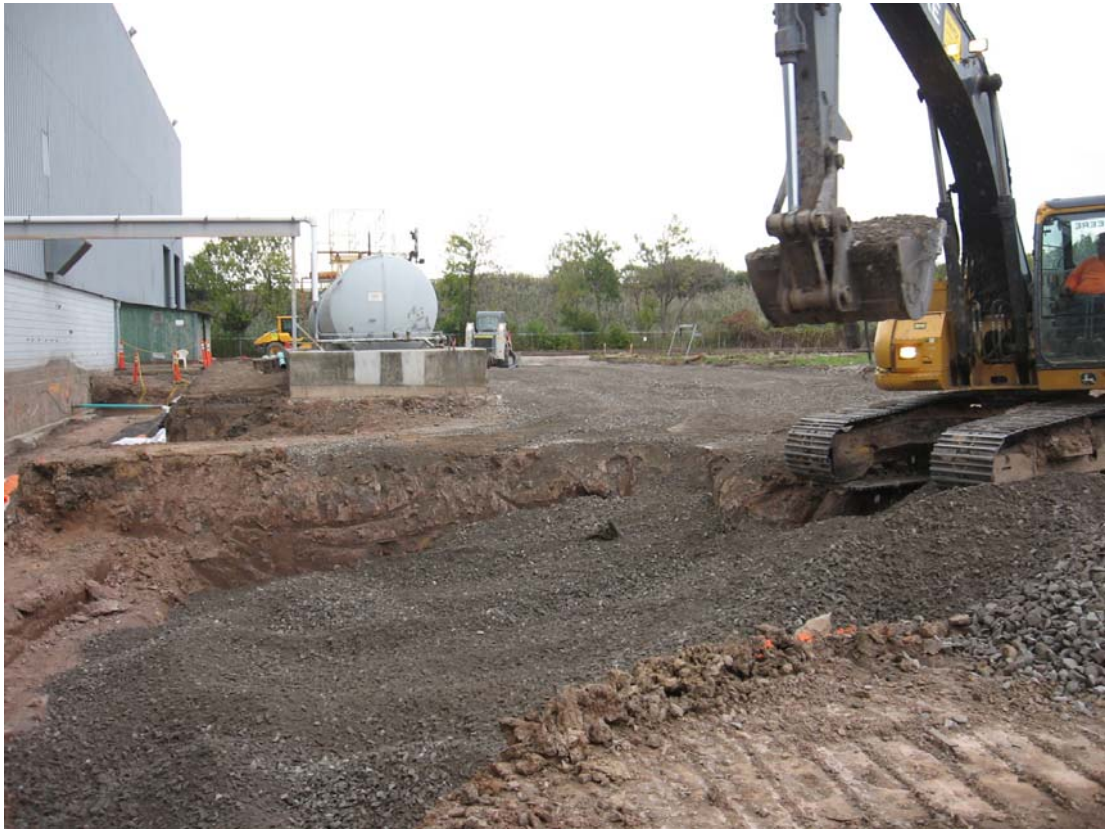
PHOTO NO: 33

Description:
Excavator backfilling the former rinse water tank excavation with No. 2 crusher run.

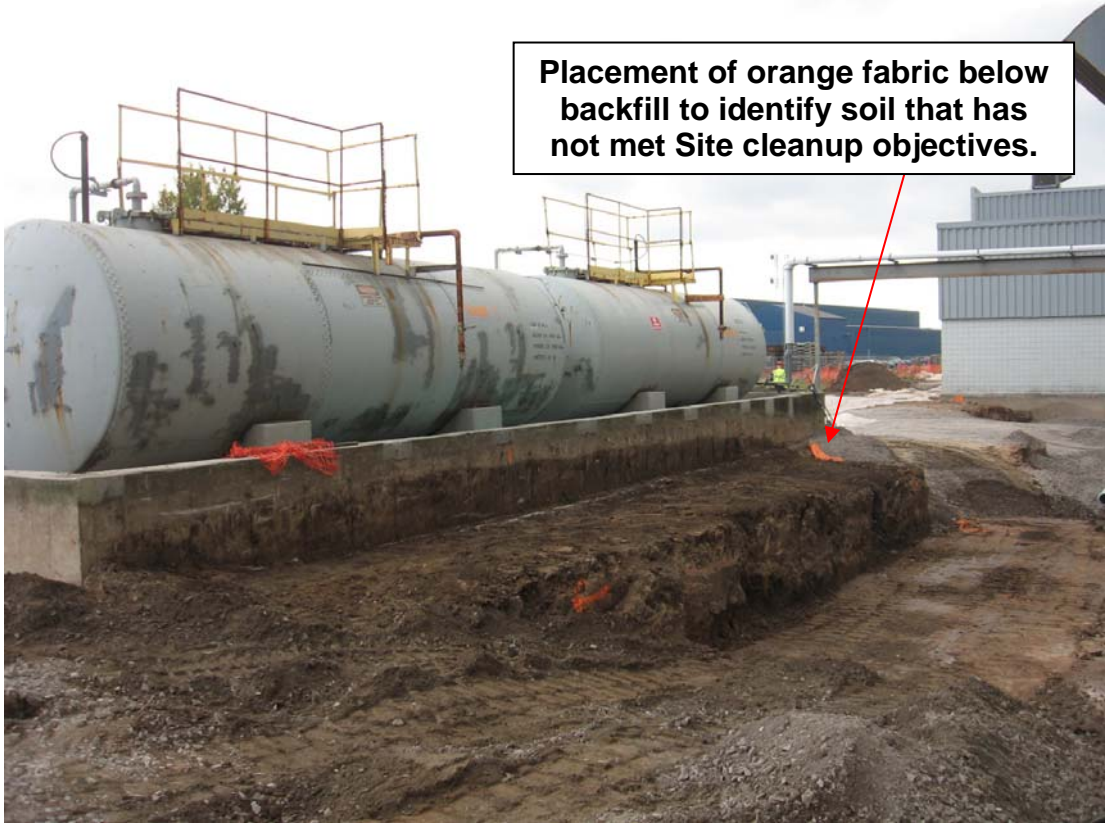
PHOTO NO: 34

Description:
View of a strip of orange fabric over soil left in place at the southwest corner of the ASTs that has not met the Site cleanup objective of 1 ppm PCBs. Additional soil removal not possible without undermining AST containment structure.

Placement of orange fabric below backfill to identify soil that has not met Site cleanup objectives.

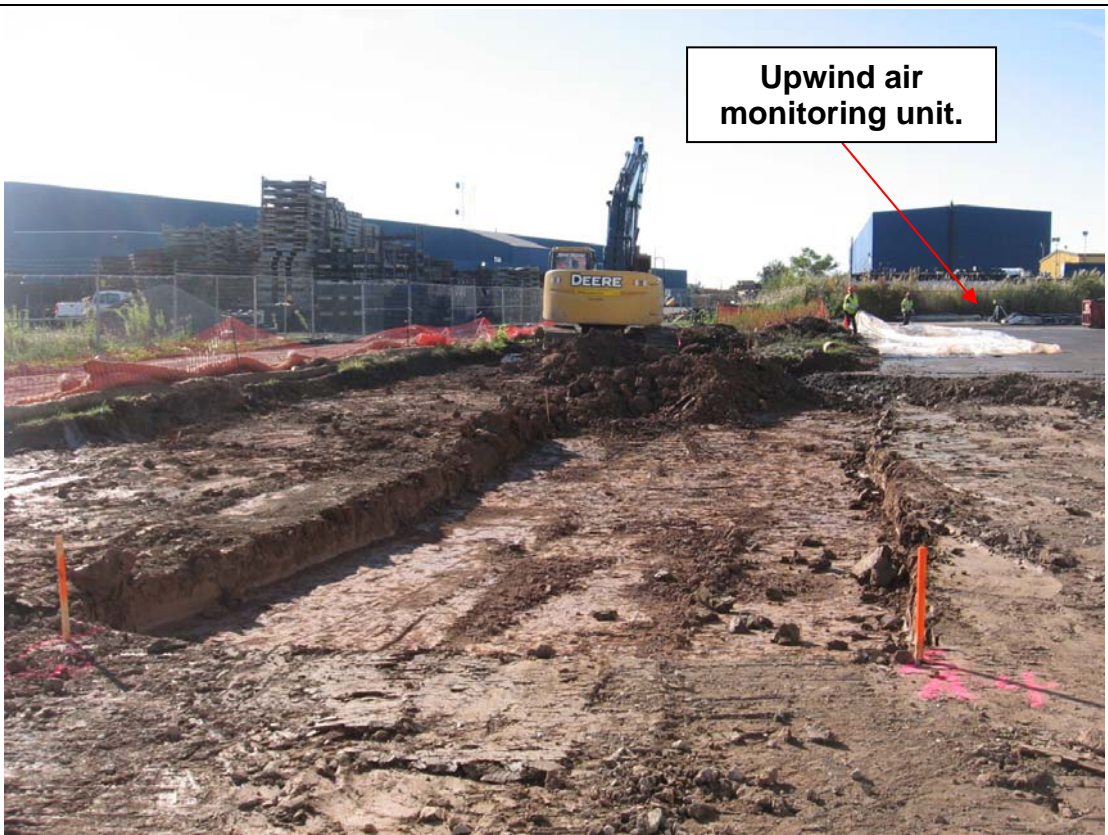
PHOTO NO: 35

Description:
Partial 2 foot excavation at southeastern portion of the Site. The upwind air monitoring unit is visible in the right hand portion of the photo.

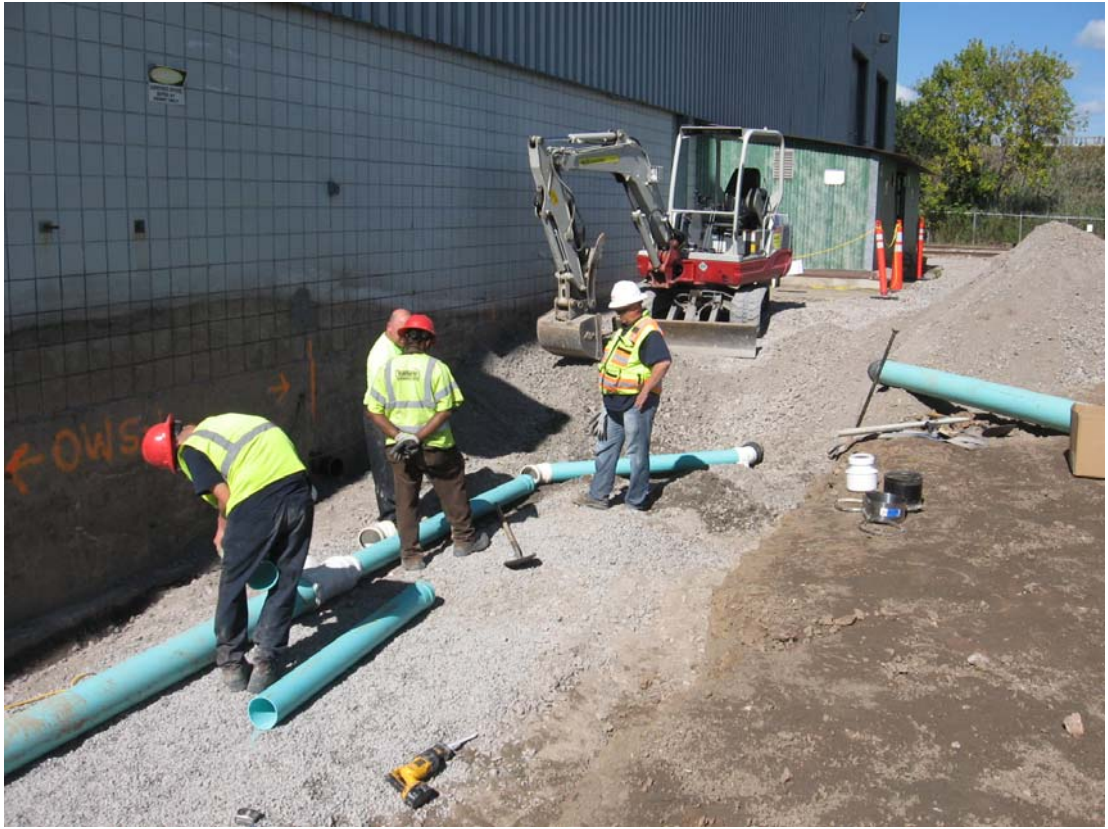
PHOTO NO: 36

Description:
View of the final assembly of the replacement 8" diameter storm sewer.

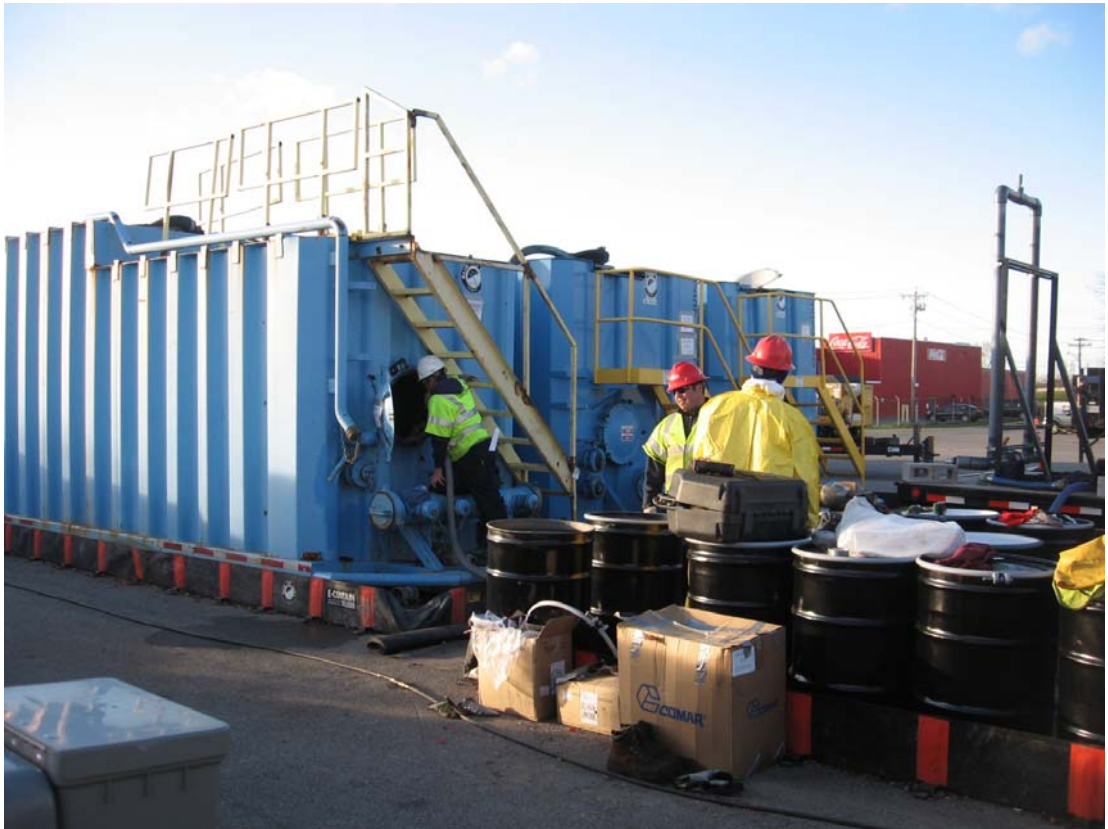
PHOTO NO: 39

Description:
View of the decontamination of a frac tank.

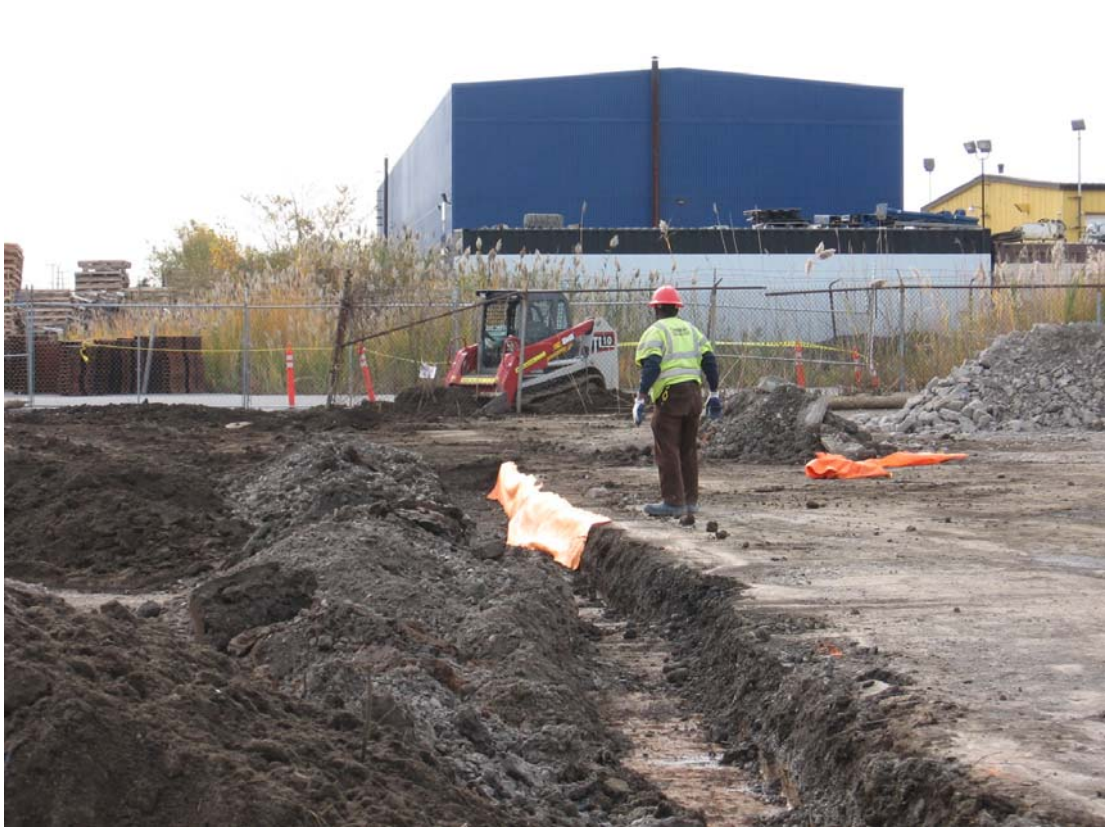
PHOTO NO: 40

Description:
View of a strip of orange fabric that was placed over soil that has not met the Site cleanup objective of 1 ppm PCBs.

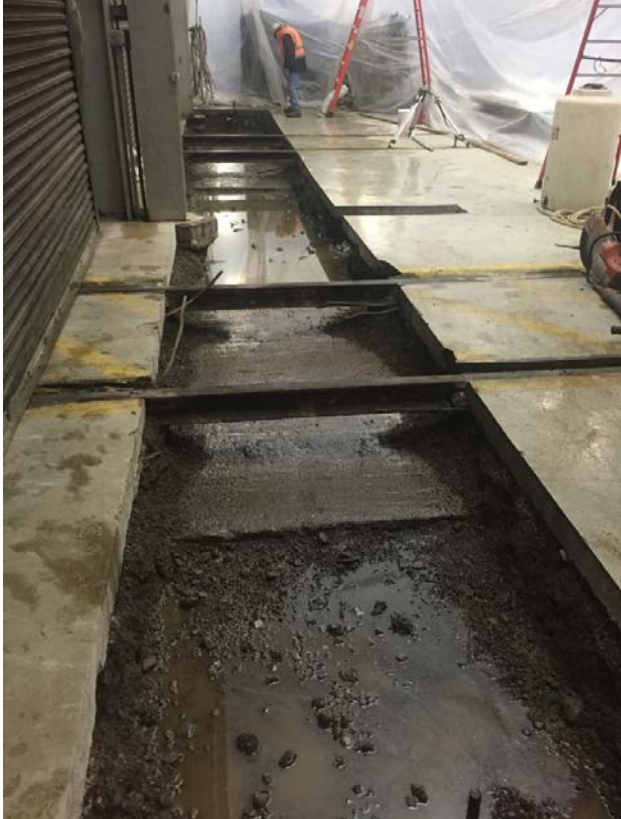
| <p>PHOTO NO: 51</p> | |

| <p>Direction: South</p> <p>Description: View of the removed trench drain inside the northeast section of the building at the rail bay doors.</p> | |

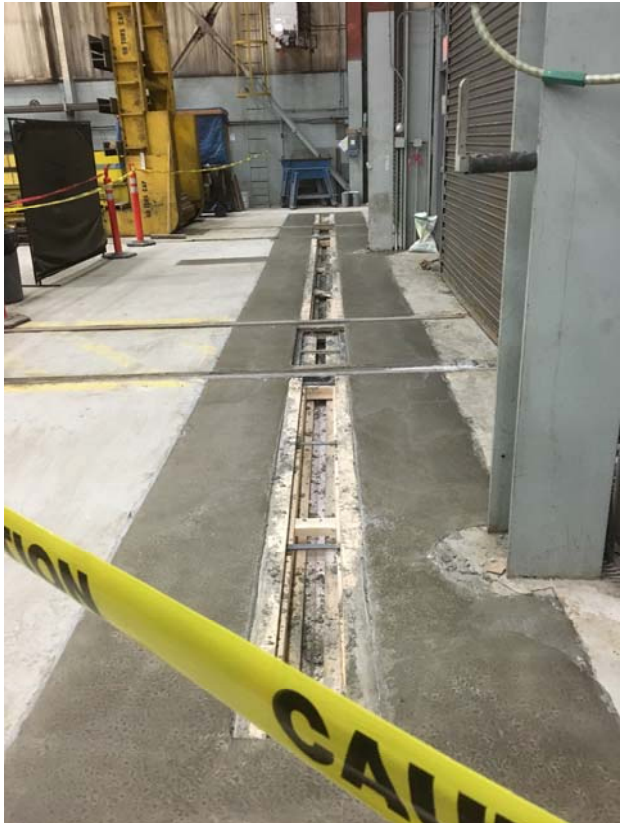
| <p>PHOTO NO: 52</p> | |

| <p>Direction: North</p> <p>Description: View of new concrete (2nd pour) as trench drain is being constructed.</p> | |
