EFFECTIVENESS OF ADAMS AVE. SEWER SLURRY WALL

August 11, 1988
88C2075B-1

Re: Effectiveness Evaluation
Adams Avenue Sewer Slurry Wall

**EFFECTIVENESS EVALUATION
ADAMS AVENUE SLURRY WALL
NIAGARA PLANT
NIAGARA FALLS, NEW YORK**

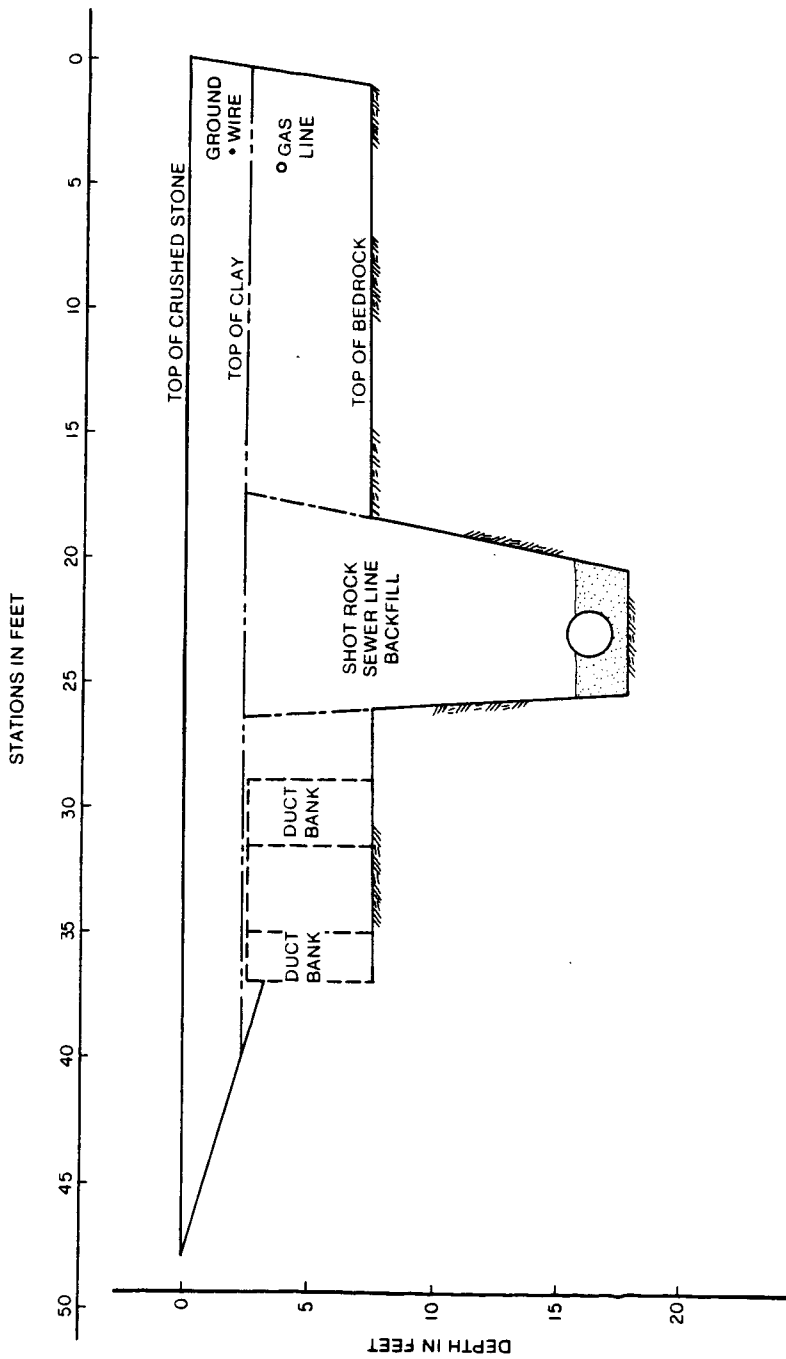
FIGURE 2

The purpose of the slurry wall was to prevent the migration of contaminants through the sewer and sewer bedding material. Construction of the slurry wall was started on June 2, 1986, and was completed on June 13, 1986. An excavation progress diagram is presented in Figure 2. The slurry wall was constructed by excavating the unconsolidated overburden and sewer backfill and replacing with a soil bentonite backfill. An as-built plan and section of the slurry wall is presented in Figure 3. The backfill was composed of soil from a local borrow source, bentonite, and water to form a slurry. The completed slurry wall is about 35 feet long, ranges in thickness from 8 feet in the sewer trench to 3 feet on top-of-bedrock, and ranges in depth from 7 to 18 feet.

EXCAVATION PROGRESS AS OF JUNE 5, 1986
 ADAMS AVE. SEWER SLURRY WALL
 DuPONT - NIAGARA PLANT
 NIAGARA FALLS, NEW YORK

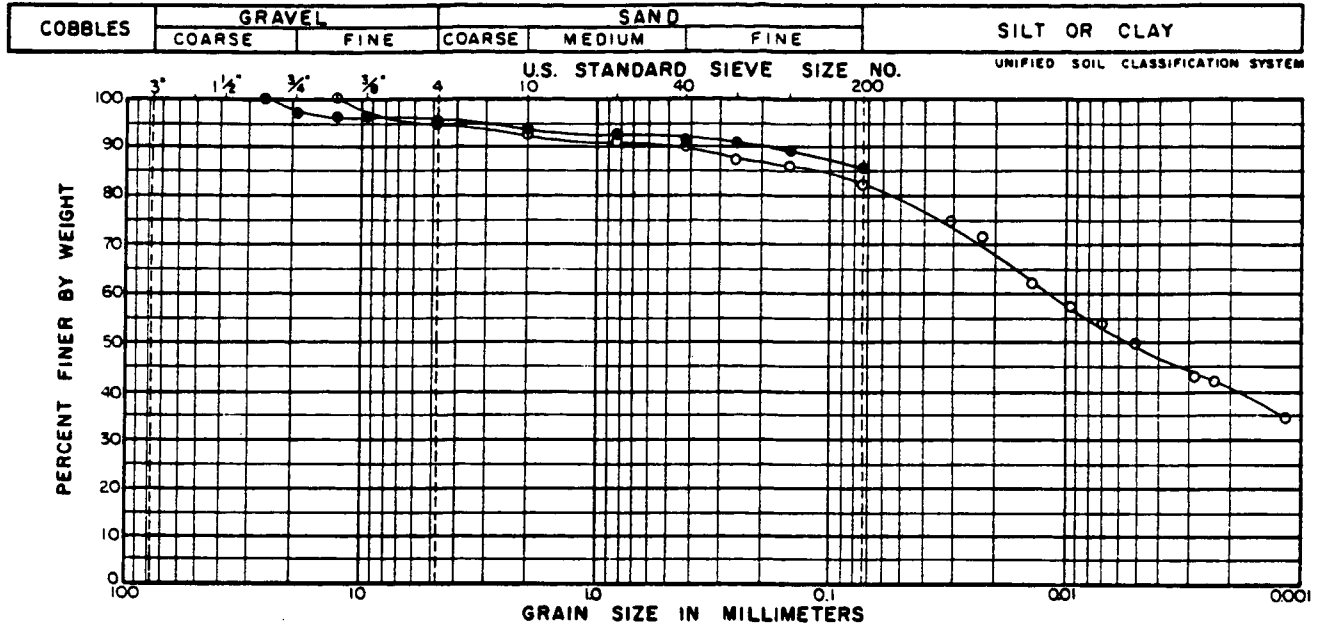
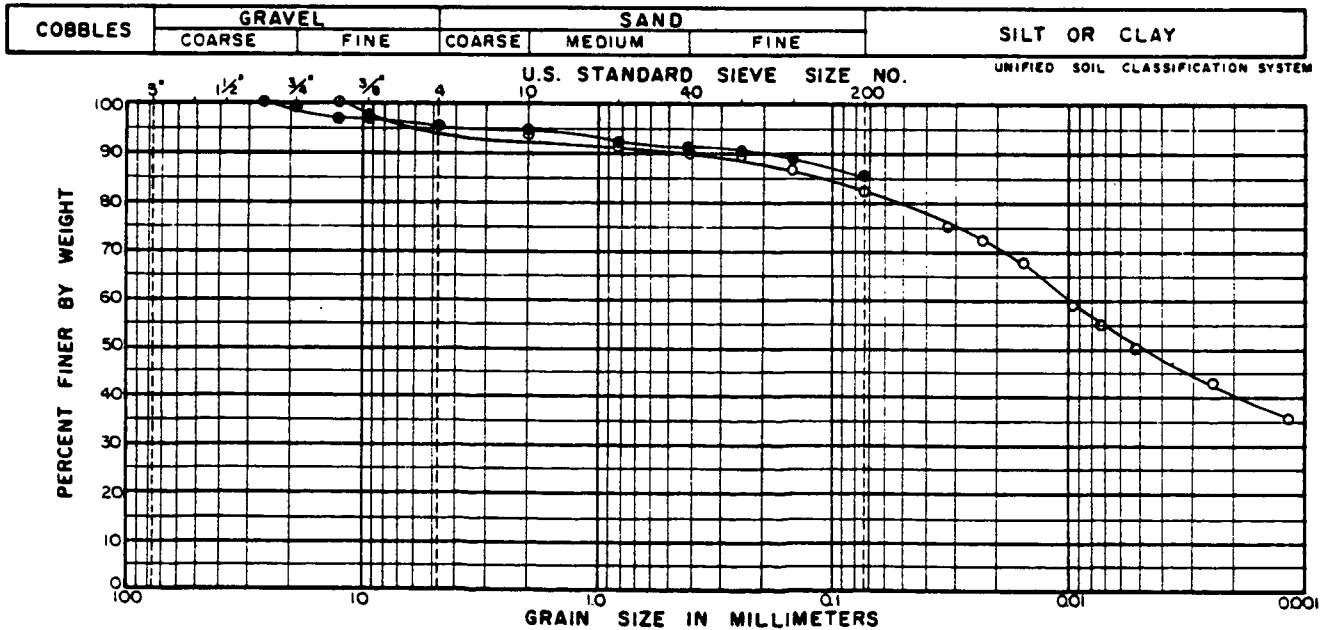
GRADATION CURVES

Two samples of the soil-bentonite backfill material were returned to WCC's Plymouth Meeting, Pennsylvania laboratory for permeability testing. The results of the permeability testing with water as the permeant indicated a backfill sample permeability of less than 6.5×10^{-8} cm/sec. The Summary of Permeability Tests is presented in Table 2, with the grain-size distribution of the backfill samples shown on Figure 4.
