**OCCIDENTAL CHEMICAL CORPORATION  
OLIN CORPORATION**

**REMEDIAL ACTION REPORT  
TRIANGULAR AREA NORTH OF BUFFALO AVENUE**

**102nd STREET LANDFILL SITE  
NIAGARA FALLS, NEW YORK**

**DECEMBER 23, 1993**

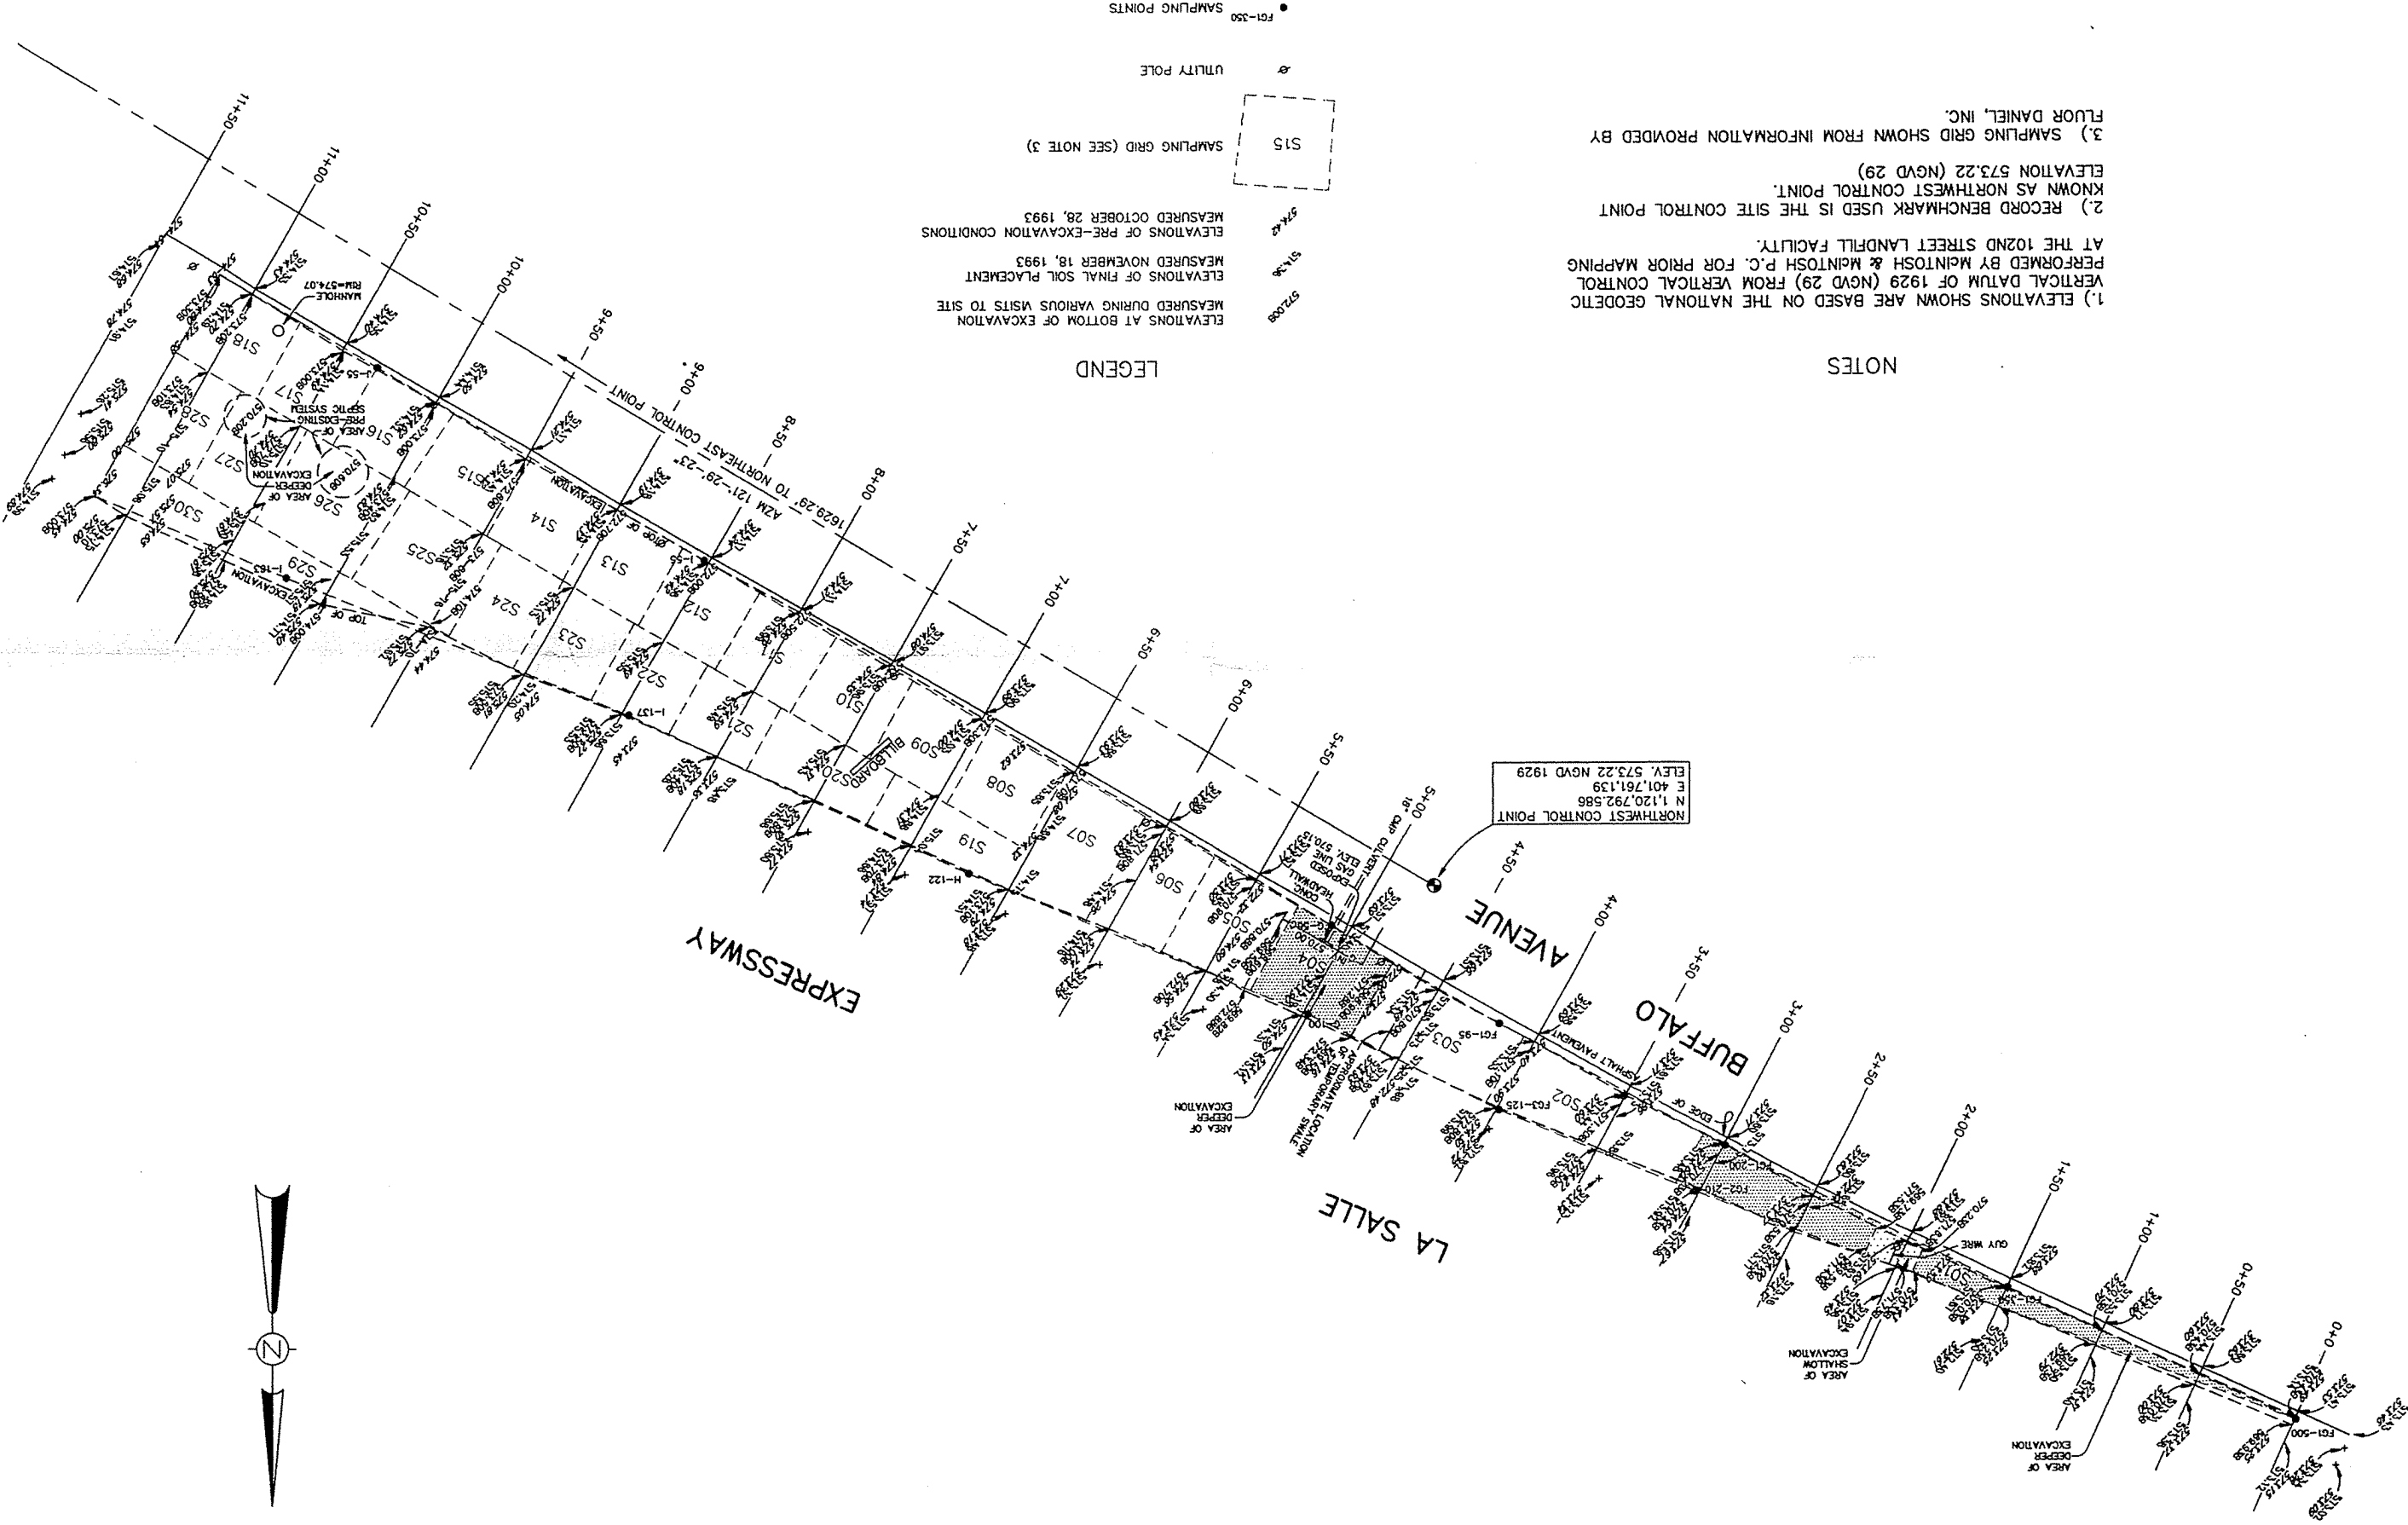
The Triangular Area was excavated to a depth of 18 inches, except for grid quadrants S01 and S04 which were excavated to depths of 36 inches and 54 inches, respectively (refer to Figure 1.2.1 for layout of grid quadrants). An approximate 1:1 horizontal to vertical slope was maintained along the southern edge of the excavation which borders Buffalo Avenue. Grid quadrant S01 was excavated to a depth of 36 inches with the exception of an area that extended approximately 11 feet on either side of the utility pole and guy wire located within the grid area. In order to ensure the structural integrity of the utility pole and guy-wire, the soil was excavated to an 18-inch depth in the vicinity of the pole and guy-wire.

verify that the required depths were met. The surveyed elevations at the bottom of the excavation are shown on Figure 1.2.1.

Several buried structures were encountered during the excavation activities. These structures are identified on Figure 1.2.1 and described briefly in the following paragraphs.

Pre-existing and final topography of the Triangular Area, prepared by McIntosh & McIntosh, P.C., a New York State licensed surveyor, are shown on Figure 1.2.1. Subsequent to topsoil placement, a mixture comprised of seed, fertilizer and mulch, was applied over the Triangular Area by hydroseeding.
