**WORK PLAN
REPAIR OF SHORELINE EROSION
REVISION NO. 1**

**GRATWICK-RIVERSIDE PARK SITE
NORTH TONAWANDA, NEW YORK**

Re: Shoreline Erosion
Gratwick-Riverside Park Site
North Tonawanda, New York

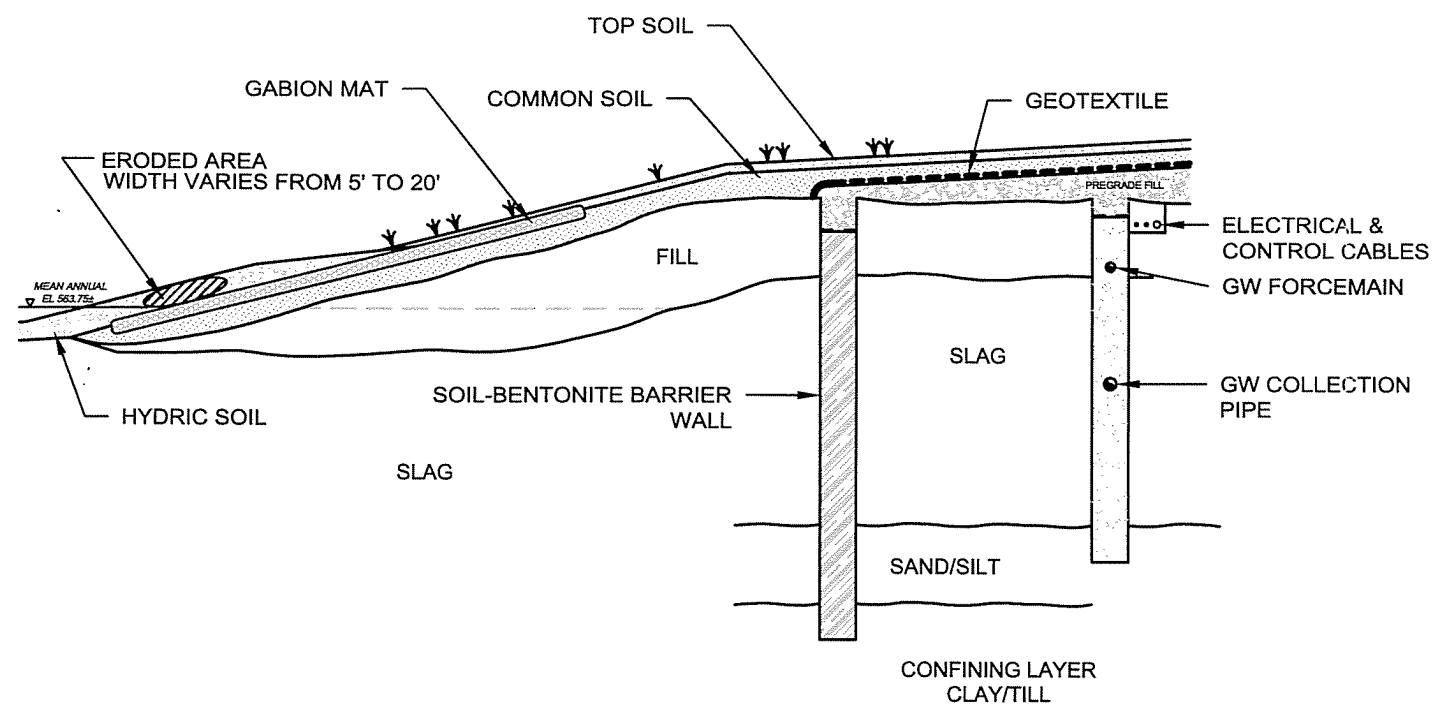
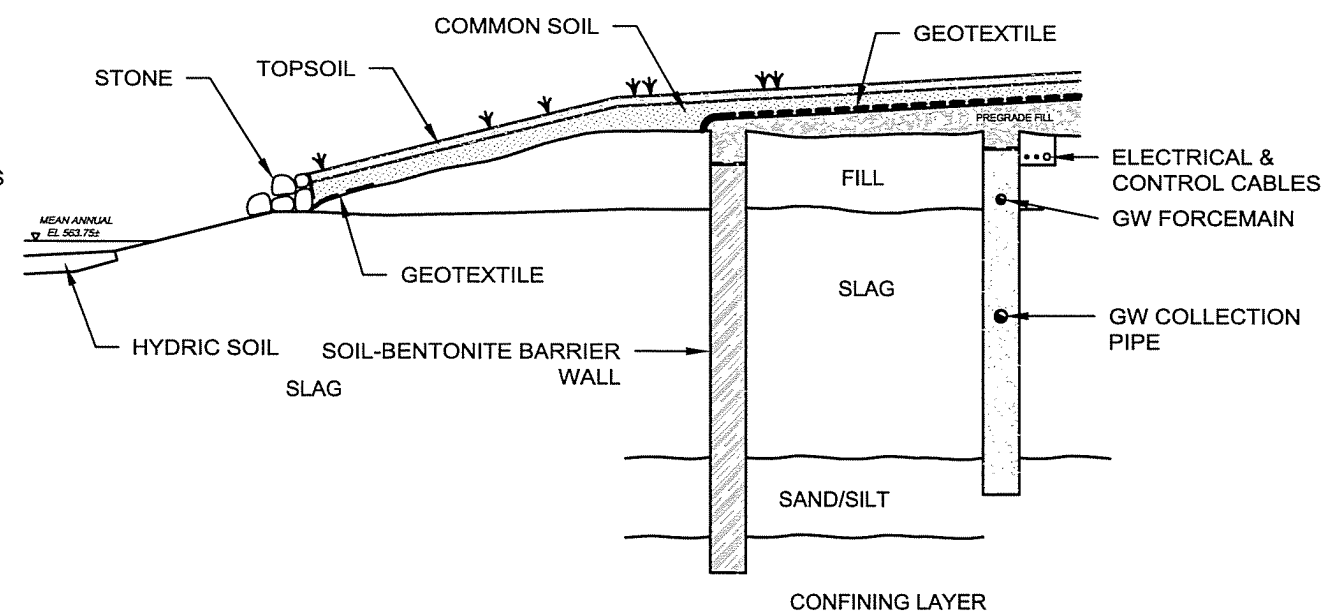
figure 2.1

Cross-sections of the sloped bank stabilization as designed and constructed are shown on Figure 2.1. One cross-section presents the details for the shoreline area which has competent slag along the River's edge and the other where competent slag is not present. A plan view of the layout of the RA, including the sloped bank stabilization, is shown on Figure 2.2.

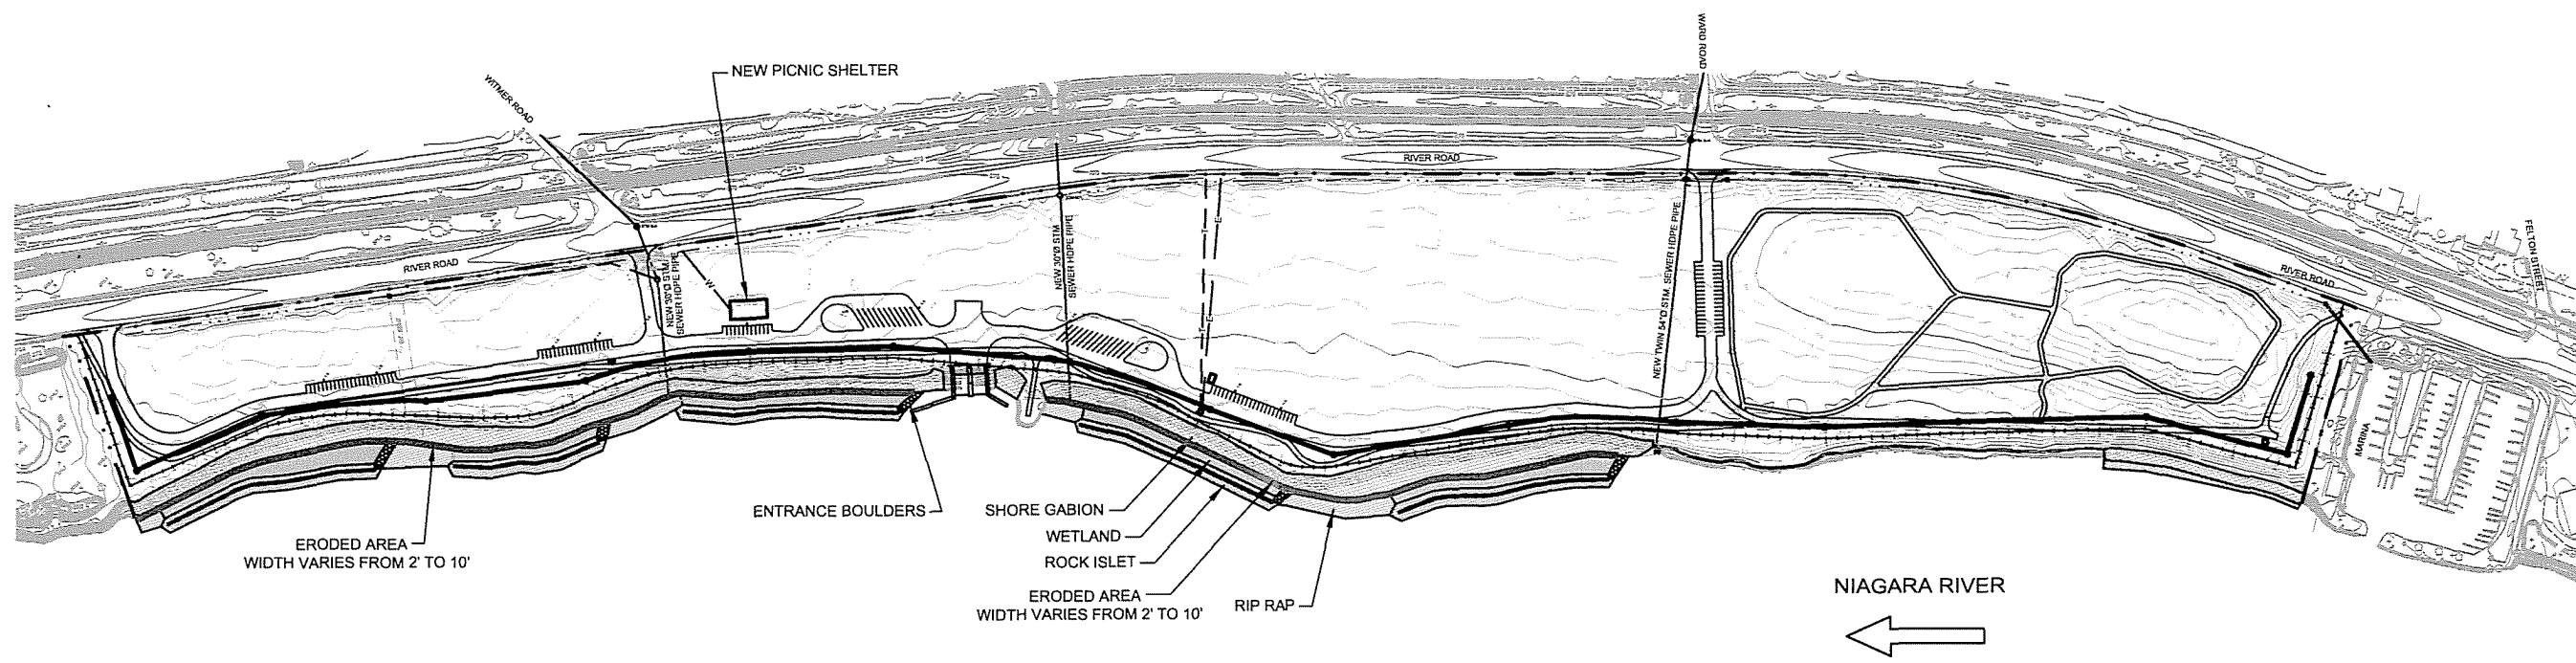
figure 2.2
 SITE LAYOUT
 SLOPED BANK STABILIZATION REPAIR
 GRATWICK-RIVERSIDE PARK SITE
North Tonawanda, New York

Also shown on Figure 2.2 are the areas where erosion of the overlying topsoil has occurred. It is noted that the underlying gabion mat and riprap contained within the gabion mat are in place and continue to prevent erosion of the underlying shoreline soil; thus protecting the constructed remedial components.

The width of the soil erosion ranges from 5 to 20 feet with an eroded area of approximately 4,640 square yards. The eroded area typically ends on the sloped bank at an erosion face which is on the order of 12-inches high.
