**REMEDIAL ACTION CONSTRUCTION
IMPLEMENTATION – ADDENDUM NO. 1
REPAIR OF SHORELINE EROSION**

**GRATWICK-RIVERSIDE PARK SITE
NORTH TONAWANDA, NEW YORK**

MARCH 2005

Prepared by:
Conestoga-Rovers
& Associates

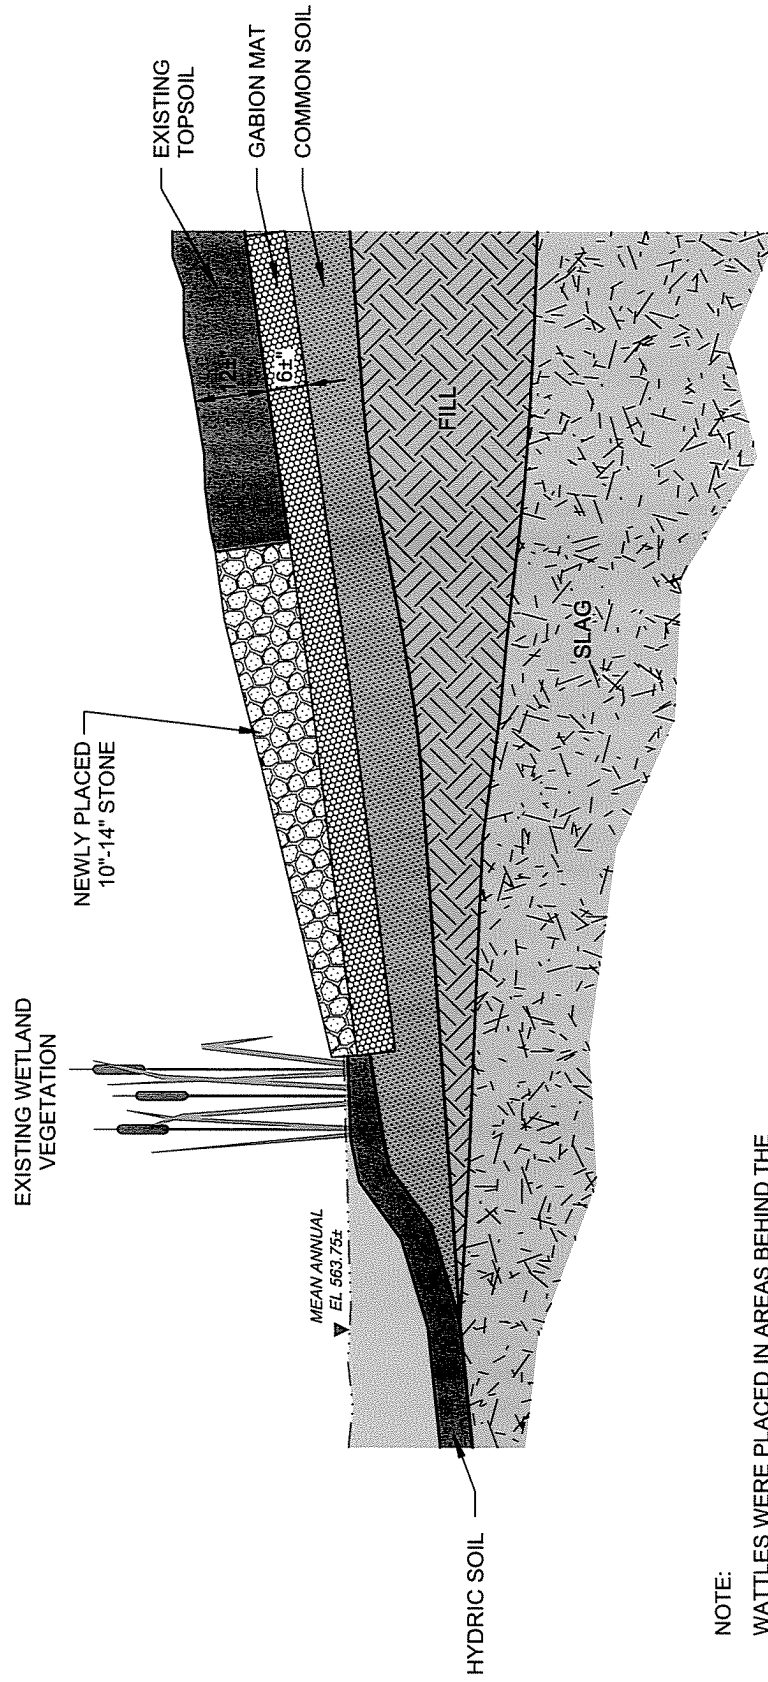
figure 2.3

REPAIR WITH ROCK ONLY
REMEDIAL ACTION CONSTRUCTION IMPLEMENTATION-ADDENDUM No. 1
SLOPED BANK STABILIZATION REPAIR

Riprap placement was performed in August 2004. Medium riprap was placed on top of the exposed gabion mat/riprap using a Morooka rubber tired dump truck and a PC 120 Komatsu trackhoe. The thickness of the riprap was one rock thickness (10 to 14-inch) in the area shown on Figure 2.3. Thus, the average thickness of the riprap is approximately 12 inches.

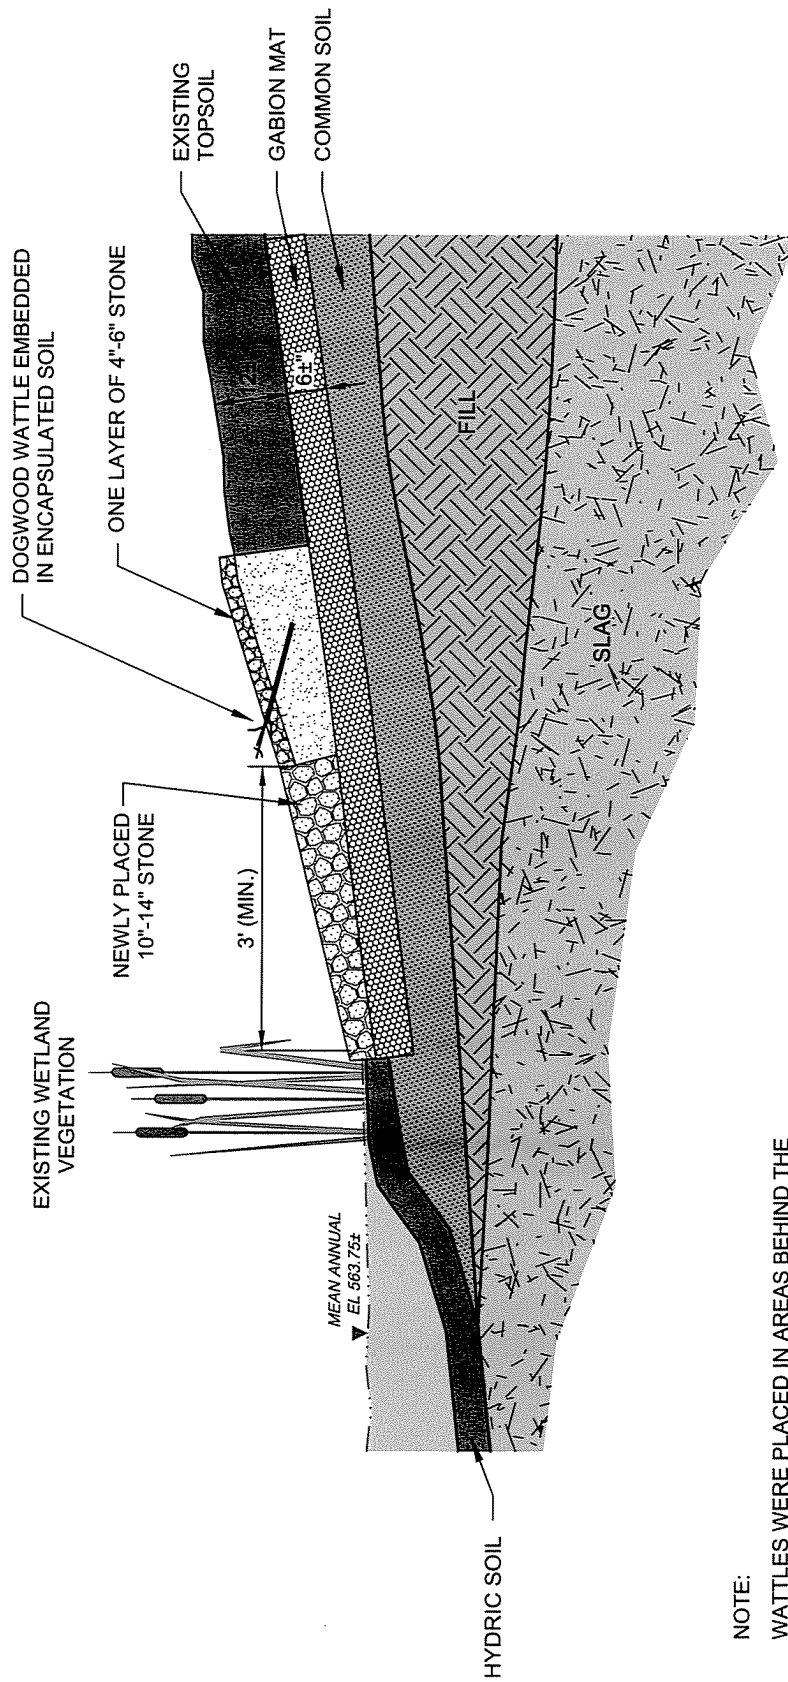
figure 2.4

REPAIR WITH ROCK AND DOGWOOD WATTLES
REMEDIAL ACTION CONSTRUCTION IMPLEMENTATION-ADDENDUM No. 1
SLOPED BANK STABILIZATION REPAIR

The Work Plan specified that dogwood wattles would be placed at selected locations along the eroded shoreline area. The wattles consist of approximately 1 cubic yard of imported topsoil wrapped in a filter cloth material to keep the topsoil encapsulated. The topsoil was typically 1 foot thick which resulted in wattles with the following dimensions (5' x 5', 4' x 6' or 3' x 8'). The soil wattles were kept at least 3 feet from the shoreline to help preserve their integrity. Thus, the wattles were only placed in areas where there was at least a 6-foot eroded width. Sixty-two soil envelopes were installed as determined based on an average placement of one wattle for every 25 feet in length of the eroded areas greater than or equal to 6-feet. The 3-foot area between the river and the wattle was filled with medium stone (see Figure 2.4).

Each wattle has 4 silky dogwood stems set in the topsoil in a rectangular pattern approximately 18 inches by 18 inches square with the exposed stem ends facing out

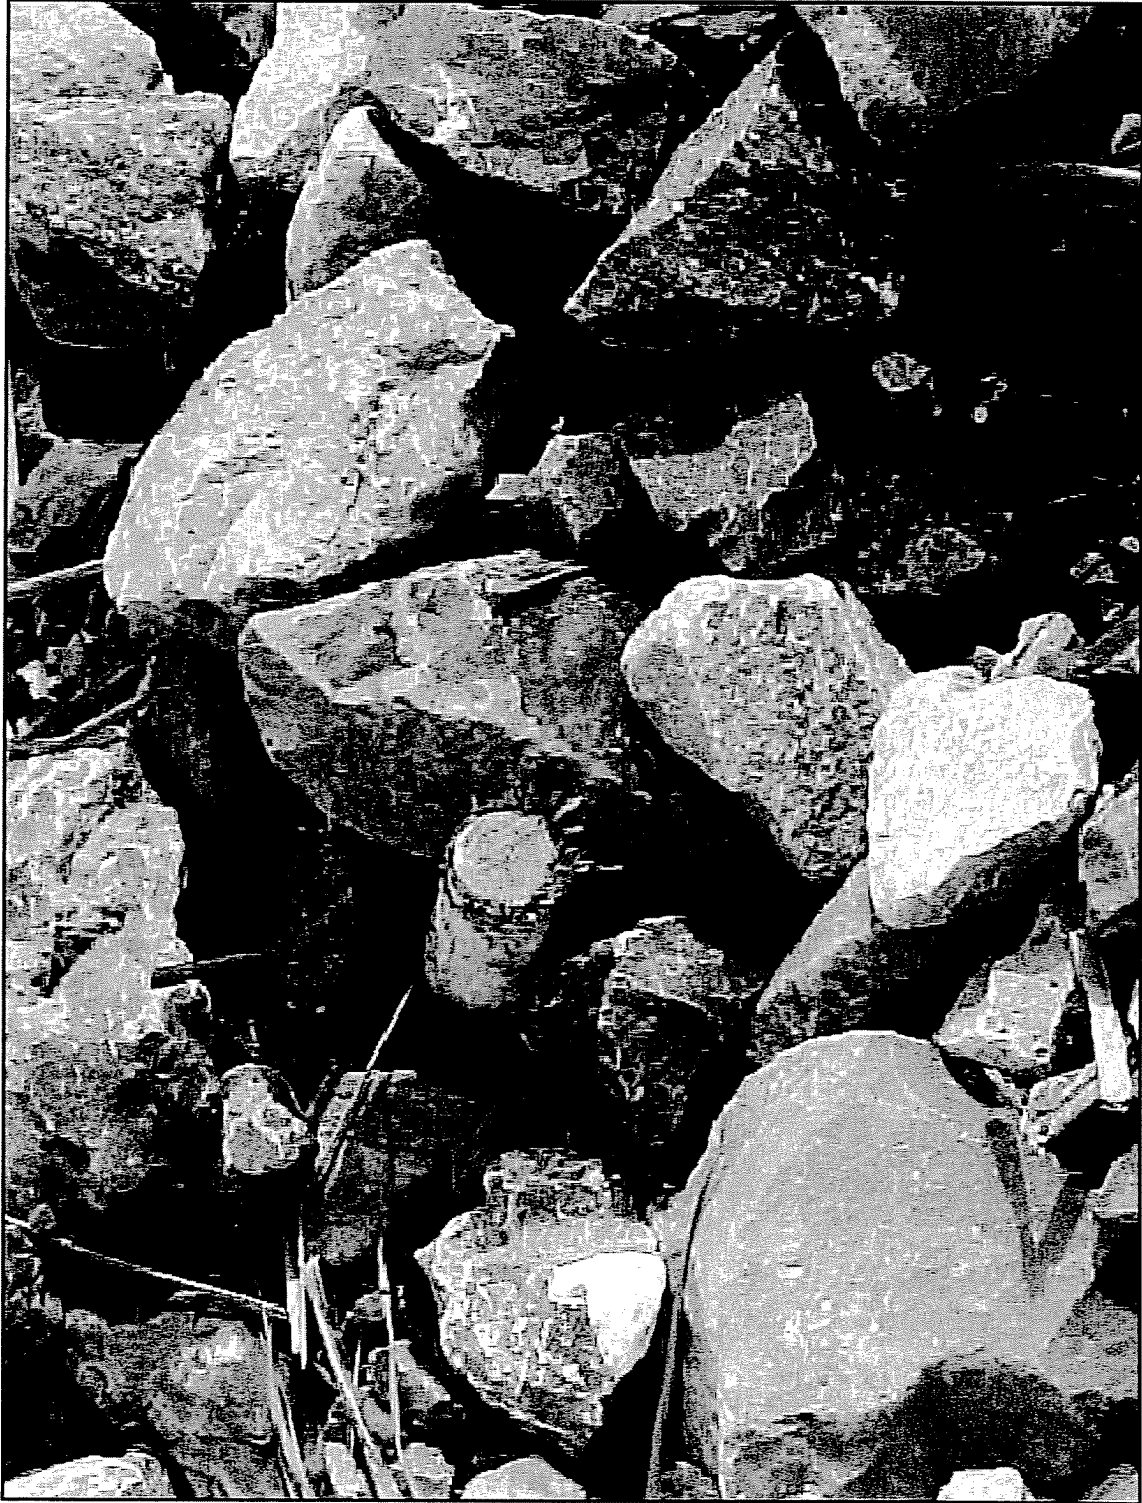
Dogwood stem surrounded by 4 to 6 inch stone

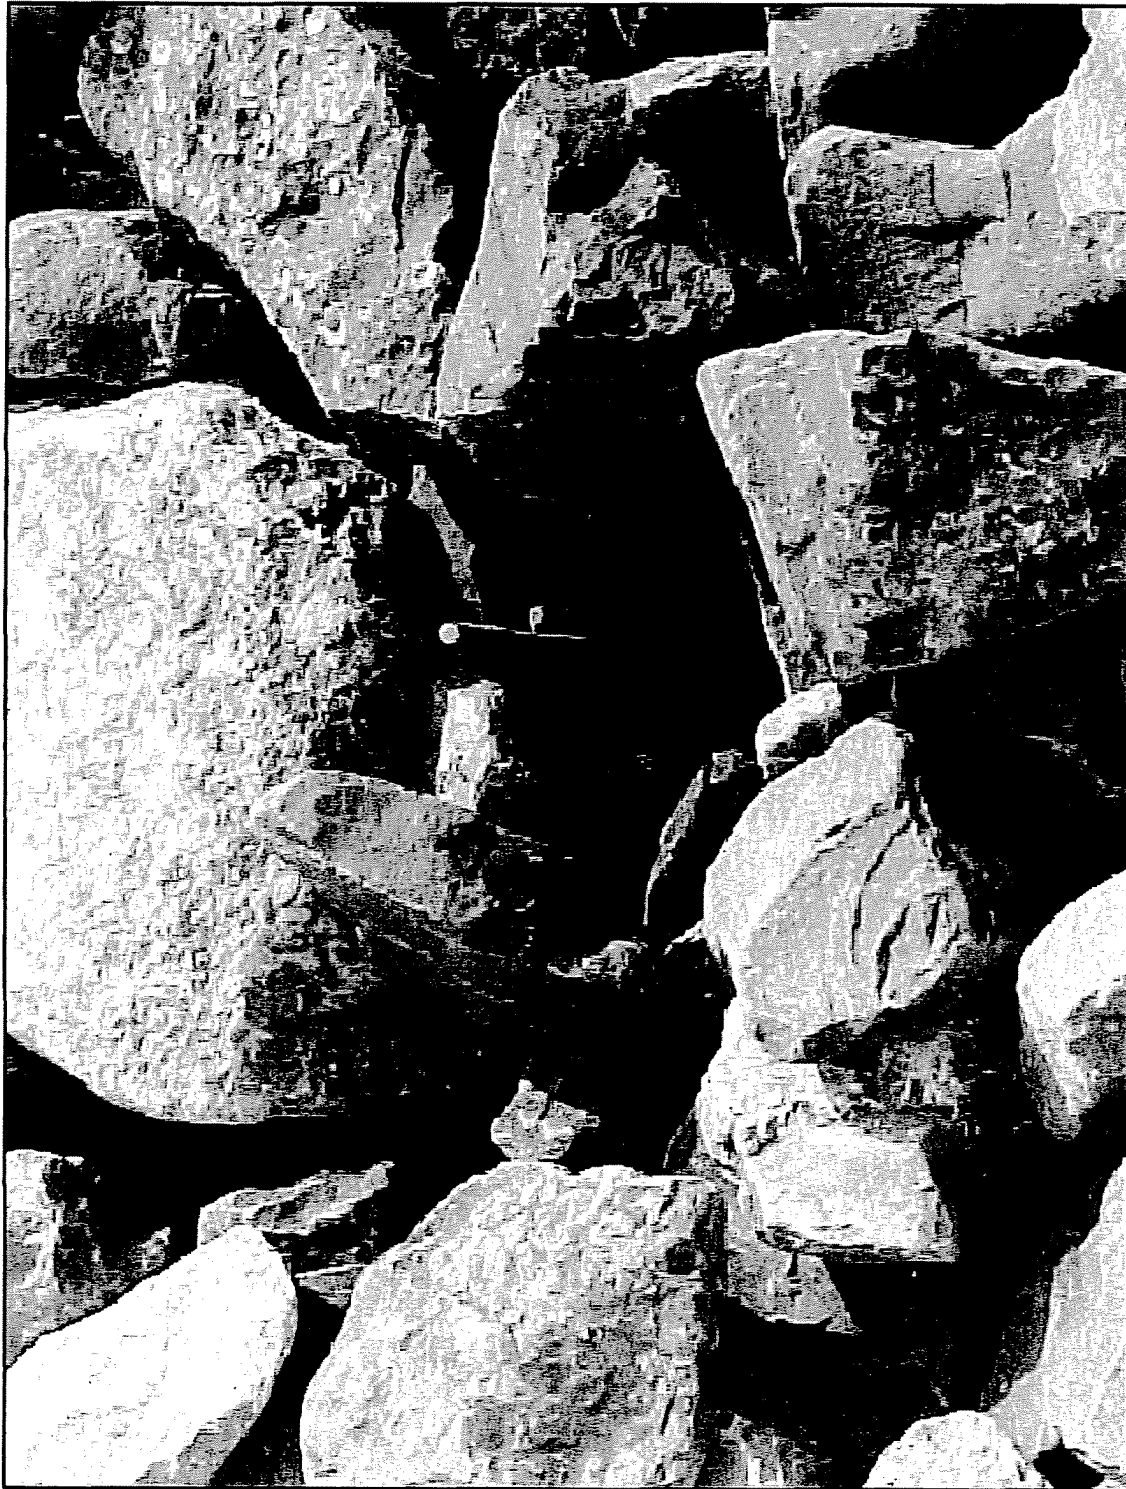
Dogwood Stem Surrounded by 4 to 6 Inch Stone
