Re: ISOICHEM Inc. – Lockport Facility
Summary of Site Reconnaissance Activities

Benchmark Environmental Engineering & Science, PLLC (Benchmark) has prepared this letter to present the findings of site reconnaissance activities performed at the ISOICHEM Inc. Lockport Facility (Site) on January 4, 2007.

SOUTH SLOPE ASSESSMENT

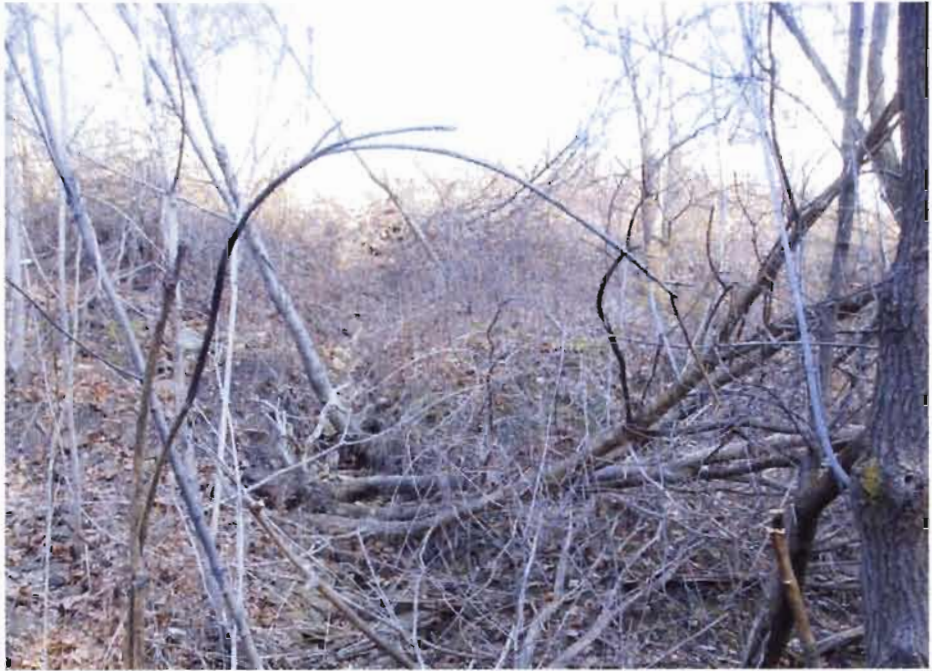
Client Name: Isochem, Inc.		Site Location: South property limits near and adjacent to Eighteenmile Creek	Project No.: 0049-007-100
Photo No. 1	Date 01/04/07

Direction Photo Taken: Looking north toward plant, upslope			
Description: Photo of one of two erosion channels and vegetation

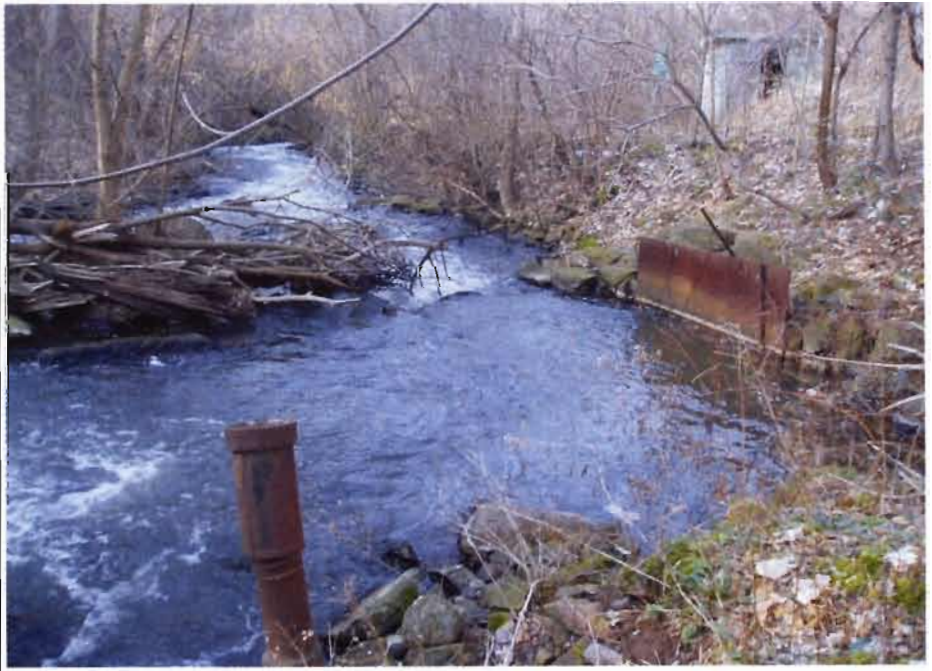
Photo No. 2	Date 01/04/07

Direction Photo Taken: Looking west downstream		
Description: Eighteenmile Creek, flowing away from view, showing man-made structures adjacent to the Creek.

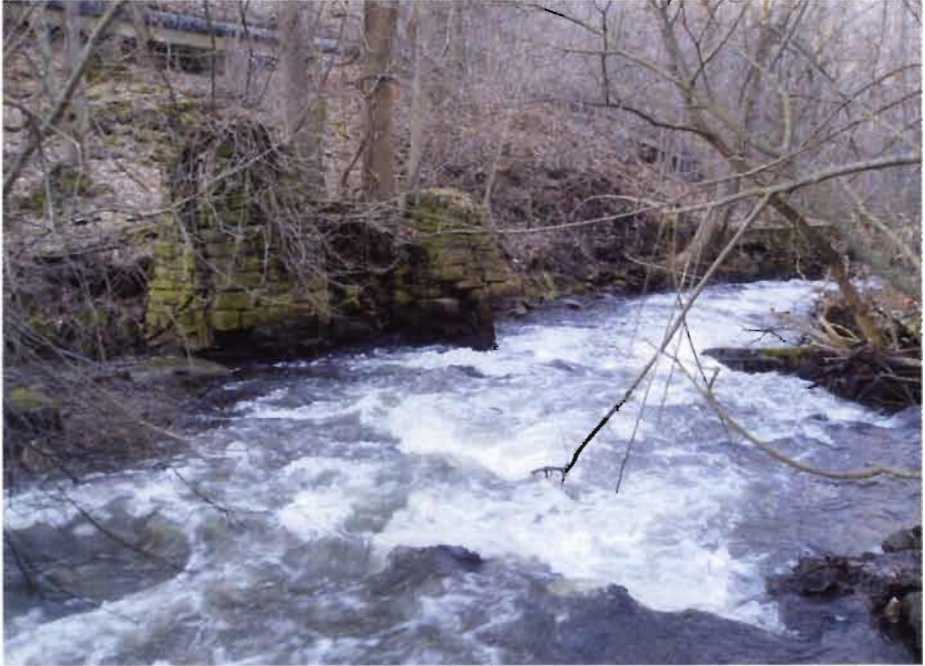
Client Name: Isochem, Inc.		Site Location: South property limits near and adjacent to Eighteenmile Creek	Project No.: 0049-007-100
Photo No. 3	Date 01/04/07

Direction Photo Taken: Looking west downstream			
Description: Evidence of historical man-made structures located south of Eighteenmile Creek - note pipe along top left of photo and stacked stone walls at left center.

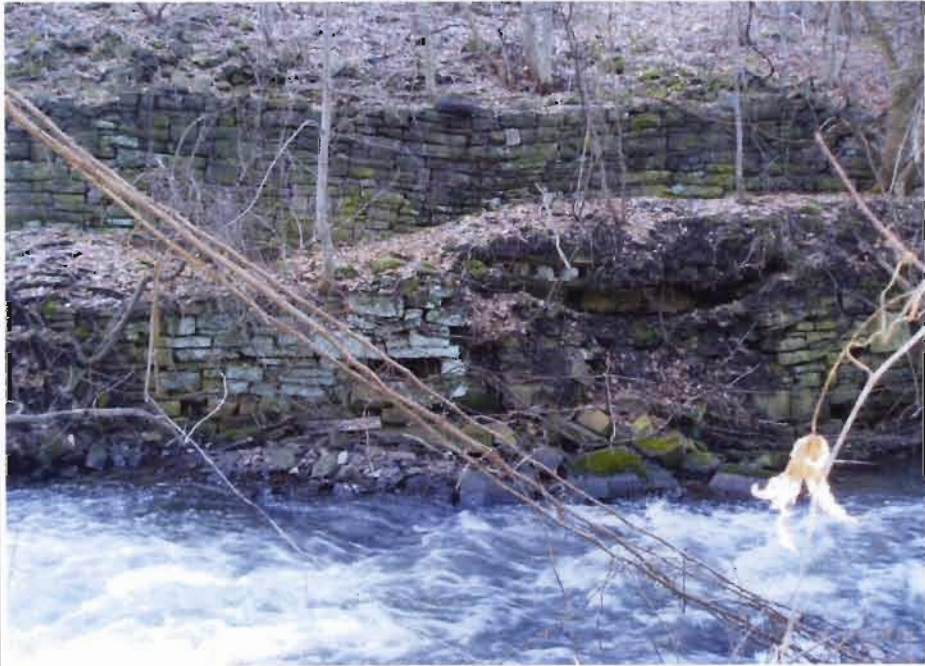
Photo No. 4	Date 01/04/07

Direction Photo Taken: Looking south across Eighteenmile Creek		
Description: Evidence of historical man-made presence located south of Eighteenmile Creek - note stacked stone walls.

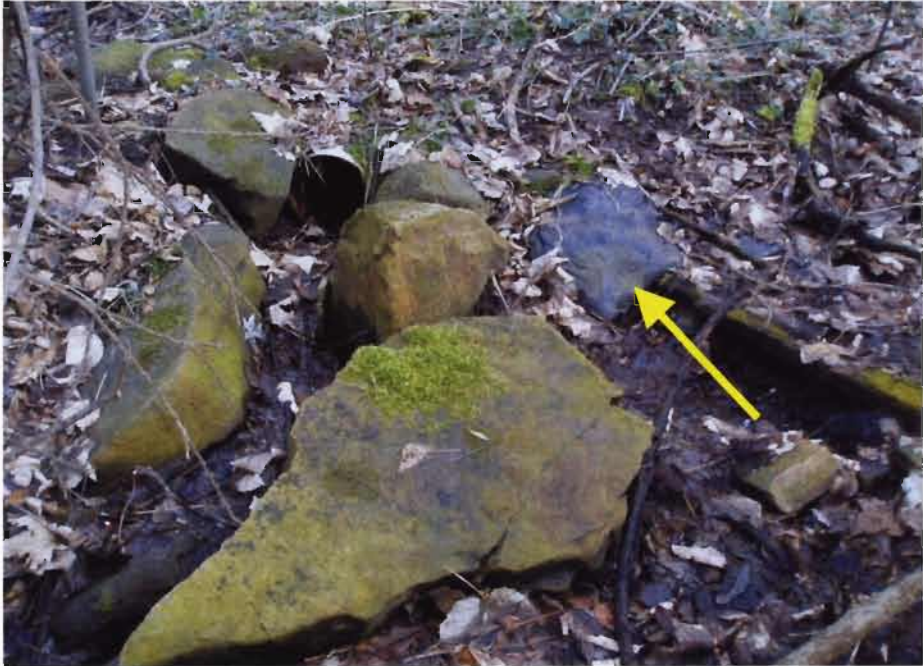
Client Name: Isochem, Inc.		Site Location: South property limits near and adjacent to Eighteenmile Creek	Project No.: 0049-007-100
Photo No. 5	Date 01/04/07

Direction Photo Taken: NA			
Description: Black material to right of 6" discharge pipe (origin unknown).

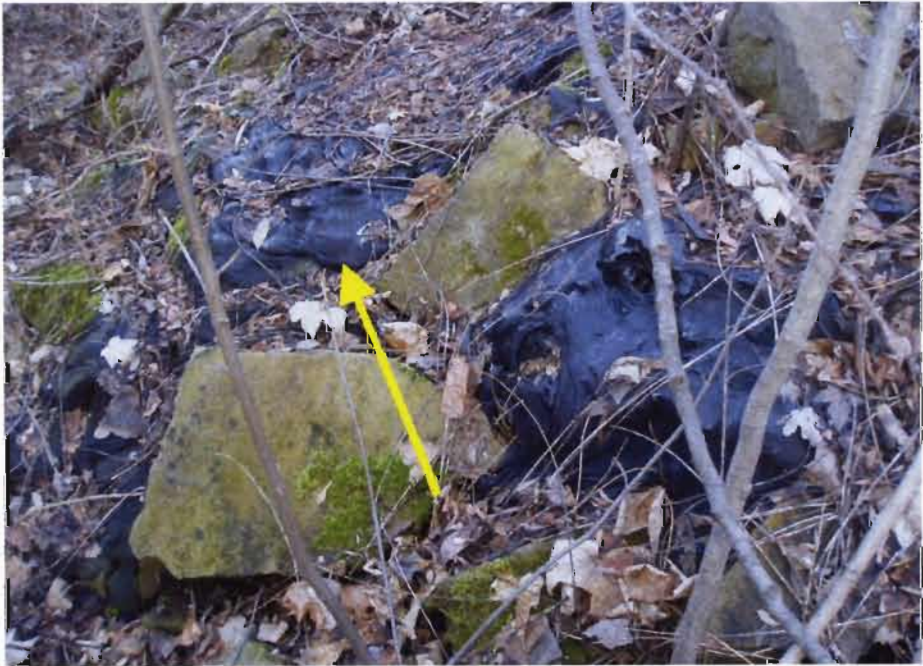
Photo No. 6	Date 01/04/07

Direction Photo Taken: NA		
Description: Black material appeared to have once flowed from north side of toe of slope toward creek bank.

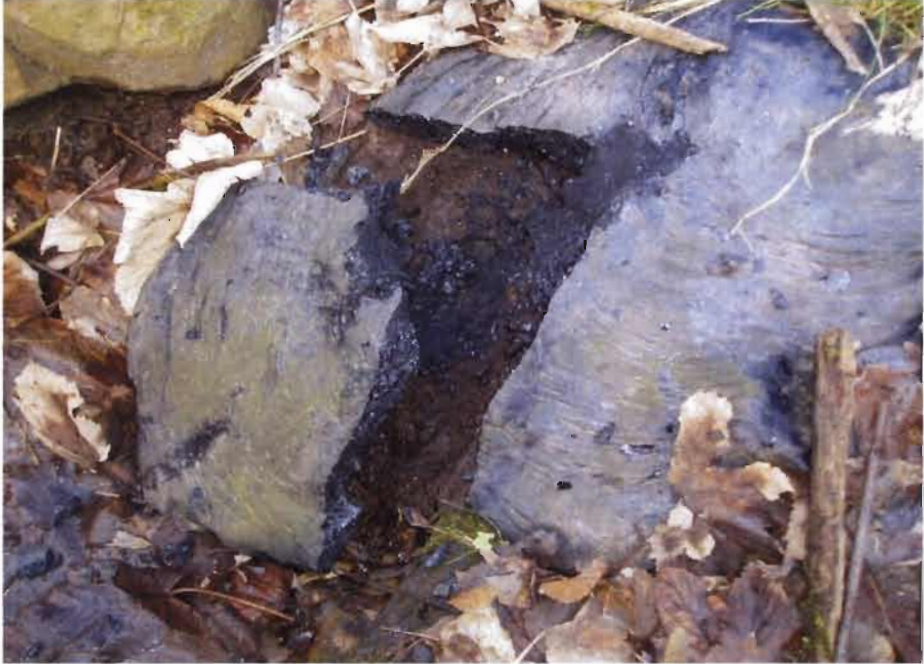
Client Name: Isochem, Inc.		Site Location: South property limits near and adjacent to Eighteenmile Creek	Project No.: 0049-007-100
Photo No. 7	Date 01/04/07

Direction Photo Taken: NA			
Description: Black material following breaking with hammer.

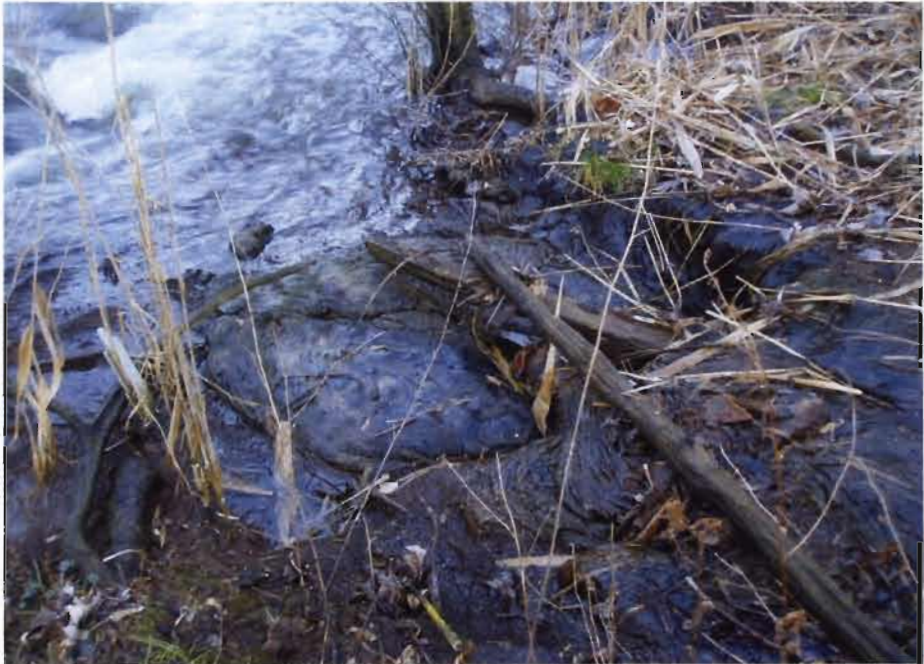
Photo No. 8	Date 01/04/07

Direction Photo Taken: Looking west downstream		
Description: Black material appears to have flowed into Eighteenmile Creek. No staining or sheen was observed.

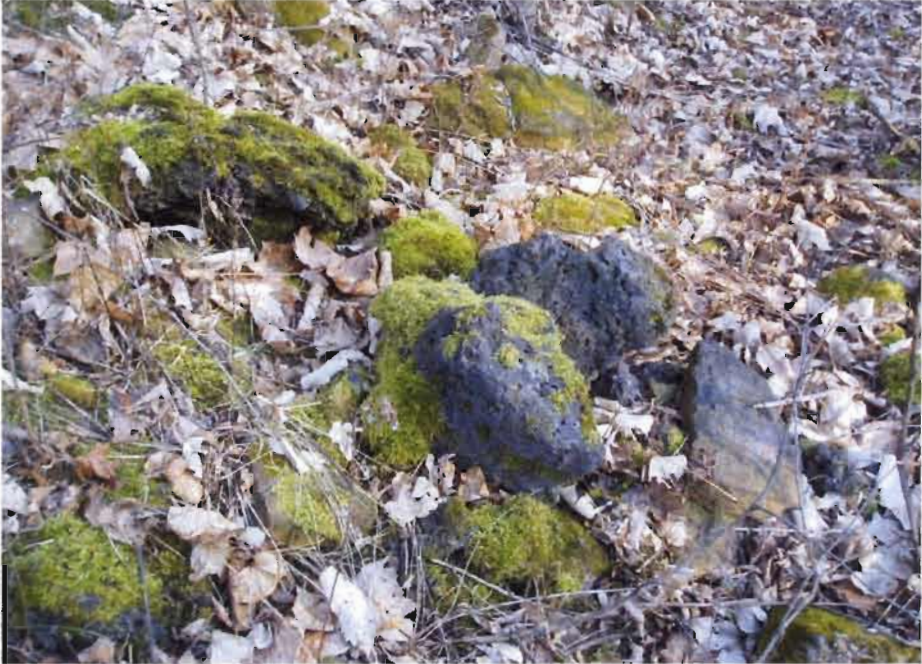
Client Name: Isochem, Inc.		Site Location: South property limits near and adjacent to Eighteenmile Creek	Project No.: 0049-007-100
Photo No. 9	Date 01/04/07

Direction Photo Taken: Looking northeast, upslope			
Description: Slag material on slope of bank.

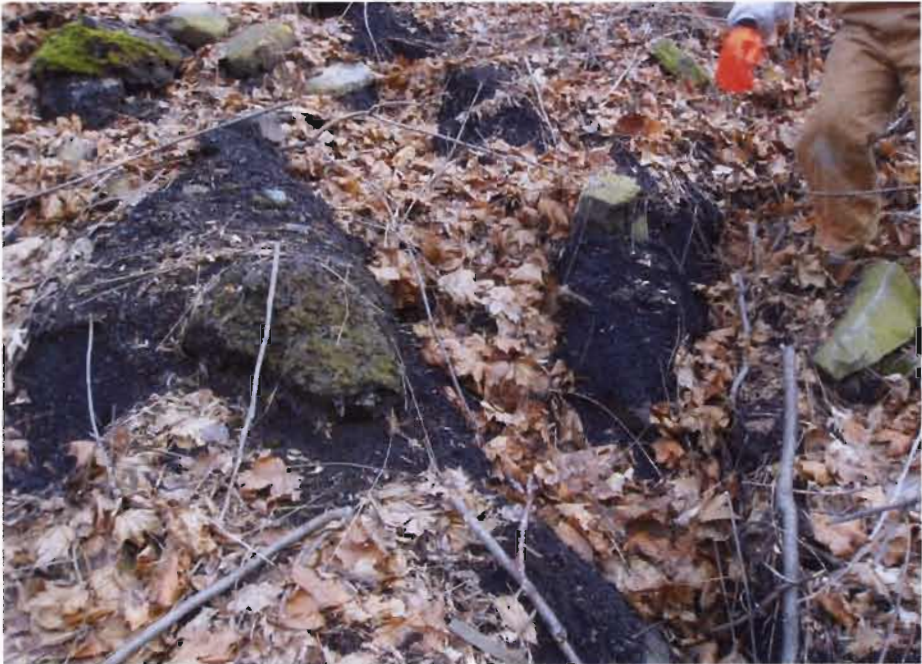
Photo No. 10	Date 01/04/07

Direction Photo Taken: Looking north, upslope			
Description: Cindery ash material on slope of bank.

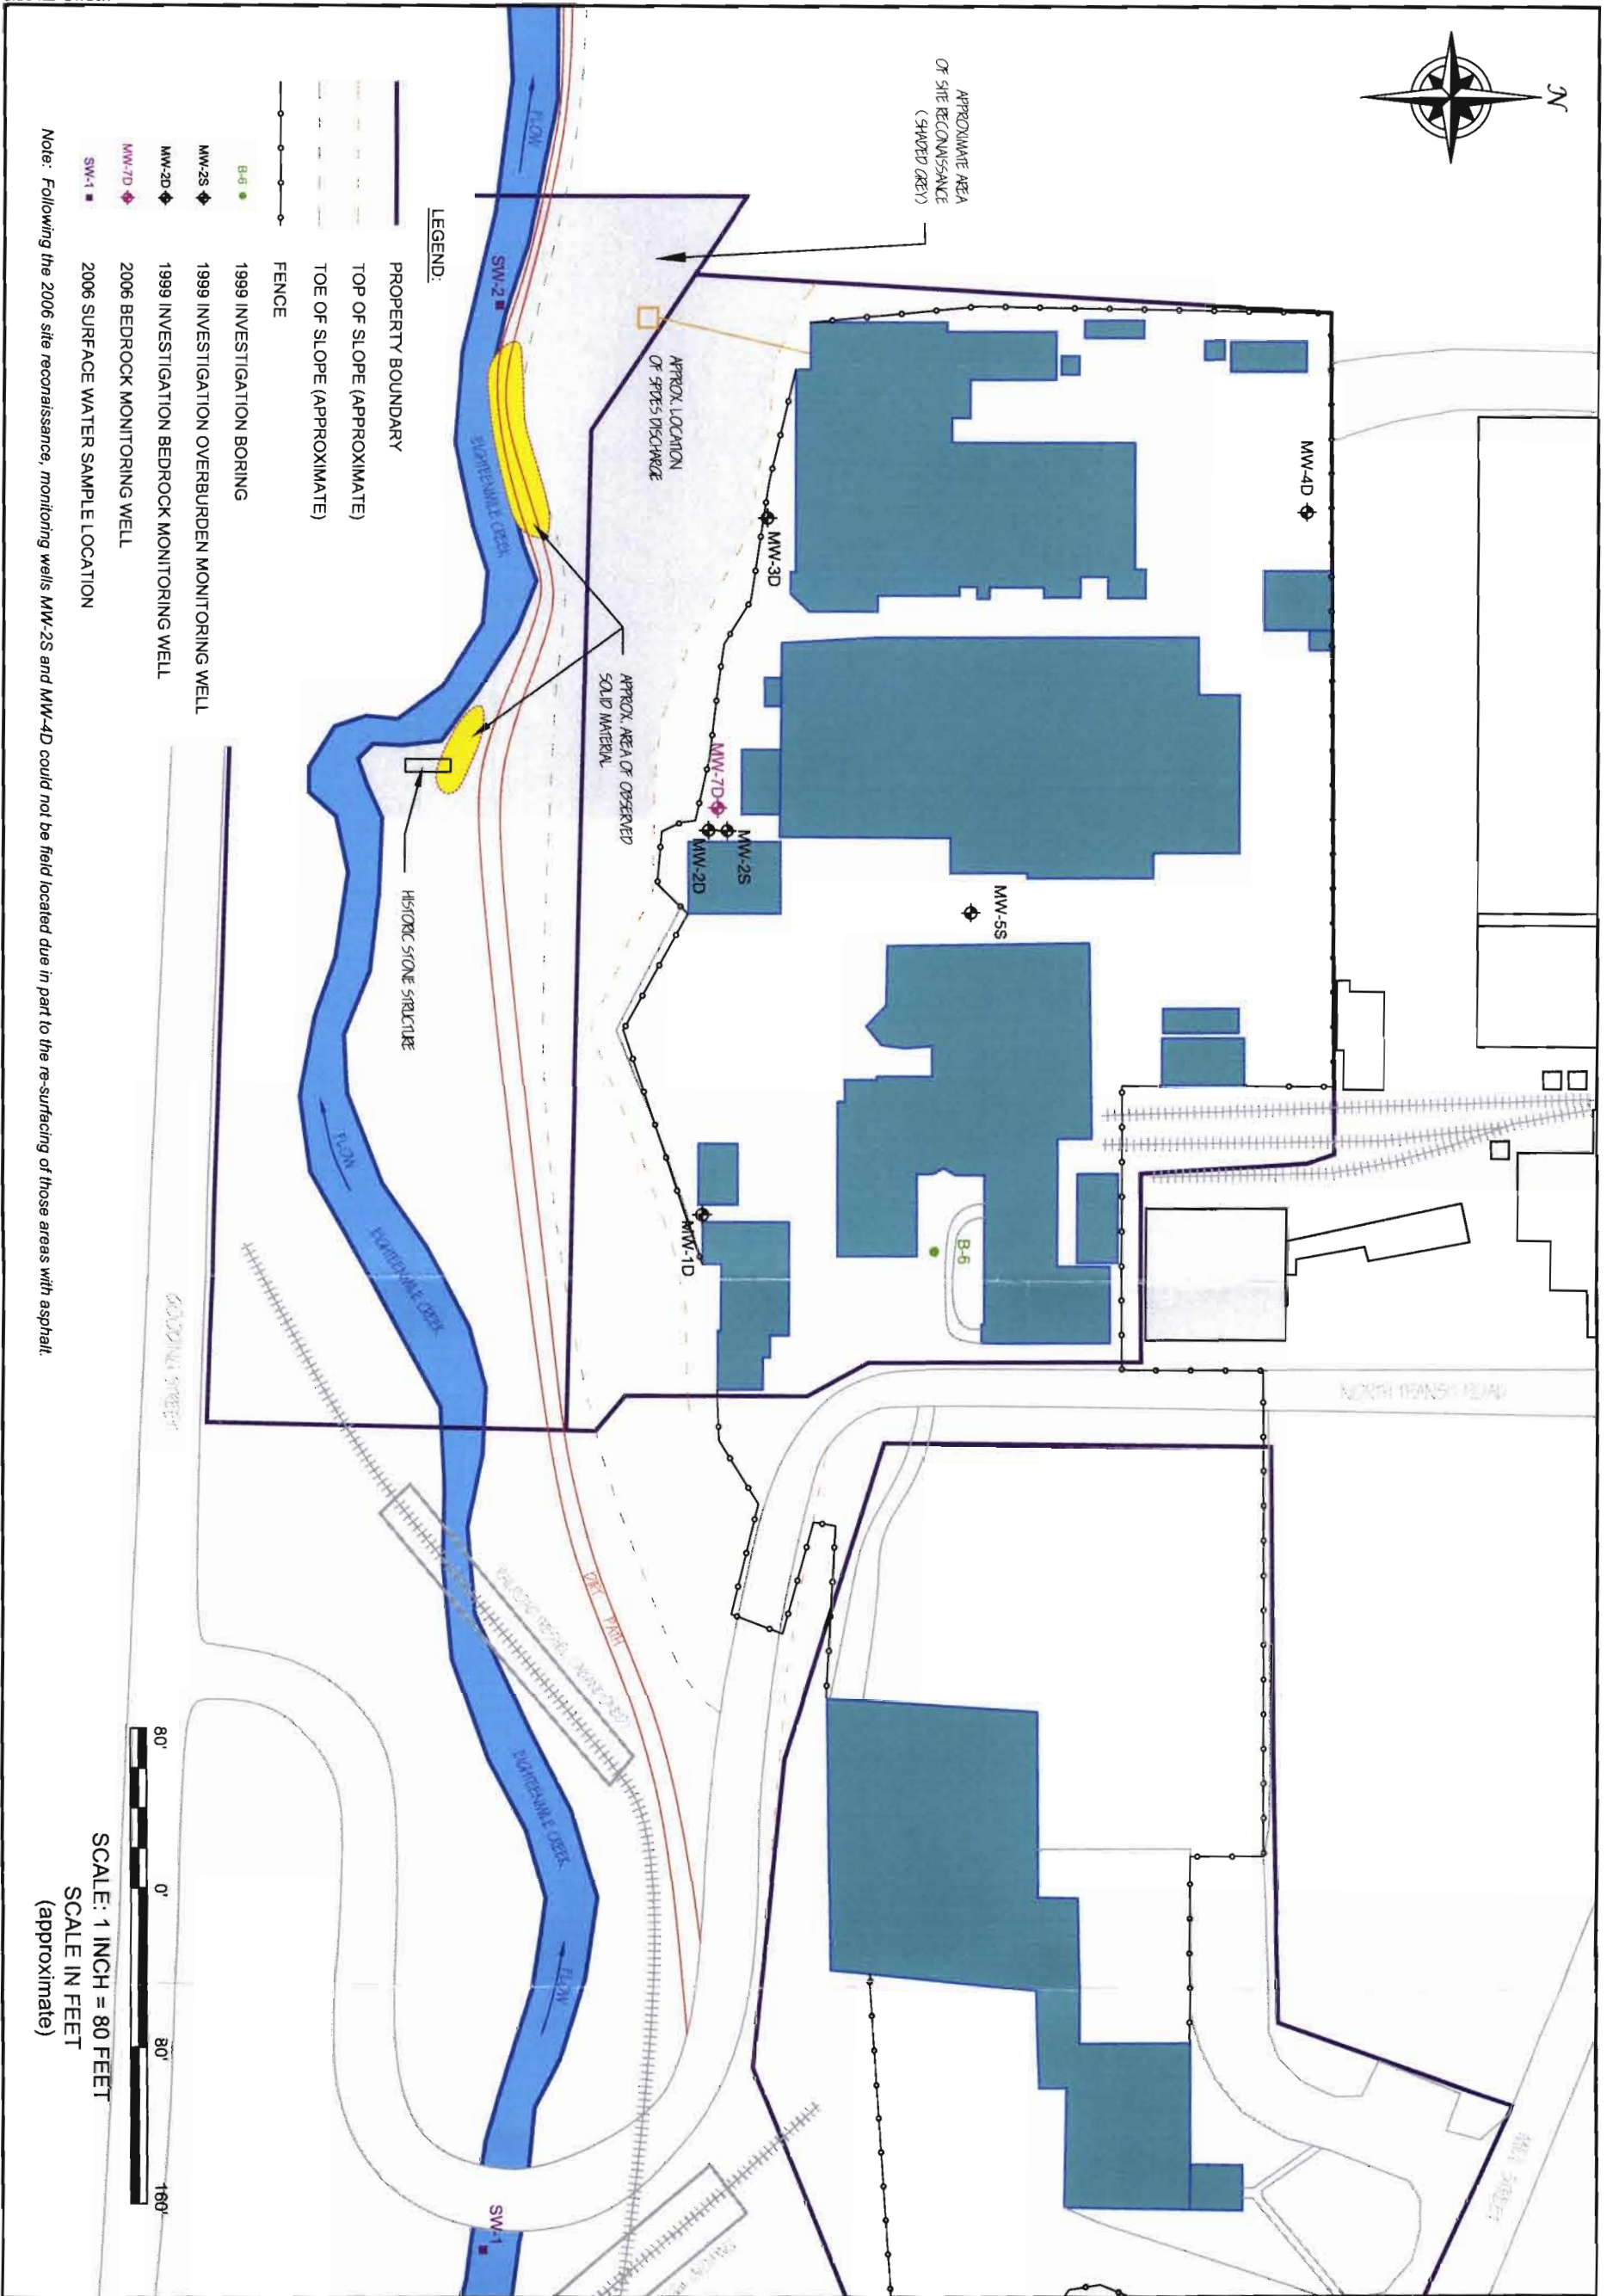
FIGURE 1

In addition to fill, a black crystallized material was visually observed at several locations along the toe of the slope within the inspection area (see Figure 1 and Attachment 1). The solidified material was hard and brittle. Samples were collected by striking the material with a hammer. Broken pieces appeared to be weathered and crystalline in composition having a slight tar-like
