PERIODIC REVIEW REPORT

**PORT-GREENBELT
SHORELINE IMPROVEMENT PROJECT
CITY OF BUFFALO, ERIE COUNTY, NEW YORK**

SITE No. B-00149-9

FEBRUARY 2017

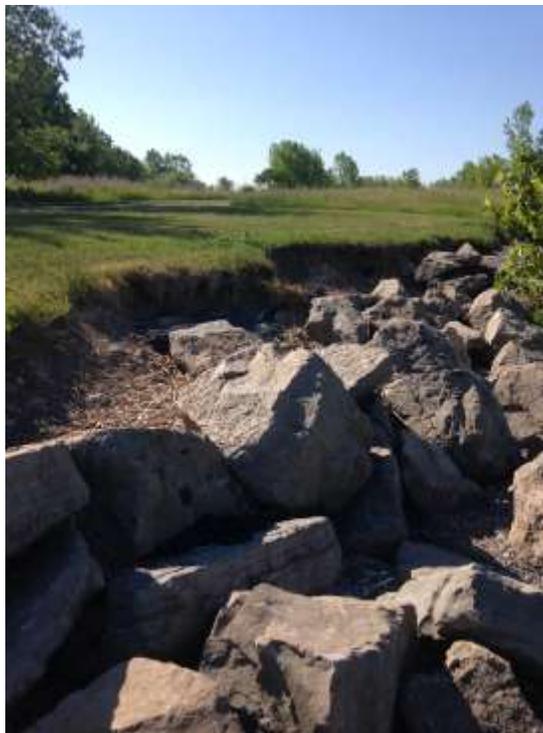
1

The final corrective measures that were implemented prior to this annual inspection included one or two rows of armor stone adjacent to the scarp with a ‘chinking’ mixture comprised of well graded cobbles, gravel, and sand that was installed in the void spaces between the larger armor stones. As noted above, the failure occurred behind this row of stone revetment. In this area, soil erosion occurred and vertical slopes were observed.

Looking south along eastern bank of Bell Slip (see Figure 1). Vertical banks are visible above stone revetment.

In order to reduce or eliminate erosion due to this wave action from storm surges, an area of medium stone fill with possible chinking mixture will be added in the area of slope erosion. This will build up the height of the revetment in this area to match or slightly exceed the ground level between the pathway and the shoreline. The stone in this upper row will take the brunt of the force from storm surges and wave action,

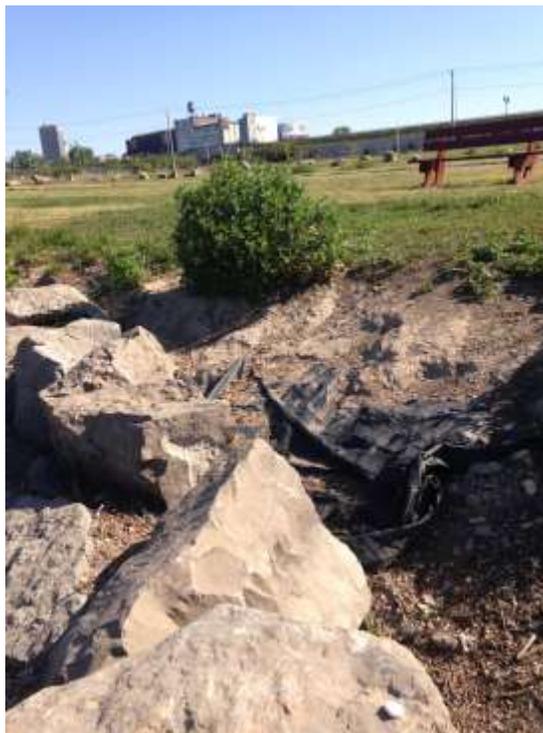
2

Looking north along eastern bank of Bell Slip (see Figure 1). Fabric and soil erosion visible above stones.

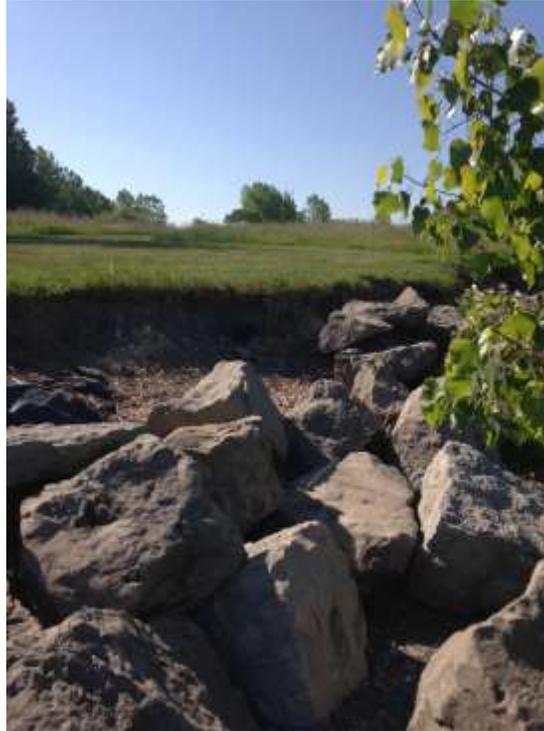
Exhibit:	Date:
3	6/9/2016

Looking south along eastern bank of Bell Slip (see Figure 1). Vertical banks are visible above stone revetment.

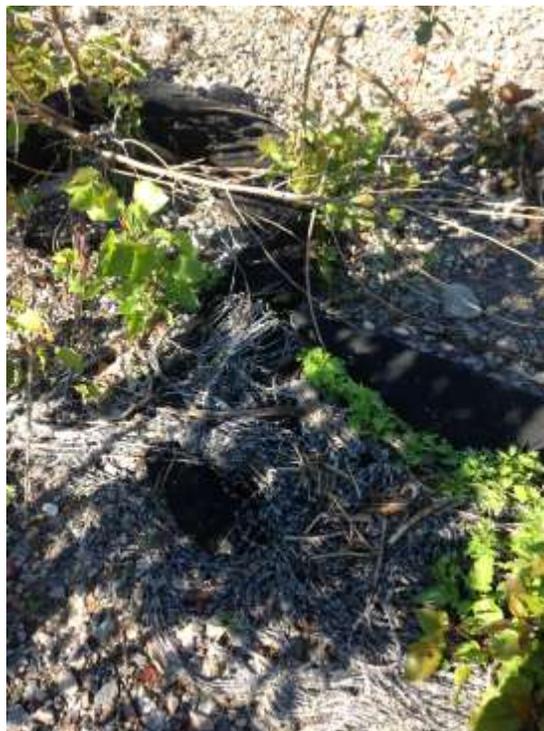
Exhibit:	Date:
4	6/9/2016

Netting and part of toe sock visible on eastern bank of Bell Slip

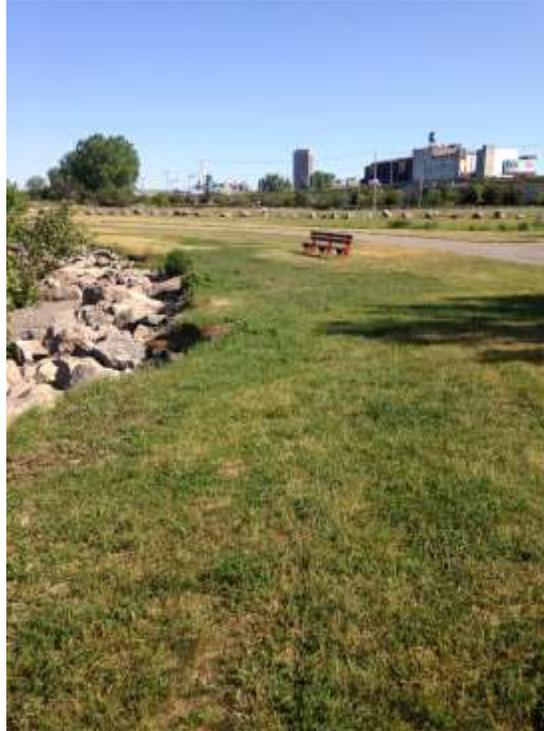
Exhibit: 5	Date: 6/9/2016	Port-Greenbelt PRR
----------------------	--------------------------	---------------------------

Looking north along path near eastern bank of Bell Slip. Darker grass and apparent depression near bench.

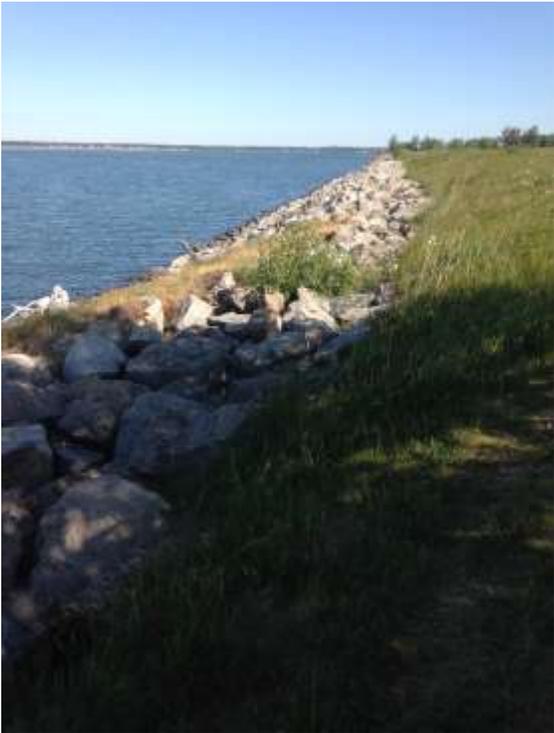
Exhibit:	Date:
3	6/9/2016

Looking north from middle of Greenbelt. Stone revetment has some soil/grass on top.

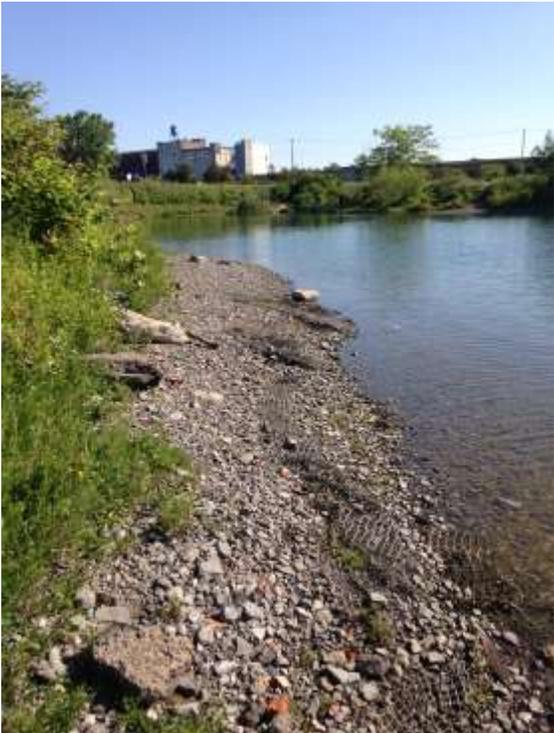
Exhibit:	Date:
5	6/9/2016

Looking east along northern bank of Bell Slip. Netting from erosion control is visible.

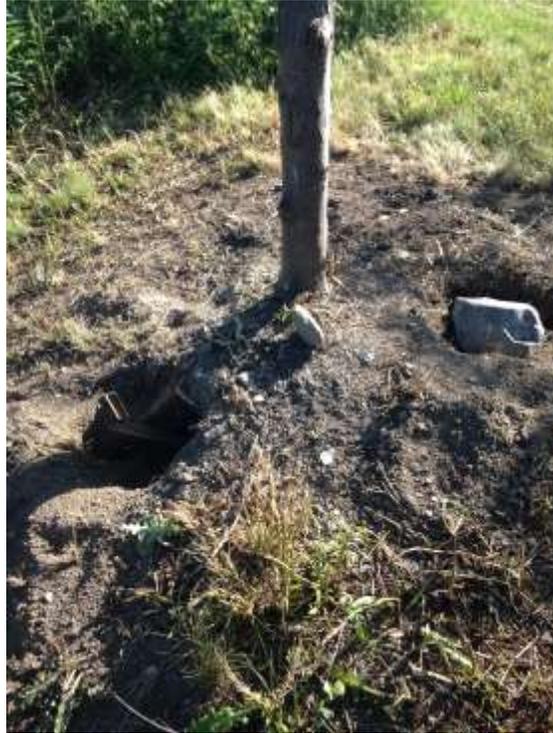
Exhibit:	Date:
6	6/9/2016

Generally, the slip looked to be in good condition with significant portions of the area covered with stones and grass cover. There were occasional animal burrows near trees located in the Bell Slip area. There was also some debris along the water's edge.

animal burrows near tree east of Bell Slip

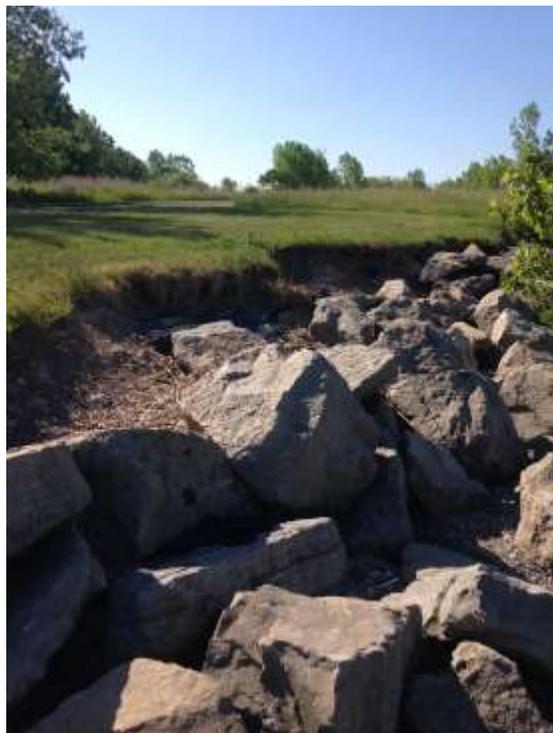
Exhibit:	Date:
7	6/9/2016

No geotextile fabric was exposed at the Bell Slip. However, there is evidence of soil erosion/sloughing in one approximately 100-foot area of the Slip, which is shown in **Figure 2**. A portion of the slope in this location has a vertical face where there is no soil or vegetation in an area behind a portion of the stone revetment. The soil cover in this portion of the Bell Slip appeared darker due to possible ponding from water that has overtopped the stone barrier during periods of high lake levels. There is also erosion from water scouring the soil behind the revetment and also slight damage to the gravel-filled bag which was displaced and tangled with some netting on shore.

Looking south along eastern bank of Bell Slip (see Figure 2). Vertical banks are visible above stone revetment.

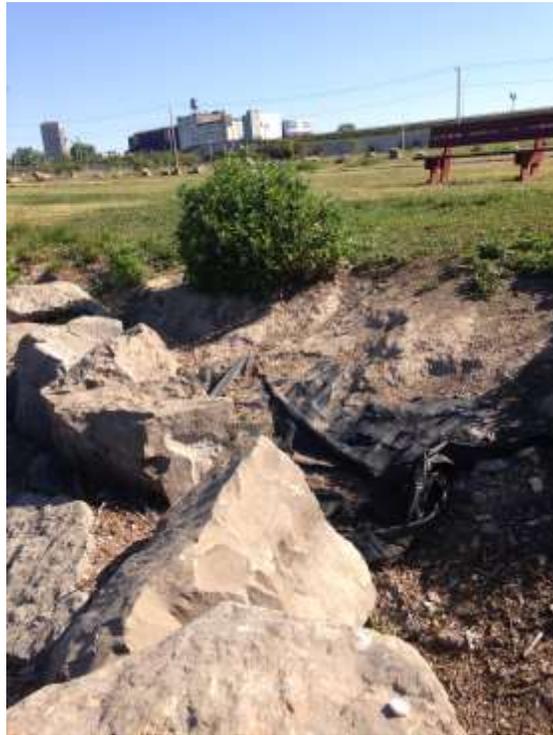
Exhibit:	Date:
8	6/9/2016

Looking north along eastern bank of Bell Slip (see Figure 2). Fabric and soil erosion visible above stones.

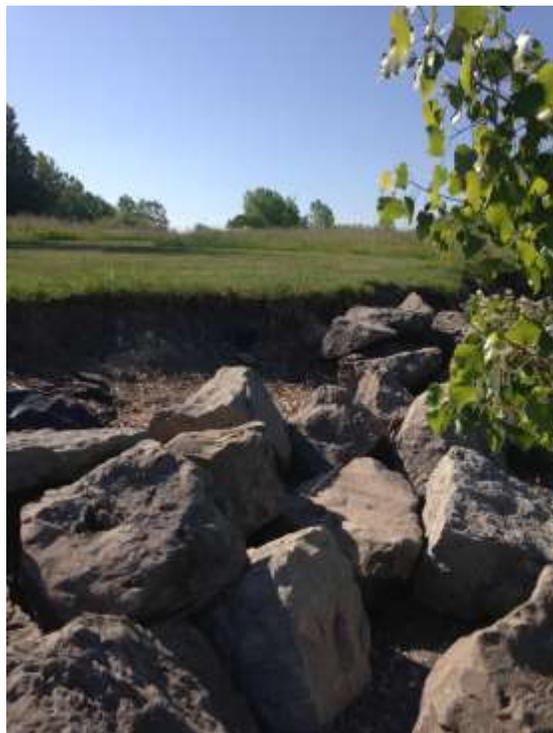
Exhibit:	Date:
9	6/9/2016

Looking south along eastern bank of Bell Slip (see Figure 2). Vertical banks are visible above stone revetment.

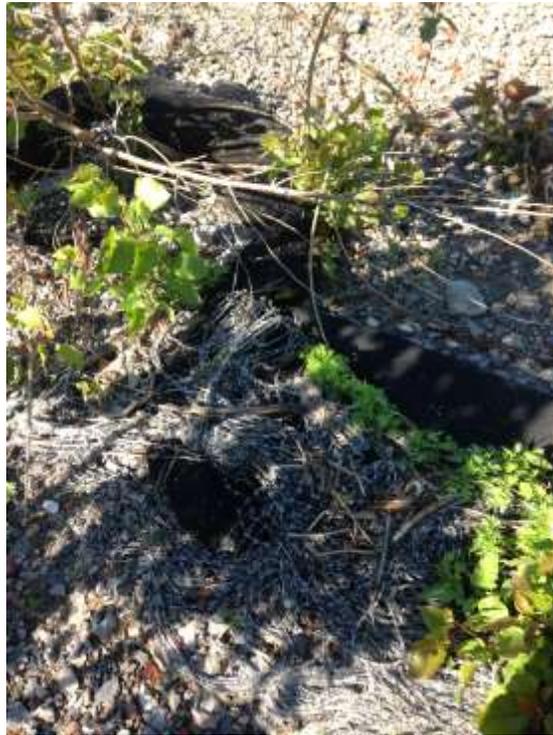
Exhibit:	Date:
10	6/9/2016

Netting and part of toe sock visible on eastern bank of Bell Slip

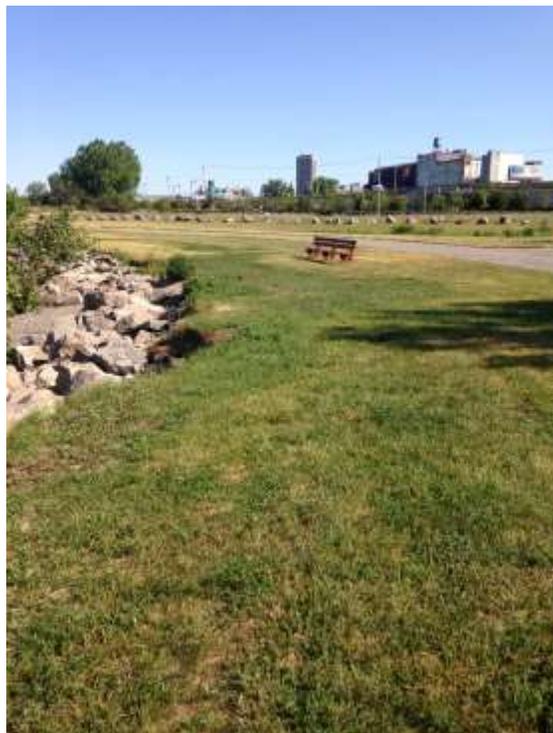
Exhibit:	Date:
11	6/9/2016

Looking north along path near eastern bank of Bell Slip. Darker grass and apparent depression near bench.
