Coating Failure Analysis Report

Sheet Pilings

De Laval Project

Poughkeepsie, NY

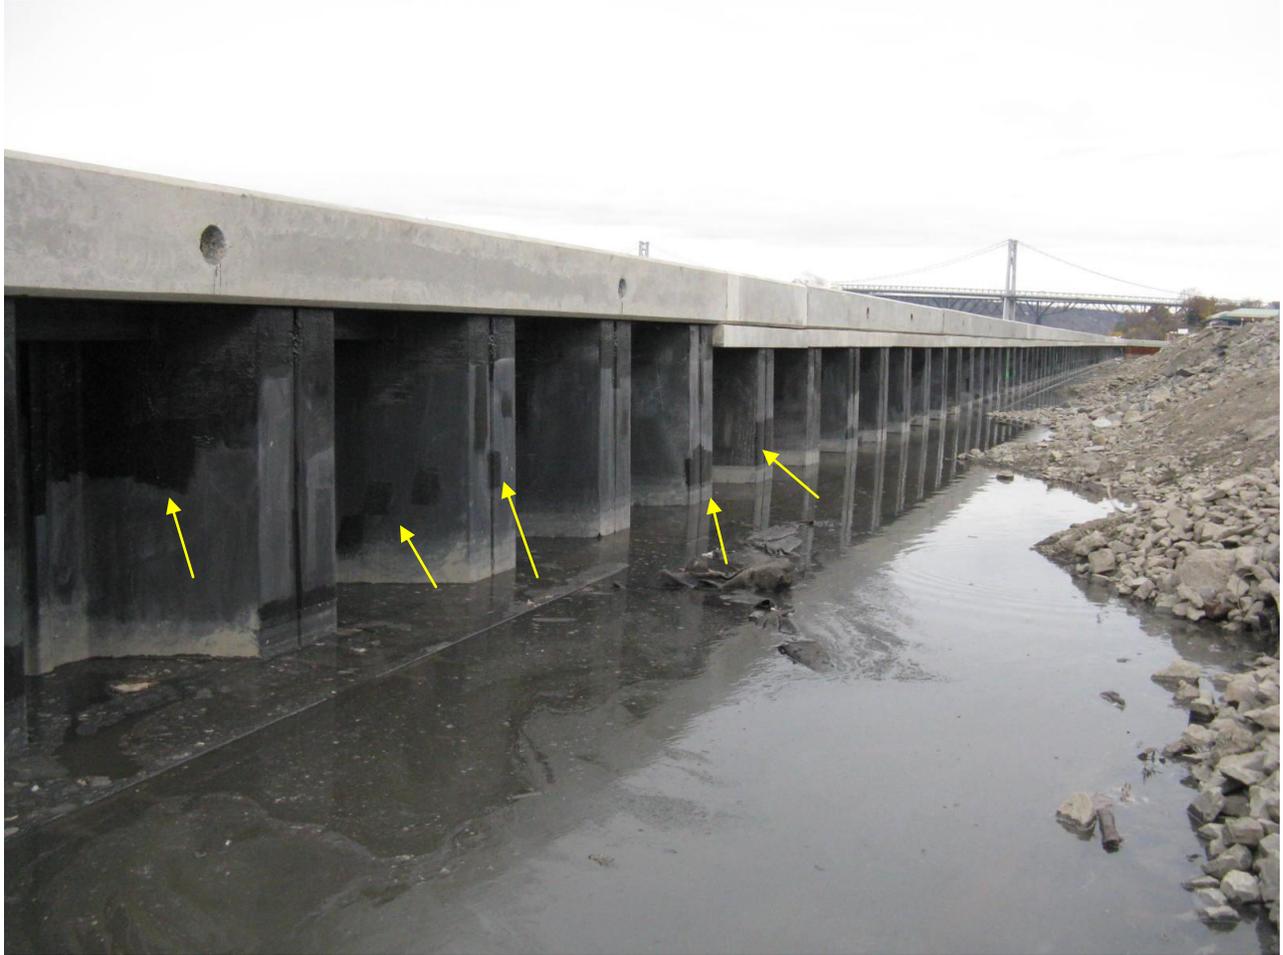
An initial observation common to both sides of the piles was that there are numerous existing touch-up coating areas. CPI remains uncertain regarding the type of failures (e.g. mechanical damage, cracking) which necessitated these field repairs, but assume that touch-up coating was performed because of a variety of coating related failures or defects. See Photo 1.

Photo 1 – Zone 1 looking north. Note numerous coating touch-up areas.

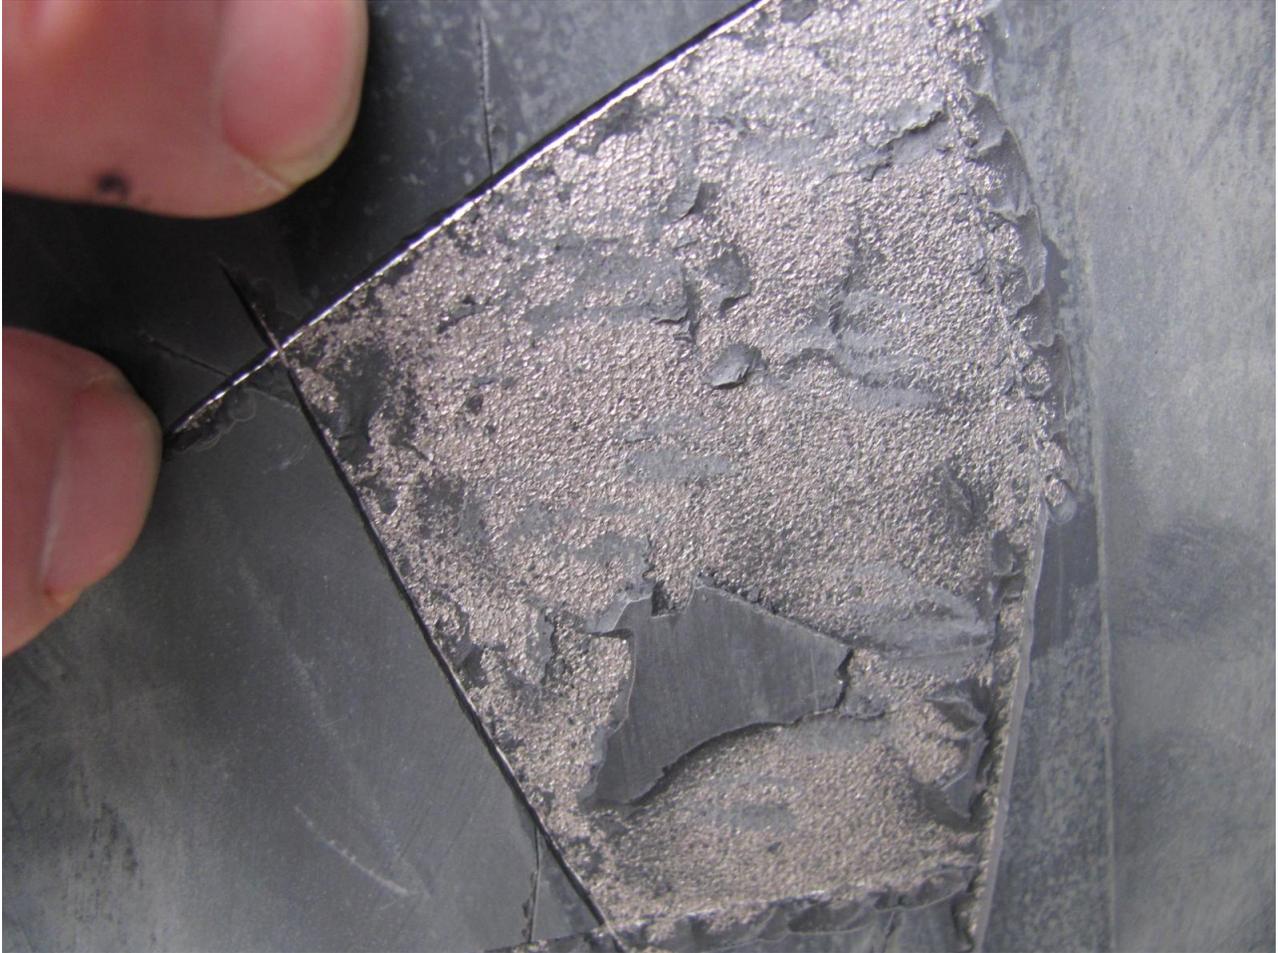
The specified degree of cleanliness was SSPC SP-10 Near –White Blast Cleaning with a surface profile of 1.5 – 2.5 mils. At all locations observed the degree of cleanliness appeared acceptable. Surface profile measurements, accomplished by comparison between respective sheet pile steel surface conditions and a (replica) surface profile comparator disc, were typically between 2.0 to 3.0 mils. However, steel surfaces had a rounded, peened texture as opposed to a sharp, angular (sandpaper-like) texture. Note that paragraph 3.1 A. of the protective coating specification Section 09905 states, in part, the following relative to surface preparation and, specifically, regarding surface profile: “Blast profile on steel shall be 1.5 to 2.5 mils in depth and be of a sharp, jagged nature as opposed to a peen pattern from shotblasting.” Recyclable (rounded) steel shot is typically used in shop surface preparation operations in combination with more angular abrasives (e.g. coal or furnace slag). It would appear that the reuse of steel shot without angular abrasives or the lack of sufficient cutting action resulted in the peened appearance of the substrate. See Photo 2.

- B. There was evidence of workmanship concerns whereas the surface profile of the steel where exposed by CPI revealed a peened appearance as opposed to the angular, sharp surface profile specified. CPI does not know the extent of this peened substrate appearance in the overall bulkhead piling surfaces.

Photo 2 – Typical peened surface profile.

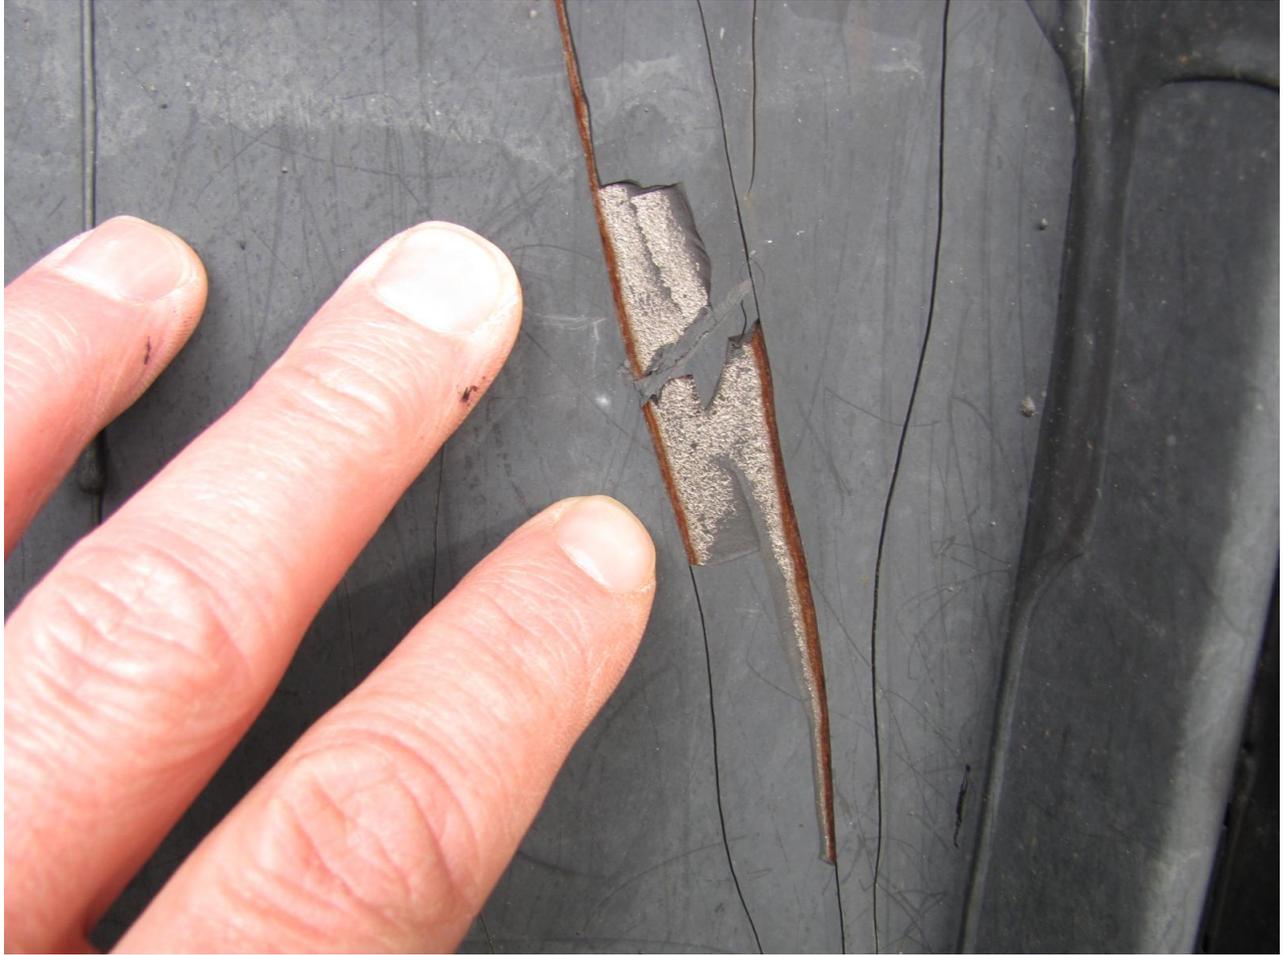
In general, visual examination of the coated piling surfaces indicated reasonably good film quality without evidence of pinholes, holidays, or delaminated coating areas. The exception to this was through film cracking of the coating at a number of areas, mostly located at bends and coincidental with pile interlocks (cracks oriented vertically). See Photos 3 and 4.

Photo 3 – Typical vertical coating cracks. Note through-crack rust.

- B. All through coating cracked locations should be repaired as follows:
 - 1. Power tool clean the crack in accordance with SSPC-SP-11 Power Tool Cleaning to Bare Metal area plus 4" on either side of the corroded crack areas feathering the cleaning onto the intact coating periphery another 2" to 3". This can be done on one tide change.

- 2. On the next tide change, pressure water wash the previously cleaned areas to decontaminate the steel. Immediately power tool clean these areas to remove flash rust corrosion product and apply the Splash Zone Coating Material in accordance with the manufacturer's recommendations. CPI understands the approved coating repair product is FX-764 Hydro-Ester Zone and Underwater Paste. This seems like a suitable product for this application. An alternate product can be considered from Sherwin-Williams, but the FX-764 does have a proven track record on similar projects.

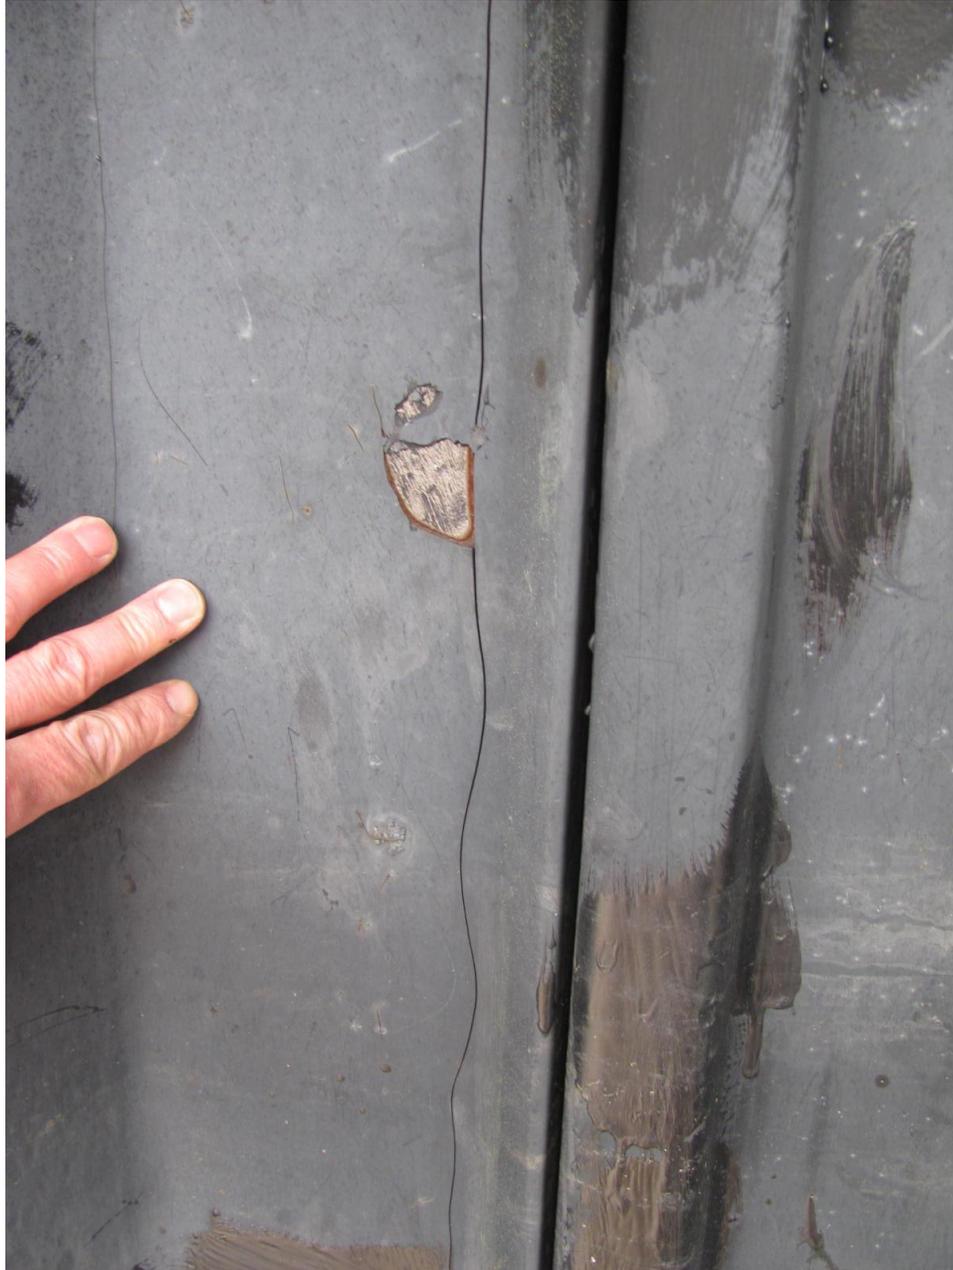
Photo 4 – Typical vertical coating crack associated with interlocks.

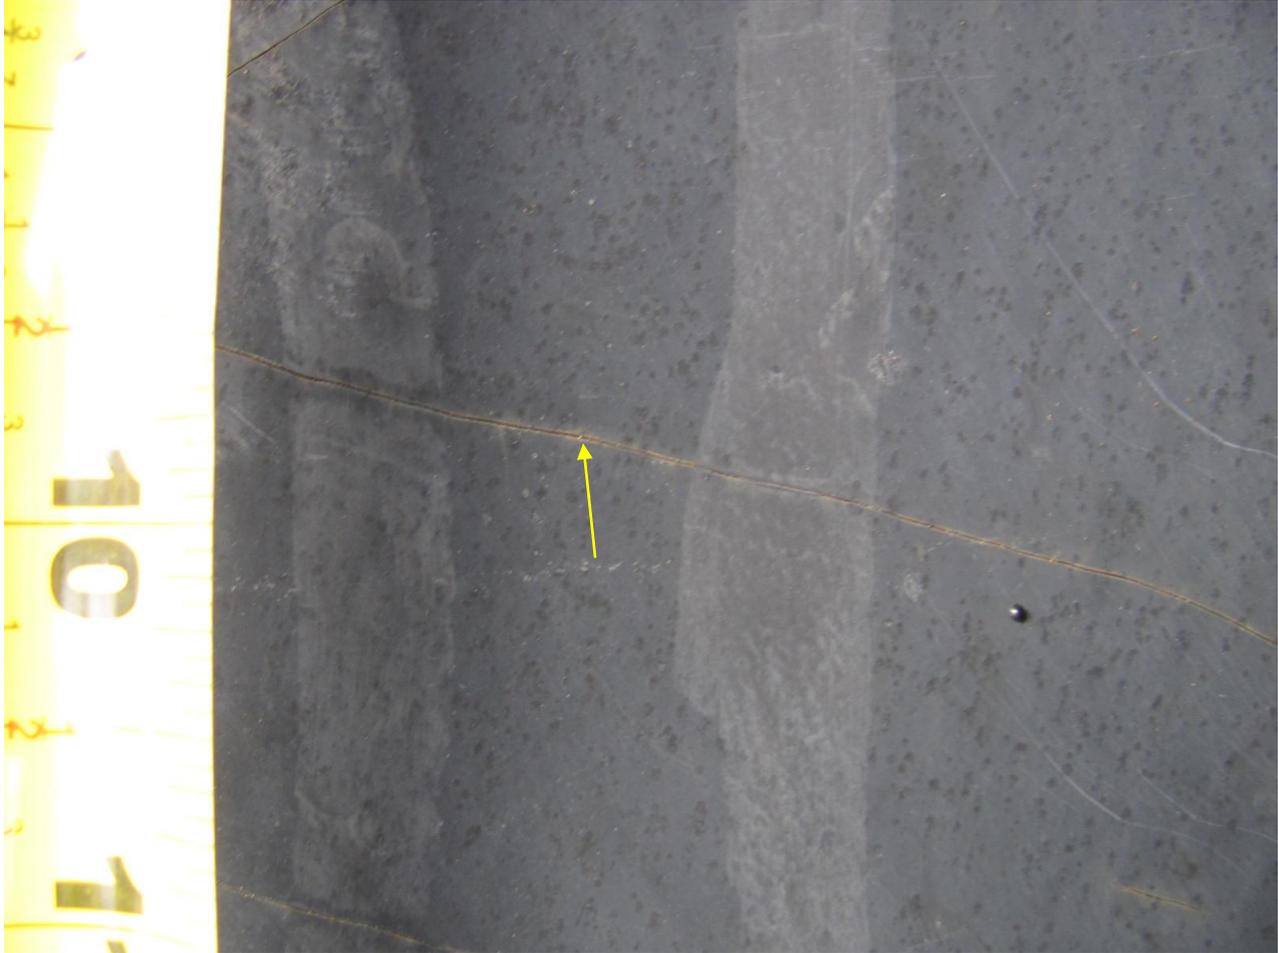
However, there were through film cracks which were also horizontal in orientation. See Photo 5. Additionally, CPI observed sporadic areas of multiple and irregularly oriented short cracks. This type of cracking is typical of film curing stresses in solvent based epoxy coatings associated with excessive film thickness during application. See Photo 6. It shows this typical condition.

Photo 5 – Typical horizontal coating crack.

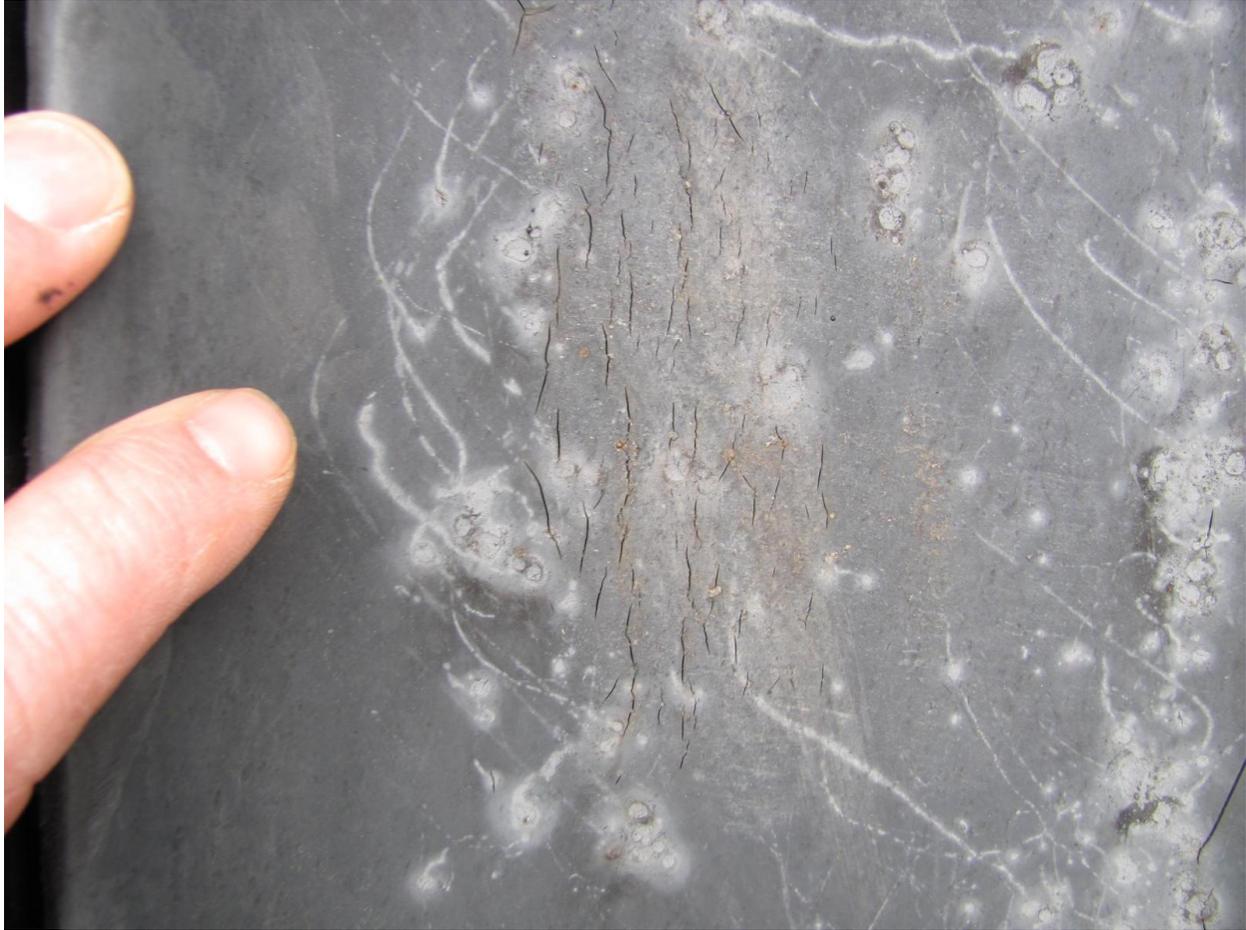
Photo 6 – Short, multiple, irregularly orientated coating cracks.

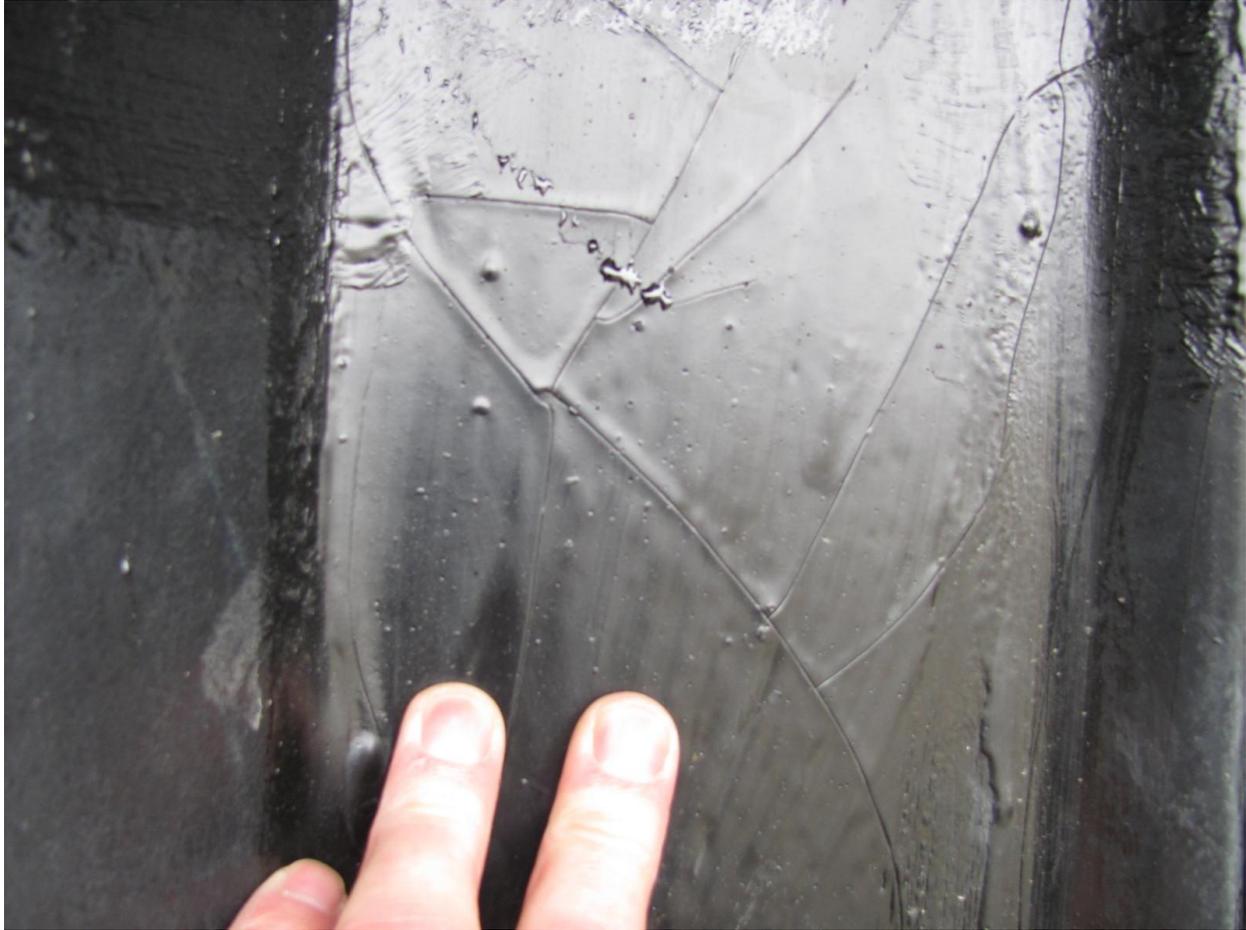
CPI also observed cracks that were coated over. See Photo 7. Those areas should be treated as recommended in Part 5.0 of this report. (Same as for cracks previously untreated.) This is not advisable to do.

Photo 7 – Overcoating of cracks.
