Re: Remedial Investigation - June 2015 Progress Report
South Shore Outdoor
1760 Fifth Avenue
Bay Shore, NY
NYSDEC Site No. C152228

Sovereign Consulting Inc (Sovereign), on behalf of First Hartford Realty Corporation (FHRC), has prepared this progress report to summarize remedial investigation (RI) activities conducted during June 2015.

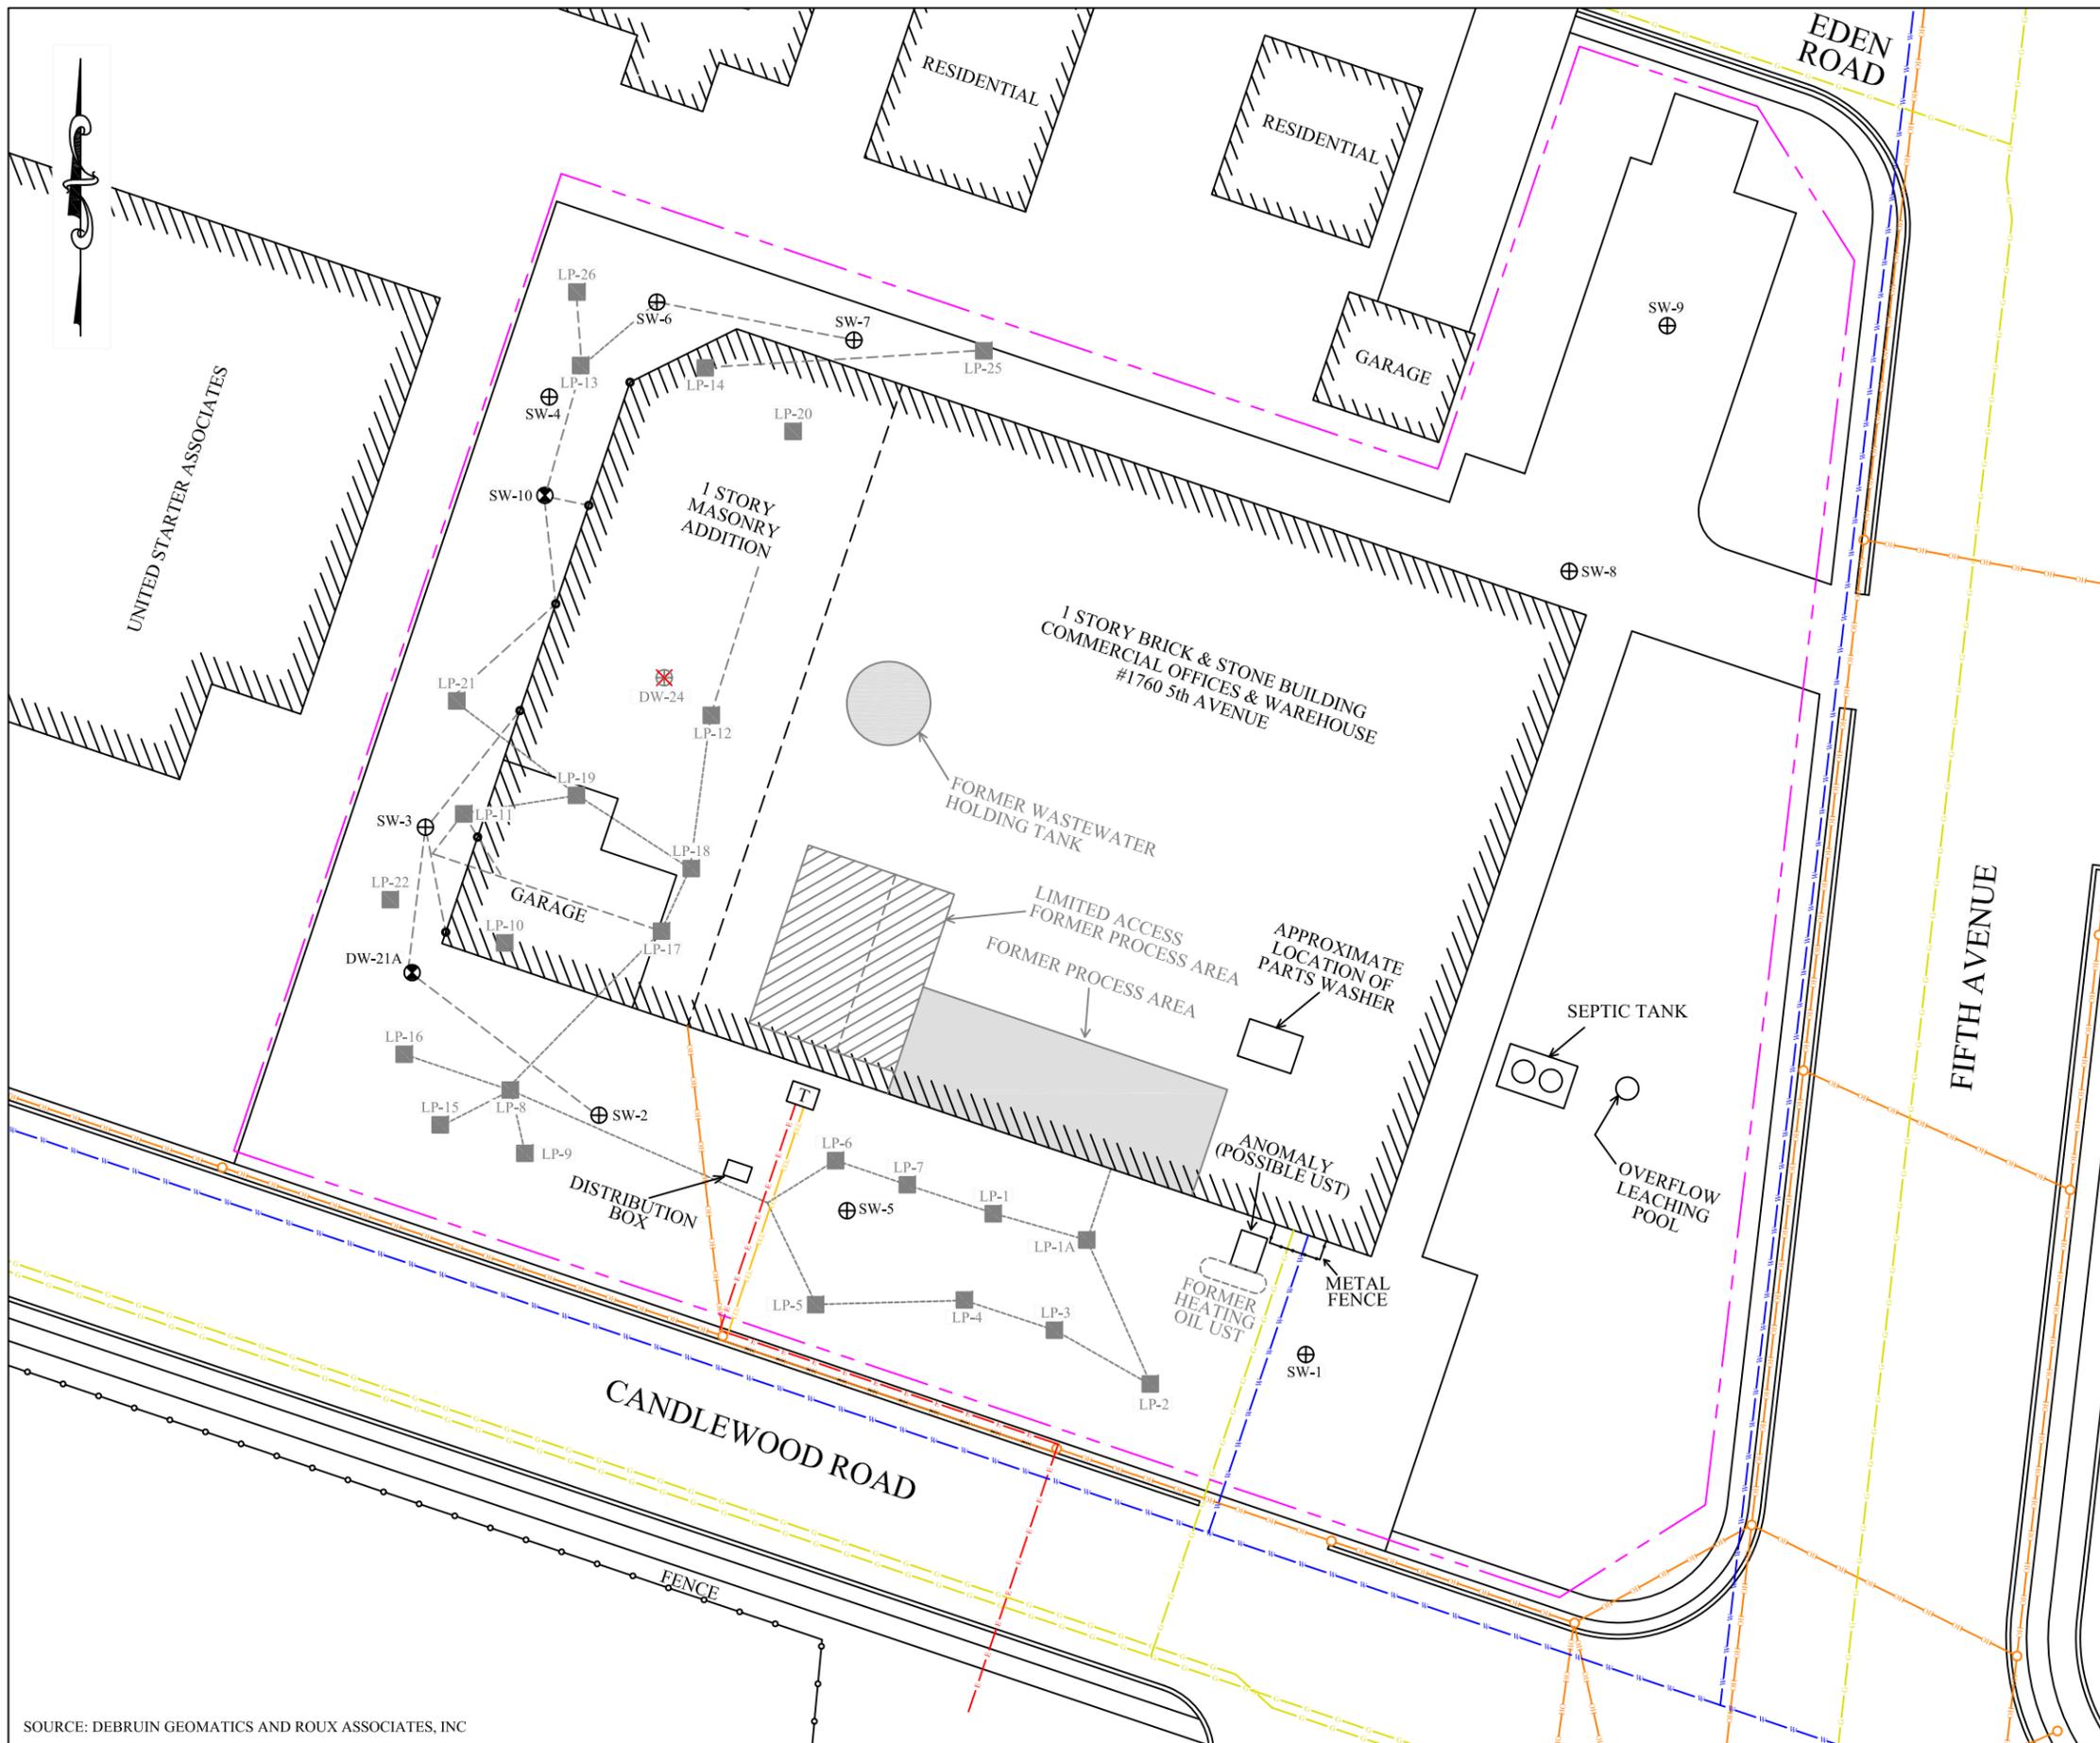
Attachment:
Figure 1 – Site Plan

Prior to initiating the RI field activities on June 22, 2015, a geophysical survey was conducted on May 8 and 11, 2015. All of the former industrial leach pools were identified, with the exception of LP-10 and LP-19. LP-10 and LP-19, located within the garage area of the building, were inaccessible due to numerous wooden pallets and other equipment. The locations of some of the leach pools and stormwater drywells were adjusted on the site plan to more accurately depict their locations. See the attached site plan. One overflow stormwater drywell (SW-10), that previously was not identified, was located on the western side of the building. See the attached site plan.

Upon opening LP-1, it was discovered that it was not backfilled. Two interconnection pipes were observed, one heading west in the direction of LP-7 and another heading towards the east. An additional geophysical survey was performed to see if there was an additional leach pool present. Another abandoned leach pool was observed approximately 20 feet east of LP-1. This leach pool was designated as LP-1A. Upon opening LP-1A, it was observed to be backfilled, but connecting pipes to LP-1 and LP-2 and a pipe heading towards the building were observed.

The owner subsequently cleared out the garage area allowing access to perform a geophysical survey at LP-10 and LP-19. LP-10 and LP-19 locations were confirmed. A screw cap attached to a riser pipe was observed at the location of LP-19. The cap was removed and it was determined that LP-19 was not backfilled and the bottom was approximately 10 feet below grade. A soil sample was collected with a hand auger and submitted for analysis. Debris (broken glass, plastic, and vinyl siding pieces) were noted in the bottom sample. It is unknown why this leach pool had a riser pipe attached to it.
