PERIODIC REVIEW REPORT

Parkview Commons Site

871 Elton Avenue
(formerly known as 436 East 161st Street)
Borough of Bronx, New York

NYSDEC BCP Site: C203014

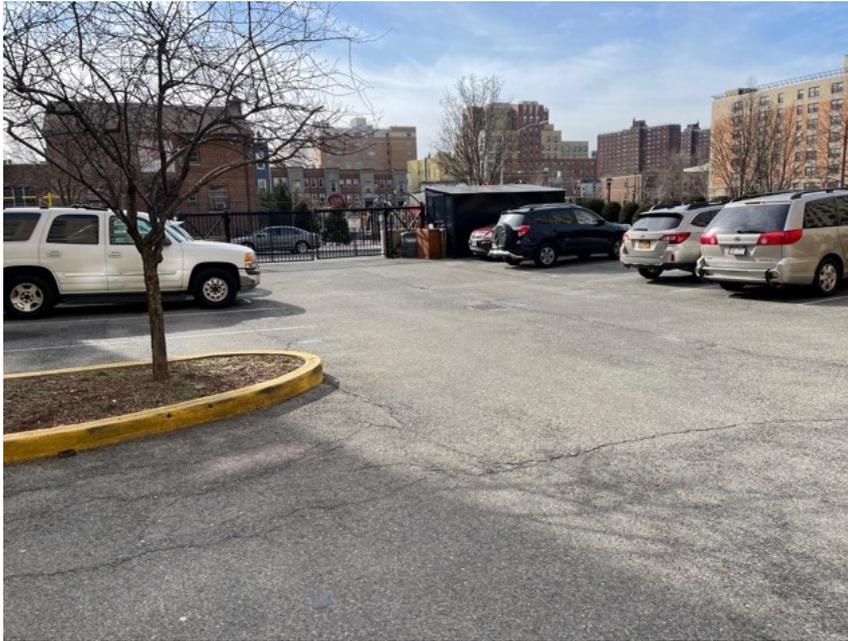
1. Asphalt parking barrier layer, western portion of Site

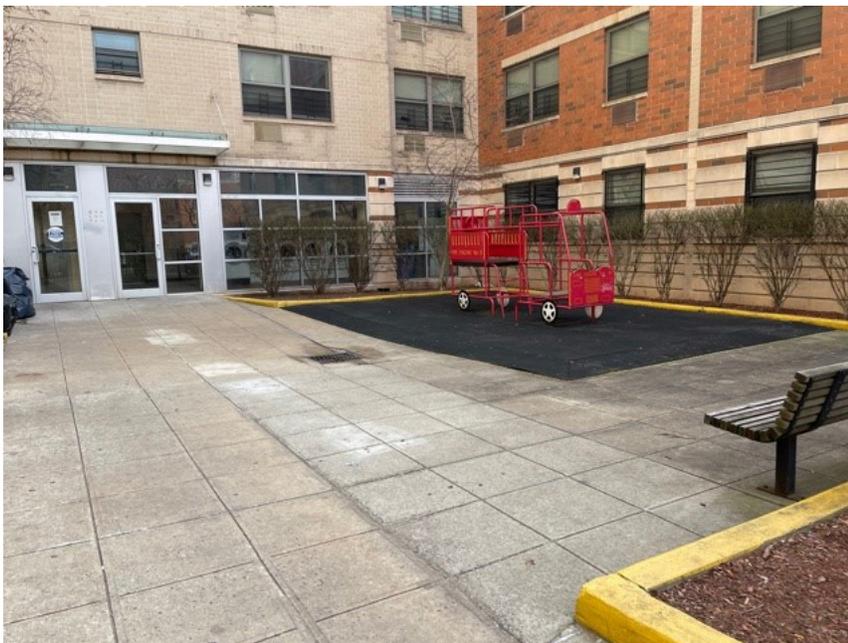
2. Courtyard barrier layer, central portion of Site

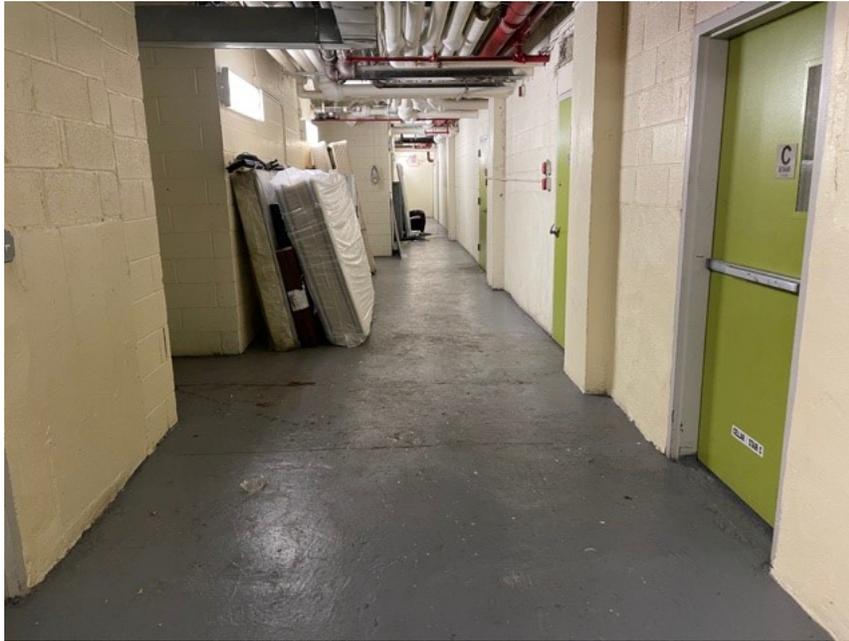
3. Cellar slab cover layer

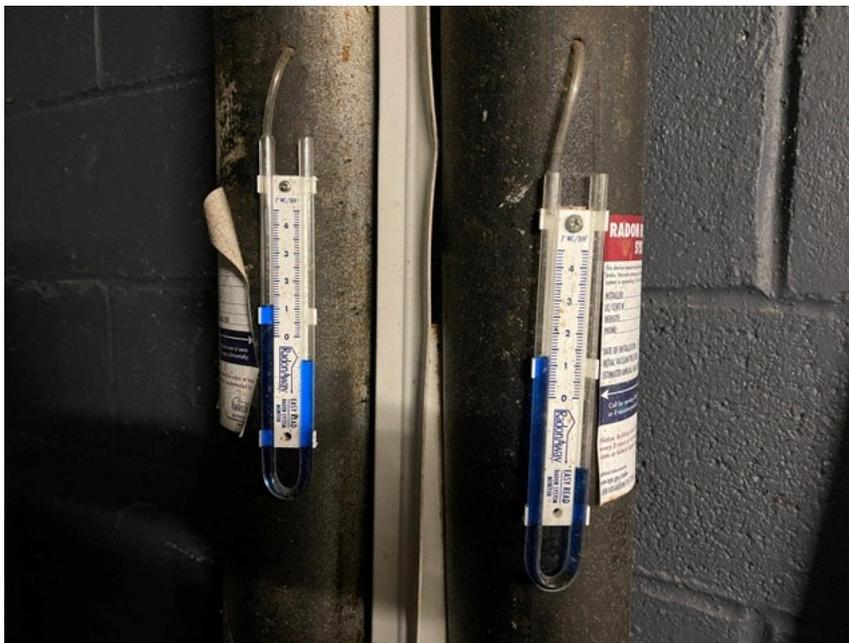
GBTS recorded readings from previously installed U-manometers, which provide visual indicators of active vacuum, at vertical pipes. Vacuum readings of the U-manometers located at VP-1 and VP-2 were recorded as -1.1 in. w.c. and -1.2 in. w.c., respectively.

4. U-manometers corresponding to VP-1 (left) and VP-2 (right), both displaying negative pressure readings

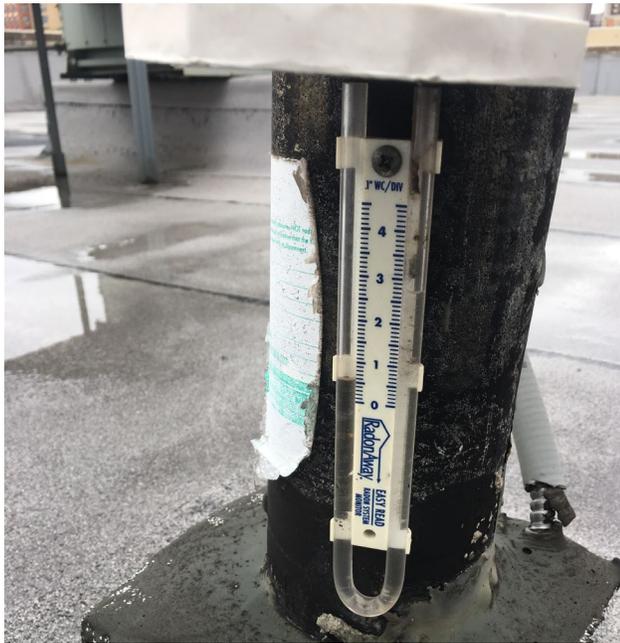
The liquid in U-manometer VP-3 (located on the roof) was clear and contained more liquid during the site inspection on January 25, 2021. GBTS was on-site on February 16, 2021 and VP-3 was replaced with a RadonAway U-manometer. A vacuum reading of -0.4 in. w.c. was recorded. Data from the U-manometer and the VEMPs indicate that the VES is working properly.

5. U-manometer corresponding to VP-3 showing extra liquid and clear liquid (to be replaced)

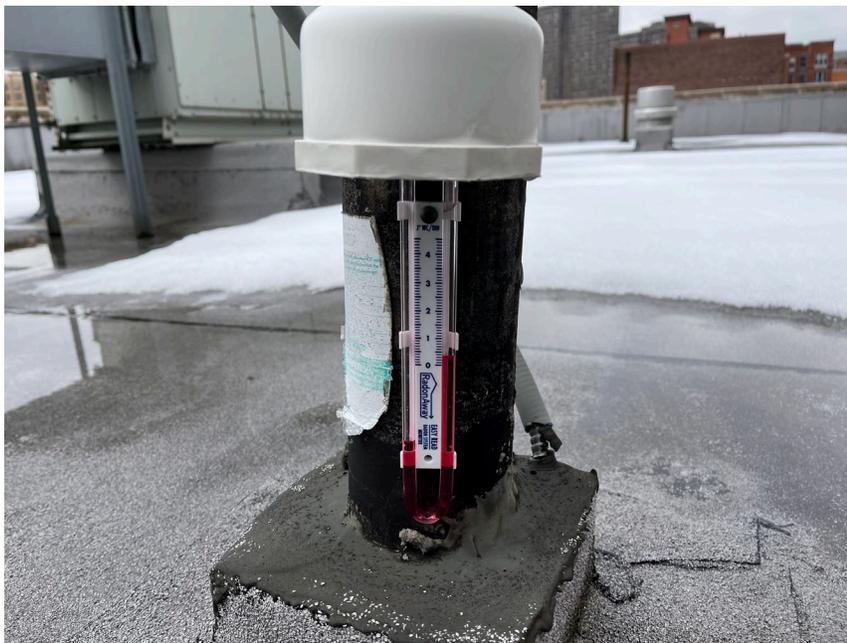
6. VP-3 replaced on February 16, 2021 and displaying a negative pressure reading

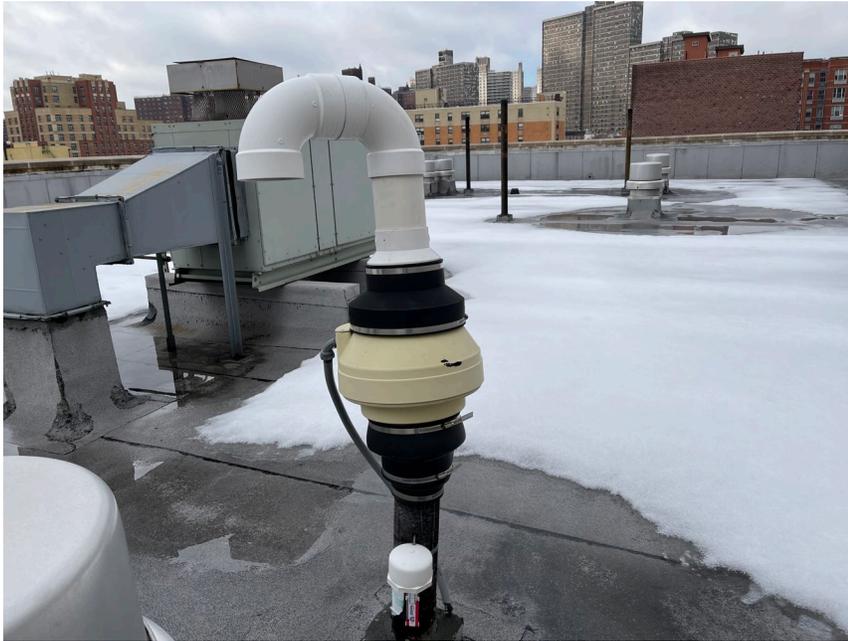
7. VES fan connected to VP-3, located on southern roof

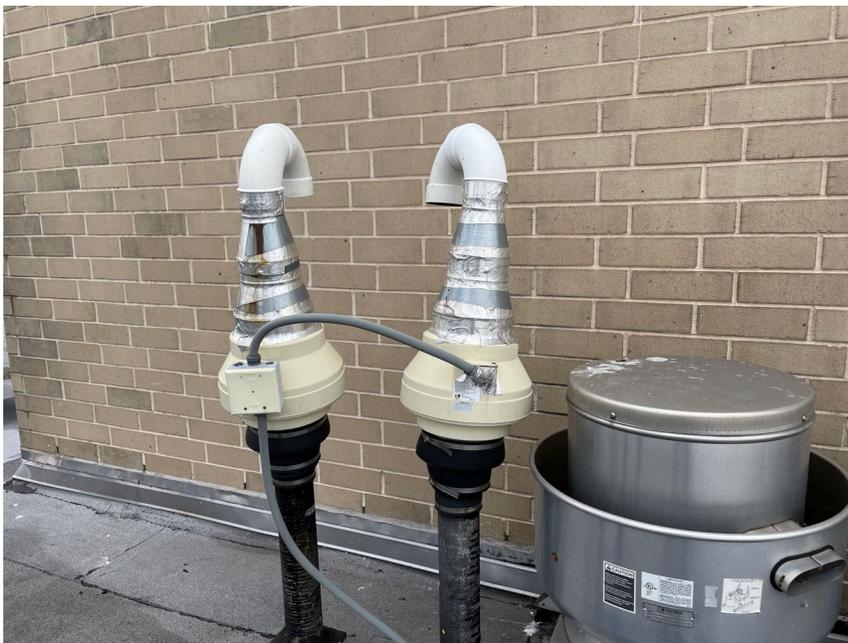
8. VES fans connected to VP-1 and VP-2, located on roof

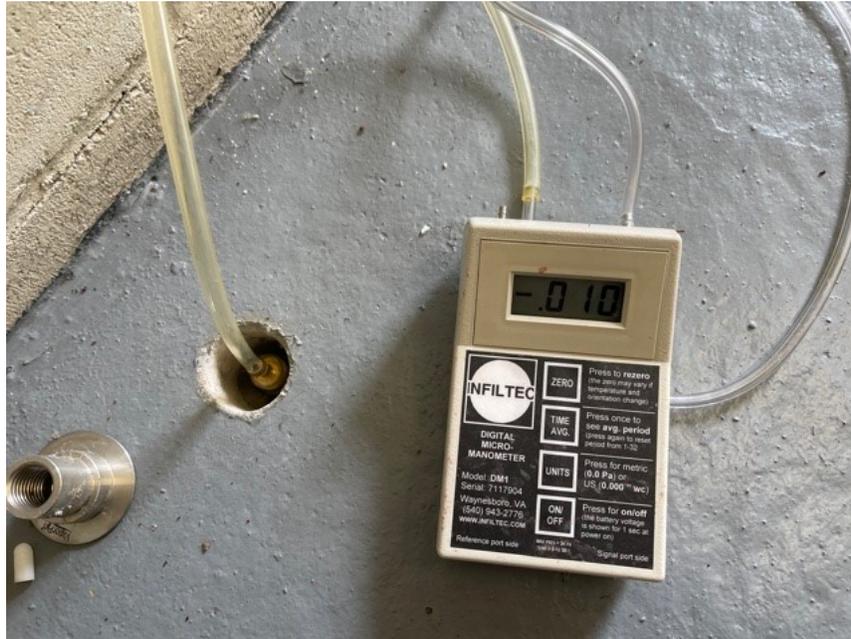
During the December 20, 2018 inspection, the seal on an abandoned monitoring point (VEMP-1) was observed to be in poor condition and appeared to influence the digital manometer readings at VEMP-1R. VEMP-1R was replaced and VEMP-1 was re-sealed on January 30, 2019 by personnel from Core Down Drilling under the direction of WCD. VEMP-3R was also replaced at this time at the request of the building manager (VEMP-3R was situated in such a way that it created a tripping hazard for building occupants).

9. Negative pressure reading at VEMP-1R, northwestern portion of building

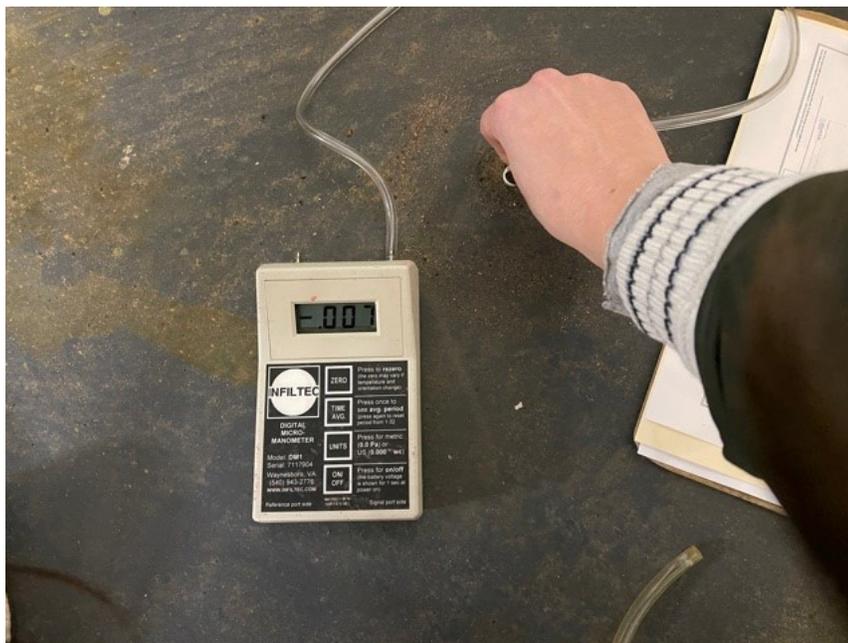
10. Negative pressure reading at VEMP-2 (northeastern portion of building)

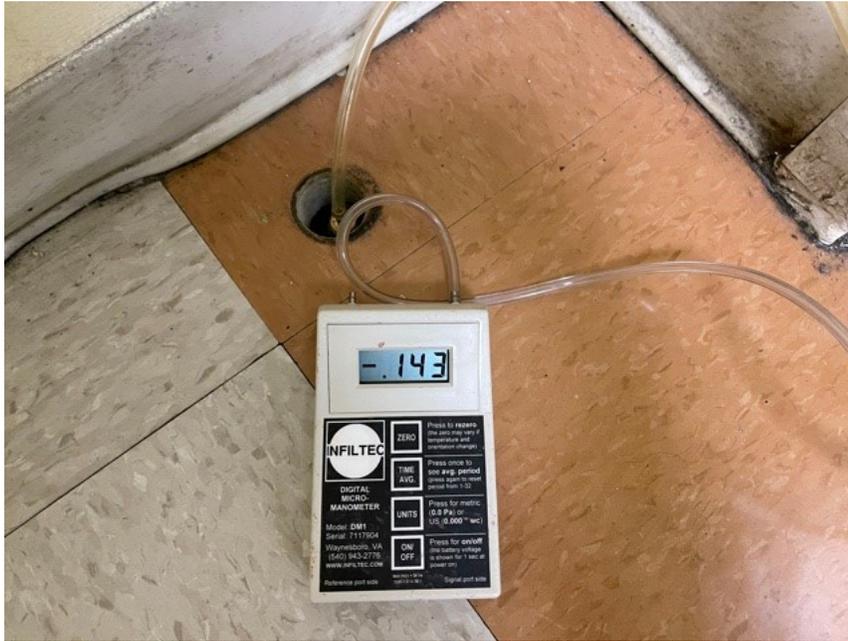
11. Negative pressure reading at VEMP-3R (southwestern portion of building)

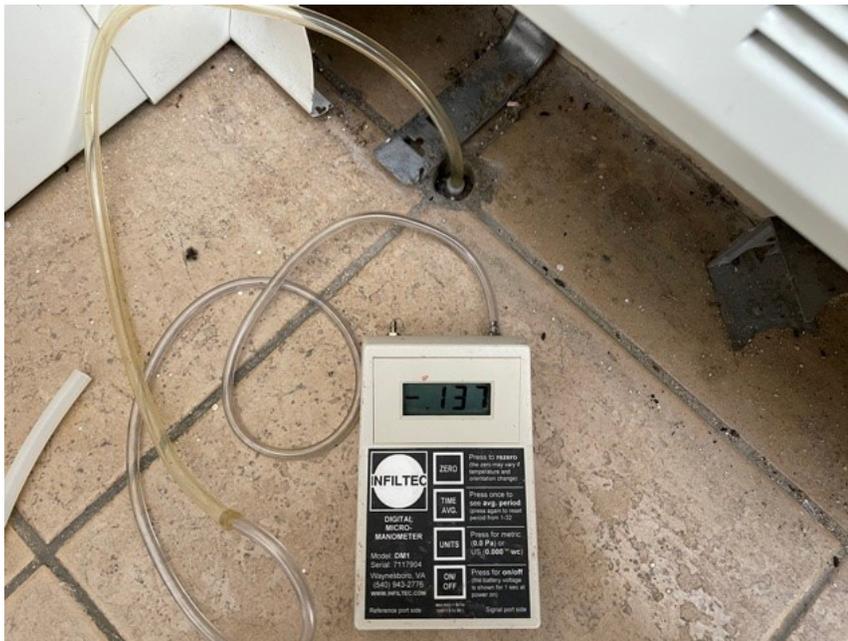
12. Negative pressure reading at VEMP-4 (southeastern portion of building)
