## Phase I Environmental Site Assessment Report

MEI Project Number 16-1111

Property located at 763-765 & 767 East 133rd Street  
and 750 East 134th Street in Bronx, New York

November 18, 2016

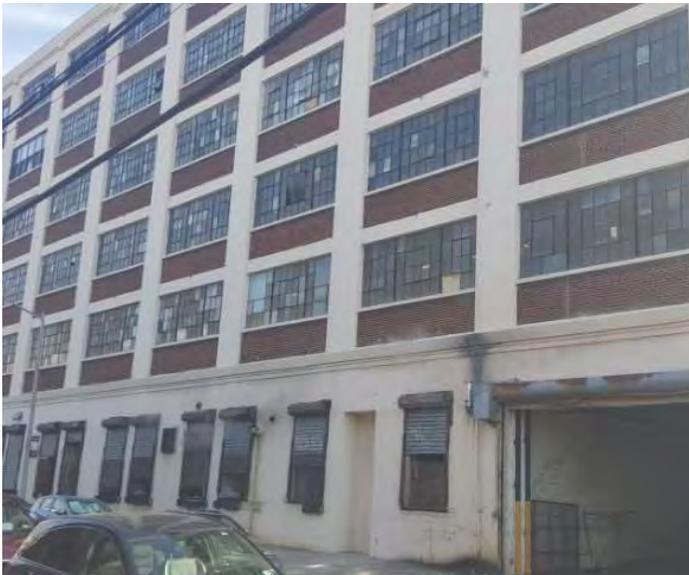
**BORDER TO THE EAST**

East - The property is bordered to the east by Willow Avenue and a commercial/light industrial building.

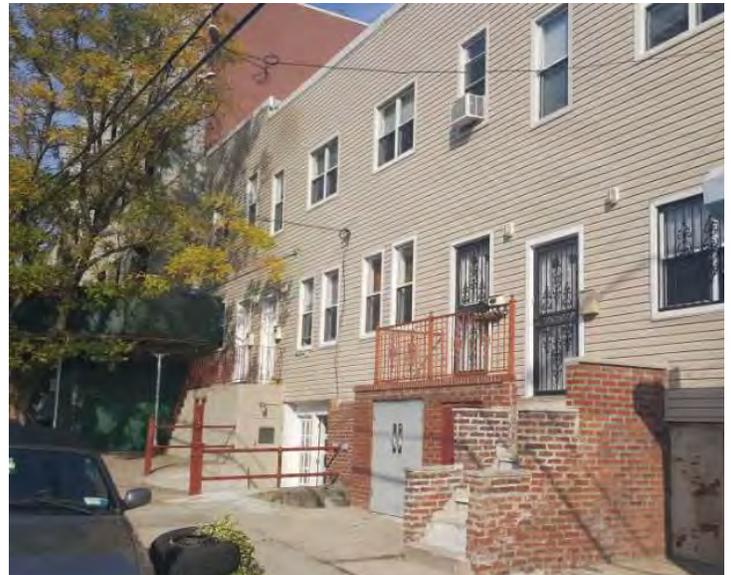
**BORDER TO THE WEST**

West - The property is bordered to the west by a residential and commercial building.
