**Re: Corrective Measures Work Plan  
Former Watermark Designs Facility (BCP Site No. C224139)  
491 Wortman Avenue, Brooklyn, NY 11208  
Langan Project No.: 170329301**

**ATTACHMENT A**  
**SITE INSPECTION PHOTOGRAPH LOG**

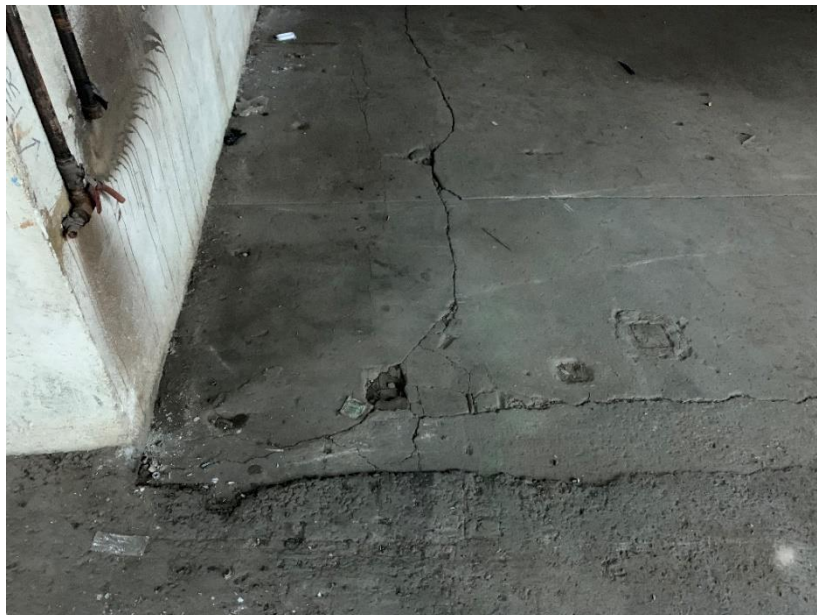
During an inspection performed on April 1, 2019, site cover system damage (e.g., holes, cracks and penetrations) was observed and documented as shown in Attachment A. Implementation of this CMWP will repair the site cover system damage.

Photo 2: View of damaged concrete building slab in the southern portion of Lot 36 (facing south)

- Repairing the site cover system (i.e., concrete slab) to match existing grade with at least 4-inches of concrete rated for at least 3,000 pounds per square inch (PSI) of unconfined compressive strength, hydraulic cement and/or polyurethane caulk (for small cracks and patches); and
- Documenting that the site cover system is free of cracks, holes, and penetrations.

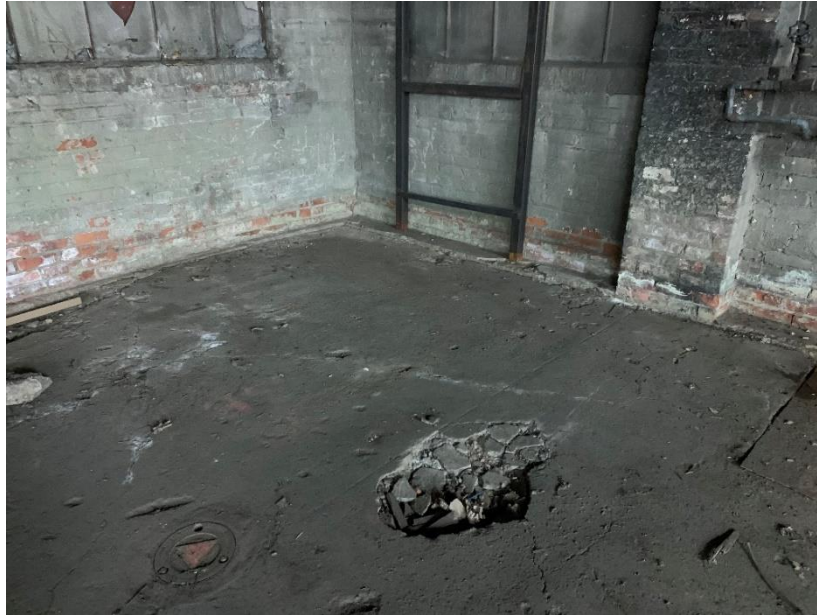
Photo 3: View of damaged concrete slab in the southern portion of Block 4384, Lot 36 (facing south)

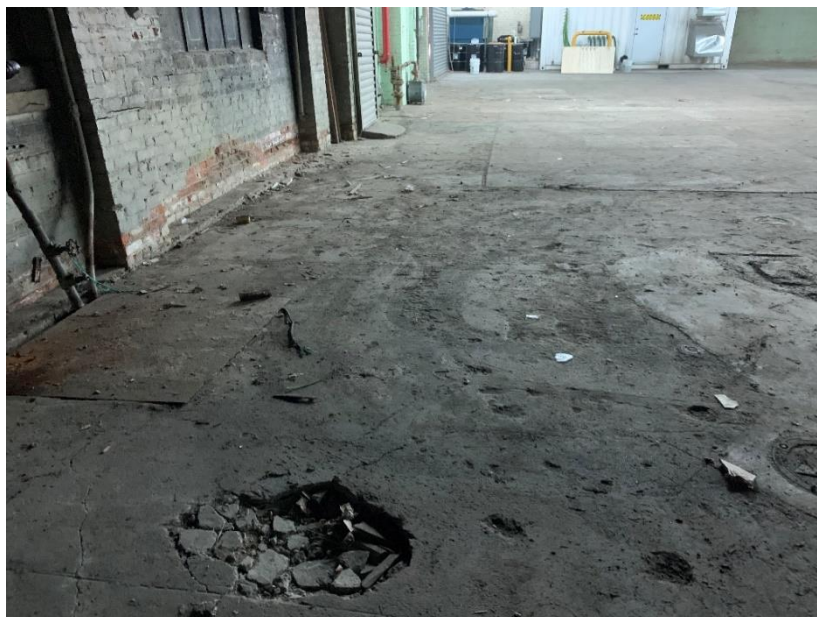
Photo 4: Another view of the damaged concrete slab in the southern portion of Block 4384, Lot 36 (facing north)

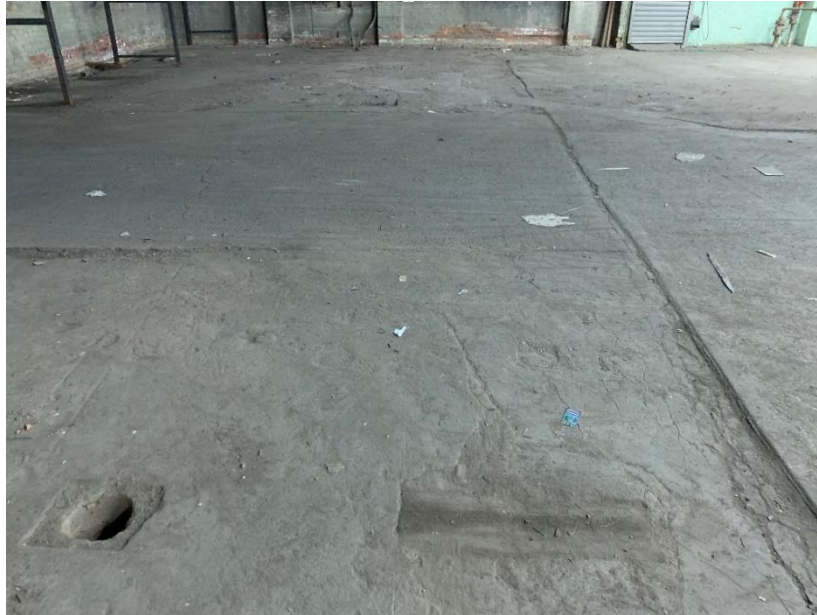
Photo 5: View of a former drain with no cover in the southeastern portion of Block 4384, Lot 36 (facing west)

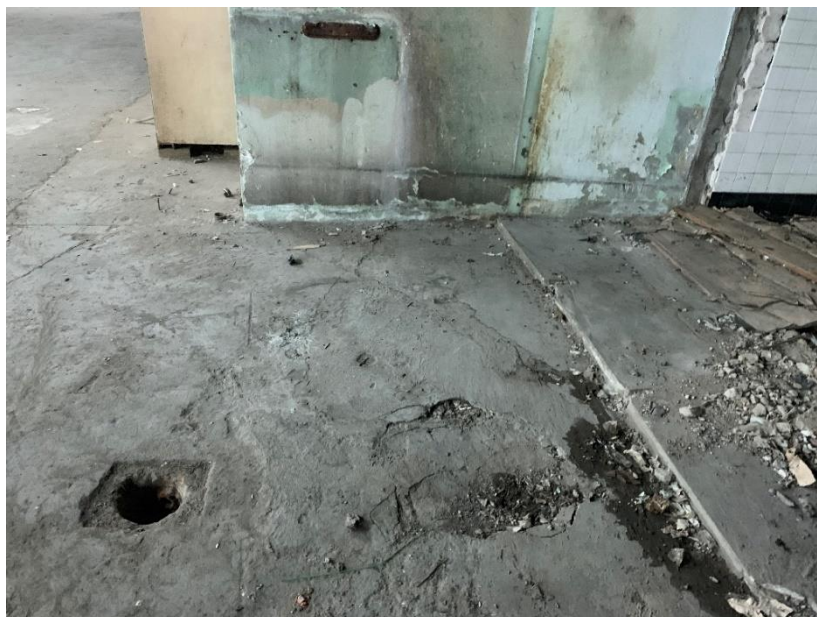
Photo 6: Another view of a former drain with no cover in the southeastern portion of Block 4384, Lot 36 (facing east)

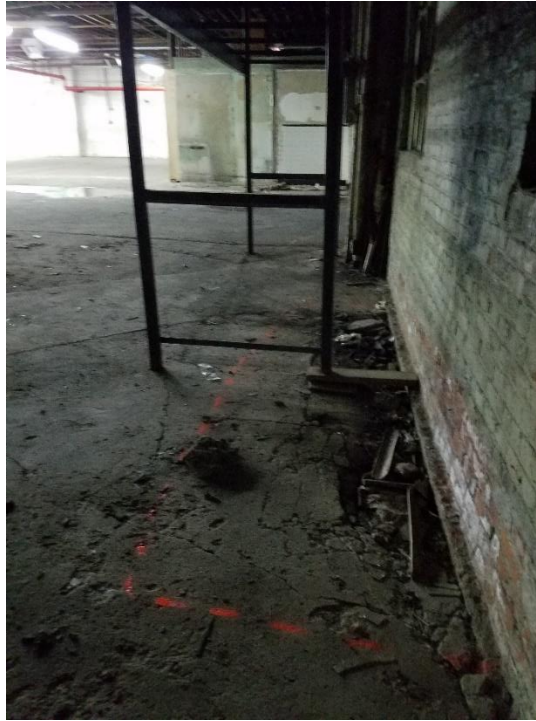
Photo 7: View of the damaged concrete slab in the southwestern portion of Block 4384, Lot 36 (facing east)

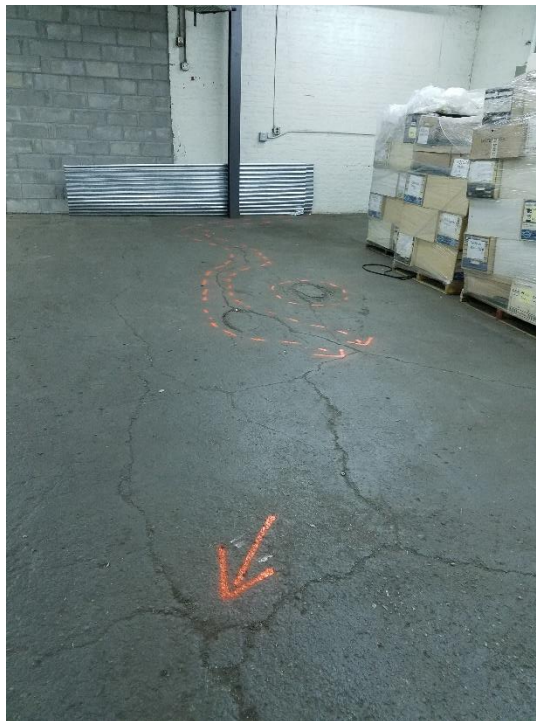
Photo 8: View of the damaged concrete slab in the western portion of Block 4384, Lot 31 (facing west)
