# Periodic Review Report

149 Kent Avenue  
Brooklyn, New York  
Site Number C224159

February 17, 2020

**Roux Environmental Engineering  
and Geology, D.P.C.**  
209 Shafter Street  
Islandia, New York 11749

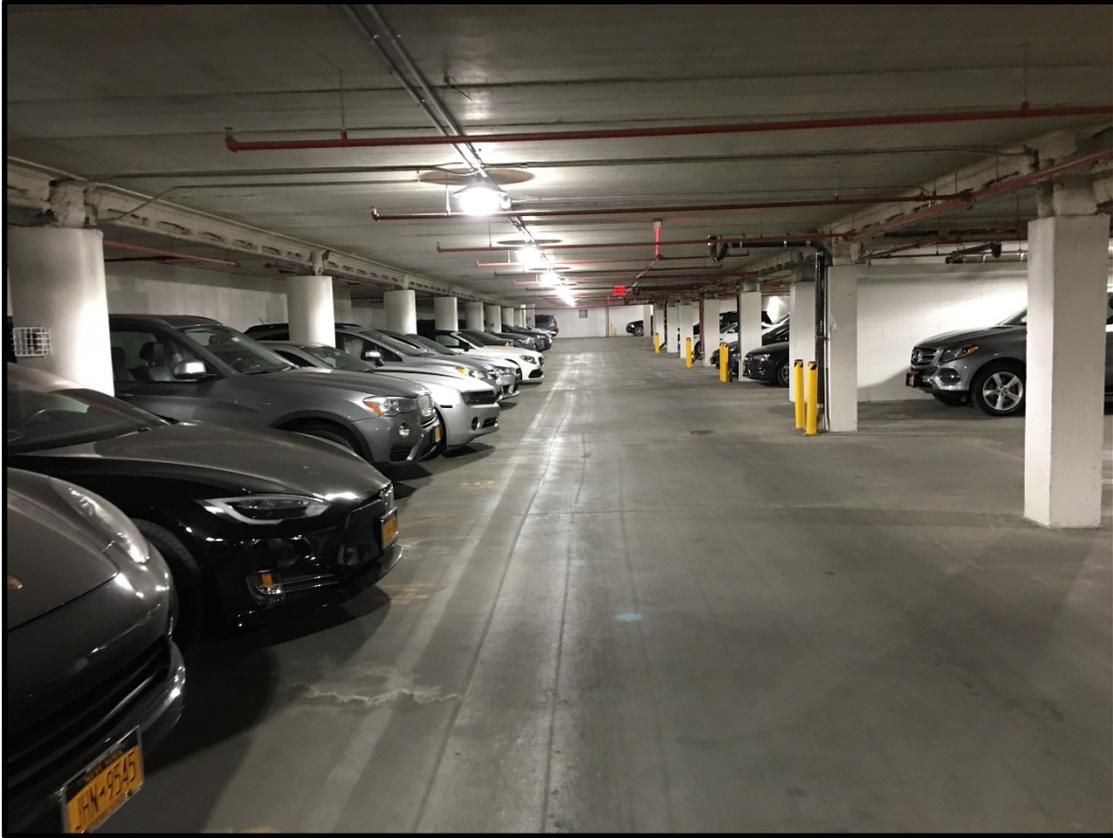
Photograph 1: View of eastern half of the cellar parking garage.

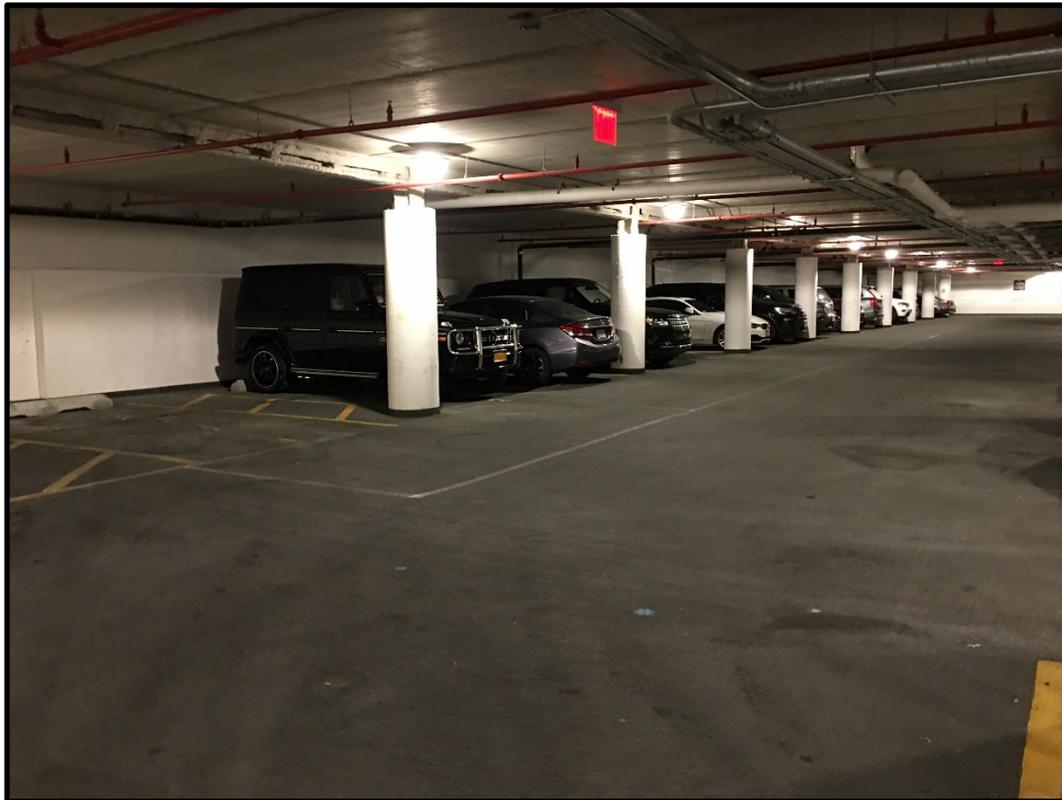
Photograph 2: Northeast wall of cellar parking garage.

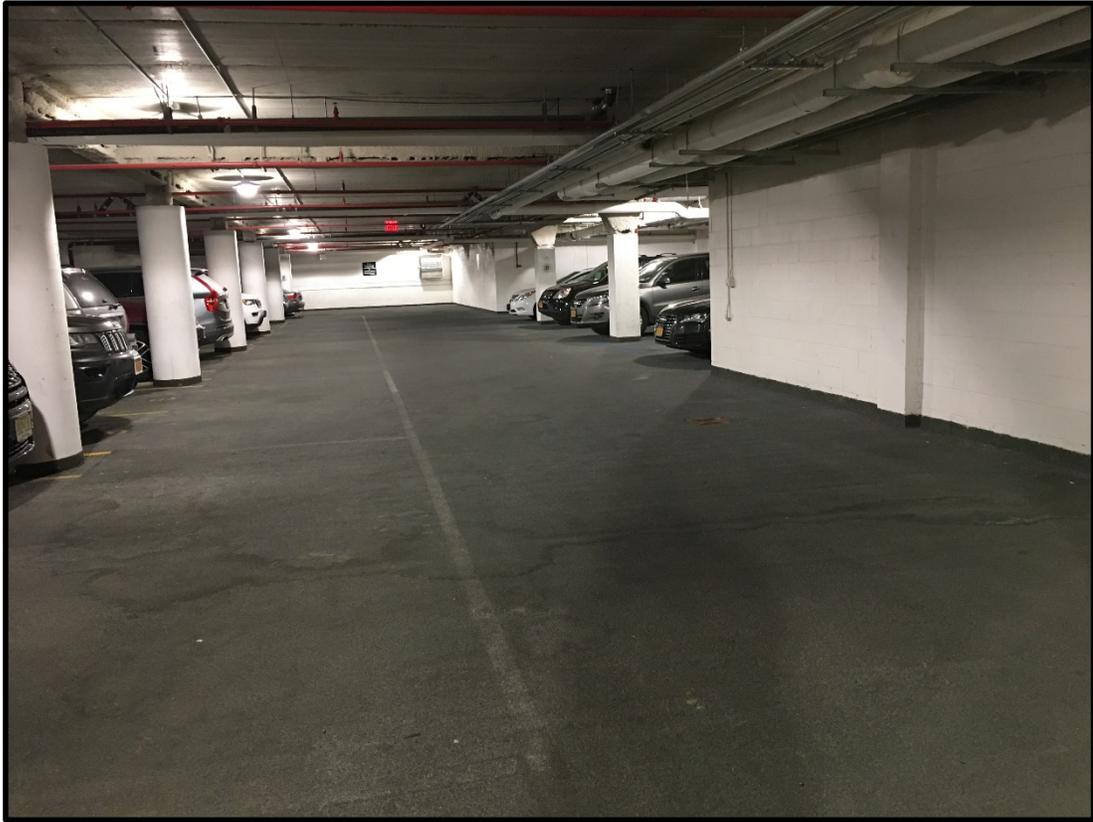
Photograph 3: Eastern extent of the cellar parking garage. All site cover components were intact.

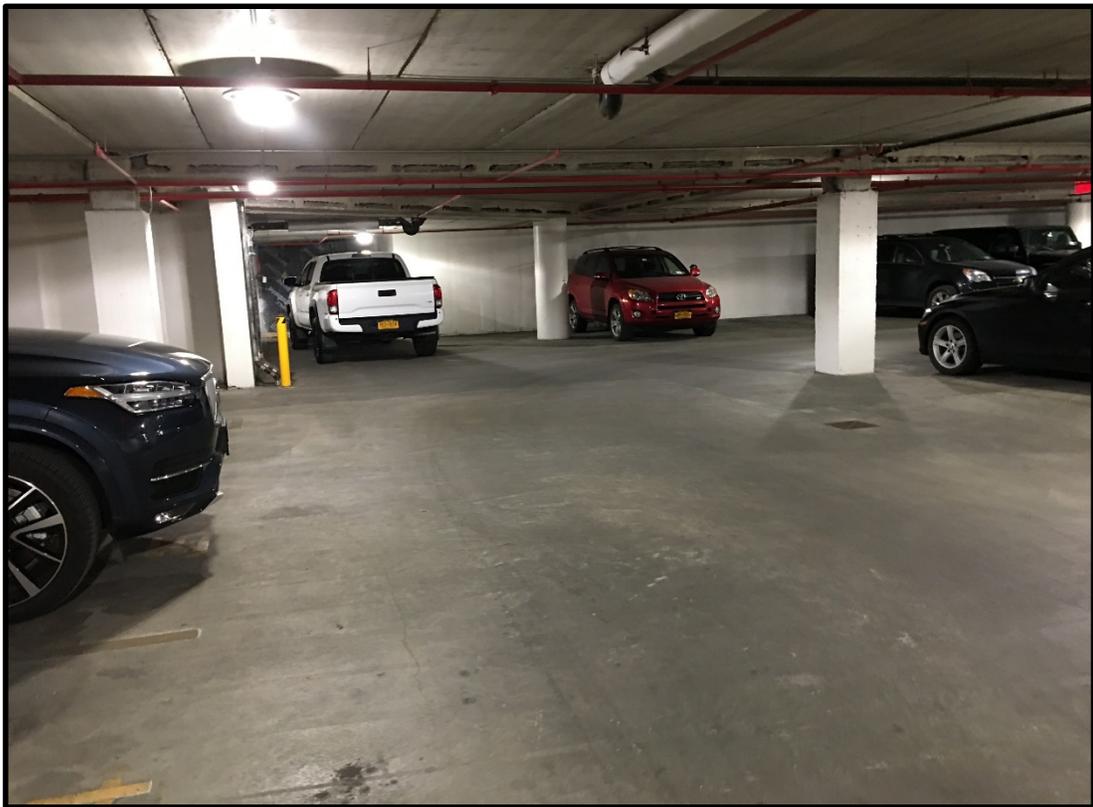
Photograph 4: View of north wall near central parking garage ramp; previously applied Grace Bituthene is in view and intact.

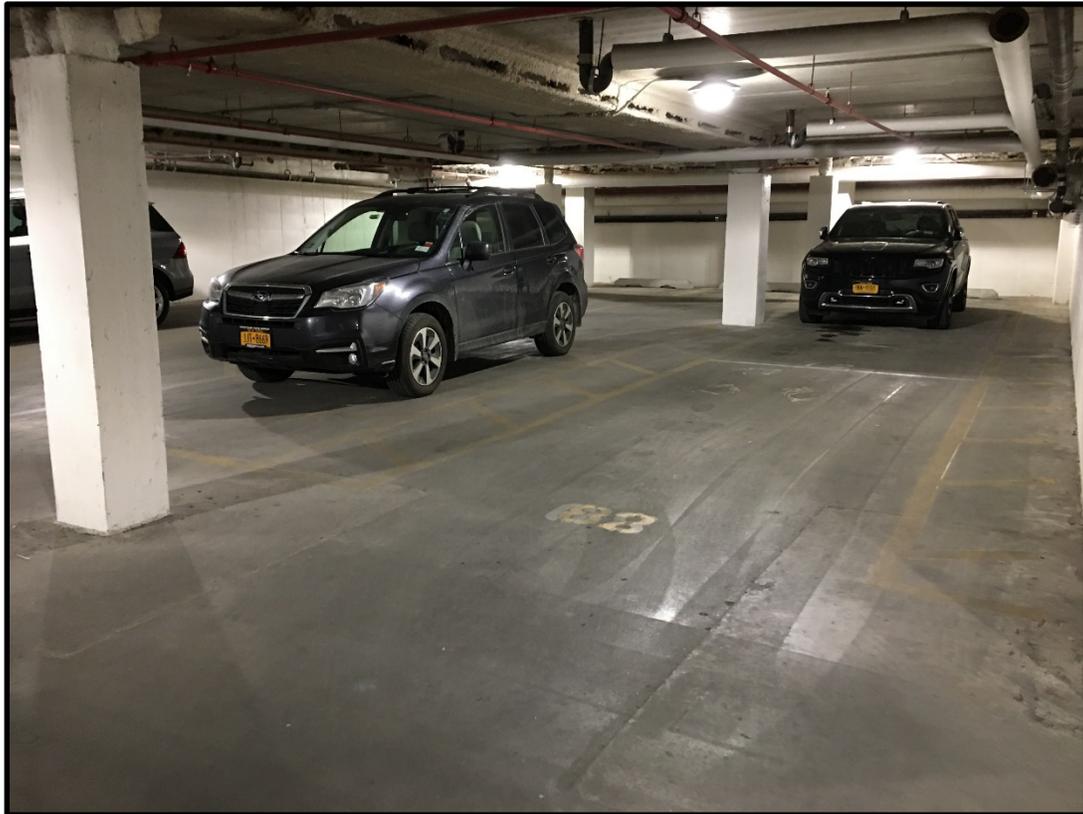
Photograph 5: Photo of south wall near midway point of cellar.

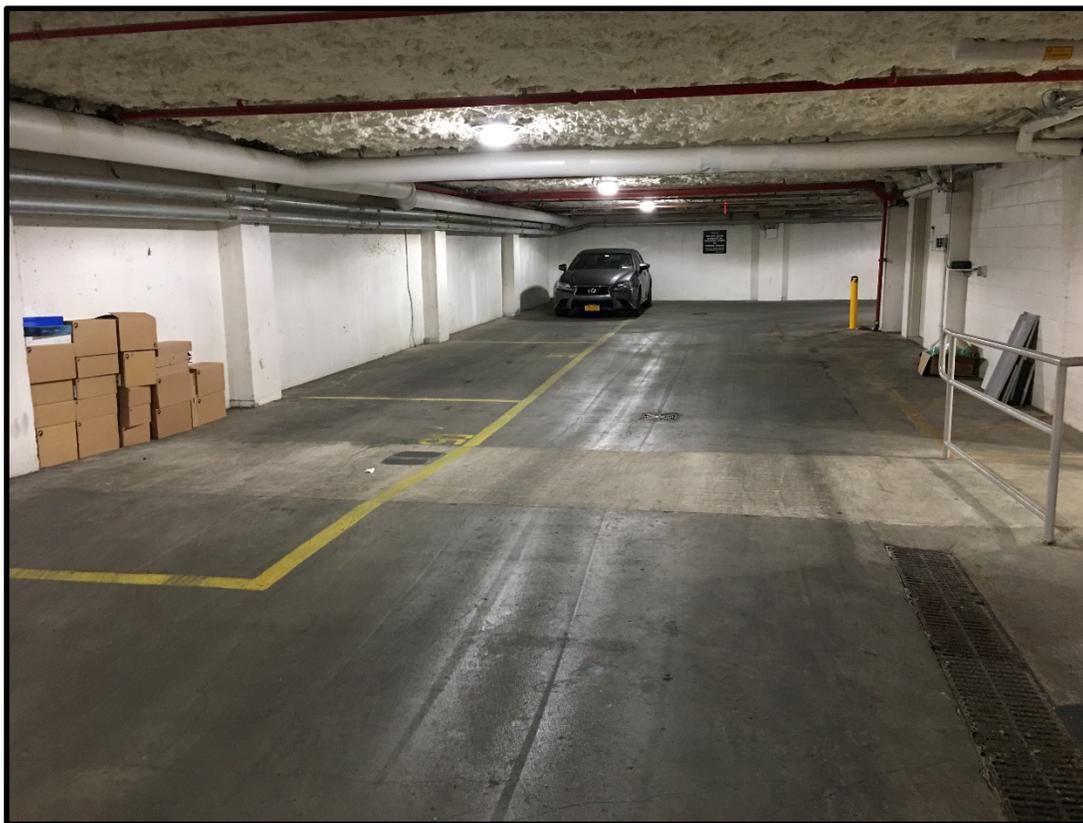
Photograph 6: View of southwest corner of parking garage during site cover system inspection.

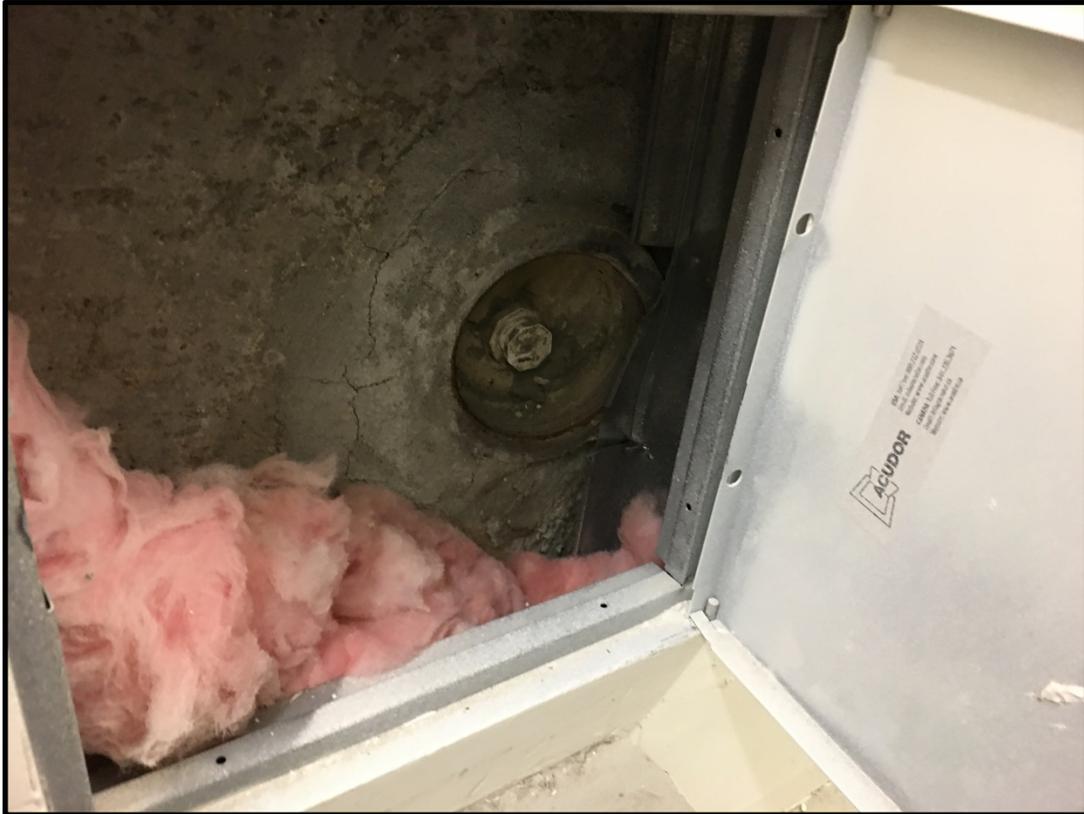
Photograph 7: Photo of MP-1 (west SSDS) within lock box within private stairwell leading from first floor to the cellar.

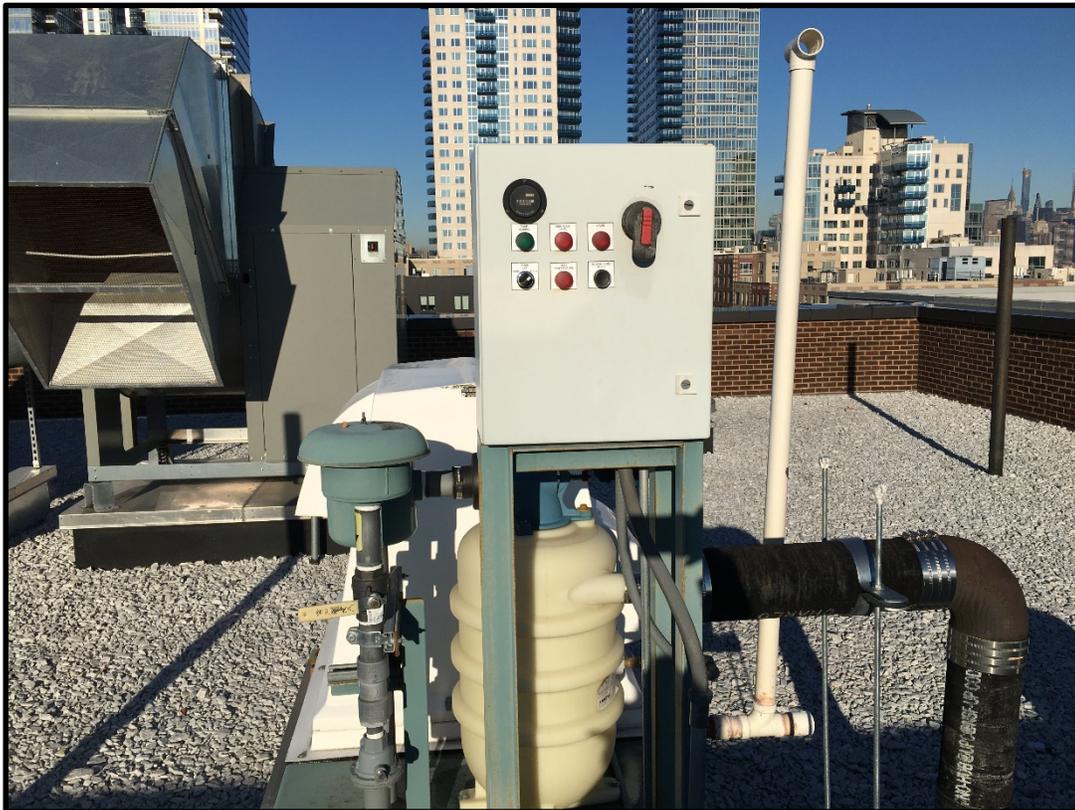
Photograph 8: Photo View of SSDS Blower 1 (west) control panel upon arrival.

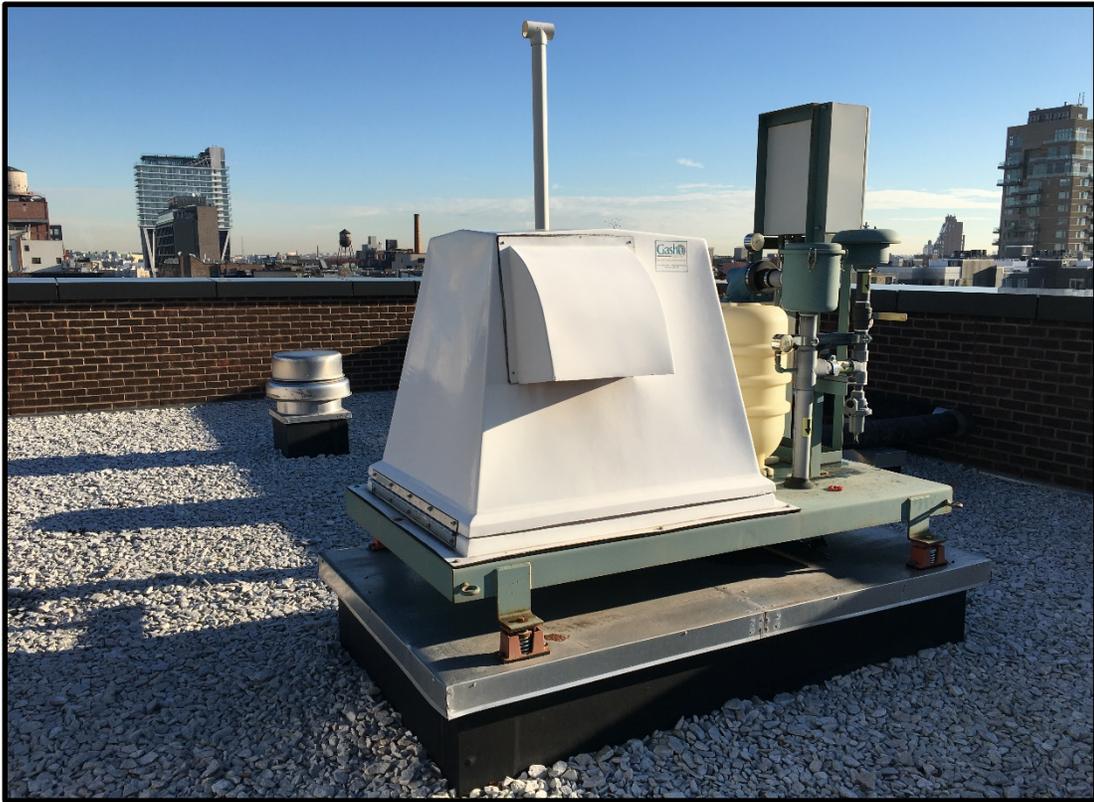
Photograph 9: SSDS Blower 1 (west) configuration, looking north.

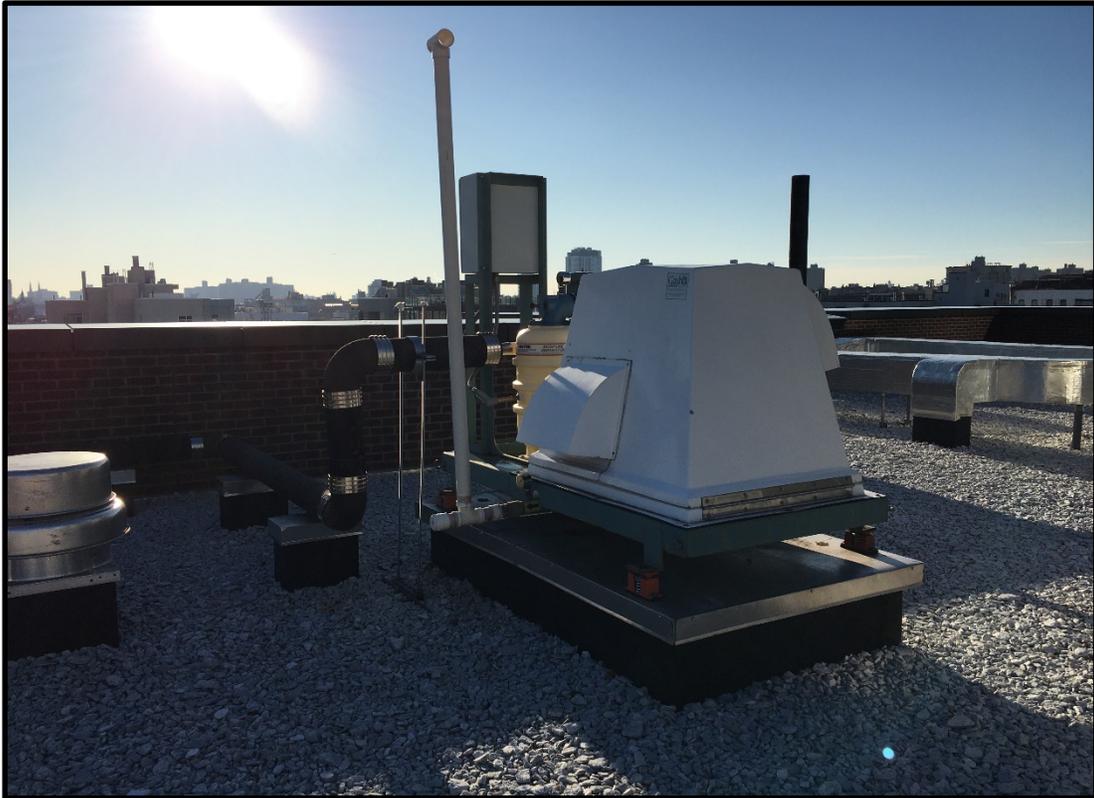
Photograph 10: SSDS Blower 1 and associated run of piping (left).

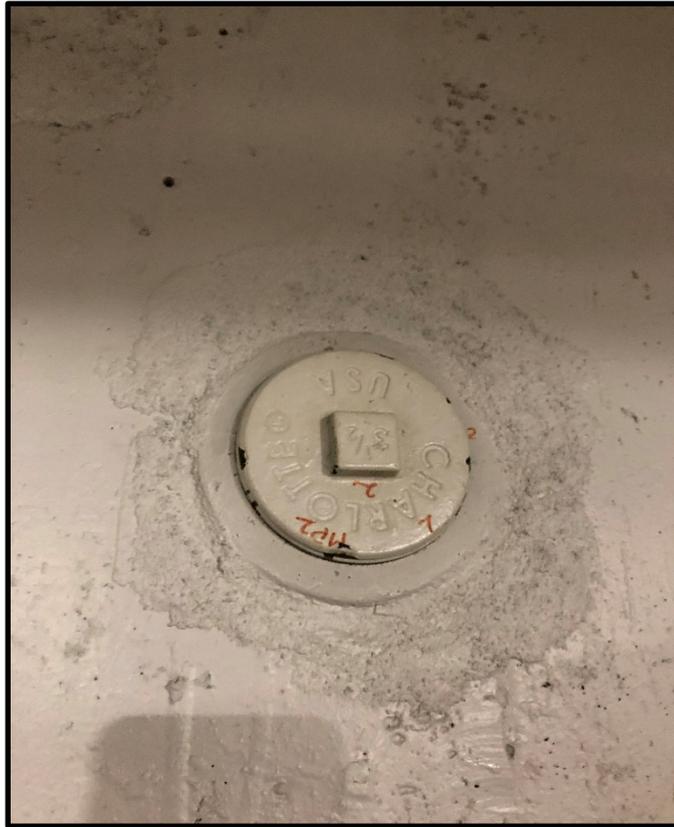
Photograph 11: View of MP-2 (east SSDS) after field pressure test.

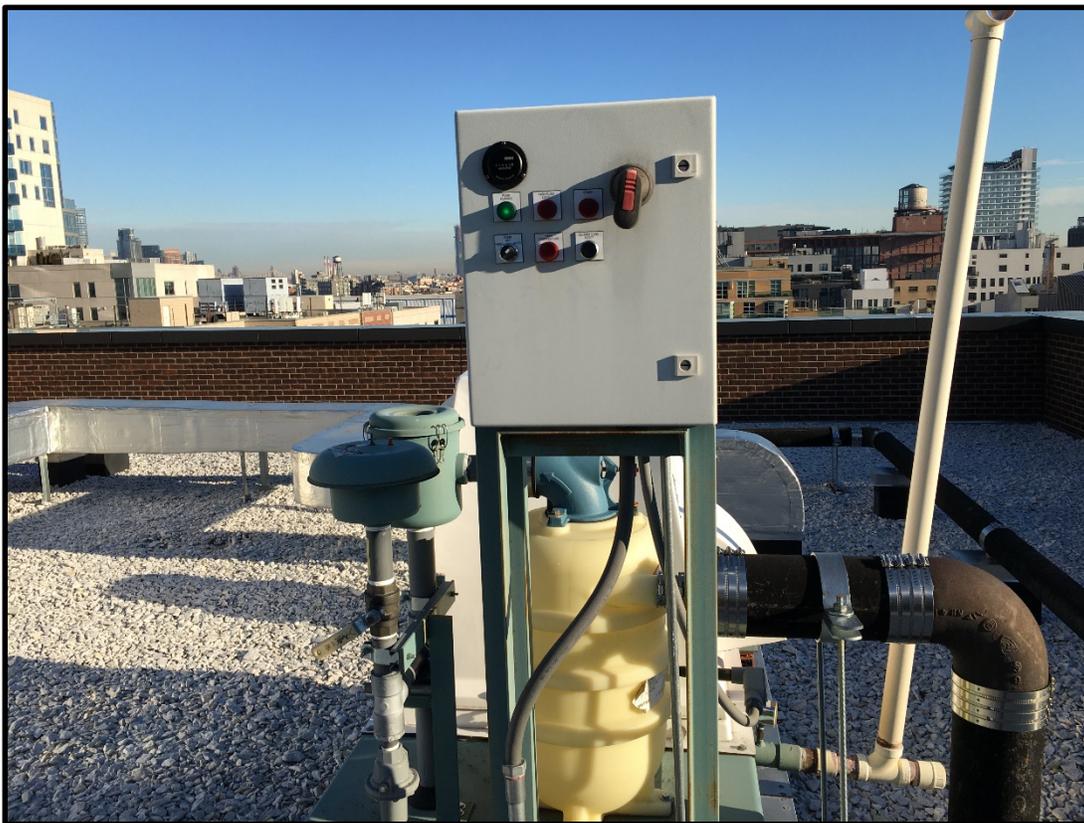
Photograph 12: Photo of SSDS Blower 2 (east) control panel upon arrival.

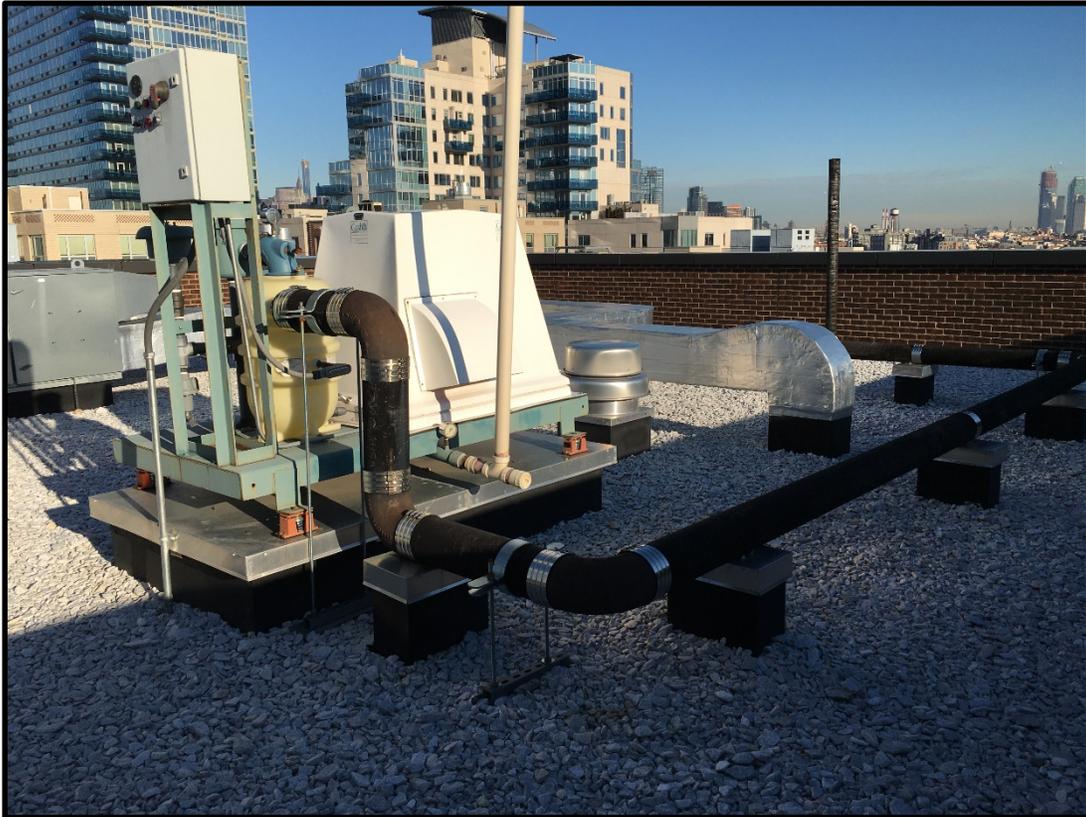
Photograph 13: Photo of the SSDS Blower 2 (east) configuration and associated piping leading to vertical riser.

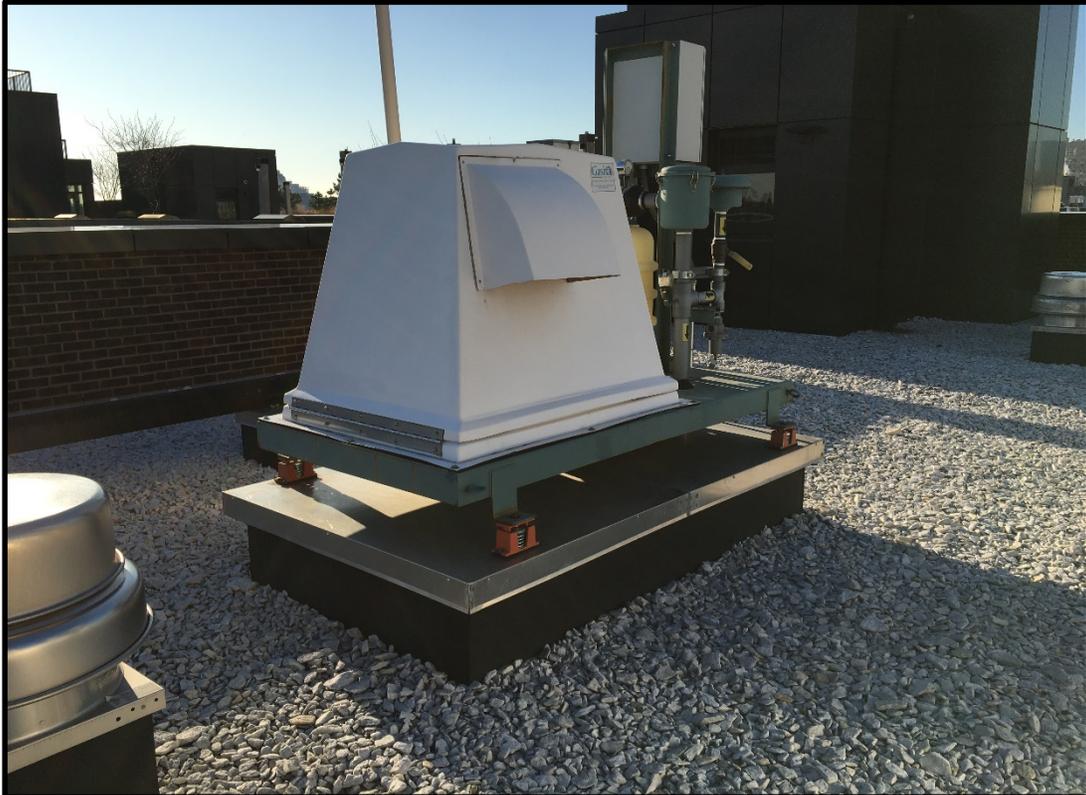
Photograph 14: Photo SSDS Blower 2 (east), looking south.
