DAILY FIELD REPORT

Project	<u>NYSDEC Site C224218 - Former Carter Spray Finishing Site</u>	Report No.	<u>2</u>
Location	<u>65 Eckford Street, Brooklyn, NY</u>	Date	<u>10/25/2021</u>
Client	<u>65-73 Eckford Realty LLC</u>	Page	<u>1</u> of <u>1</u>
Contractor	<u>Prestige NY</u>	File No.	<u>0202156-000</u>
Weather	<u>Cloudy</u>	Temperature	<u>70-75° F</u>

NYSDEC Site C224218 - Former Carter Spray Finishing Site
65 Eckford Street, Brooklyn, NY
File No. 0202156
Date Photographs Taken: 25 October 2021

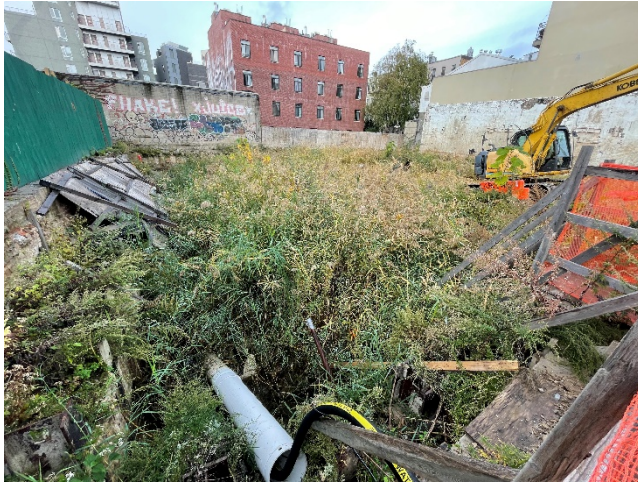
Photo 1: Pre-work view of the site facing northwest.

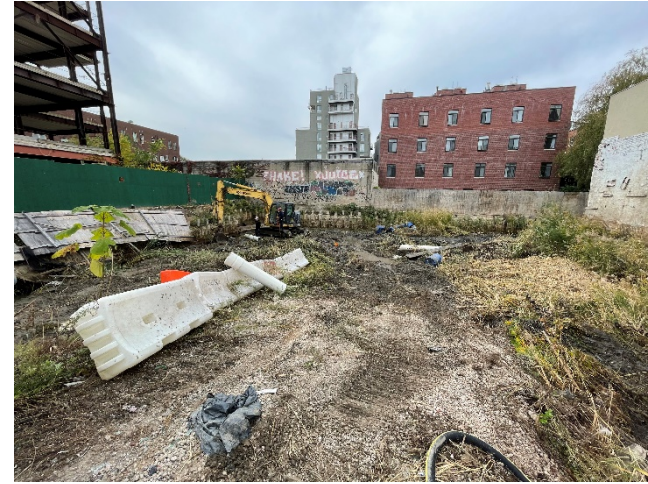
Photo 2: View of the site after vegetation removal.

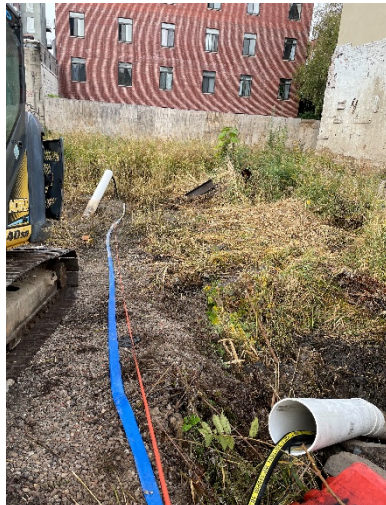
Photo 3: View of the disconnected dewatering suction points.

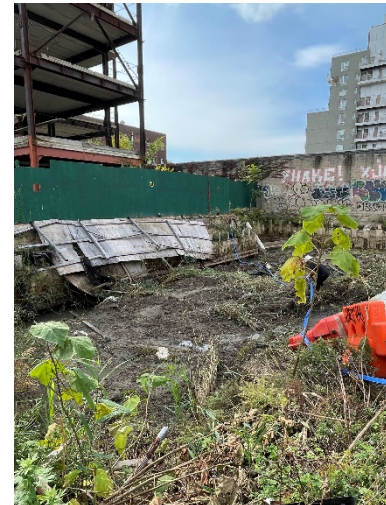
Photo 4: View newly installed dewatering suction points.

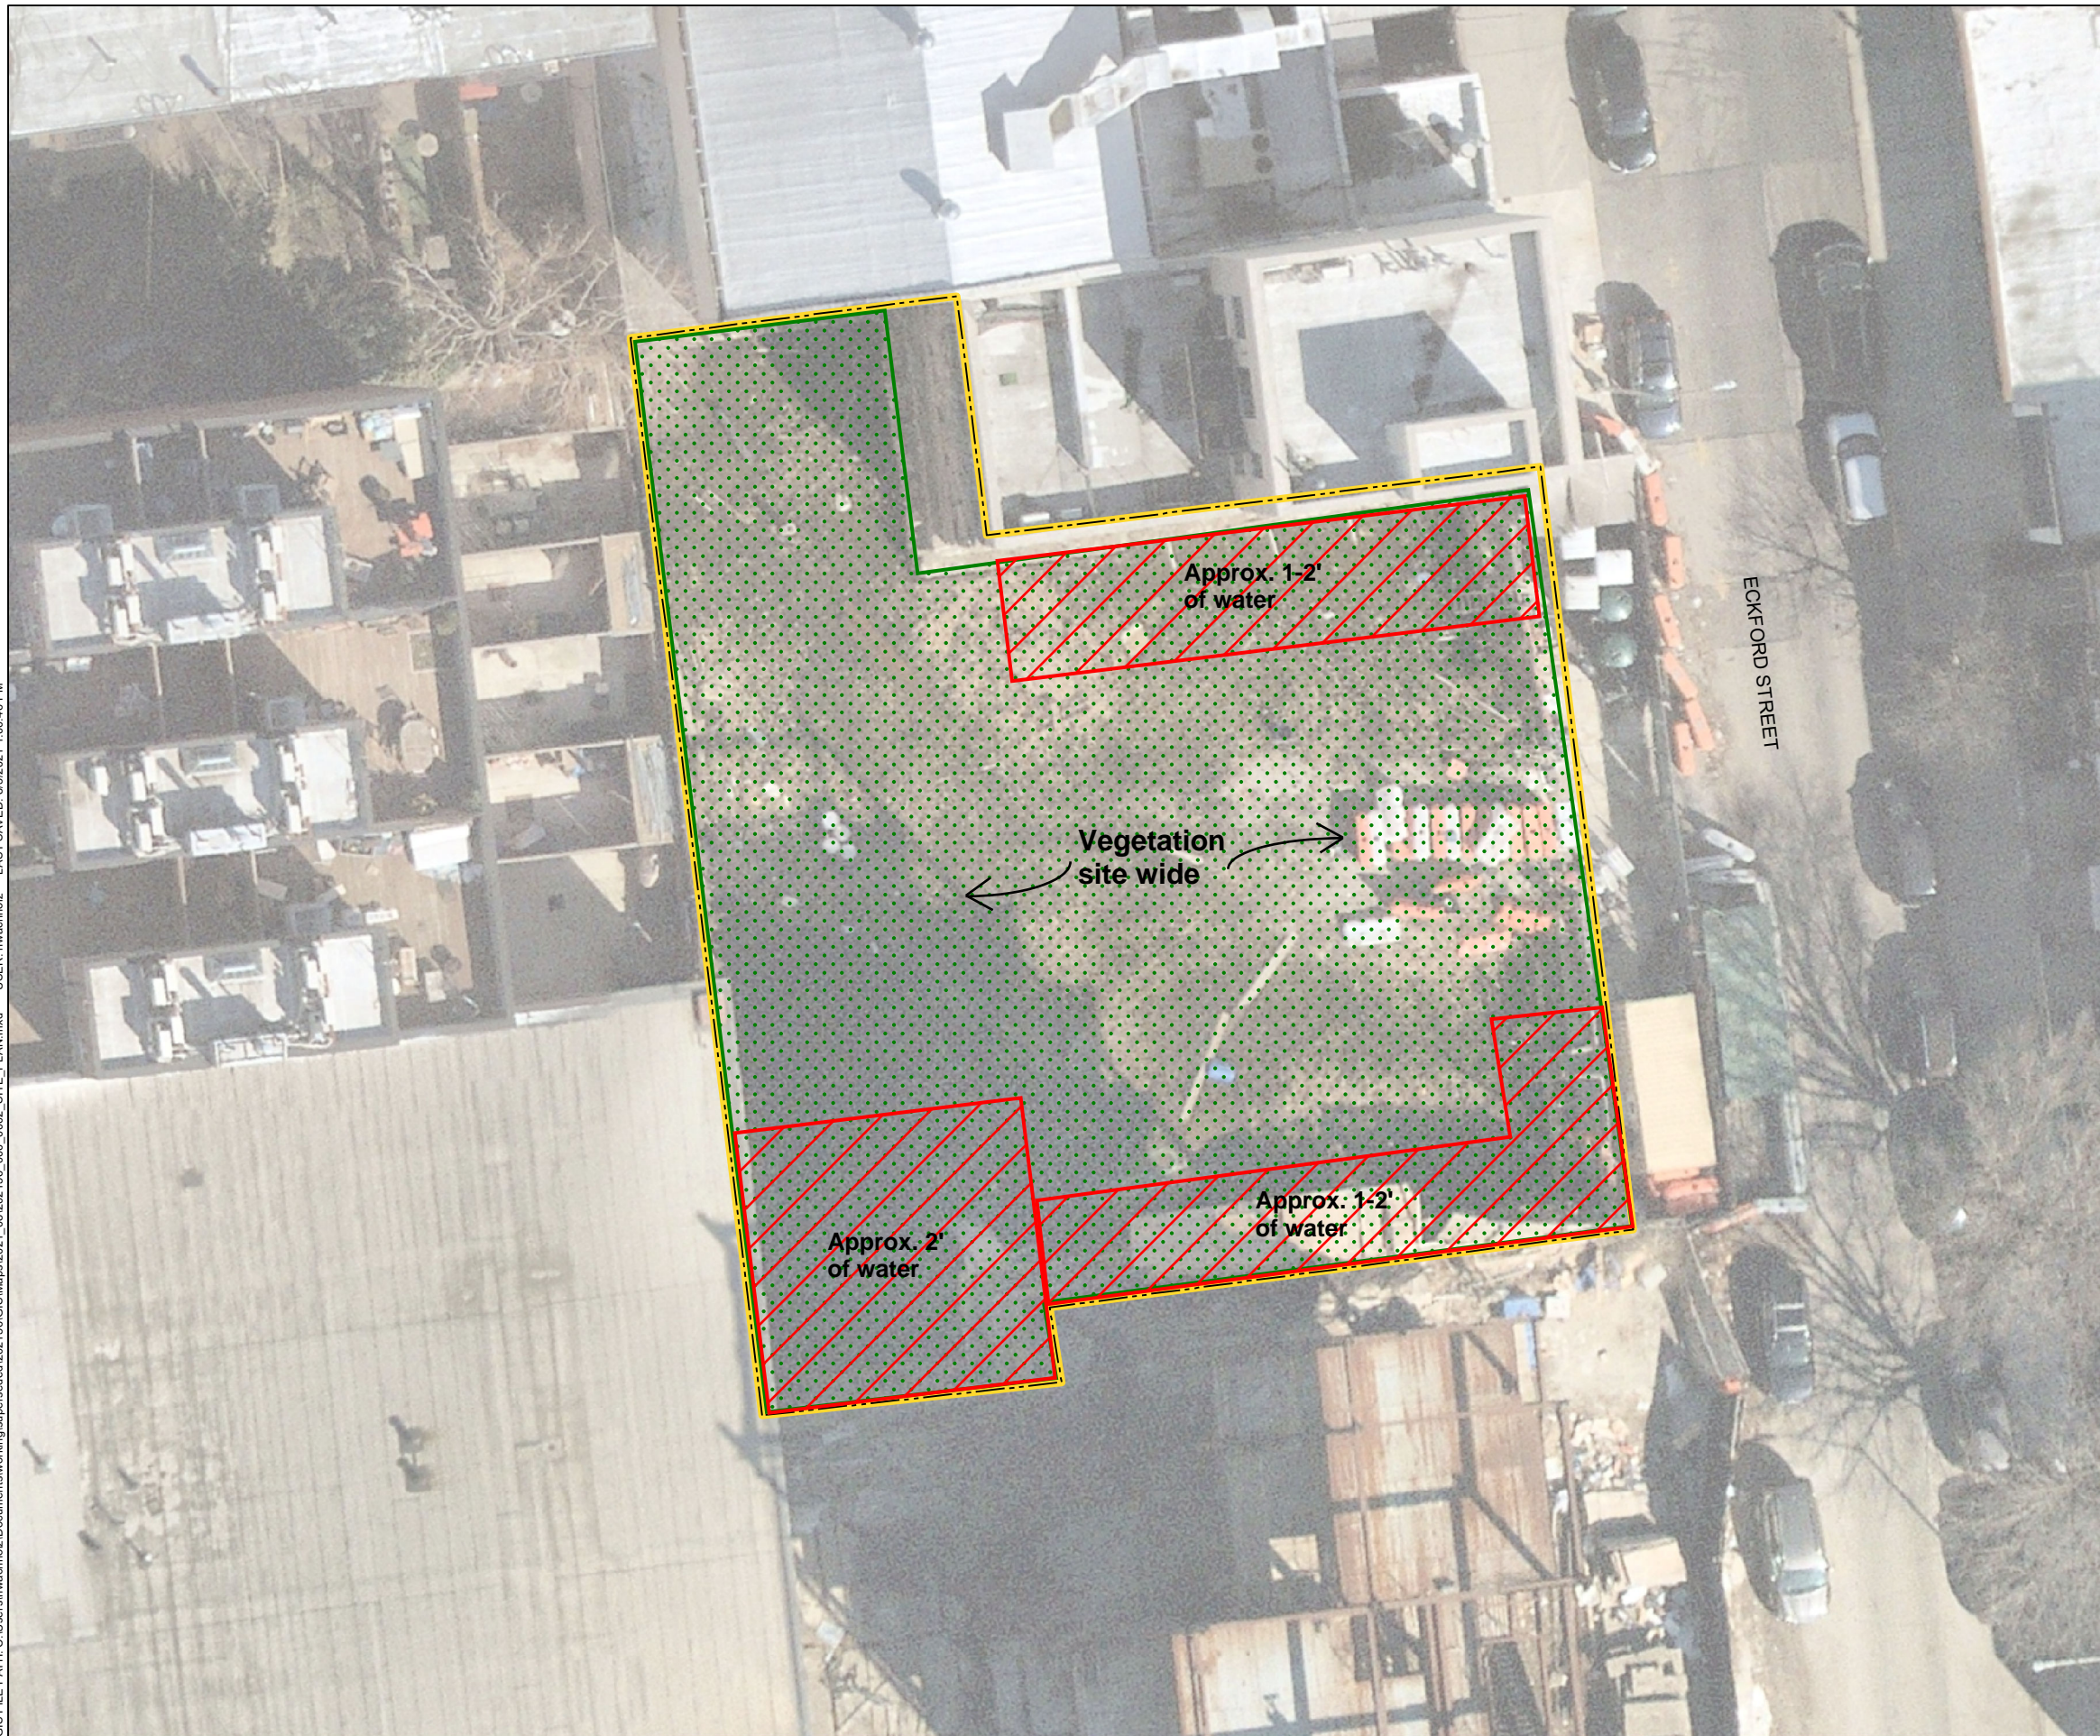
FIGURE 1

1. 95% of site is covered in thick vegetation (i.e. reeds and weeds).
1. Excavation depth site wide is approx. 6' bgs (potential to be deeper as site gently slopes to the west).
3. Existing construction ramp located in the central portion of the site and contains gravel.
4. Debris and garbage located within the excavation and entrance area.
5. One permanent groundwater monitoring well observed in the southwestern corner of the site (i.e. in sidewalk within construction fence).
