# ENVIRONMENTAL SITE ASSESSMENT

FLATLANDS AVE. & PENNSYLVANIA AVE.  
BROOKLYN, NEW YORK

03-172

APRIL 2003

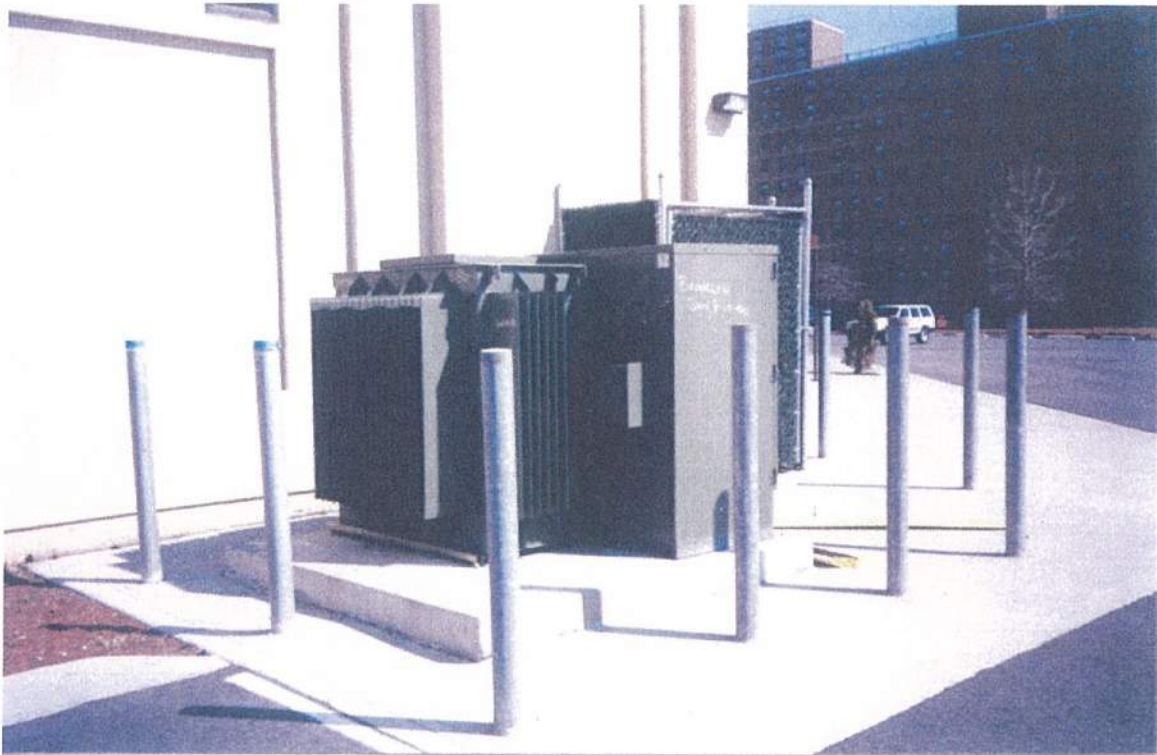
One (1) pad mounted electrical transformer was identified outside the southwestern portion of the subject building. The aforementioned transformer is owned and maintained by **Consolidated Edison Company of New York, Inc. (Consolidated Edison)**. Inspection of the transformer revealed it to be in good condition, with no visible signs of leakage or damage. There were no pole mounted electrical transformers observed at the subject property.

**VIEW OF PAD-MOUNTED ELECTRICAL TRANSFORMER**

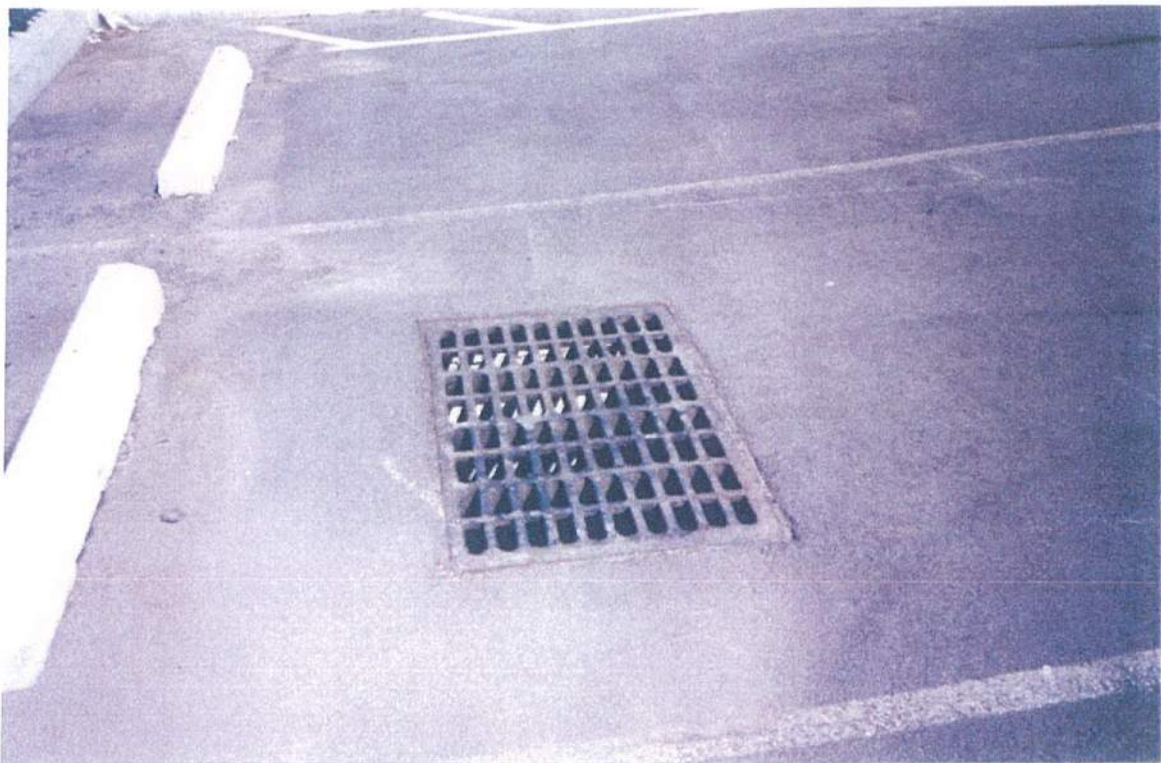
Numerous open grate and solid covered manholes were observed throughout the parking fields. Reportedly, said structures are associated with the on-site storm water drainage system which discharge to the municipal sewer system.

**VIEW OF TYPICAL OPEN-GRATE SUBSURFACE  
DRAINAGE STRUCTURE**

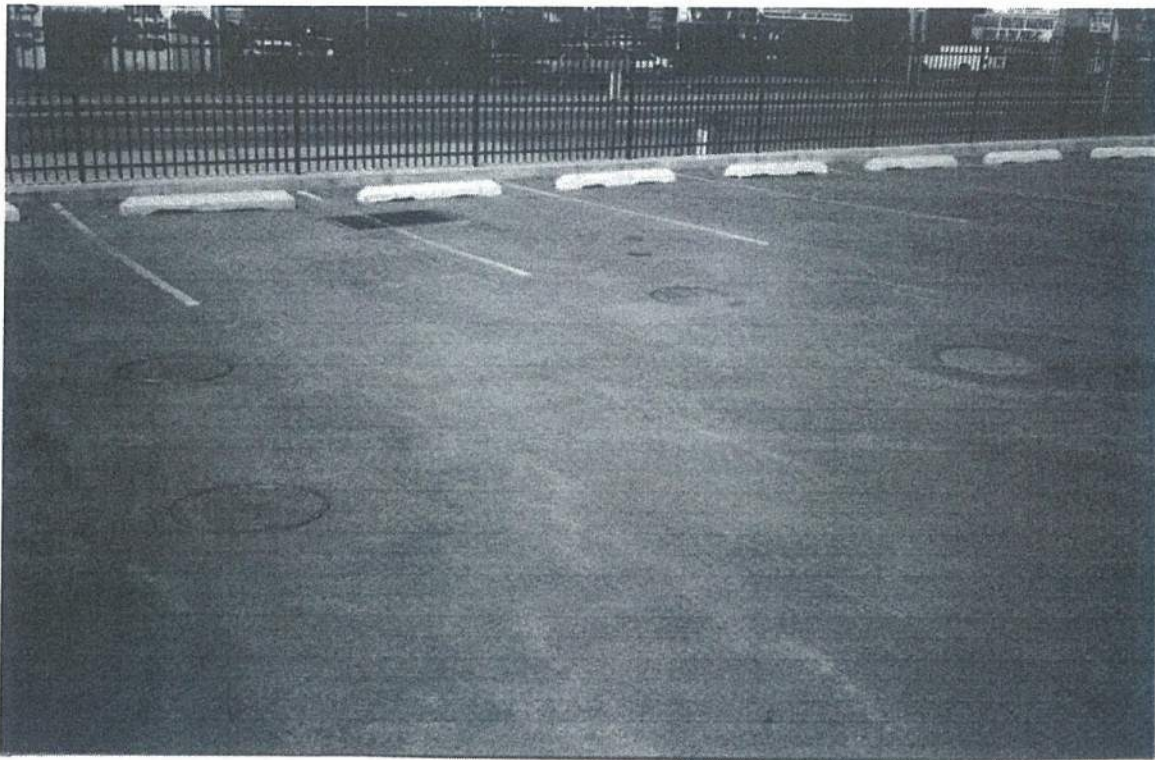
**VIEW OF TYPICAL SOLID MANHOLE COVERS IN A  
PARKING AREA**

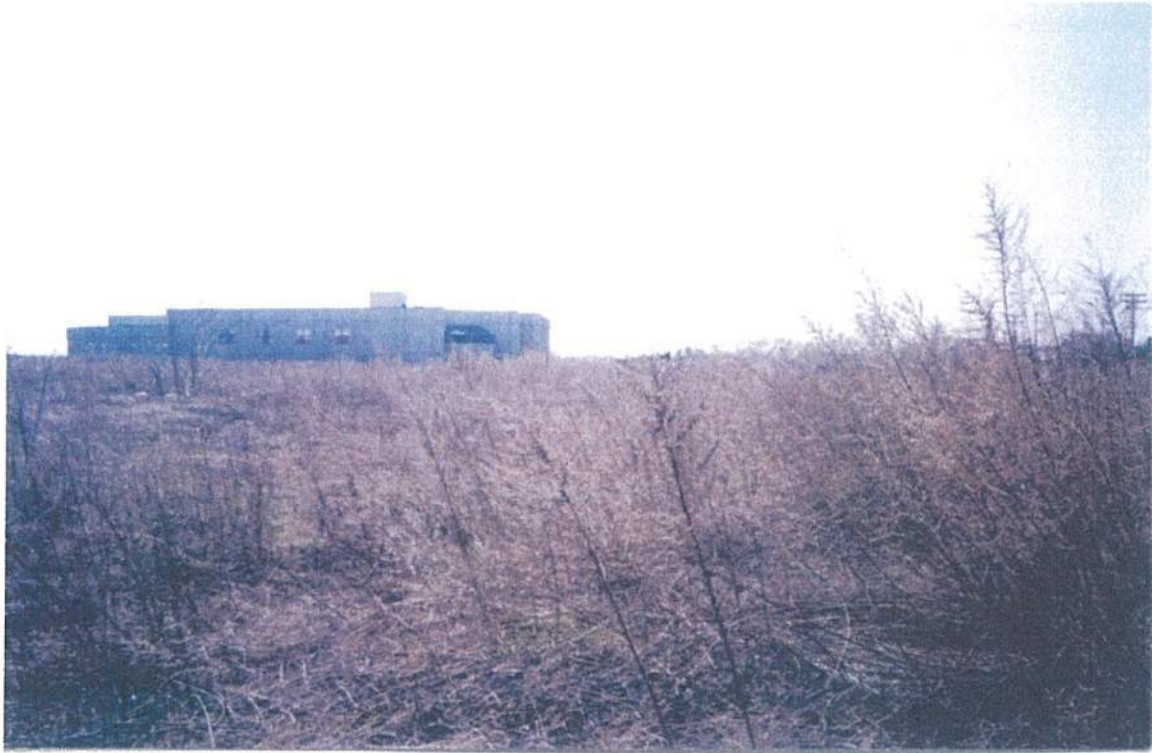
- The eastern portion (approximately 4.0 acres) of the subject property consists of vacant land comprised of several deciduous trees, exposed surface soils, and overgrown secondary vegetation. A small excavation was noted along the western portion of this area. Rubber tires, metal, and demolition debris were observed to be intermixed with surface soils. An abandoned crane and several piles of rubber tires, demolition debris, and common household trash were identified at various locations.

**VIEW OF EASTERN 4.0 ACRES - LOOKING WEST**

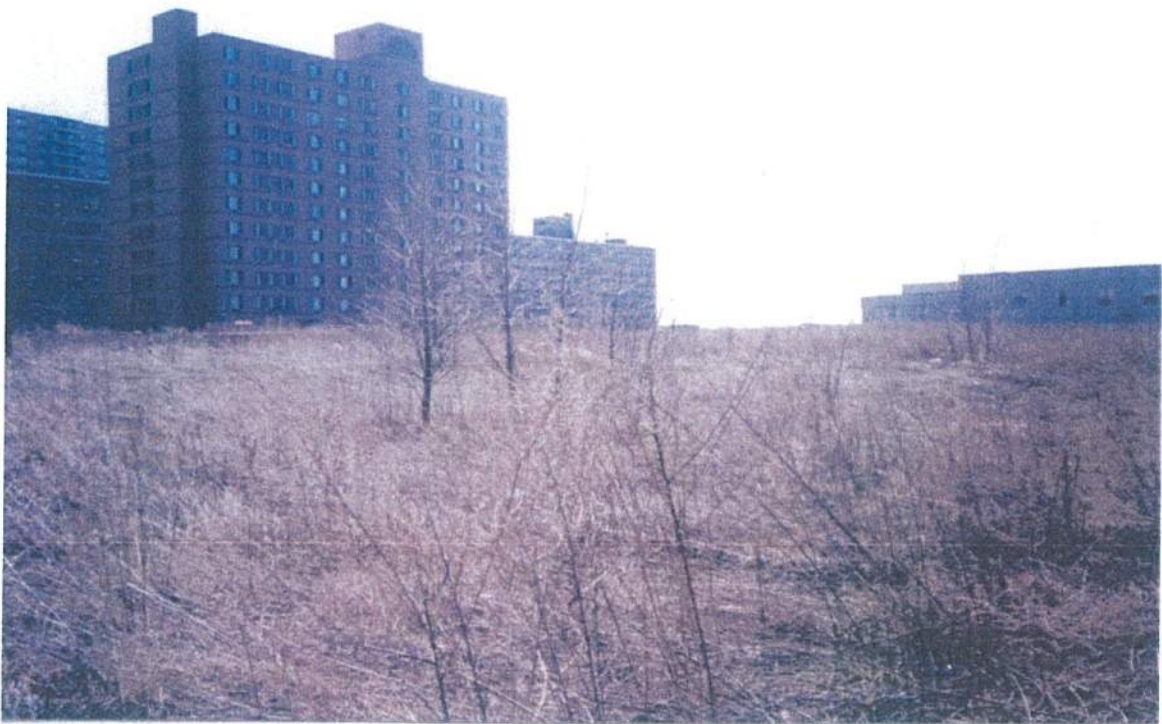
**VIEW OF EASTERN 4.0 ACRES - LOOKING SOUTHWEST**

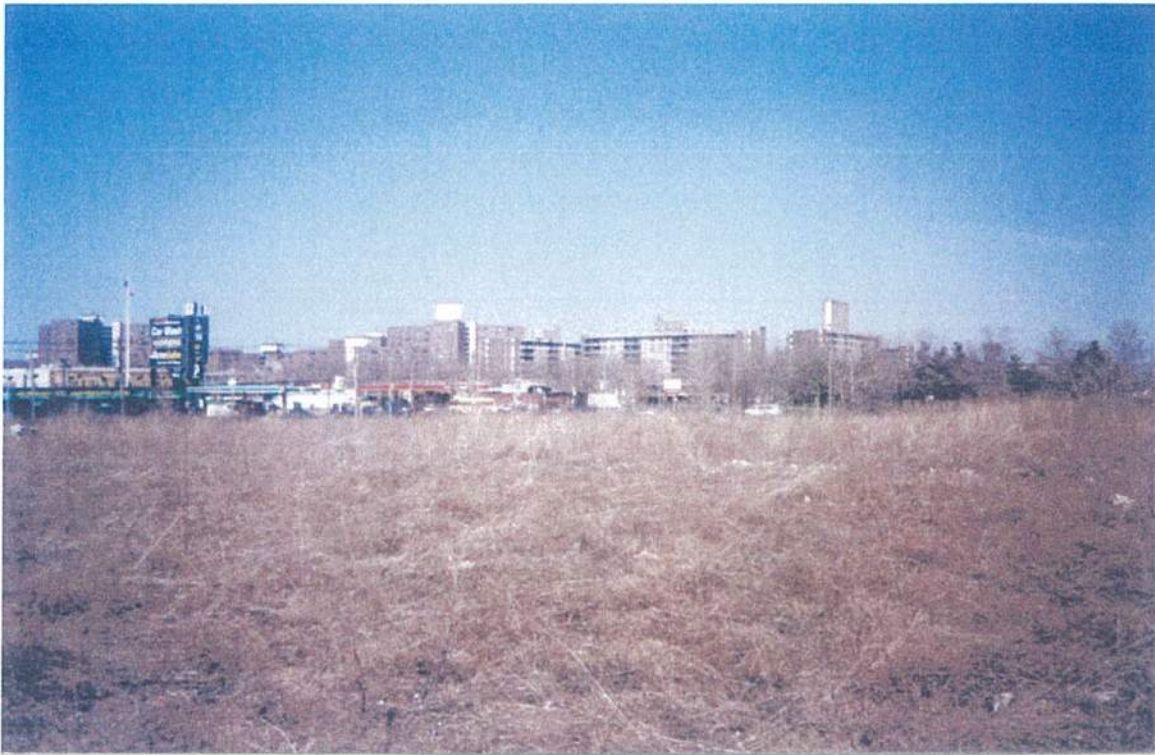
**VIEW OF EASTERN 4.0 ACRES - LOOKING NORTHEAST**

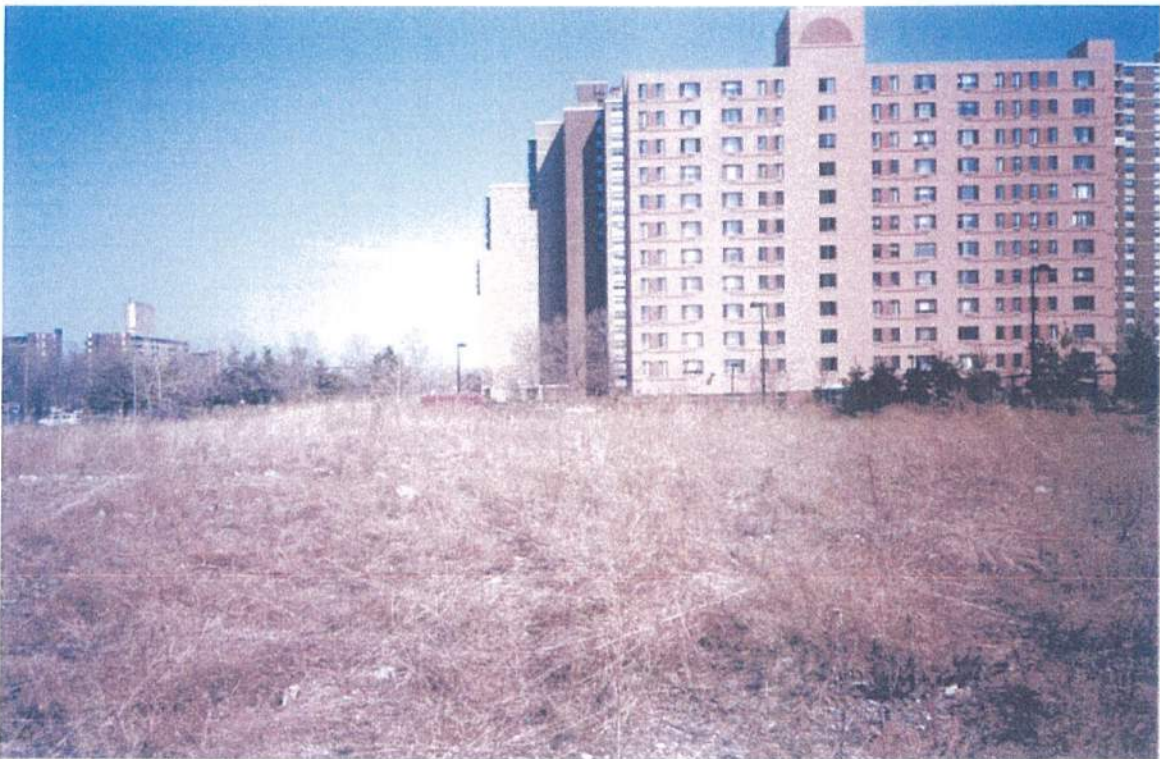
**VIEW OF EASTERN 4.0 ACRES - LOOKING EAST**

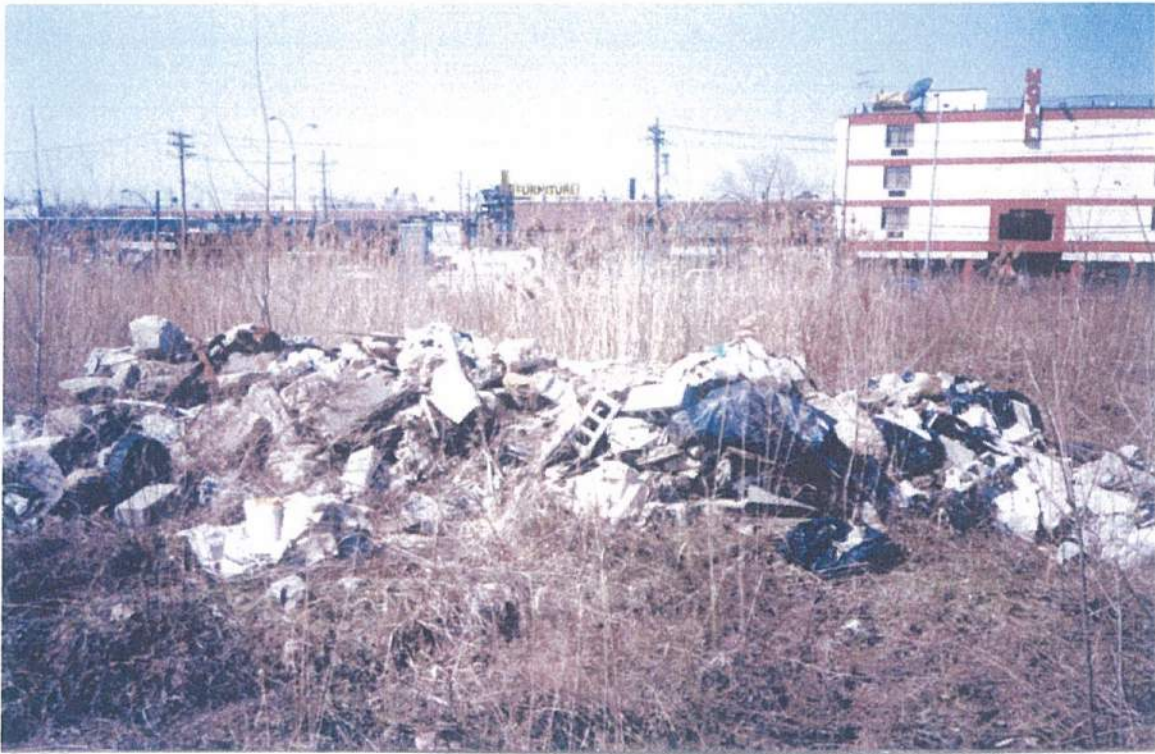
**VIEW OF PILE OF DEBRIS - LOCATED ON  
EASTERN 4.0 ACRES**

2.) We recommend the proper removal and disposal of the abandoned crane and piles of rubber tires, demolition debris, and common household trash identified at the eastern portion of the site.

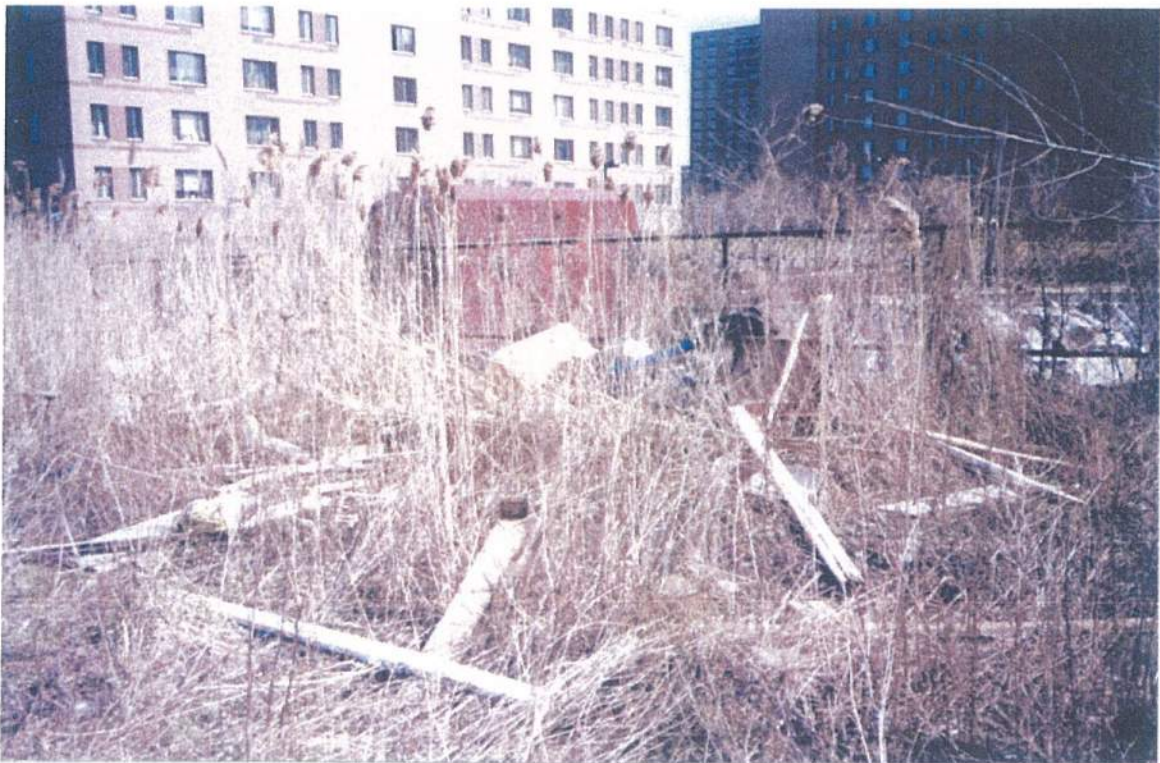
**VIEW OF PILE OF DEBRIS - LOCATED ON  
EASTERN 4.0 ACRES**
