SITE OBSERVATION REPORT

Wednesday, November 16, DATE: **PROJECT No.:** 170552901 2022 Overcast, 39-50 °F CLIENT: PROJECT: WEATHER: 159 Boerum Street Wind: WNW @ 3.9-6.6 SPG Boerum LLC mph LOCATION: Brooklyn, NY TIME: 7:00 am to 4:00 pm CONTRACTOR: LANGAN REP. : SD Builders Lauren Roper

Langan was present to observe environmental protocols in accordance with the New York State Department of Environmental Conservation (NYSDEC)-approved Remedial Action Work Plan (RAWP) for Brownfield Cleanup Program (BCP) site C224291 at 159 Boerum Street (Block 3071, Lot 40). Observed activities were as follows:

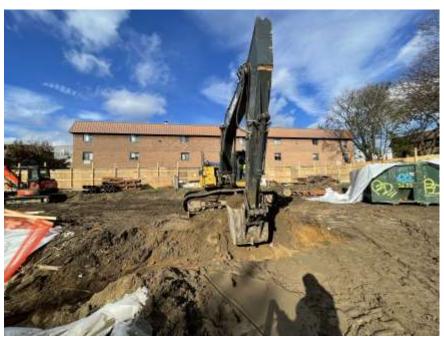
- Rise excavated an about 20-foot long by 10-foot wide area to about 4 feet below grade surface (bgs) in the
 northeastern part of the site. Excavated material consisted of hazardous lead contaminated fill and was
 screened for odors, staining, and organic vapors using a photoionization detector (PID); evidence of impacts
 were not observed. The excavated fill was containerized in a polyethylene-lined roll-off container and securely
 covered at the conclusion of excavation. The roll-off container was stored in the northeastern part of the site
 for future off-site disposal.

Photo 1: View of Rise excavating hazardous lead contaminated fill in the northeastern part of the site (facing north).

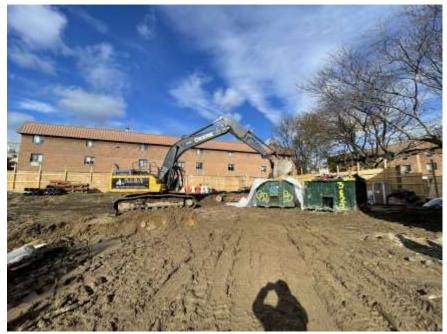
Photo 2: View of Rise containerizing hazardous lead contaminated fill in a polyethylene lined roll-off container in the northeastern part of the site (facing northeast).
