LANGAN SITE OBSERVATION REPORT – Week of September 13, 2021

CLIENT: 473 President LLC	DATES: Monday, September 13, 2021 to Friday, September 17, 2021
PROJECT No.: 170361303	BCP SITE ID: C224080
PROJECT: President Street Properties	
LOCATION: 469 President Street and 532 Union Street, Brooklyn, New York	
EQUIPMENT: DK-50 Track-Mounted Drilling Rig MiniRAE 3000 Photoionization Detector TSI DustTrak II	PRESENT AT SITE: Langan: Tyler Goodnough, Andrew Nesci, Caroline Devin Pillori Associates, P.A.: Sebastian Leon Warren George, Inc. (WGI)

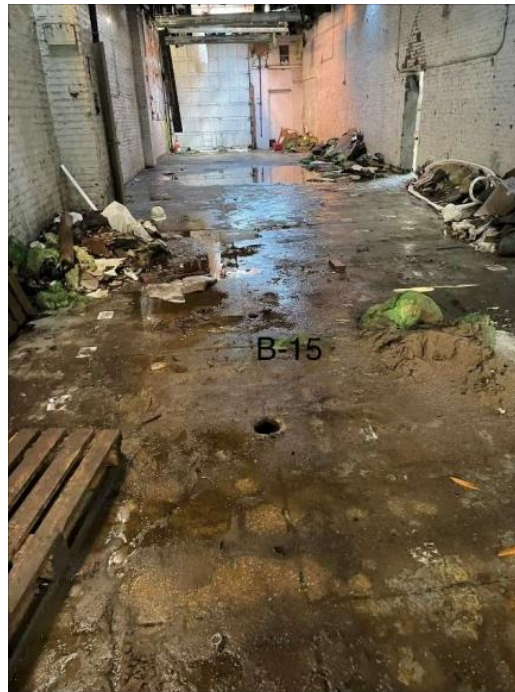
- WGI continued advancing geotechnical borings as part of a geotechnical subsurface investigation. WGI advanced one boring, B-15, inside the vacant 532 Union Street building using a track-mounted drilling rig to 87 feet below grade (bgs) and one boring, B-17, inside the vacant 469 President Street building to 77 feet bgs.

Photo 1: Boring B-15 (facing south)

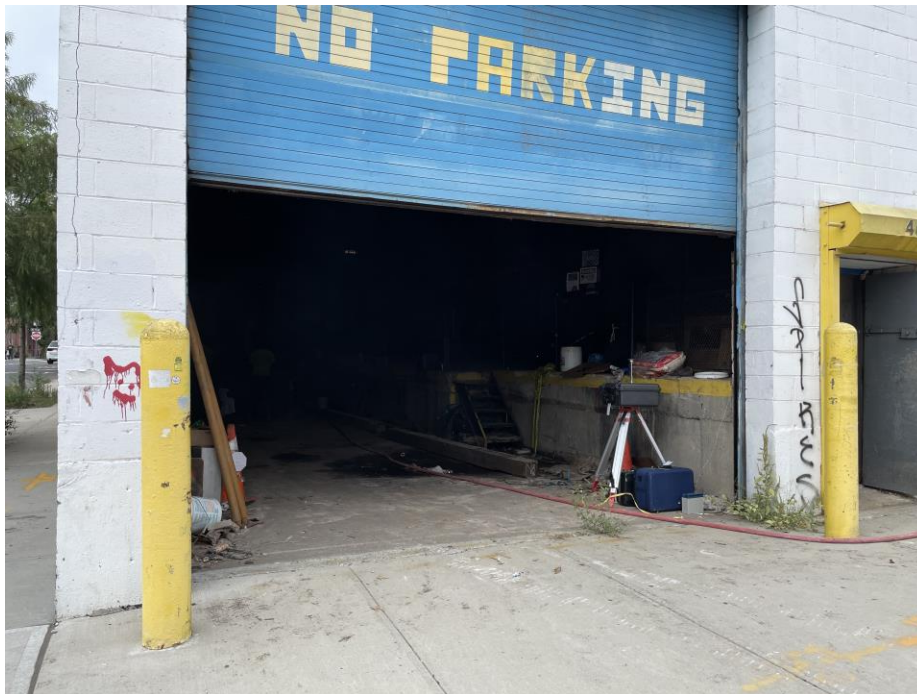
- Langan performed continuous air monitoring on the site perimeter for volatile organic compounds (VOCs) and particulate matter smaller than 10 microns in diameter (PM10). One air monitoring station was located inside of the garage door at the southern end of the buildings.

Photo 2: Air monitoring station (facing north)
