| PROJECT No.: 170361306 PROJECT: 514 Union Street LOCATION: Brooklyn, New York BCP SITE ID: C224318 | CLIENT: Gowanus President Owner LLC | DATE: Thu., February 16 th , 2023 WEATHER: Clear, 50 – 60 °F Wind: SW @ 8 – 12 mph TIME: 6:45 am – 4:00 pm MONITOR: Audrey Seery |

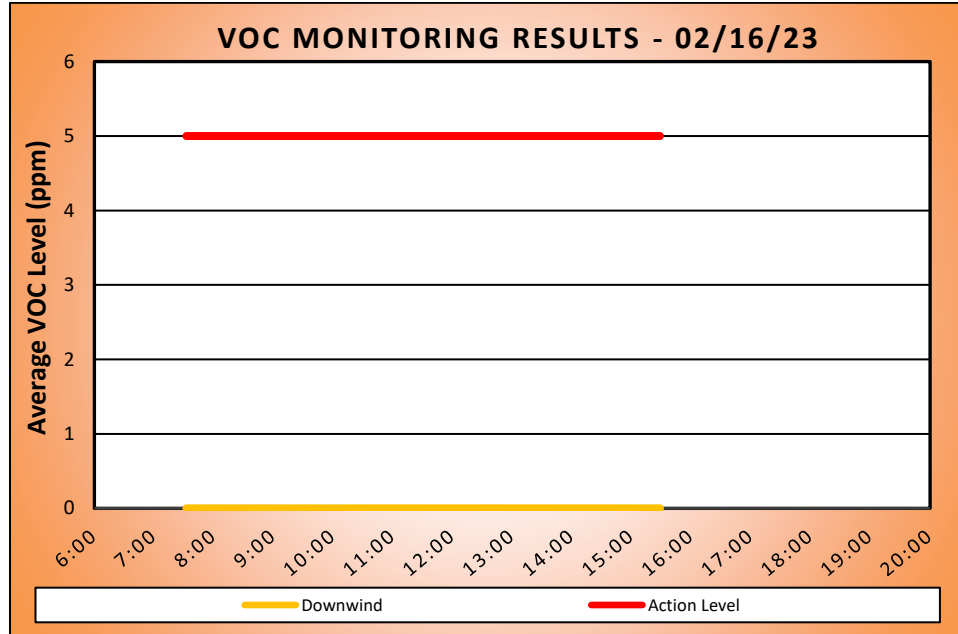
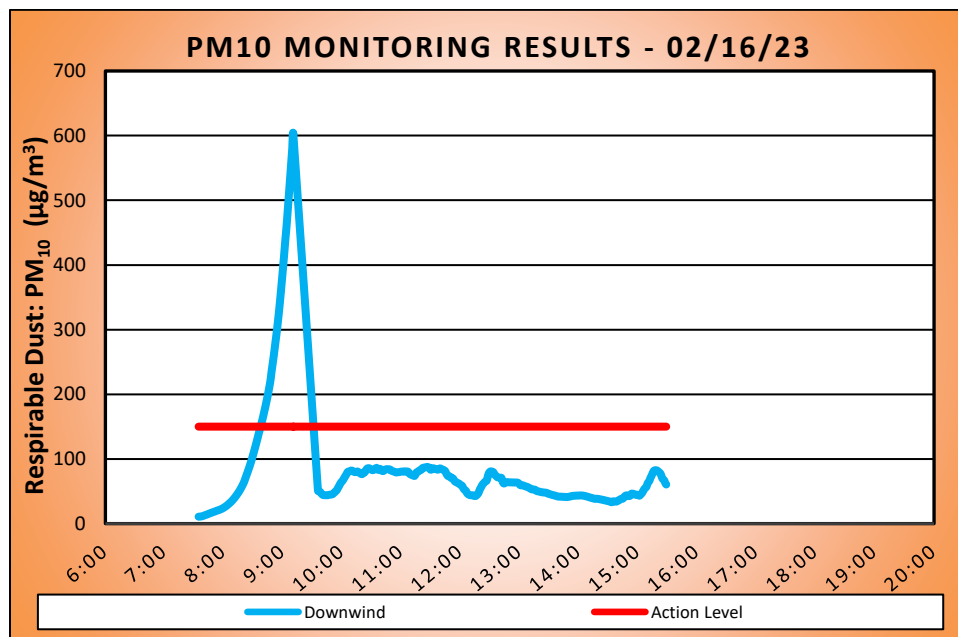
- Langan performed continuous air monitoring at the downwind perimeter of the work zone for volatile organic compounds (VOCs) and particulate matter smaller than 10 microns in diameter (PM10). VOC action levels were not exceeded during the monitoring period. PM10 action levels were exceeded between 8:38 am and 9:11 am. There were no drilling activities during this time period and the elevated concentrations are attributed to an equipment malfunction. The equipment was recalibrated and concentrations decreased to below the action level. No visible dust clouds were observed. Recorded air monitoring data is summarized in the following graphs:

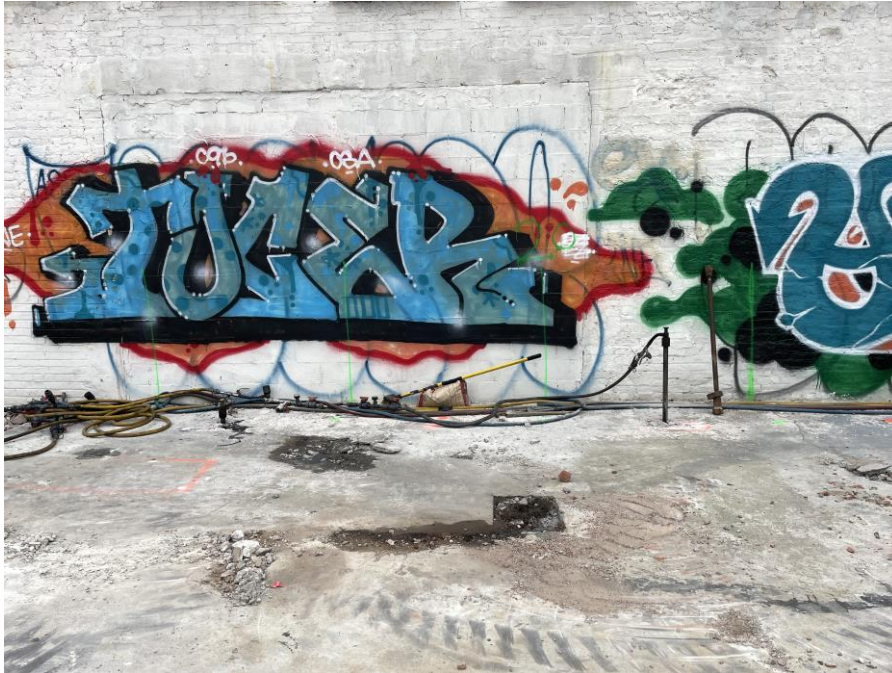
Photo 1: Regensis applying remedial products at injection points IP19 and IP21 (facing north).

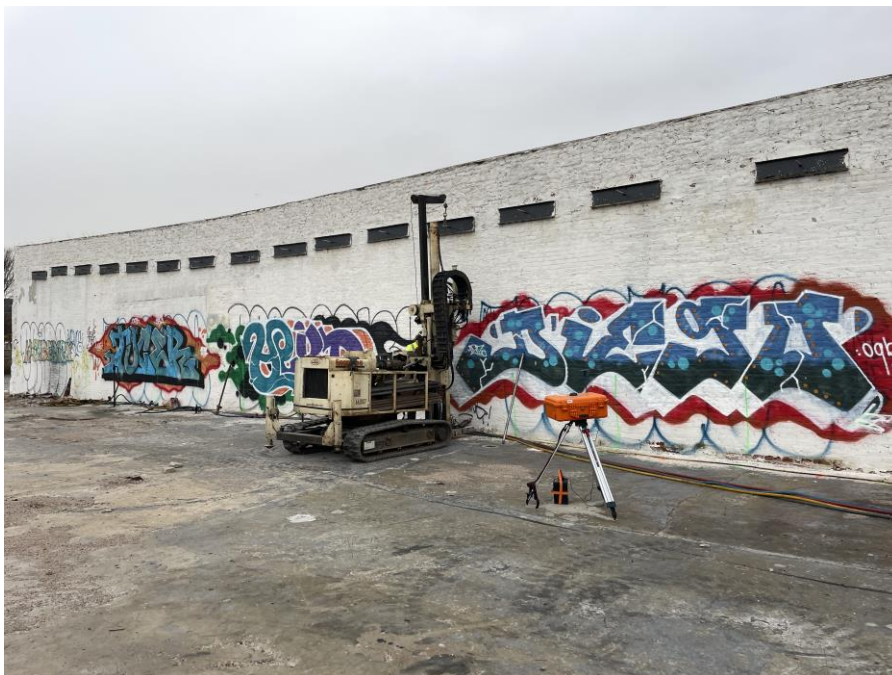
Photo 2: Regensis applying remedial products at injection point IP25 (facing north).
