Prepared by: A. Platt Date: 5/18/2022

Project: BCP Site No. C241149, Teitelbaum Cleaners - Long Island City, NY

Engineer: Matthew Carroll, P.E.	Field Scientist: Ashley Platt
Tenen Environmental, LLC	Tenen Environmental, LLC
Contractor: Jemzn

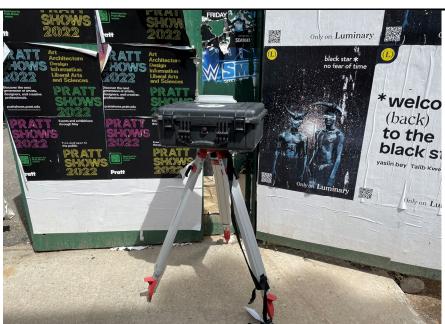
Photo 1: View of the downwind CAMP station set up at the perimeter of the Site.

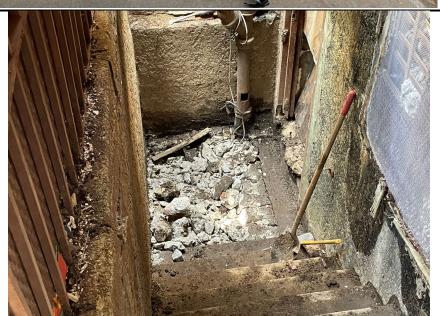
Photo 2: View of the concrete slab following demolition.
