SITE OBSERVATION REPORT – Remedial Investigation – Day 04

PROJECT No.: 170698601 CLIENT: DATE: Monday, 14 November 2022

PROJECT: 125 3rd Street Third Street WEATHER: Partly Cloudy, 40-46 °F

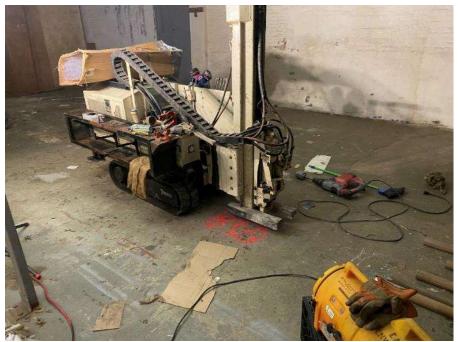
- o **SB21** was advanced to a depth of about 16 feet below grade surface (bgs) (confining layer encountered at about 15 feet bgs). No visual, olfactory, or instrumental evidence of impacts was identified.

Photo 1: Eastern advancing soil boring SB21 (facing northeast).

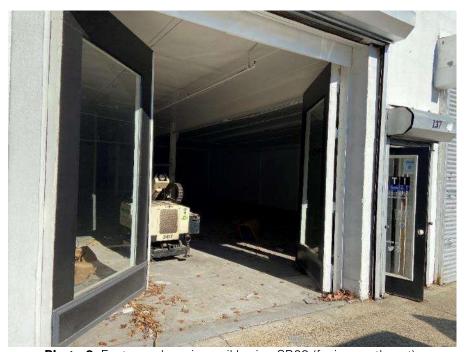
- SB23 was advanced to a depth of about 16 feet bgs (confining layer encountered at about 15.5 feet bgs). No visual, olfactory, or instrumental evidence of impacts was identified. SB23 was completed with a monitoring well (see below).

Photo 2: Eastern advancing soil boring SB23 (facing northeast).
