DAILY FIELD REPORT

Project	Bedford Beverly Brownfield Site	Report No.	2
BCP Site	BCP Site No. C224384	Date	9/21/2023
Location	2359 and 2360 Bedford Avenue, Brooklyn, NY	File No.	0205432
Client	Bedford Beverly Acquisitions LLC	Temperature	57-72 °F
Contractor	Haley & Aldrich, Lakewood Environmental Solutions	Wind Direction	N to S, 2-5 mph
Weather	Sunny	Personnel on Site	S. Sotomayor, C. Evertz
Humidity	75%	Time on Site	6:45am to 3:00pm

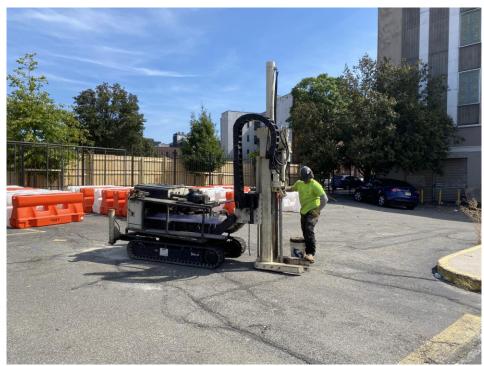
Photo 1: View of contractor advancing waste characterization borings, facing southeast.

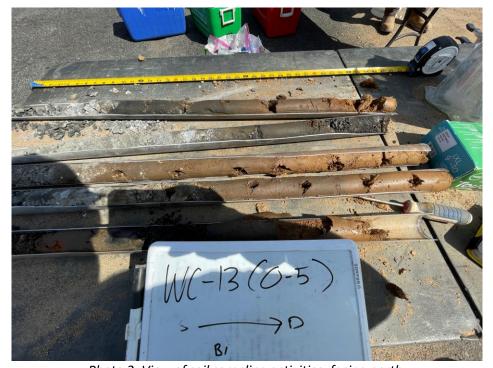
Photo 2: View of soil sampling activities, facing north.
